# National Transportation Safety Board

WPR21LA358

## **MATERIALS LABORATORY**

Factual Report 22-075

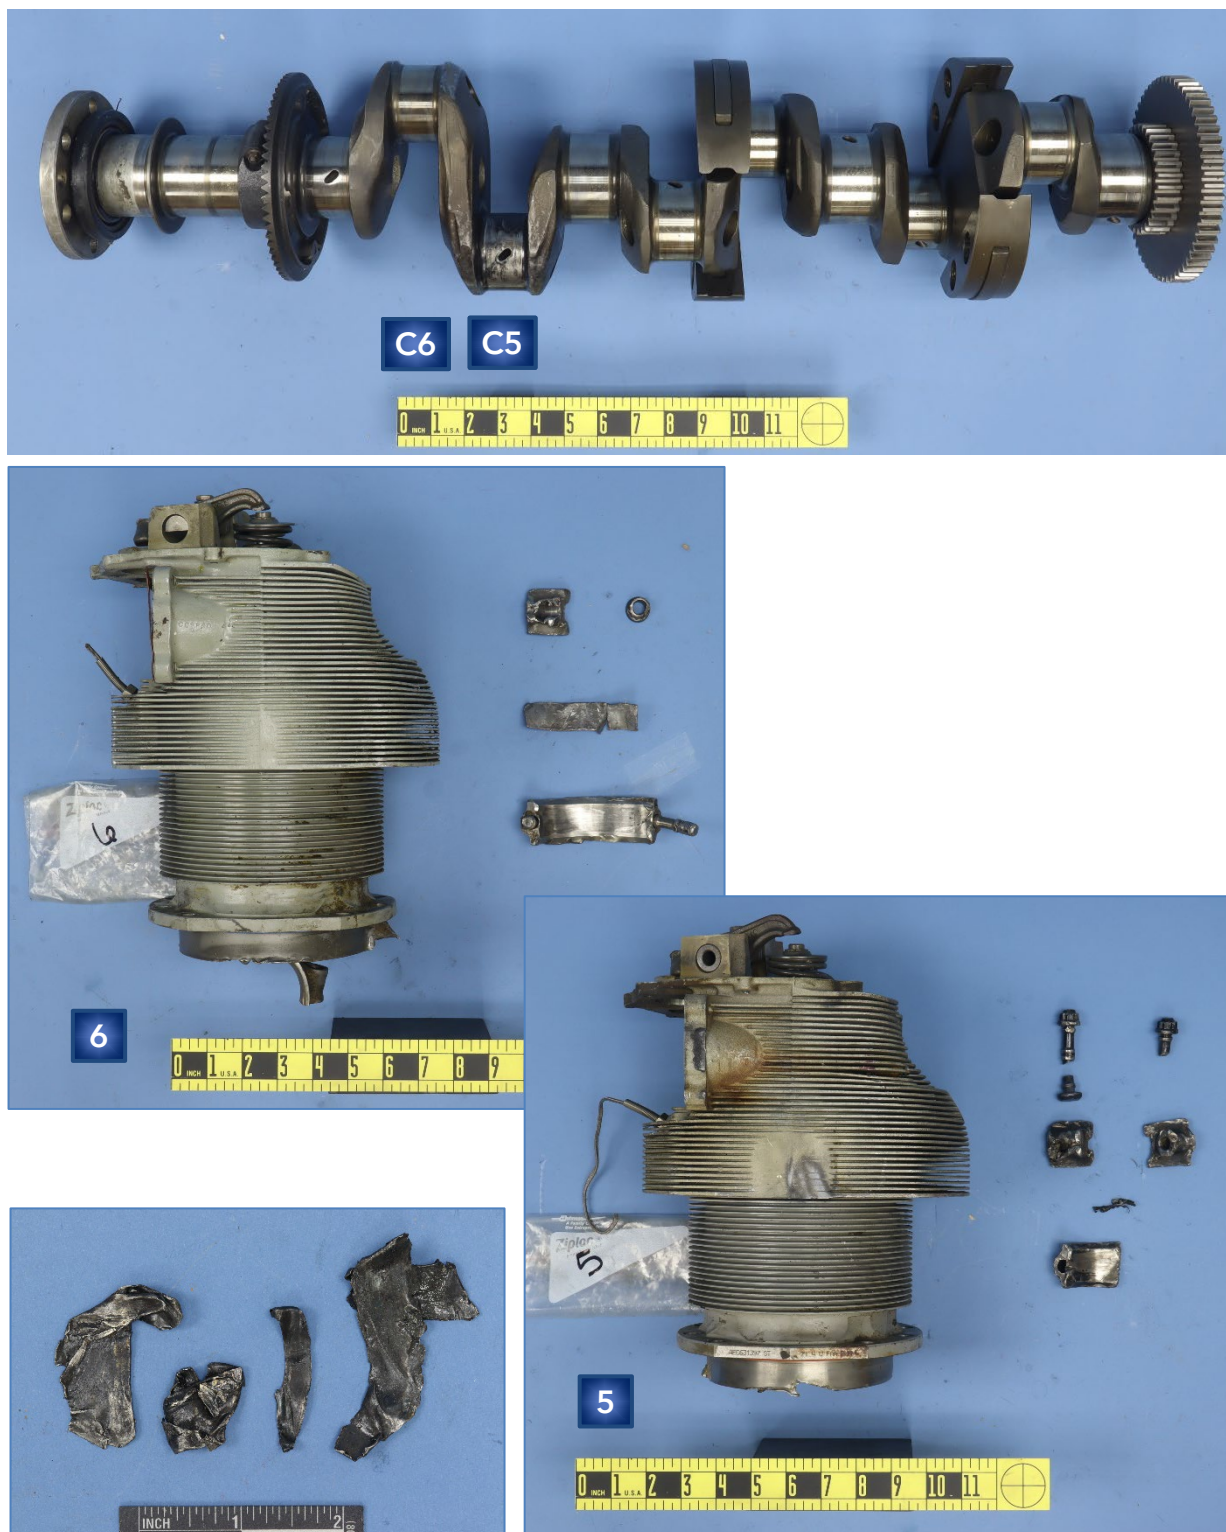
Overall views of the submitted components are shown in figure 1. The crankshaft was intact. The connecting rods for both cylinders were fractured at the big end, and fractured and damaged pieces of the connecting rods, bearings, and fasteners were included as shown in figure 1. The piston assemblies remained within the damaged barrel sections of the cylinders, and the small ends of the connecting rods remained attached to the wrist pins in the pistons. Piston skirts on both pistons were fractured with missing pieces. The barrel skirts on both cylinders were also damaged consistent with contact with the fractured connecting rods.

**Figure 1.** Overall views of the submitted crankshaft (upper image), number 5 cylinder and associated connecting rod pieces, and bearing pieces (lower images), and number 6 cylinder with connecting rod pieces and a bearing half (middle image).

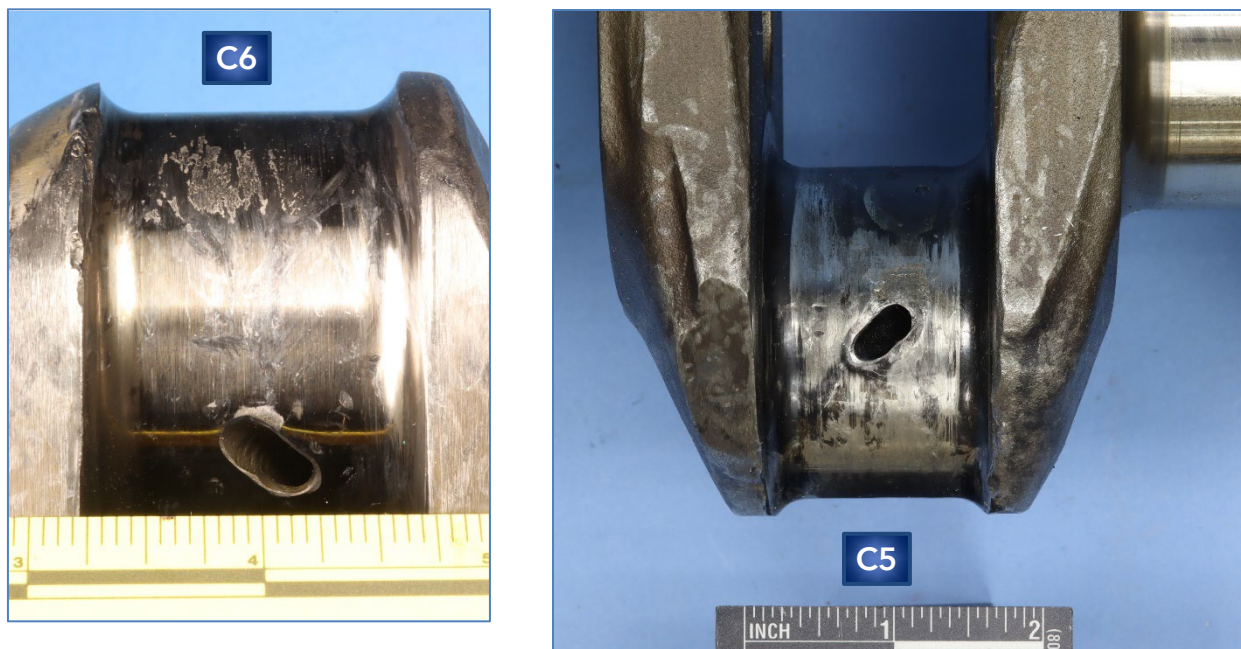
Closer views of damaged connecting rod journals on the crankshaft are shown in figure 2. Scoring, deposited material, and heat tint damage was observed on the journal for the number 5 connecting rod (C5). Scoring and pitting damage was also observed on the journal for the number 6 connecting rod (C6). The remaining journals for the connecting rods and the main journals had a nominal appearance with no damage noted.

**Figure 2.** Connecting rod journals C5 and C6.

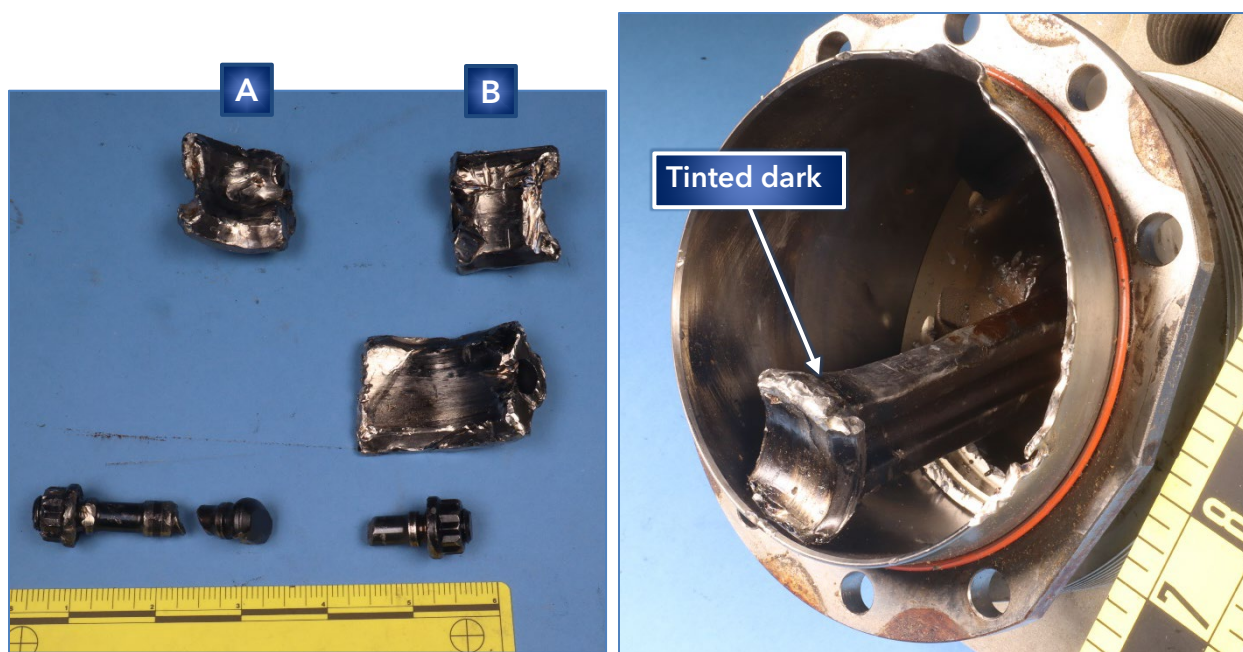
Closer views of connecting rod pieces and connecting rod bolts from the number 5 cylinder are shown in figure 3. The big end of the connecting rod was tinted dark as indicated in the right image in figure 3 consistent with exposure to high heat. The broken connecting rod pieces shown in the left image in figure 3 also showed tinting consistent with high heat exposure. The corresponding bearing remnants shown in the lower left image in figure 1 were severely worn, deformed, broken, flattened, and darkened consistent with high heat exposure.

Approximately half of the cap and the head end of one of the connecting rod bolts were missing. Fracture features on both bolts and the cap had rough features and deformation consistent with ductile overstress fracture.

**Figure 3.** Broken connecting rod in the number 5 cylinder barrel (right image) and closer views of the number 5 connecting rod strap, cap, and attachment bolt pieces (left image). Strap pieces are arbitrarily labeled A and B for reference.

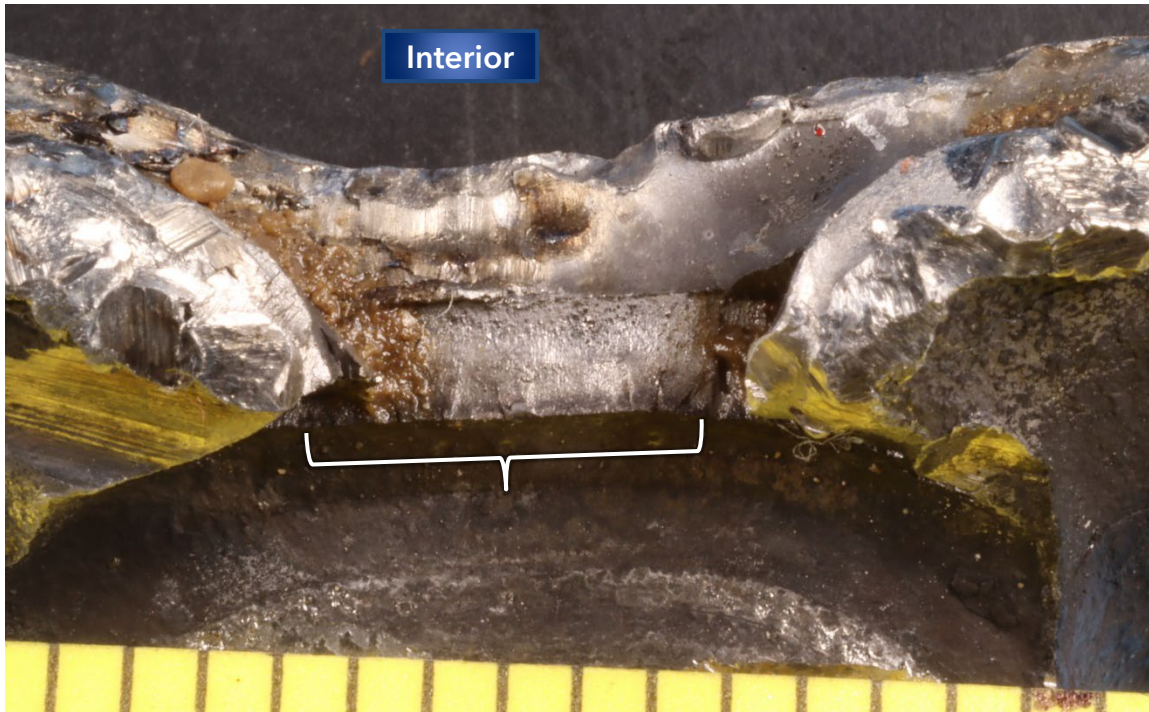
The fractured strap pieces from the number 5 connecting rod were arbitrarily labeled "A" and "B" as shown in figure 3 for reference in this report. A close view of the fracture surface of strap piece A is shown in figure 4. A portion of the fracture surface near the exterior surface had relative smooth fracture features separated by ratchet marks<sup>1</sup> and curving crack arrest lines, features consistent with fatigue. The fatigue initiated from multiple origins in the radius of the attachment boss as indicated with a bracket in figure 4. Most of the fracture surface was smeared and obliterated by post-fracture damage, but the relatively small fatigue region transitioned to relatively rough matte gray features in the remaining portion of the fracture surface shown in figure 4.

**Figure 4.** Fracture surface of strap A showing a fatigue region with multiple origins in the bracketed area at the radius of the attachment bolt boss.

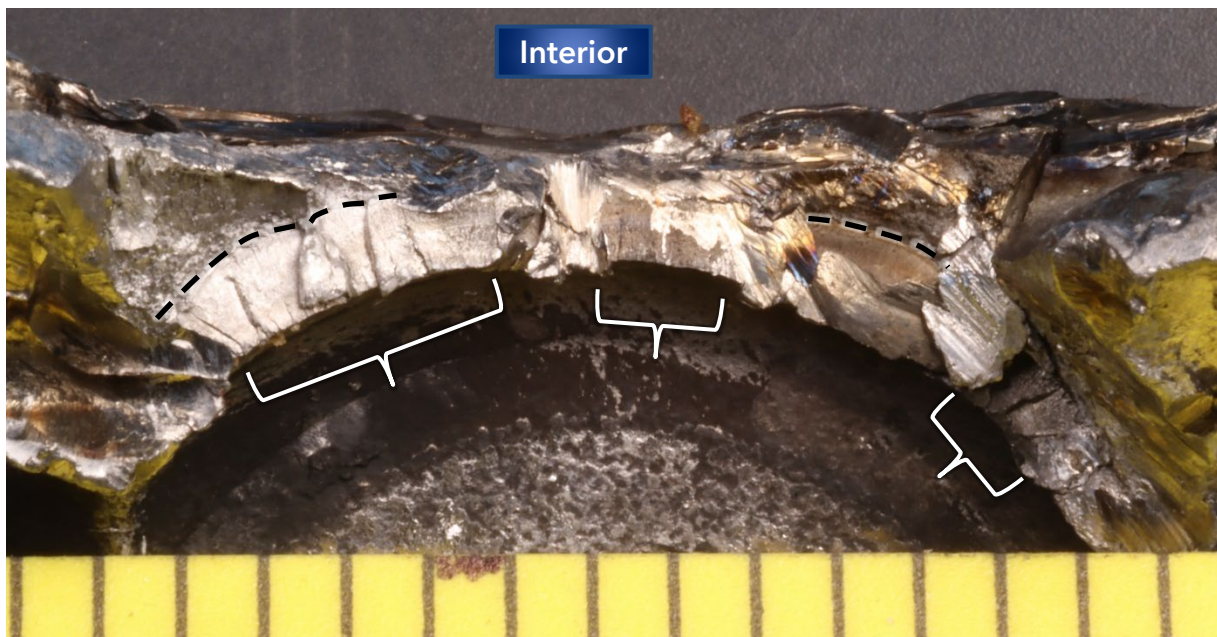
A close view of fracture features on strap B is shown in figure 5. The fracture surface on the strap B piece was also substantially damaged. However, relatively smooth fracture features with curving crack arrest lines and ratchet marks were observed consistent with fatigue. Multiple fatigue origin were observed within each of the bracketed areas indicated in figure 5, and areas between the brackets were obliterated by post-fracture impacts. The fatigue origins were located at the radius for the attachment bolt boss, similar to the location on strap A. Partial fatigue boundaries were observed as indicated with dashed lines in figure 5, but impact

damage prevented identification of the entire extent of the fatigue boundary or boundaries.

**Figure 5.** Fracture surface of strap B showing fatigue regions with multiple origins at the radius of the attachment bolt boss. Brackets indicate origin areas, and dashed lines indicate partial fatigue boundaries.
