# National Transportation Safety Board

WPR21LA358

## **ENGINE EXAMINATION REPORT**

Location: Baker, Nevada  
Date: September 11, 2021  
Time: 1300 PDT  
Airplane: Beech 35-B33, N8983M

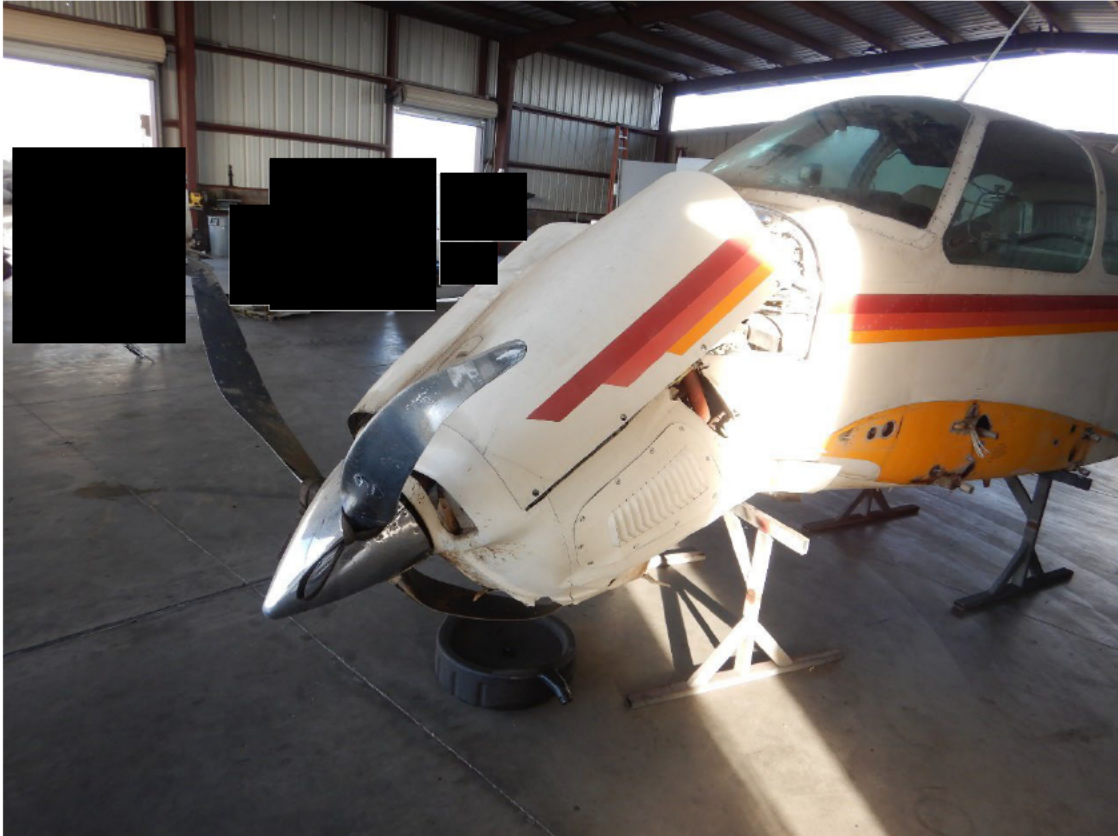
The airframe remained intact. The wings were removed to facilitate recovery of the airplane. The engine remained connected to the airframe via the engine mounts. The propeller hub and blades remained attached to engine. All three propeller blades showed evidence of S-bending with the blades all curled aft. Throttle, mixture, and propeller were moved from their cockpit controls with full travel noted.

Photo 1 - View of Airframe and Propeller System

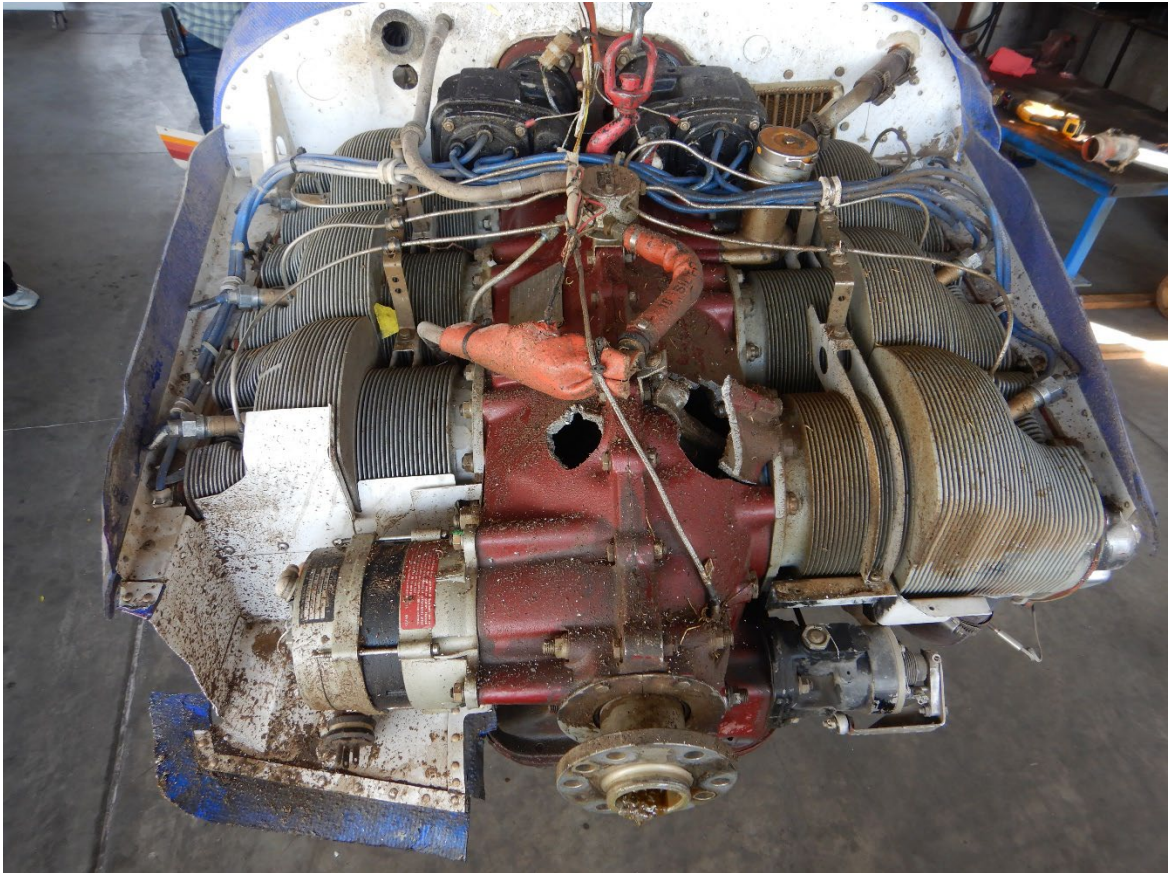
Visual examination revealed two holes in the forward part of the engine case at cylinders No 5 and 6. The top portion of the connecting rod were found lying on the lower cowling. No 5. Cylinder is an ECi.

Photo 2 - View of Engine with holes in the case

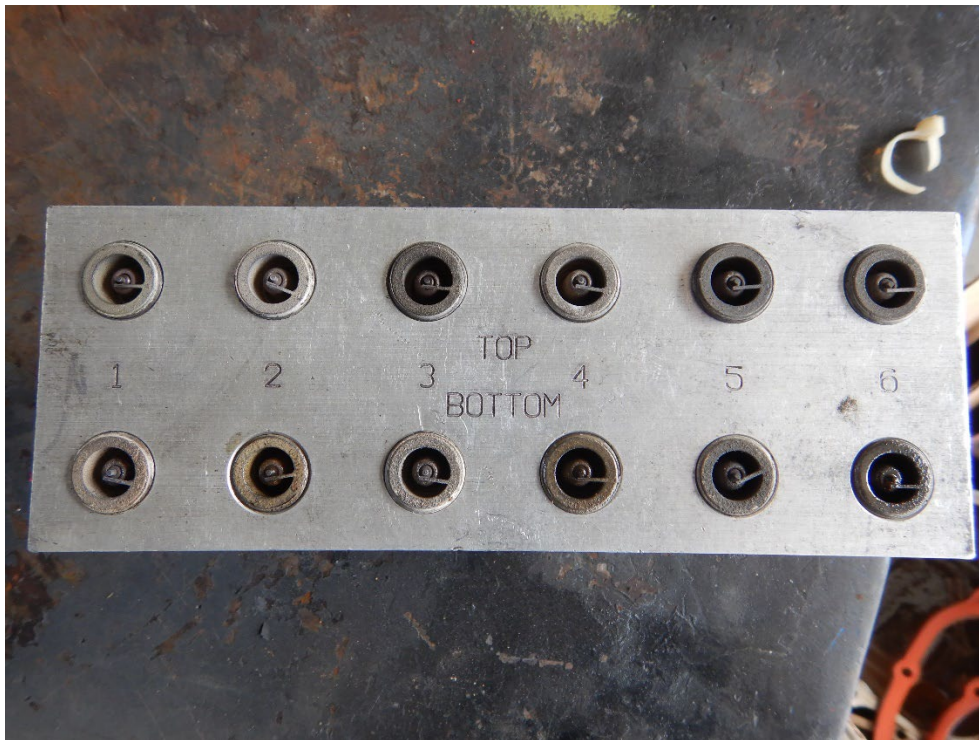
The top and bottom spark plugs were removed. According to the champion Check-a-plug chart AV-27, the electrodes exhibited normal wear appearance.

Photo 3 - View of the Spark Plugs

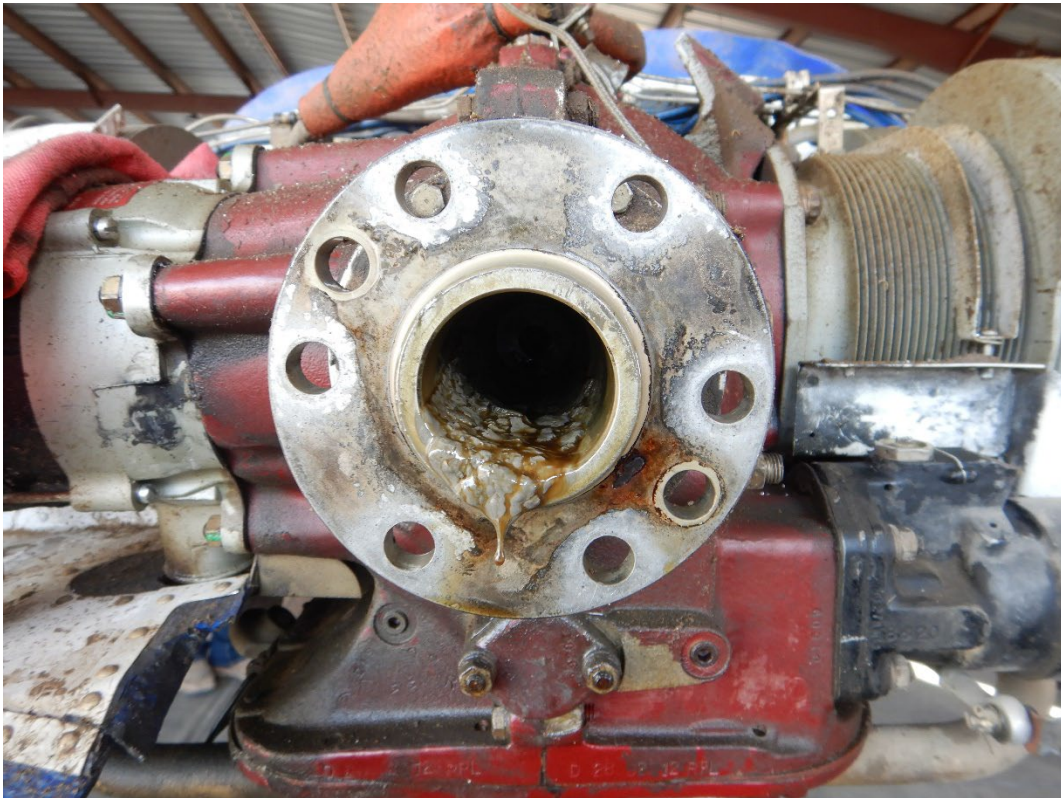
The crankshaft had lead separation from the oil present, likely result of fuel in the system.

Photo 4 - Forward View of Engine

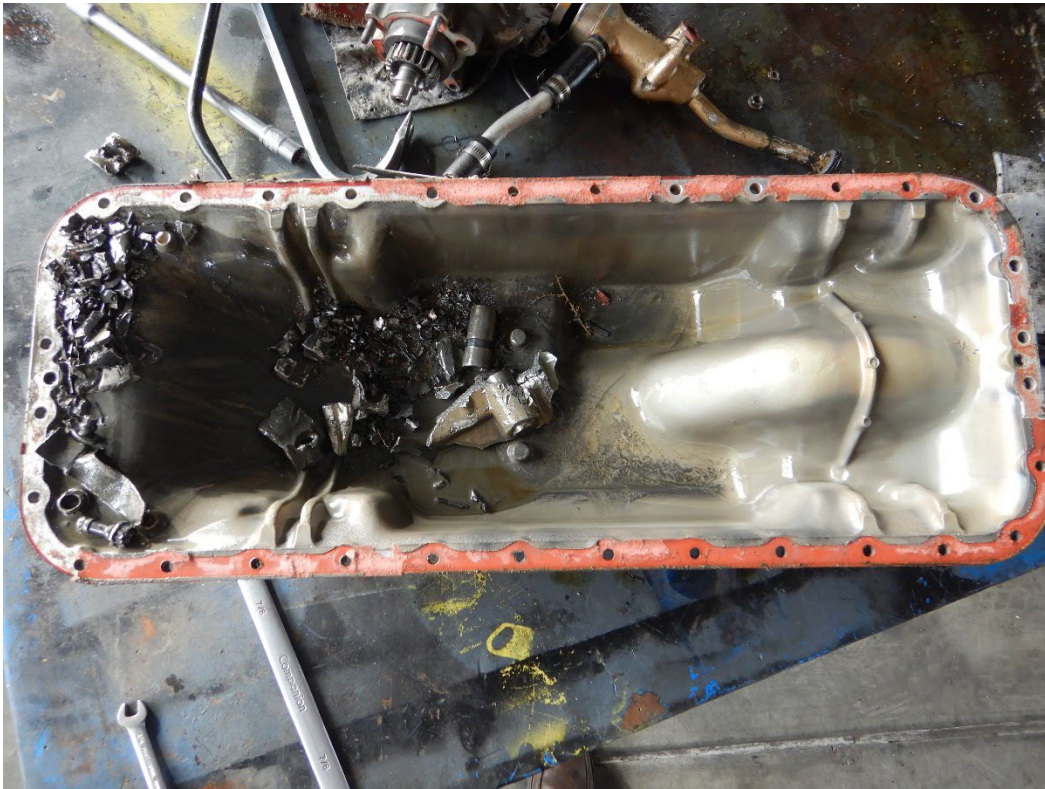
The oil sump was removed and connecting rod material and lifters along with various other metal pieces were identified in the sump.

Photo 5 - View of Oil Sump

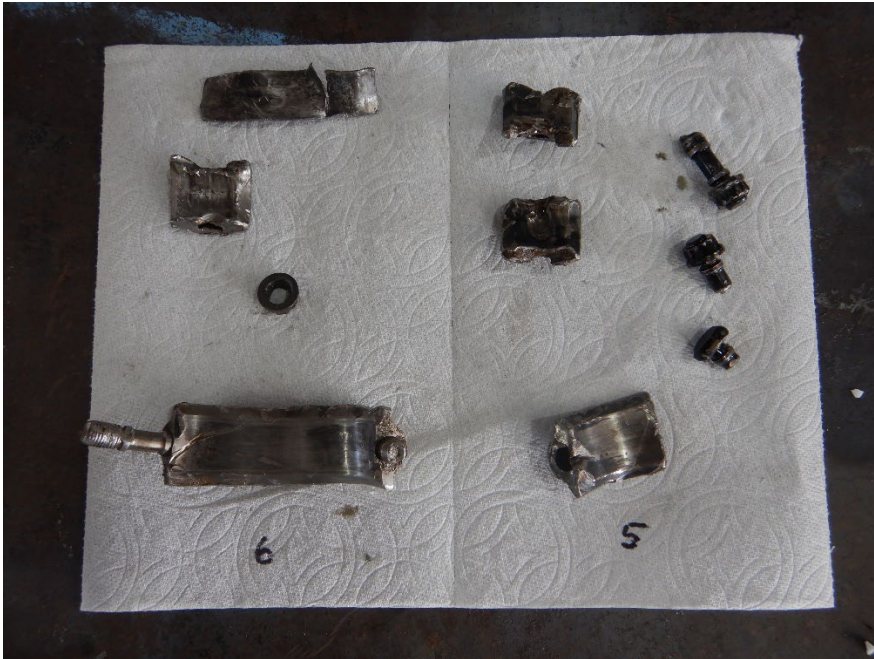
Photo 6 - View of Connecting Rod Pieces and Hardware

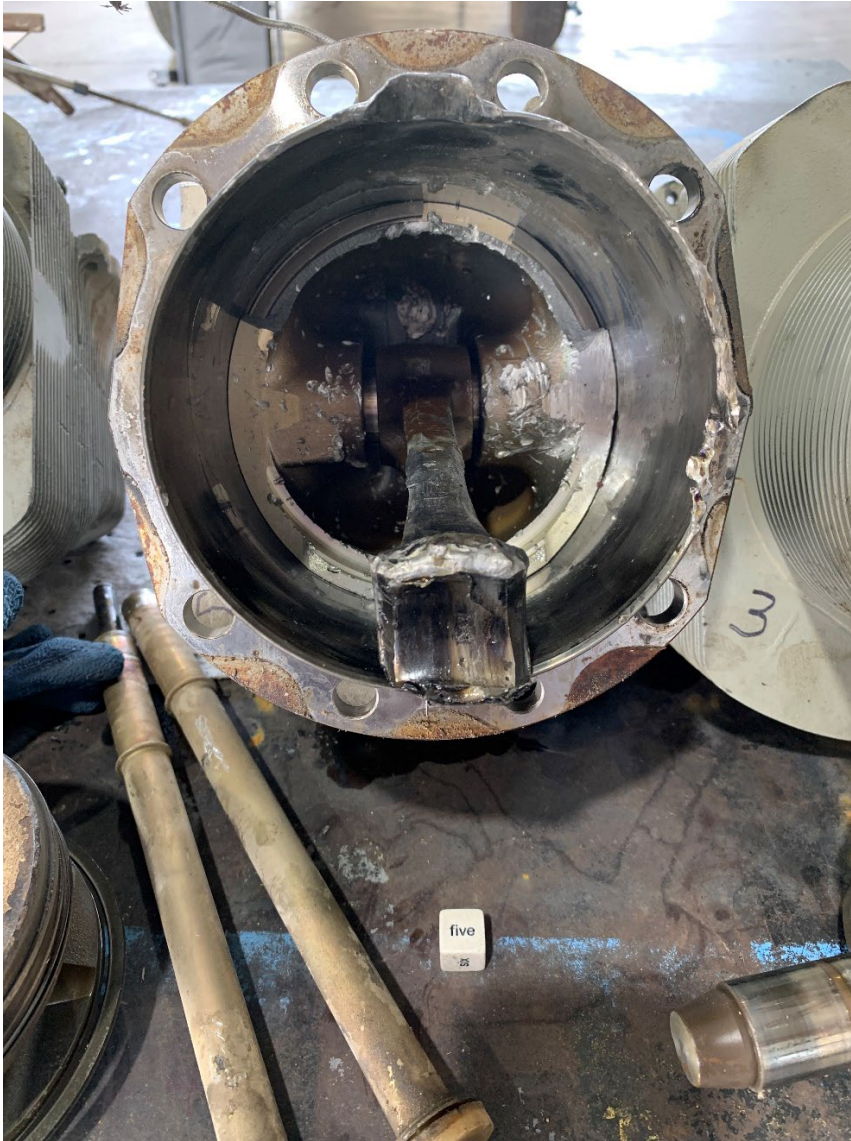
Photo 7 - View of No 5 Cylinder

The No's 5 and 6 cylinders with connecting rods and pistons, as well as pieces of connecting rods from the oil sump and the crankshaft were shipped to the materials laboratory for further examination.
