## **NATIONAL TRANSPORTATION SAFETY BOARD**

### **ENGINE EXAMINATION SUMMARY**

**WPR21LA363**

| Aircraft: | Piper PA-32-300, N33022 |

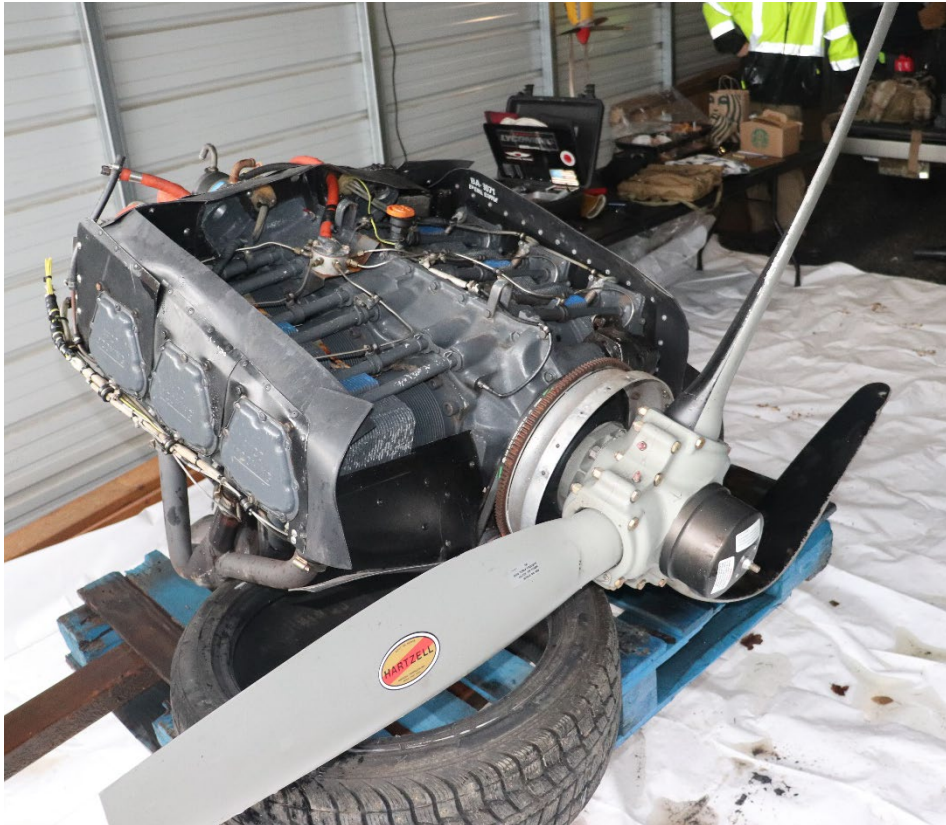
Examination of the recovered engine was conducted on March 2, 2022, at the facilities of Nu Venture Air Services, LLC. The engine (figure 1), a Lycoming IO-540-K1A5), serial no. L-12770-48 was separated from the airframe during recovery. Per logbook records, the engine had a time since overhaul of 143.77 hours.

**Figure 1. Picture of accident engine**

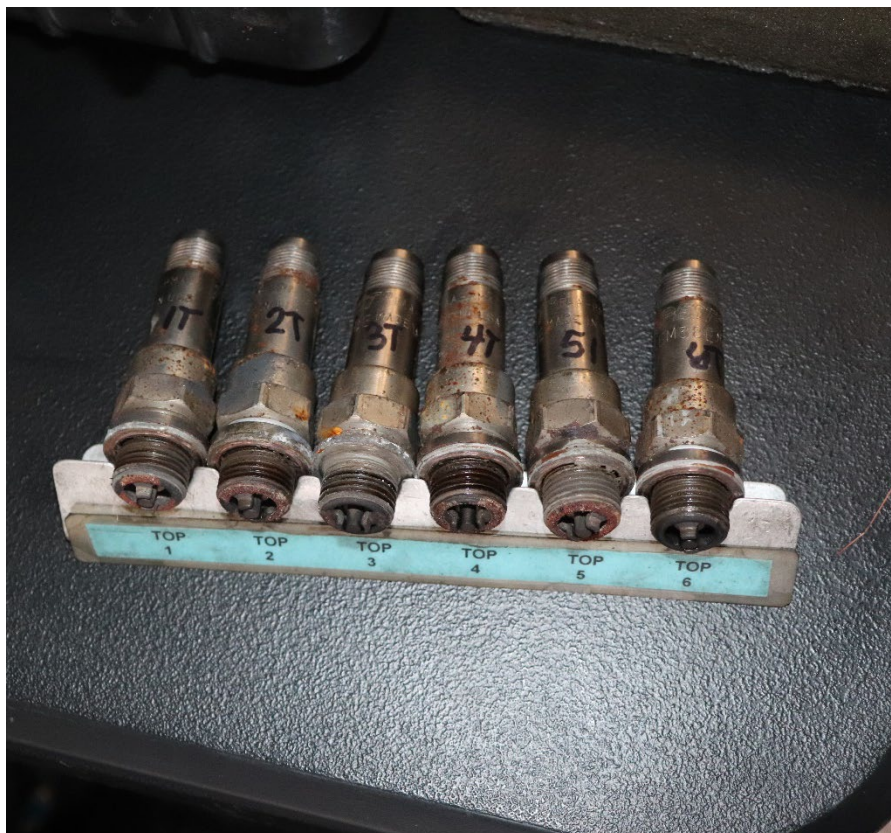
The top spark plugs were removed (figure 2), and all spark plug electrodes were intact with carbon build-up; all spark plugs revealed symmetrical wear. The crankshaft was manually rotated using the propeller, thumb compression in all six cylinders and mechanical valve train continuity were established.

**Figure 2. Picture of six top spark plugs**

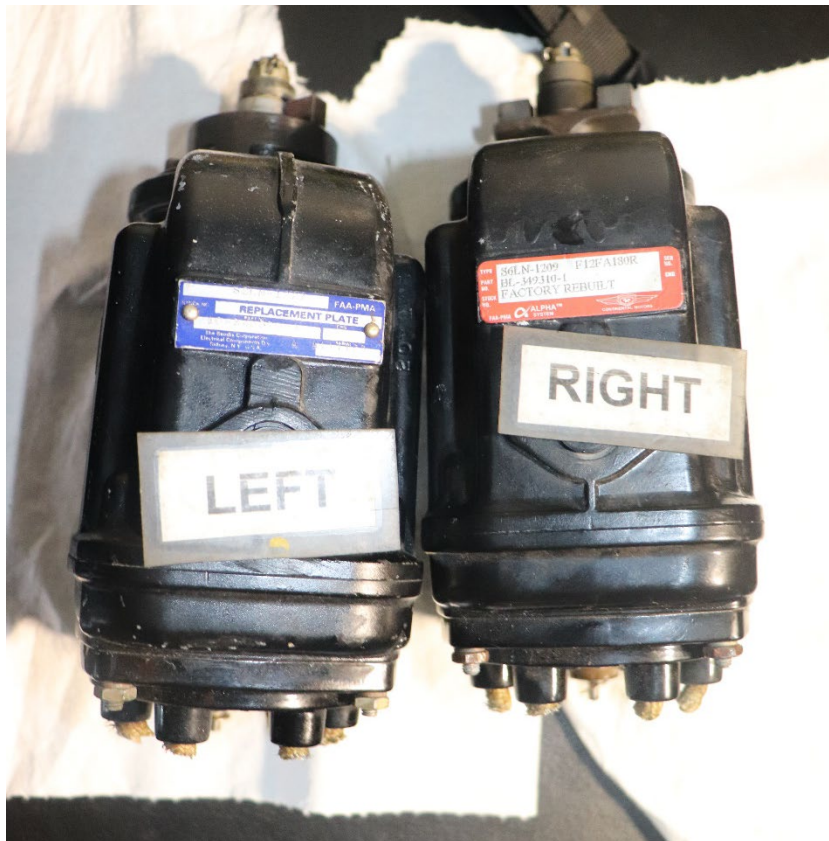
The left Bendix magneto model no. 10-349370-4, serial no. A117129, sustained impact energy damage and was partially displaced from the mounting pad. The fracture surface signatures at the magneto-mounting flange were consistent with overload forces. The pieces of magneto flange that remained at the mounting pad were securely clamped. Magneto to engine timing could not be ascertained. The impulse coupler drive was found intact and secure. The magneto was removed and manually rotated; it produced sparks at the six leads during hand rotation the drive.

The right Bendix magneto model no. BL-349310-1, serial no. F12FA180-R, was found securely clamped at the mounting pad. The magneto to engine timing was observed at approximately 23° BTDC of the cylinder no. 1. The magneto was removed, and the drive was found intact and properly safetied. The magneto was manually rotated; it produced sparks at the six leads during hand rotation the drive.

**Figure 3. Picture of left and right magneto**

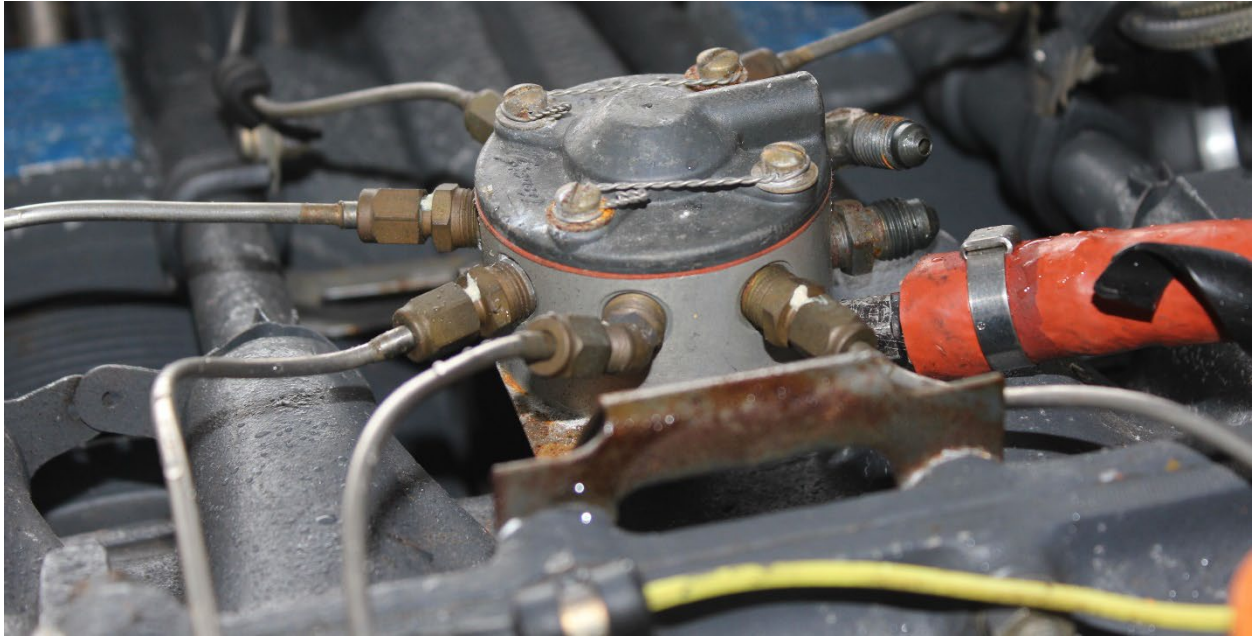
The fuel flow divider (figure 4) remained intact. All six output fuel lines to the cylinders remained intact and connected to its respective fuel nozzle. The fuel flow divided cover was removed and revealed that the diaphragm and spring were intact. No water or contaminants were found within the cavity.

**Figure 4. A close-up picture of the fuel flow divider**

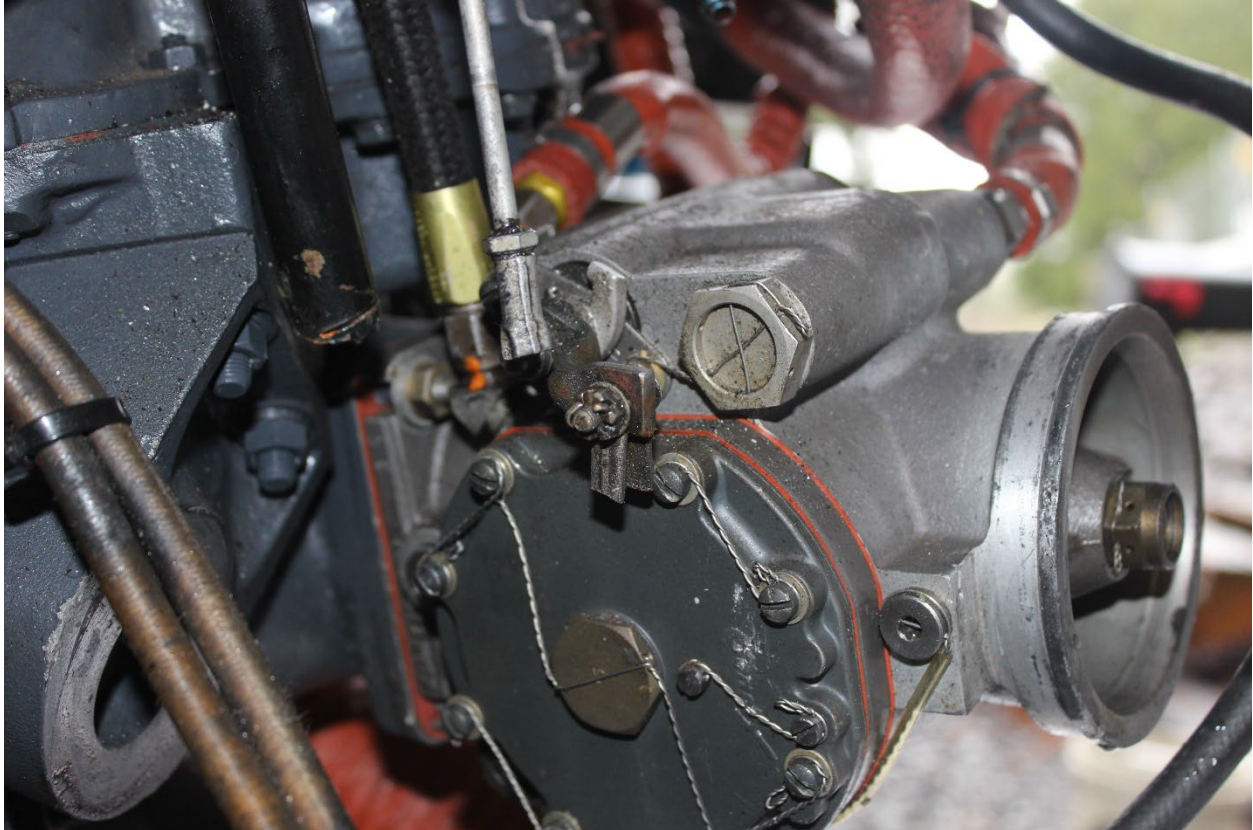
The fuel flow servo body was intact (figure 5). The mixture mechanism was mechanically cut during recovery. All input and output fuel lines were intact. The fuel line from the output section of the fuel pump to the input section of the fuel servo body was found intact and no fuel was found within the line. Fuel flow servo fuel filter was removed and found unremarkable. Fuel was found within the cavity of the servo and no water was found in the fuel.

**Figure 5. A close-up of Fuel Flow Servo**

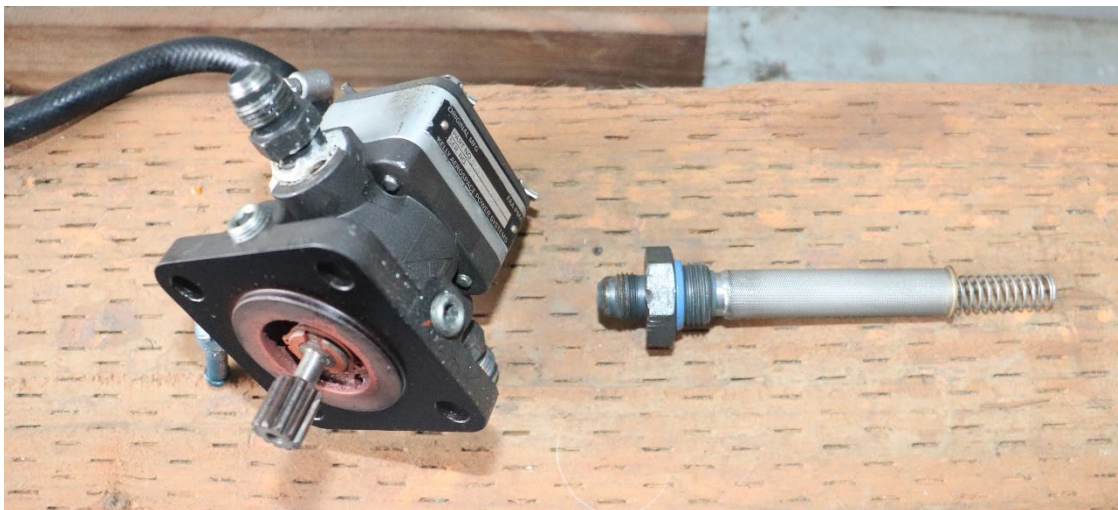
The fuel pump (figure 6) was removed and found intact. The fuel pump gear was found intact and unremarkable; gear was manually rotated and freely spun.

**Figure 6. A picture of the fuel pump and fuel flow servo fuel filter**

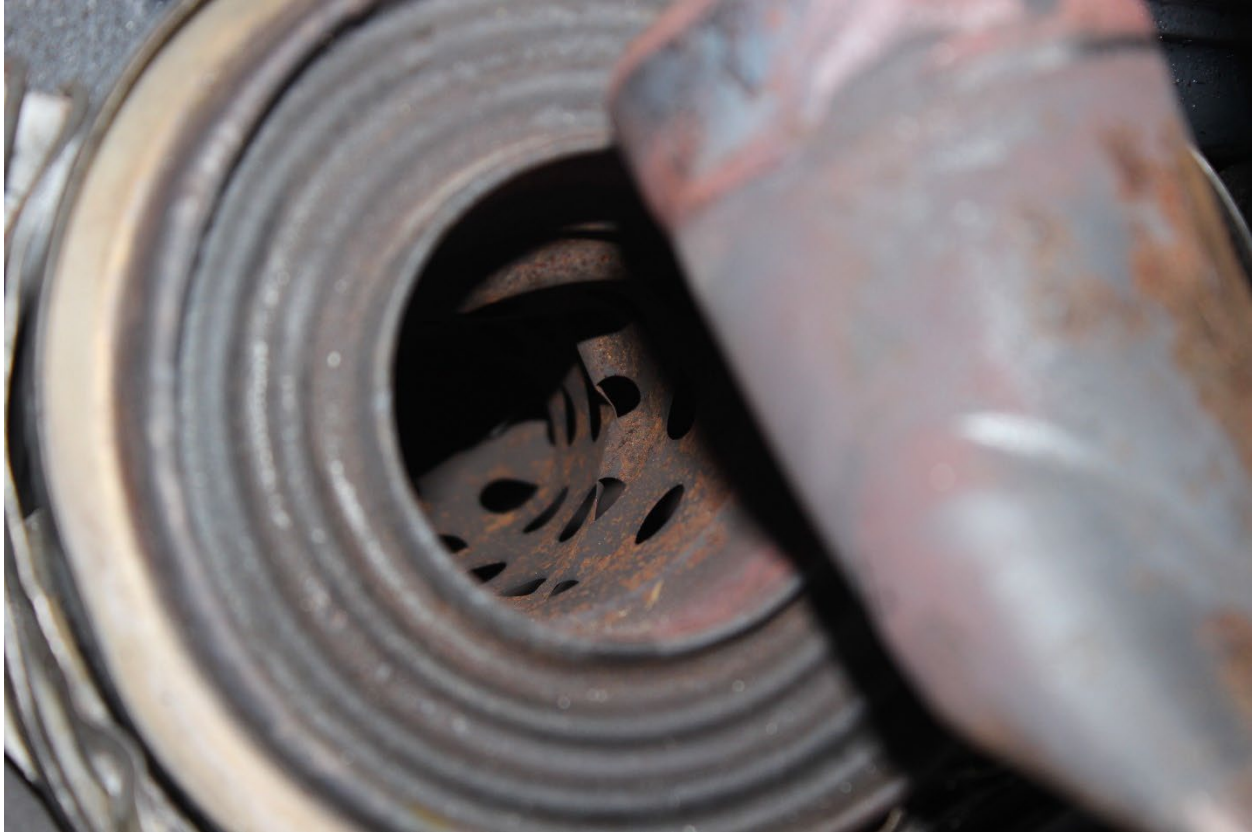
The muffler sustained impact damage; its internal metal lining (figure7) was intact but sustained impact damage.

**Figure 7. A picture of muffler and its internal metal lining.**

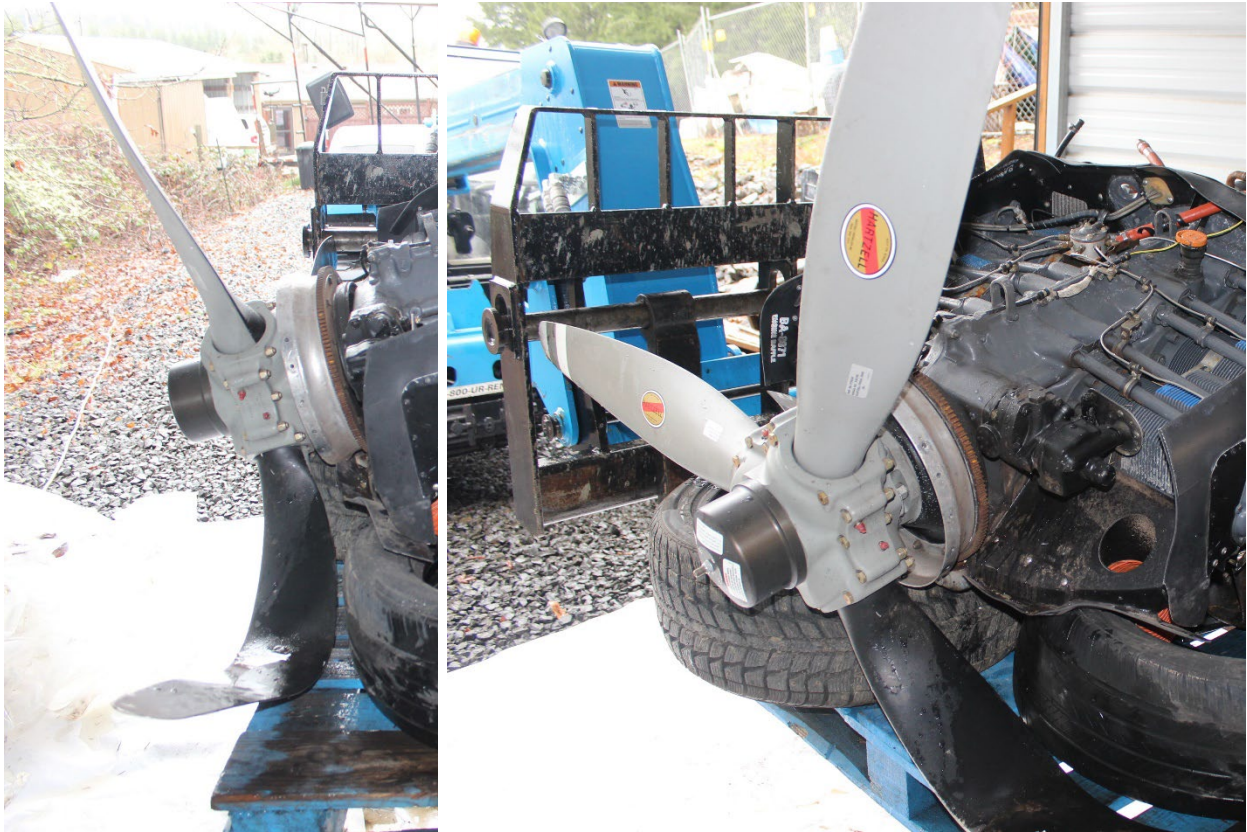
The spinner, propellor hub, and 3 blades were still attached to the hub. One blade was bent aft midspan (figure 8). The other blades were intact with minor chordwise scratches.

Figure 8. Two viewpoint pictures of propeller blades and hub assembly
