## **NATIONAL TRANSPORTATION SAFETY BOARD**

# **AIRFRAME AND ENGINE EXAMINATION**

**WPR22FA001**

| Aircraft: | Piper, PA28-181, N2868H \ |

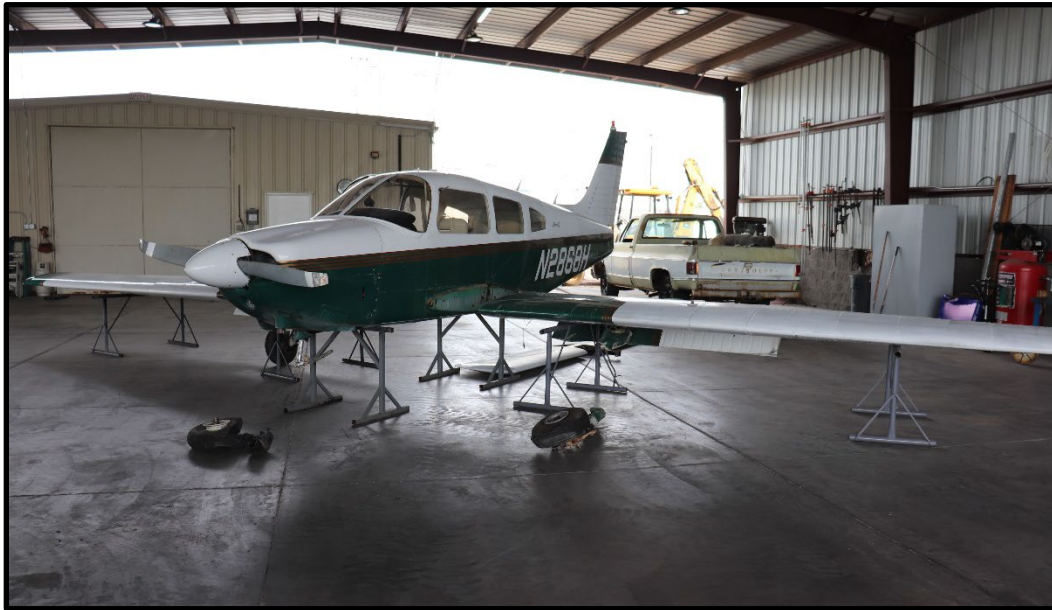
Figure 1: front view of airplane during exam

Both wings were removed from the airframe by the recovery company to facilitate transportation and storage. Examination of the airframe revealed that the nose landing wheel and tire, and the left landing gear assembly were separated from the airframe. Additionally, the recovery personnel drained about 30 gallons of fuel from the left and right fuel tanks to facilitate recovery.

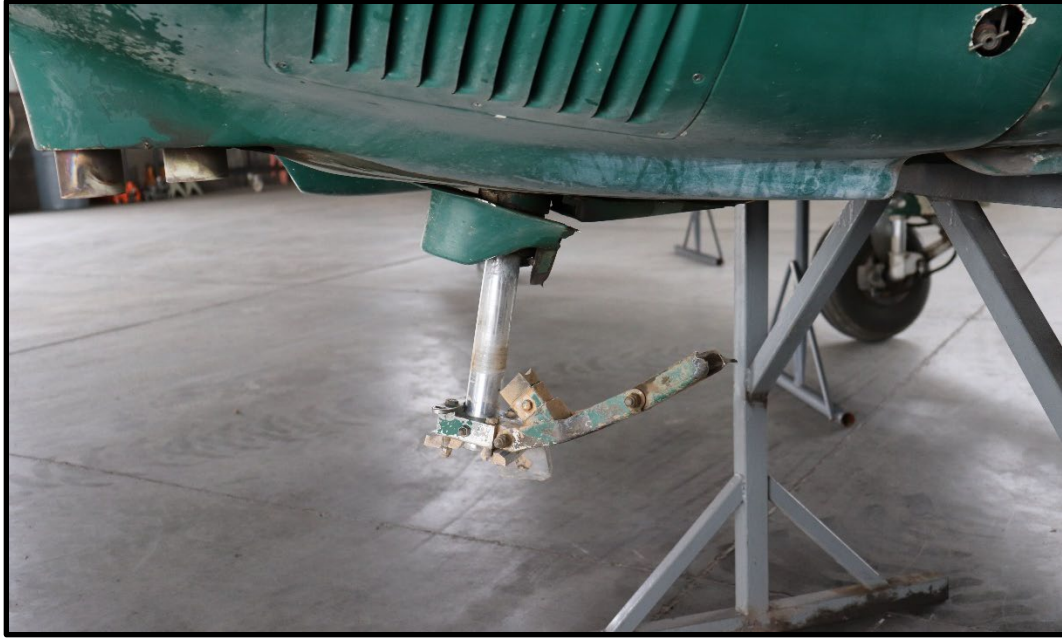
Figure 2: view nose landing gear wheel assembly

The nose landing gear wheel assembly was separated from the strut fork assembly. The tire was cut near the center diameter, from tread to tread, consistent with main rotor impact. Impact damage, constant with main rotor blade contact was observed to the outer diameter of the tire rim assembly. Impact damage consistent with main rotor blade contact was noted to the nose landing gear oleo strut assembly. The nose landing gear fork casting was fractured near the upper attachment point; the left-side and right-side forks separated from the casting.

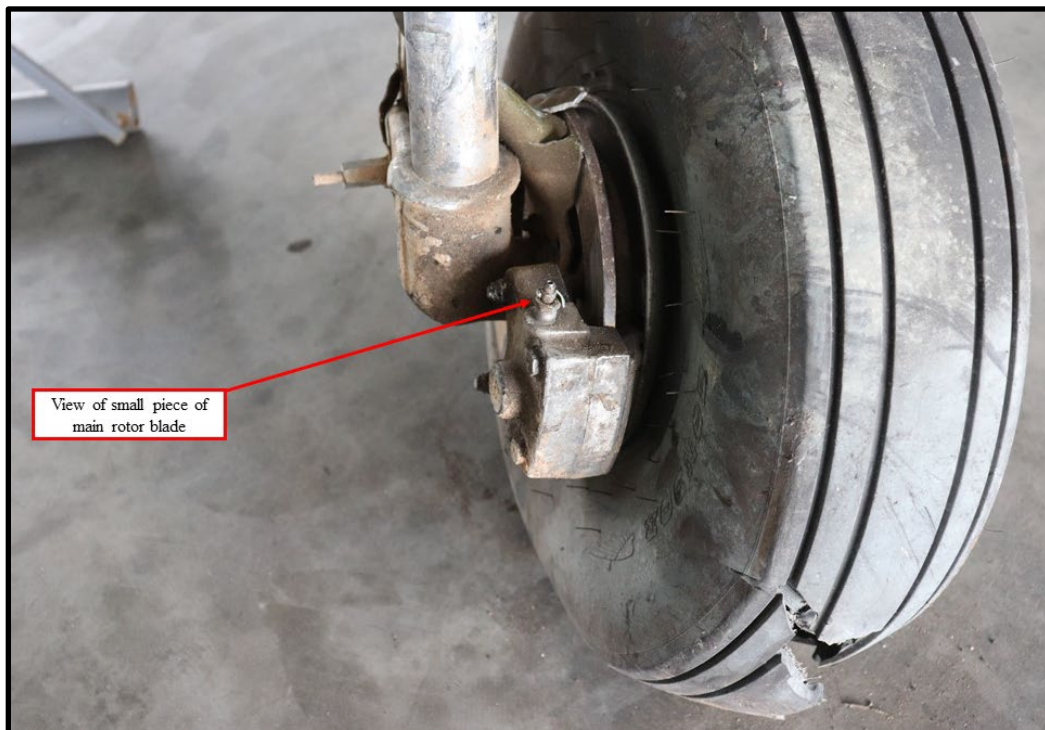
Figure 3: view left main landing gear

The left main landing gear was separated from the airplane at the wing spar attachment. The left landing gear strut fairing was partially separated from the wing. The landing gear strut fairing had impact damage near the bottom section, consistent with main rotor impact. The tire was cut, about 9 inches in length on the tread, consistent with main rotor impact. A small piece of main rotor blade was imbedded in the upper brake bleeder valve seat.

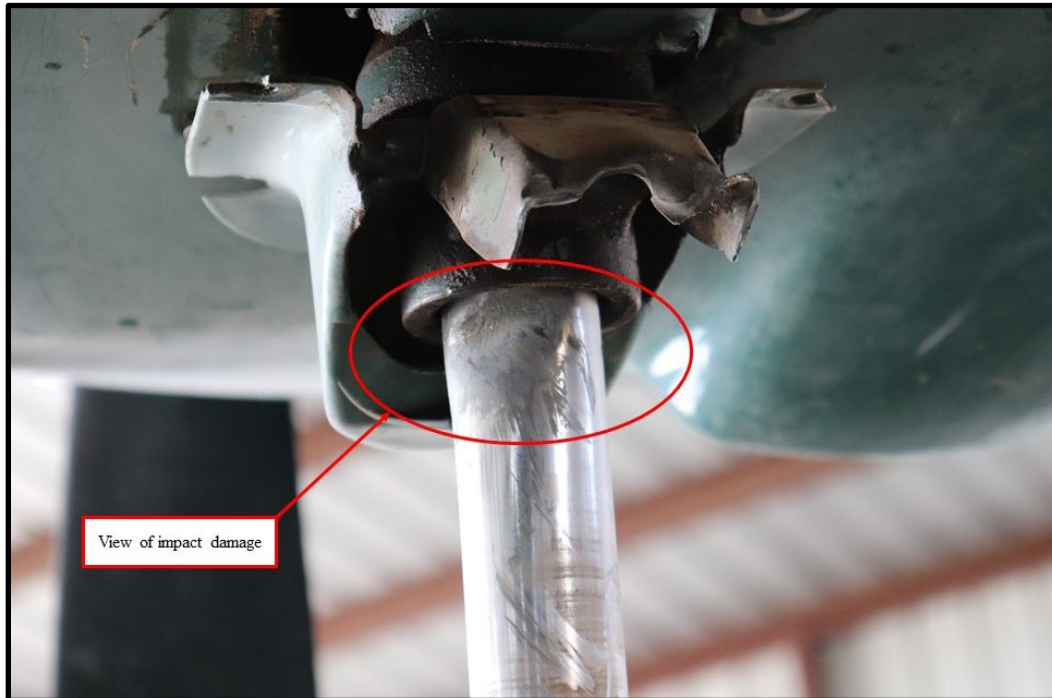
**Figure 4: view right main landing gear**

The right main landing gear remained attached to the right wing. Impact damage was noted on the right main landing gear strut fairing from the aft section to the landing gear. The chromed inter cylinder of the landing gear had impact damage, consistent with main rotor impact.

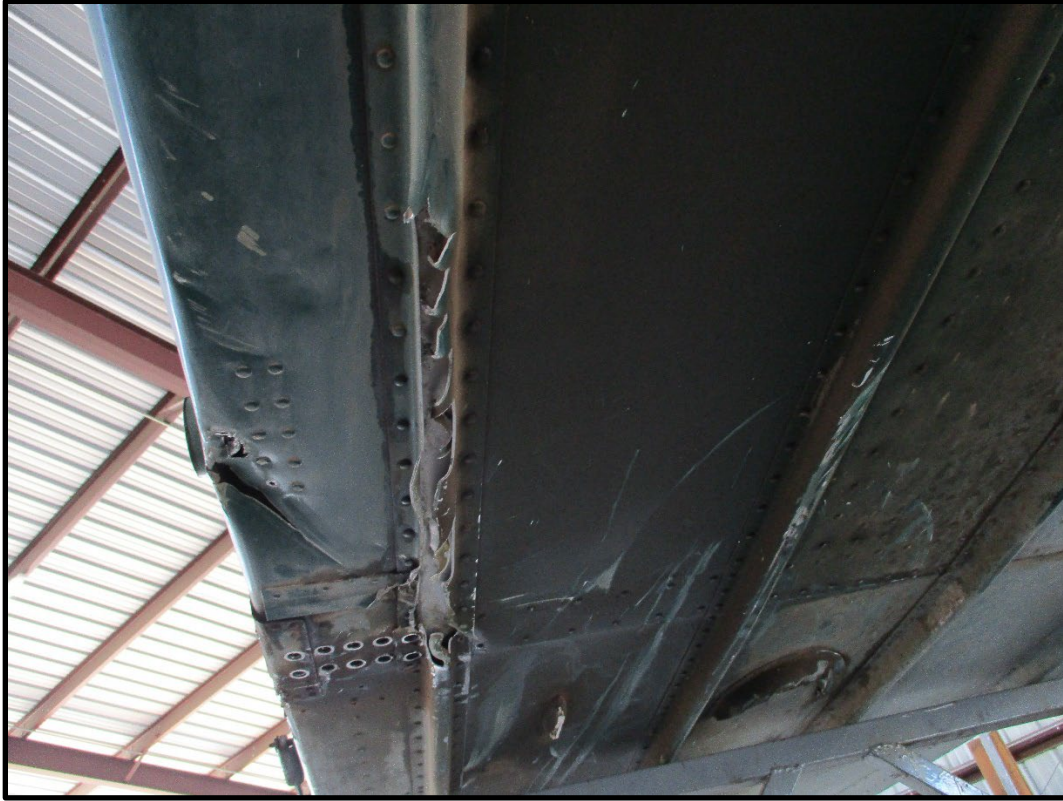
Figure 5: view airplane fuselage undercarriage

Examination of the airplane fuselage undercarriage revealed crushing and jagged tearing measuring about 18 inches in length on the hat channel, along the longitudinal axes near the wing root.

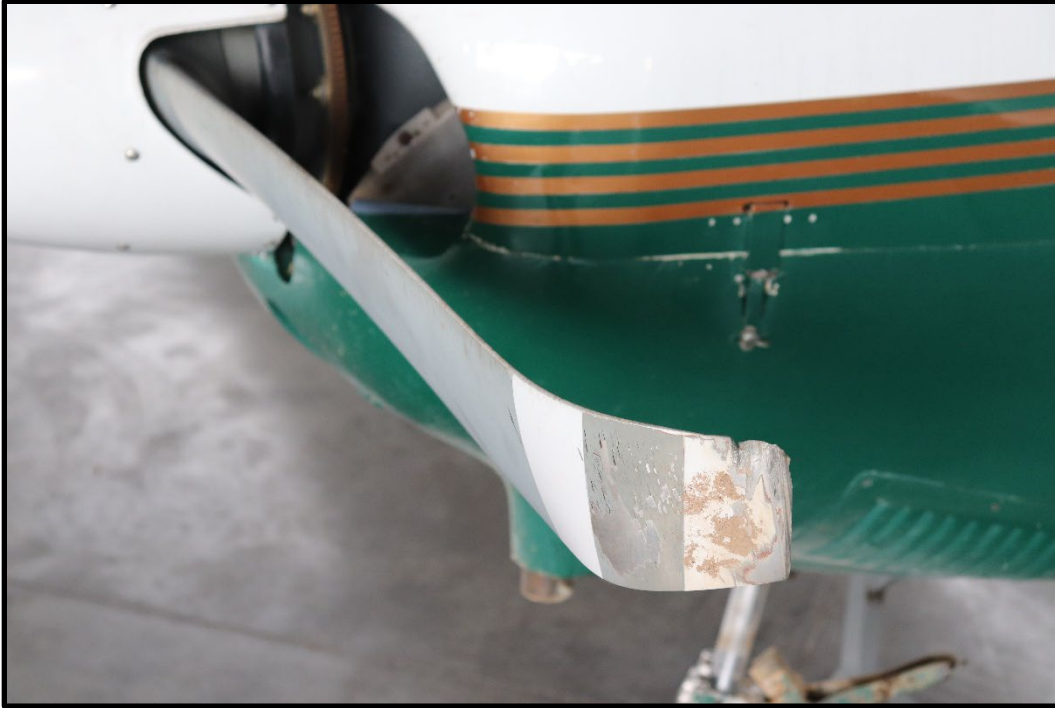
Figure 6: view of airplane propeller blade A

The airplane was equipped with a 2 blade, fixed pitch propeller. Both propeller blades remained attached to the propeller hub. Propeller blade A was bent about 90° aft, about 6 inches from the propeller tip, consistent with runway impact.

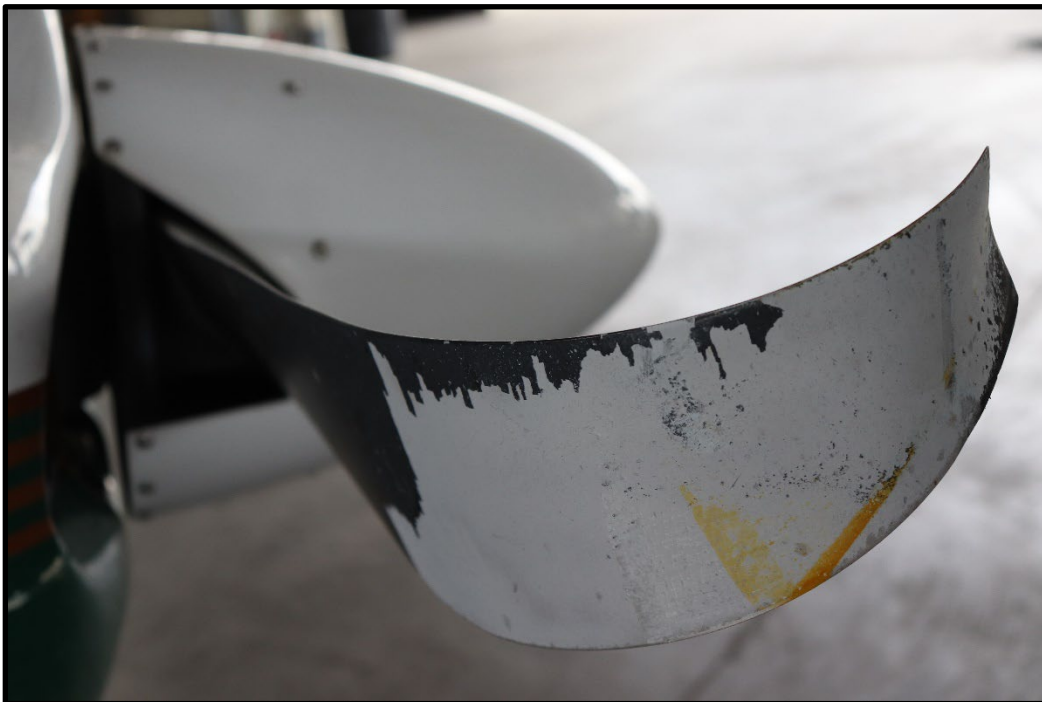
Figure 7: view of airplane propeller blade B

Propeller blade B remained attached to the propeller hub. A yellow paint mark about 4 inches in length, near the propeller tip on the cord side. The propeller was bent about 90° forward, about 9 inches from the propeller tip.

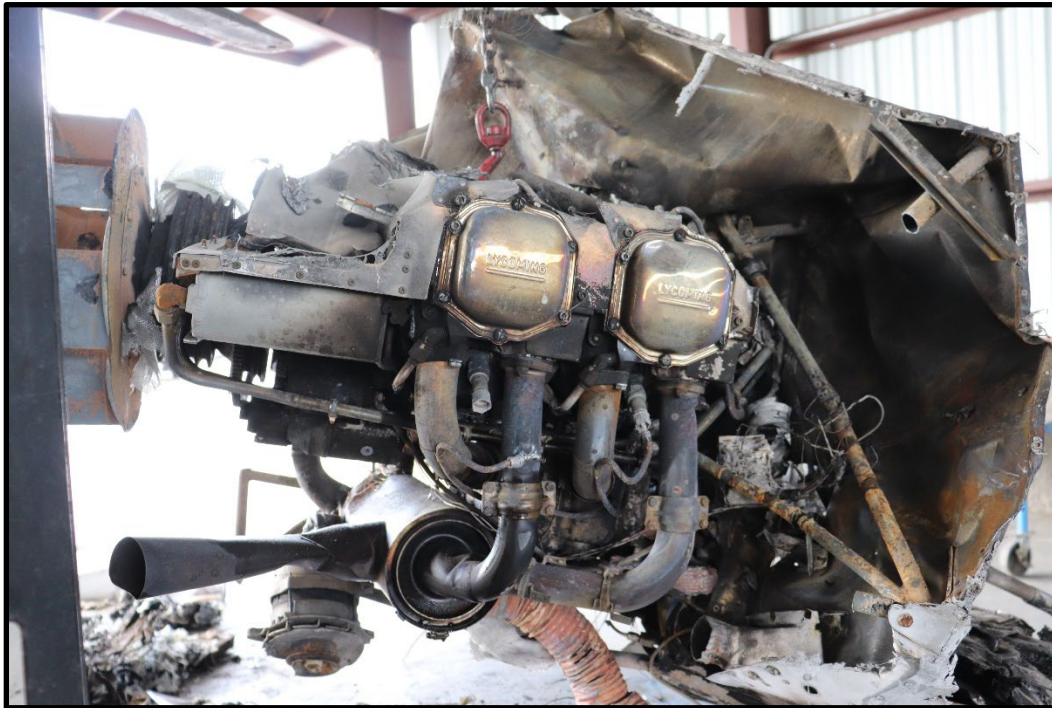
Figure 8: view of right side of helicopter engine

Examination of the recovered engine revealed that the engine remained attached to the engine mounts. Extensive thermal damage was noted throughout the engine. All four cylinders remained attached.

Impact damage was noted on all rocker box covers except, on the number 2 cylinder. Thermal damage was observed on all rocker box covers. All rocker box covers were removed. The intake and exhaust rocker arms were intact and oil coated. Thermal and impact damage was noted to the number 1 and 3 cylinder intake and exhaust valve springs. The number 2 and 4 intake and exhaust valve springs were in place and visually appeared to be undamaged. The upper spark

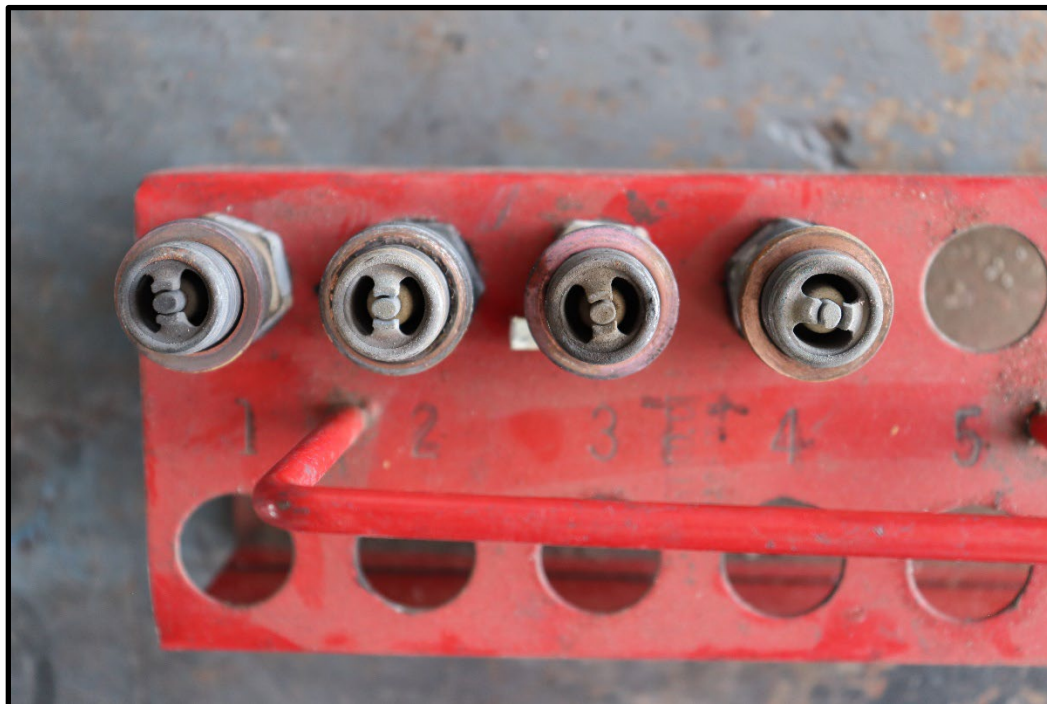
Figure 10: view of helicopter engine spark plugs

plugs were removed, and all four cylinders were examined internally using a lighted borescope. A normal amount of combustion deposits was observed within the combustion dome of each cylinder and piston face. All of the intake and exhaust valves were unremarkable. The crankshaft was rotated by hand from the cooling fan. Rotational continuity was established throughout the engine and valve train. Thumb compression and suction was obtained on the number 2 and 4 cylinders. Due to thermal and impact damage to the 1 and 3 cylinder, thumb compression and suction was not obtained.
