## **NATIONAL TRANSPORTATION SAFETY BOARD**

# **ACCIDENT SITE EXAMINATION SUMMARY**

**WPR22FA001**

Location: Chandler, Arizona  
Date: October 1, 2021  
Aircraft: Piper, PA-28-181, N2868H /  
Robinson Helicopter Company, R22, N412TL  
NTSB Investigator-in-Charge: Eric M. Gutierrez

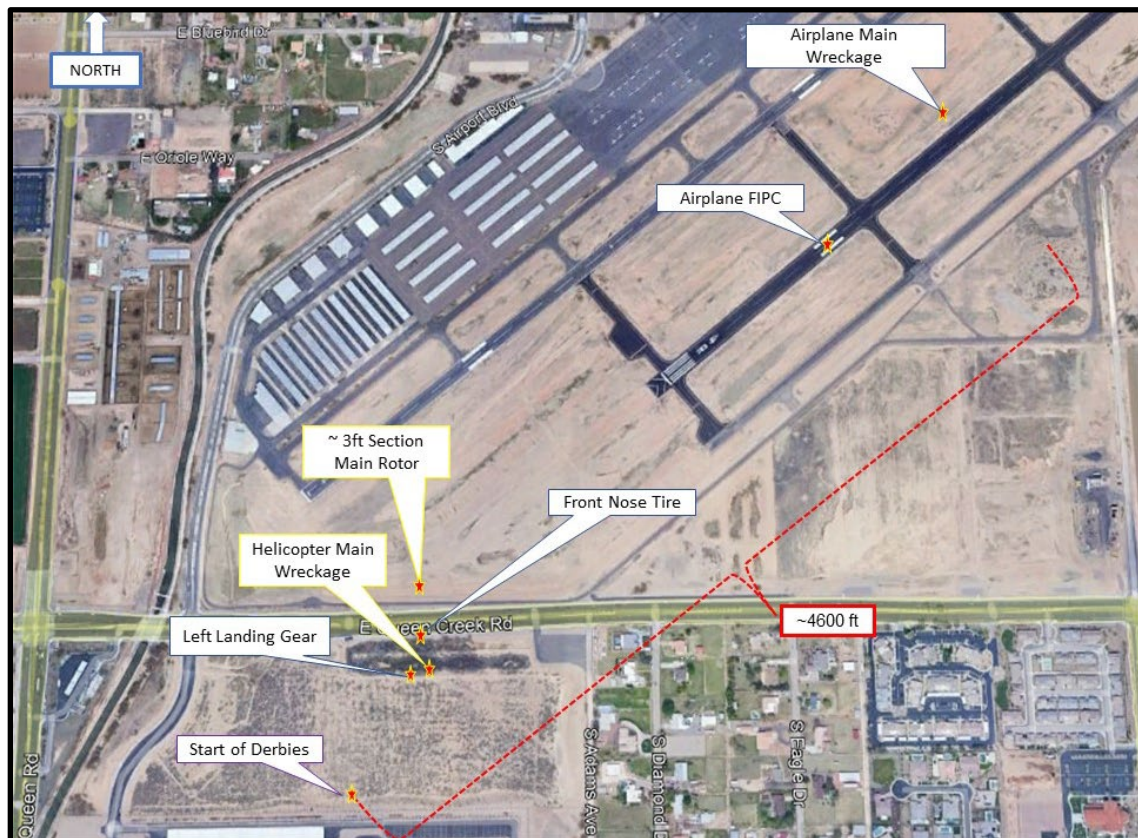
Figure 1: View of accident site diagram

Examination of the airplane accident site revealed that, the airplane landed on runway 04R, veered left and exited the left side of the runway. The airplane came to rest on the dirt field between runway 04R and 04L, on a heading of about 345° magnetic, at an elevation of 1,224 ft mean sea level (msl).

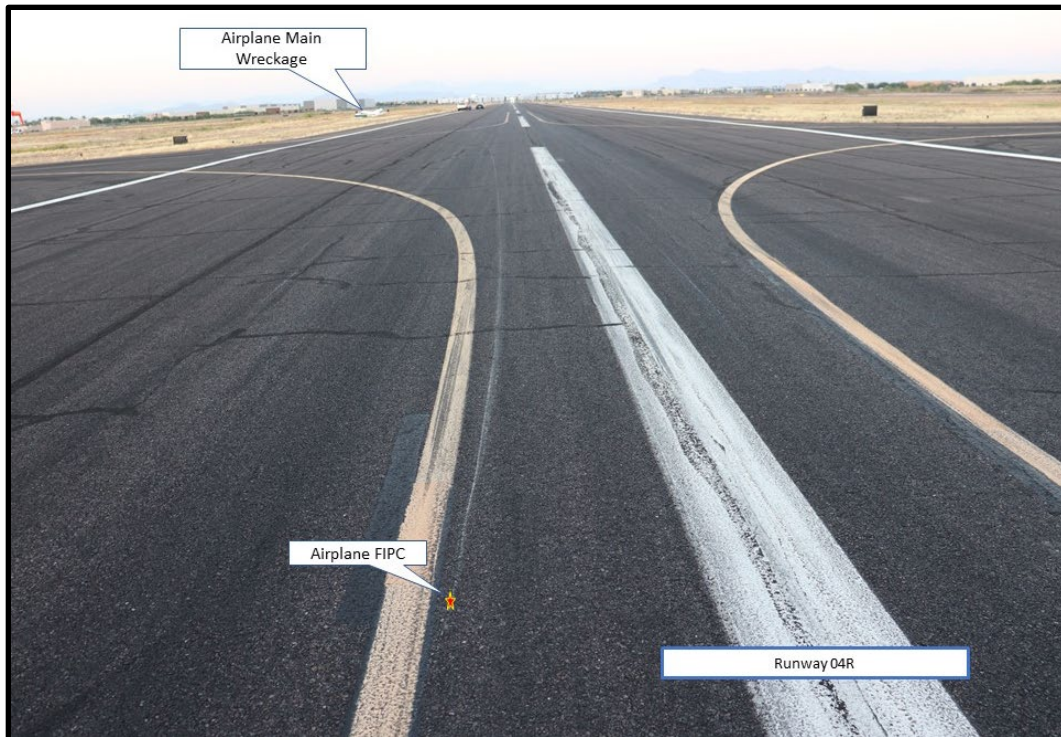
Figure 2: View of initial impact ground scar

The first identified point of contact (FIPC) with the runway was a ground scar/impression that started about 1,200 ft beyond the landing threshold of runway 04R. The ground scar/impression was about 730 ft long and 4 inches wide and terminated at the airplane.

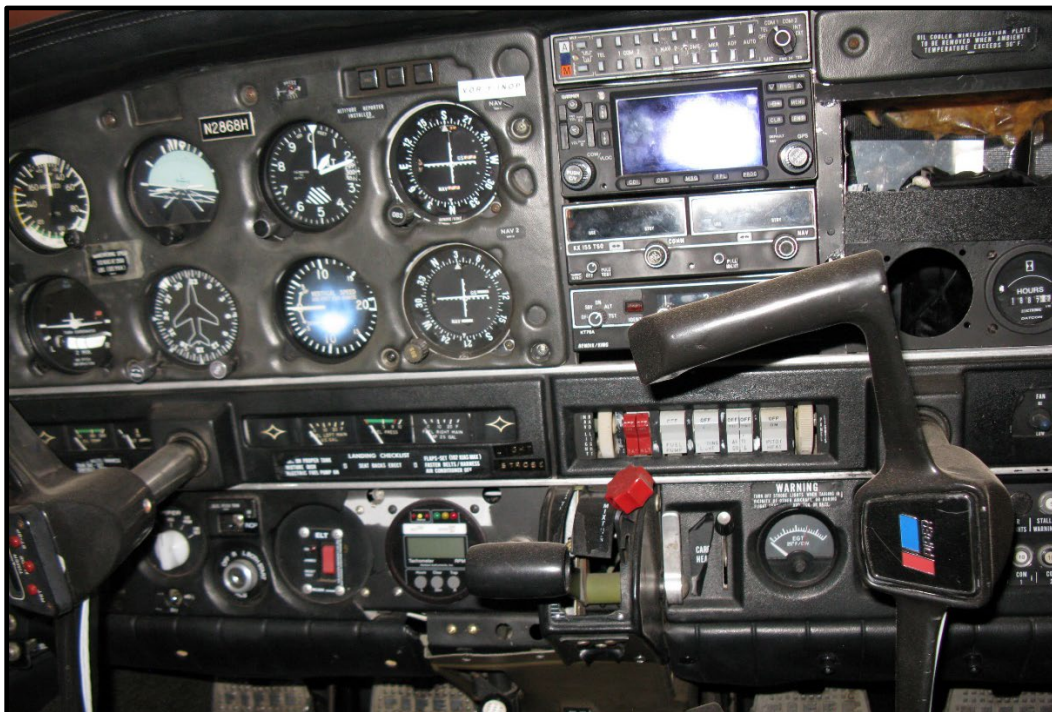
Figure 4: View of airplane instrument panel

- Throttle: aft / idle
- Mixture Lever: aft
- Fuel Selector Lever: off
- Fuel Gauges: 0
- Oil Pressure: 0
- Oil Temp: 0
- Turn/Bank: level / ball to the left
- Altimeter: 1220 / kollsman: 30.00
- Vertical Speed Indicator: 0
- Airspeed: 0
- Attitude Indicator: about a 10° to the left
- Heading Indicator: 325
- Ignition Switch: Off
- Panel Lights: Off
- Flaps: Extended to 40°
- Circuit breakers: all were in, except the pitch/trim. The pitch/trim circuit breaker was zip-tied (collared) in the open position.

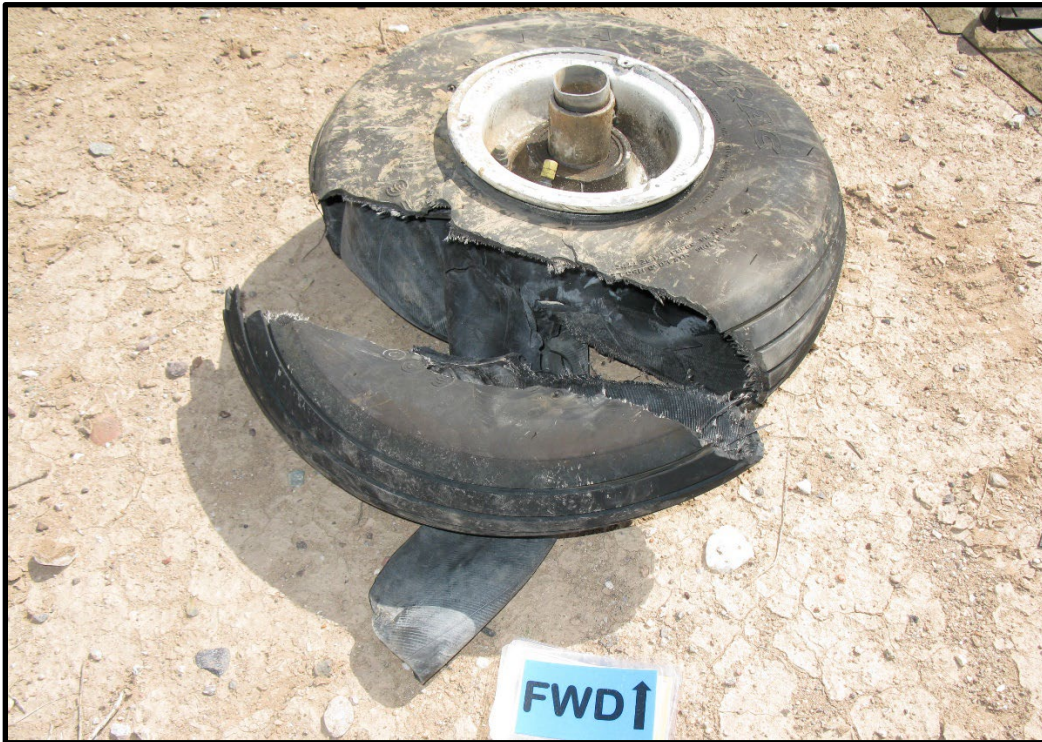
Figure 5: View of airplane nose landing gear wheel and tire

The nose landing wheel and tire separated from the nose gear assembly and were located near the helicopter accident site. The nose landing gear fork casting had fractured near the upper

attachment point; the left-side and right-side forks separated from the casting and were located near the runway edge, about 10 ft behind the main wreckage.

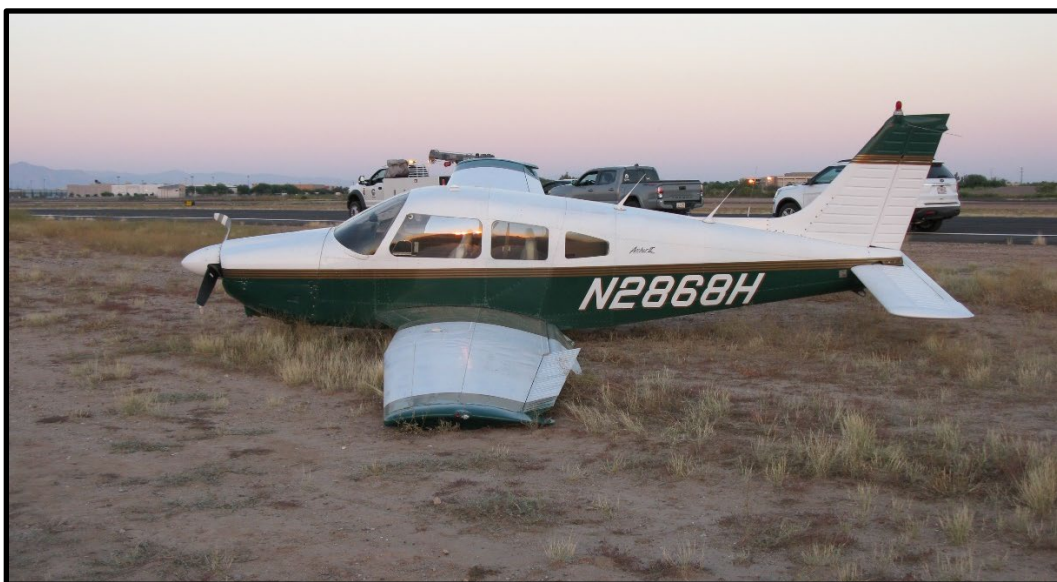
Figure 6: View of airplane left wing

The left wing remained attached to the fuselage. The left flap and aileron remained attached via their respective mounts. The fuel tank fuel cap was observed in place and secure. The flap was observed in the “down” position. Damage was observed to the left flap trailing edge throughout the entire span of the flap.

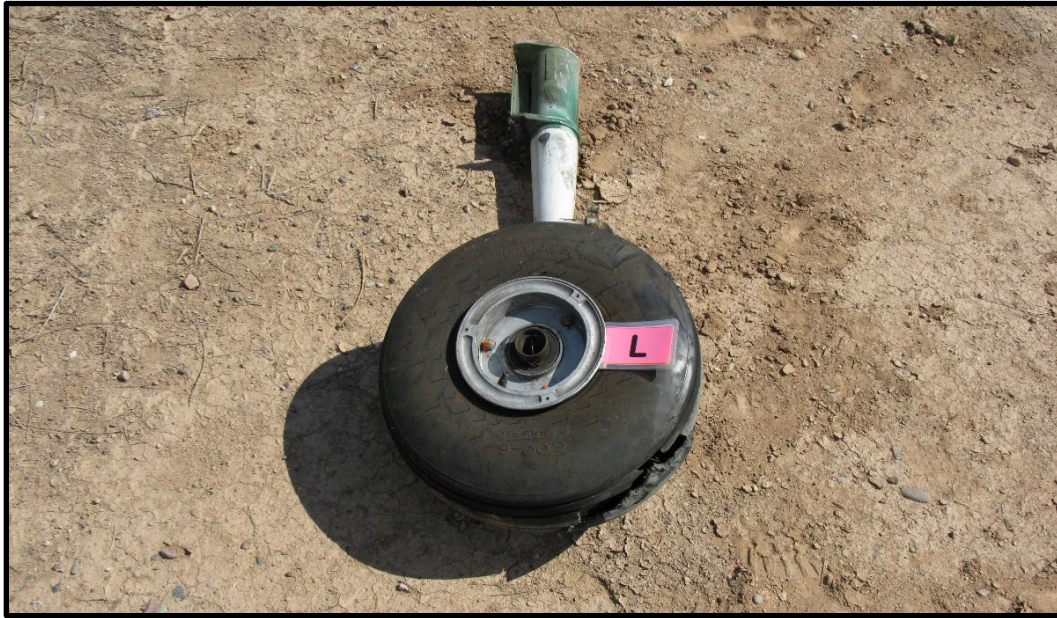
Figure 7: View of airplane left landing gear

The left main landing gear was separated from the airplane at the wing spar attachment and located near the helicopter accident site. The landing gear strut fairing exhibited impact damage near the bottom section. The tire was cut, about 9 inches in length on the tread.

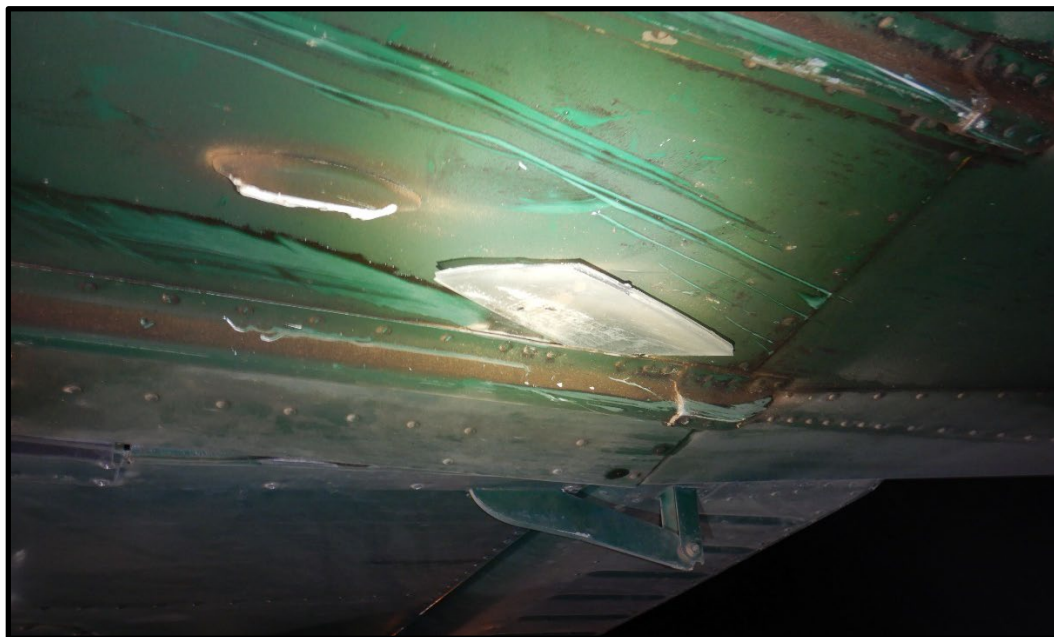
The airplane fuselage was mostly intact; the undercarriage revealed crushing and jagged tearing measuring about 18 inches in length on the hat channel, along the longitudinal axes near the wing root. A fragment of the helicopter's canopy was found lodged in the hat channel on the airplane's undercarriage.

Figure 8: view of helicopter's canopy lodged in airplane hat channel (photo courtesy of Piper)

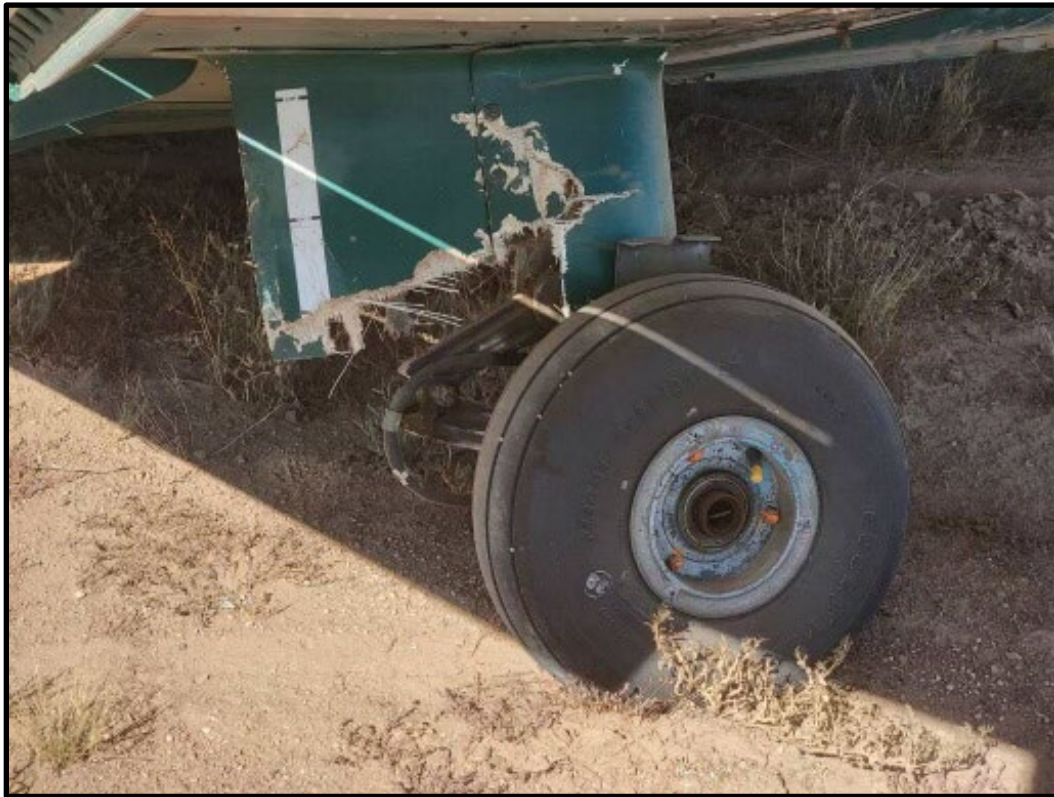
Figure 9: view of airplane right main landing gear (photo courtesy of the FAA)

The right main landing gear remained attached to the right wing. Impact damage was noted on the right main landing gear strut fairing from the aft section to the landing gear.

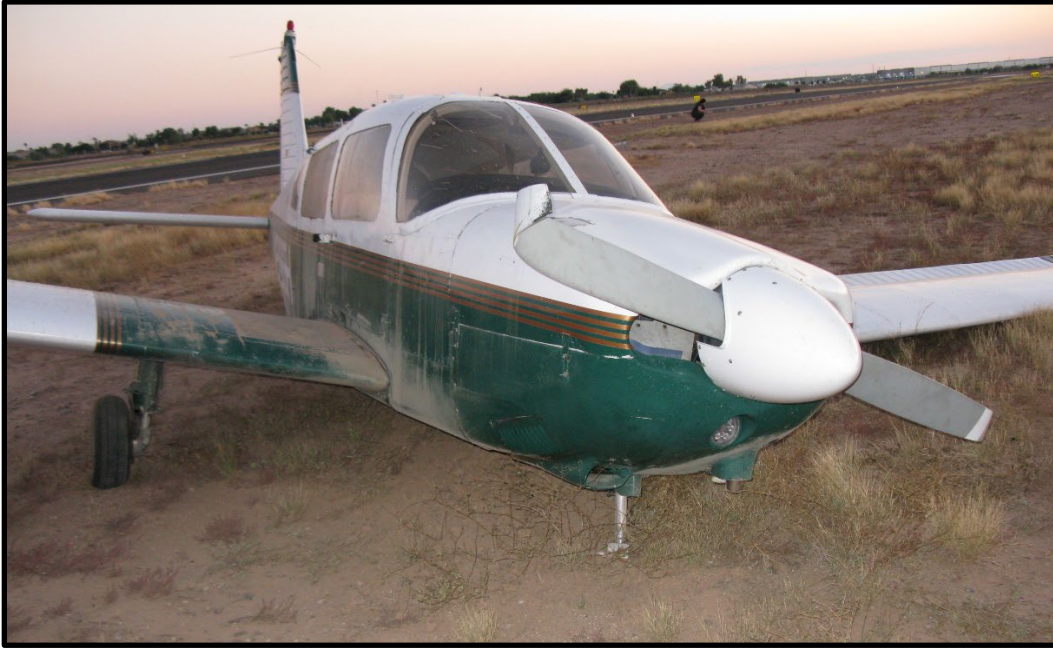
Figure 10: View of airplane propeller

The 2 bladed propeller assembly remained attached to the crankshaft. For the purposes of this investigation One propeller blade was lettered A and the other propeller blade was labeled B. Propeller blade A remained attached to the propeller hub, and was bent about 90° aft, about 6 inches from the propeller tip.

Propeller blade B remained attached to the propeller hub. A yellow paint mark about 4 inches in length, near the propeller tip on the cord side and was bent about 90° forward, about 9 inches from the propeller tip.

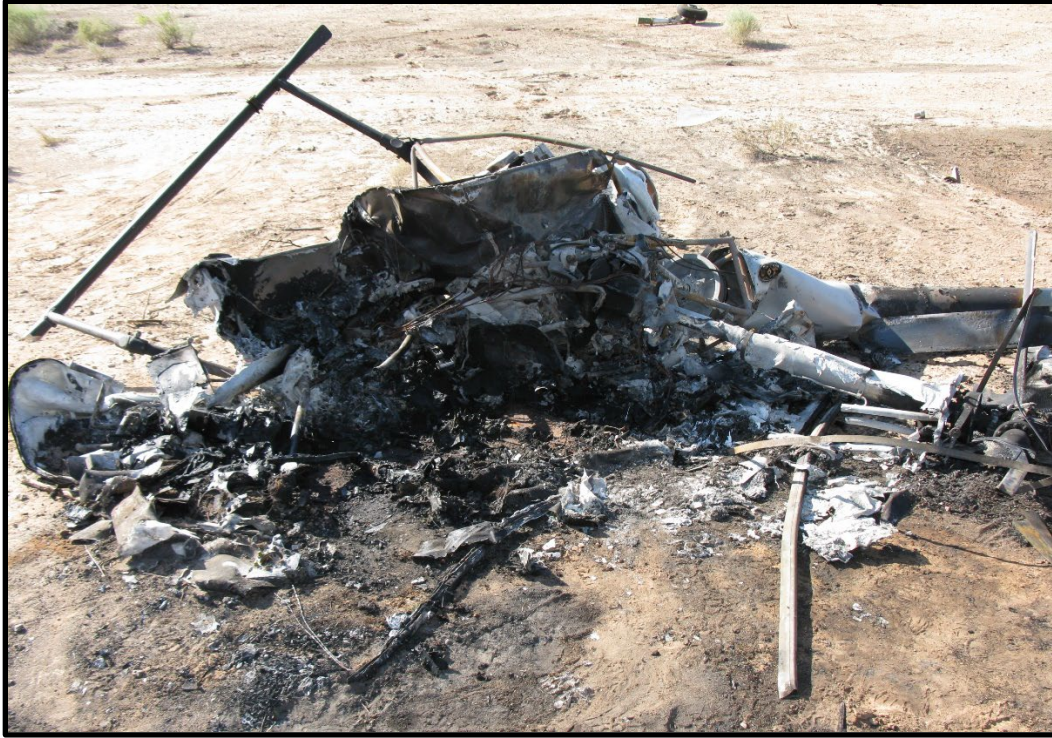
Figure 11: View of helicopter wreckage

Examination of the helicopter accident site revealed that the helicopter impacted terrain about .5 mile southwest of the approach end of runway 04R. The helicopter came to rest on its left side, on a heading of about 53° magnetic, at an elevation of 1,236 ft msl. No visible ground scars were observed surrounding the wreckage. All major structural components of the helicopter were located within about 15 ft of the main wreckage.

The airframe was mostly consumed by fire except for the aft tail cone. The instrument panel, and the navigation/communication unit separated from their respective areas in the cockpit and had sustained impact and thermal damage. The cockpit mixture control was in the full rich position and the carburetor heat control was impact and thermal damage

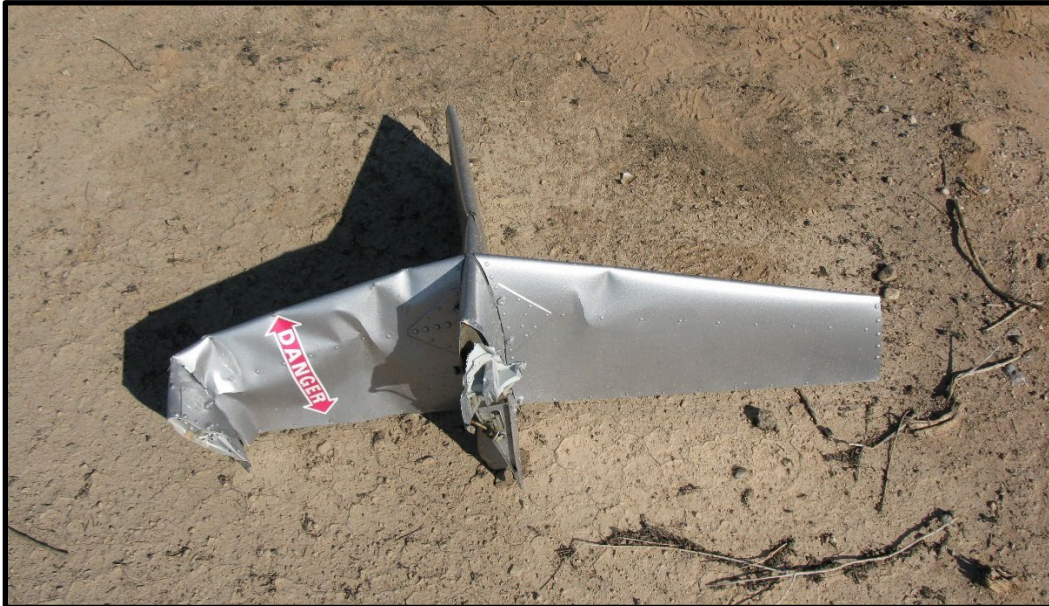
Figure 13: view of helicopter empennage

The empennage was separated from the aft tail cone bulkhead. Crushing and bending consistent with impact was noted throughout the vertical stabilizer. The horizontal stabilizer was bent about 4 inches from the vertical stabilizer consisting with impact damage.

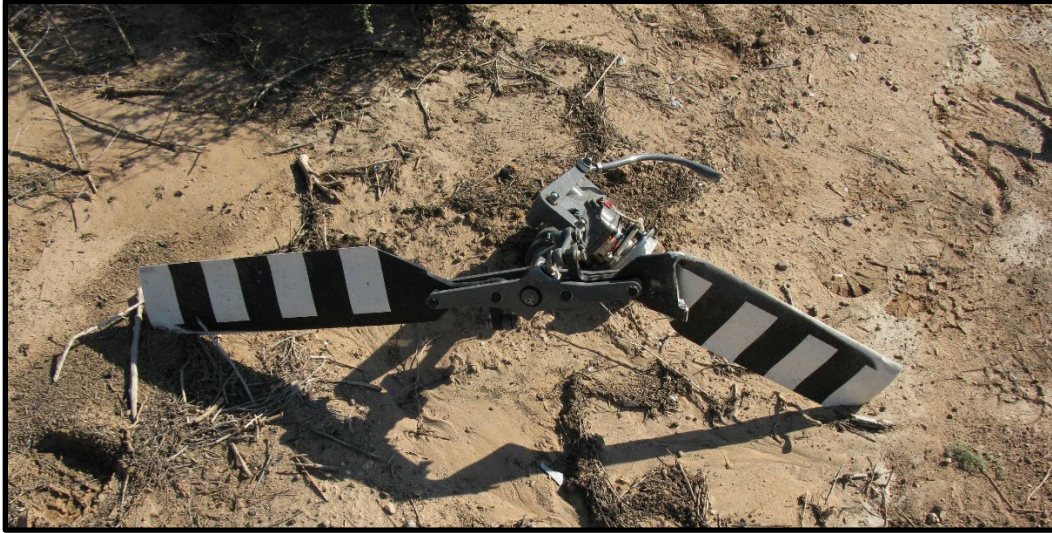
Figure 14: view of helicopter tail rotor

The tail rotor remained attached to the tail rotor gearbox; however, the tail rotor gearbox was fracture separated from the tail cone. The pitch change bearing moved freely with no binding. Tail rotor blade serial number 10368 was bent about 30° toward the trailing edge constant with impact damage.

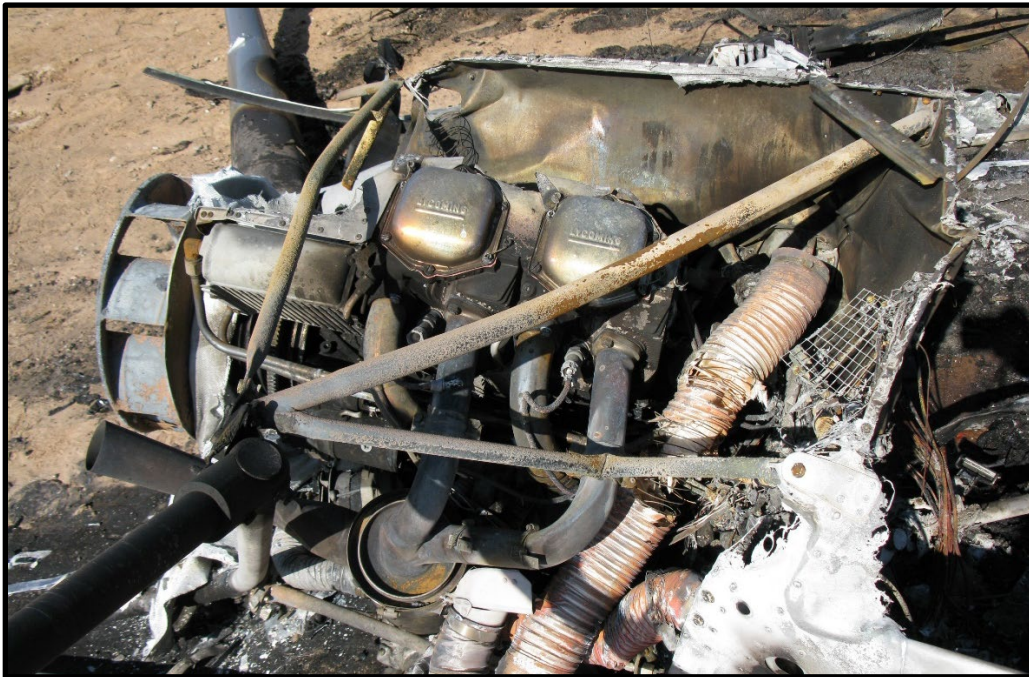
Figure 15: view of helicopter engine

Examination of the helicopter engine revealed that the engine remained attached to the engine mounts. Extensive thermal damage was noted throughout the engine. All four cylinders remained attached.

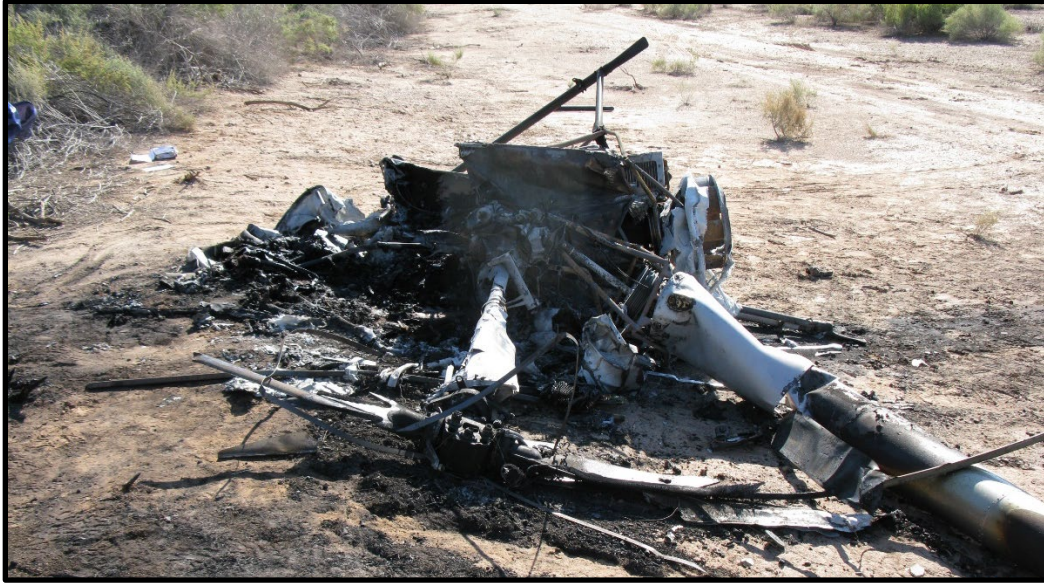
Figure 16: view of helicopter main rotor system

The main rotor system sustained extensive impact and thermal damage. The main rotor gearbox remained attached to the upper tube frame in its normal position and had been fractured and thermally damaged. The main rotor mast and main rotor gear box were both thermally damaged; the main rotor mast remained attached to the main rotor gearbox.

The main rotor hub assembly components exhibited varying degrees of visible damage consistent with sudden stoppage from impact with terrain. The swashplate remained attached to the main rotor mast. Both main rotor blades remained attached to the main rotor hub but were destroyed.

The pitch change link of main rotor blade “A” was fracture separated near the rod end connection to the pitch change horn, consistent with impact damage. Blade “A” was fractured approximately 31 inches from the blade root. A separated section of the spar of blade “A” (about 76 inches in length) was collocated with the main wreckage and bent down about mid span.

The pitch change link of main rotor blade “B” remained attached to the swashplate and the pitch change horn of the blade. Blade “B” was fractured approximately 75 inches from the blade root and was bent down and toward the trailing edge.
