# National Transportation Safety Board

WPR22FA021

## **ON-SCENE FIELD NOTES**

Location: Dunsmuir, California  
Date: October 20, 2021  
Time: 1100 Pacific daylight time (PDT)  
1800 coordinated universal time (UTC)  
Airplane: N5268Q

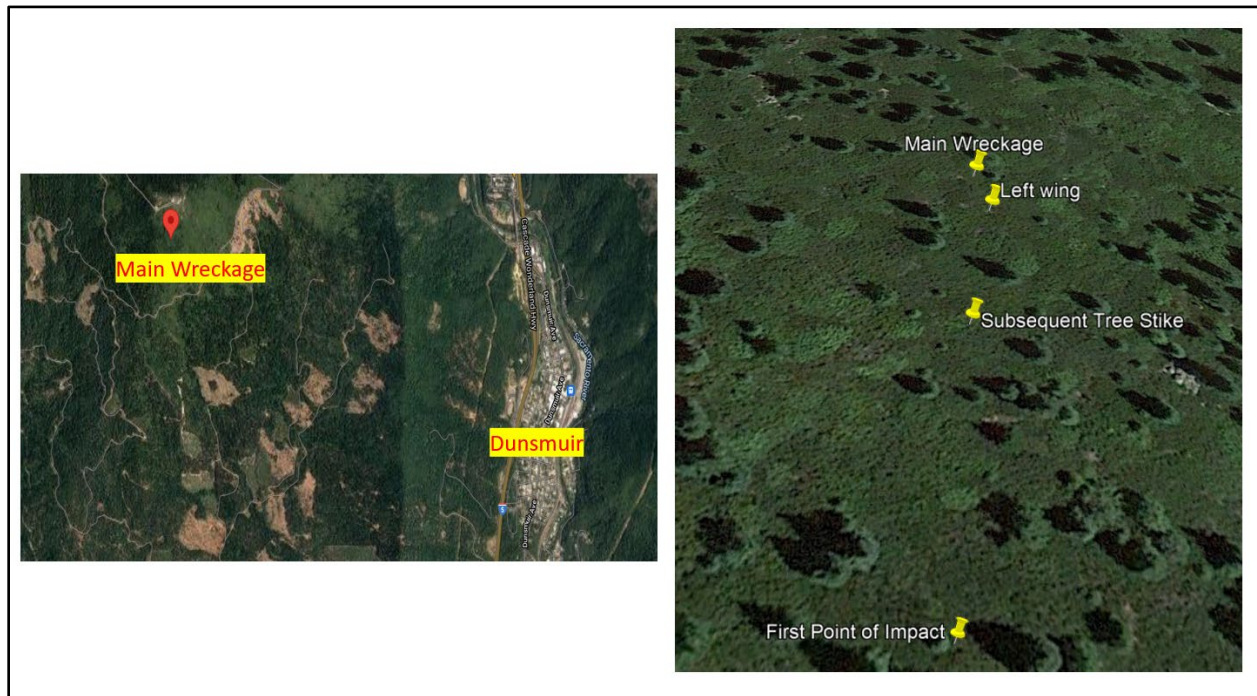
The airplane was located about 2 nm northwest of Dunsmuir, California on a mountain side at a field elevation of about 5,290 ft msl. The airplane came to rest on a 15° slope on a heading of 350° magnetic. The first point of impact (FPI) was identified by two 40-foot-tall pine trees and several broken tree branches. A debris path was marked by subsequent tree strikes that began about 75 ft forward of the FPI and was oriented on a heading of 360° magnetic. The left wing was separated and found 20

feet southeast of the main wreckage. The main wreckage marked the end of the debris path and was located at 41.2197222, -122.308889, about 225 ft beyond the FPI.

**Figure 1. Location of main wreckage and accident site**

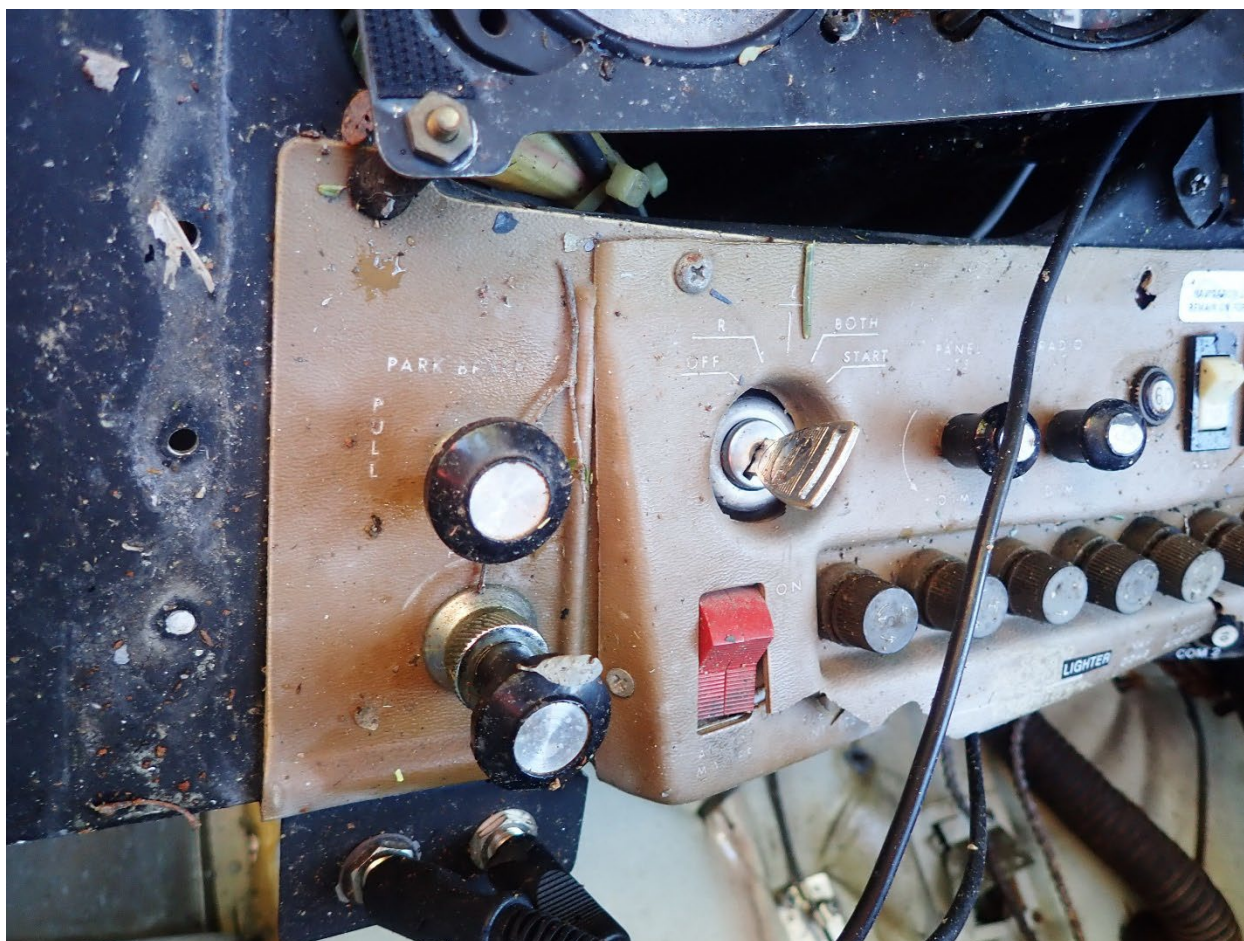
The master switch was in the OFF position. All other instrument switches were also in the OFF position. The ignition was in the BOTH position. The fuel selector lever was in the ON position. The aircraft was modified by removing pilot and copilot seats by a bench installation. The control yokes were also modified by a dragster type steering wheel.

**Figure 2. View of ignition and batter switches (Courtesy of the airframe manufacturer)**
