# National Transportation Safety Board

WPR22FA023

## **WRECKAGE AND EXAMINATION REPORT**

Location: Snoqualmie, Washington  
Date: October 28, 2021  
Time: 0911 LTZ  
1611 UTC  
Airplane: 1993 Mooney M20M

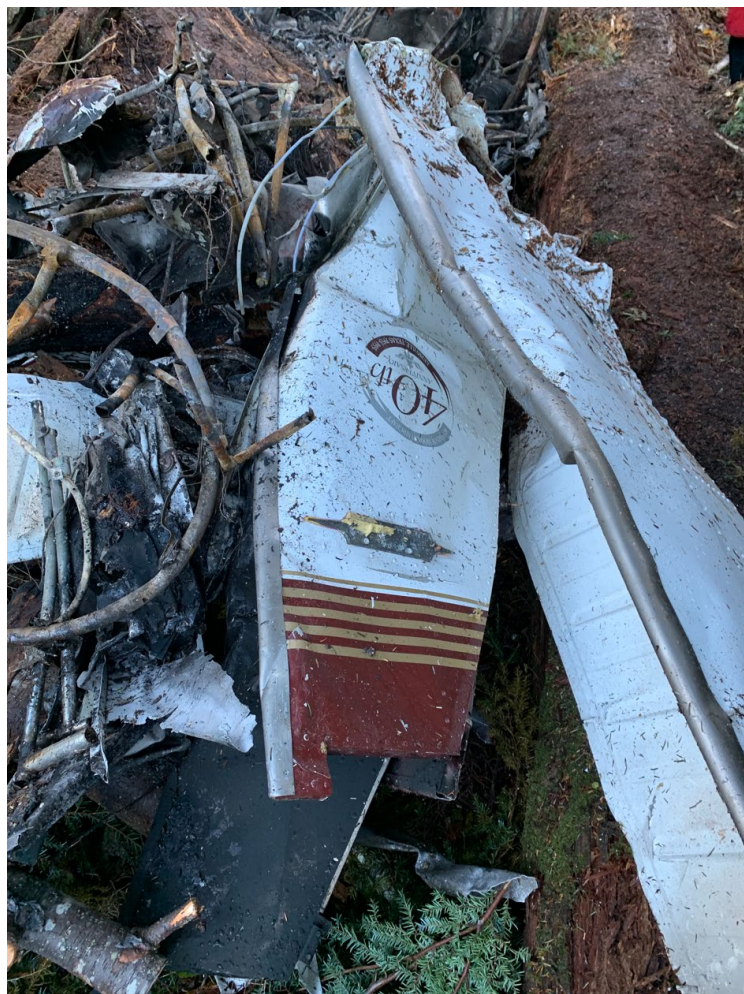
The left horizontal stabilizer and elevator impacted the ground and sustained thermal damage. The rudder was sandwiched between the vertical stabilizer and the left horizontal stabilizer. Resting underneath the vertical stabilizer and the rudder was the inboard right elevator, and on top of it rested the right horizontal stabilizer. The TKS system affixed to the leading edges of the vertical and horizontal stabilizer were present and sustained gross impact damage and deformation to their surfaces. Rudder and elevator continuity were not observed because of impact and thermal damage.

Figure 1: Post-accident view of the empennage

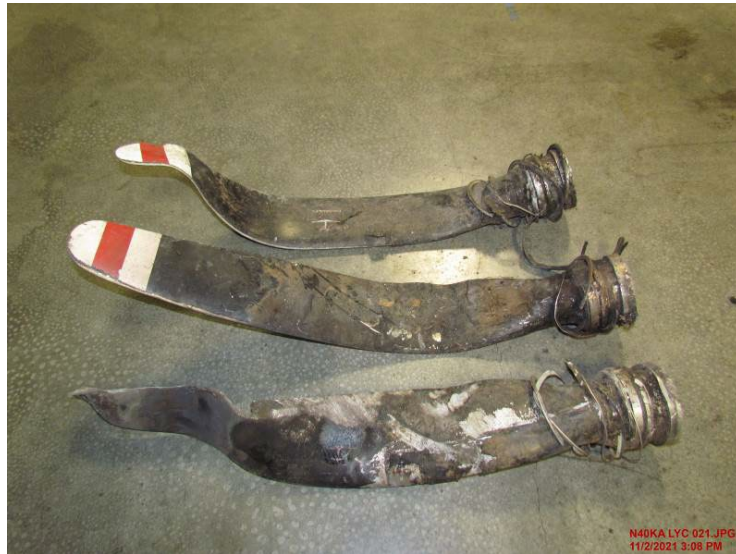
Three metallic propeller blades were liberated from the propeller hub. Two of the blades were bent forward and deformed. One blade was bent aft and deformed. The propeller governor was consumed by the post-impact fire. The

Figure 2: Post-accident view of the propeller blades

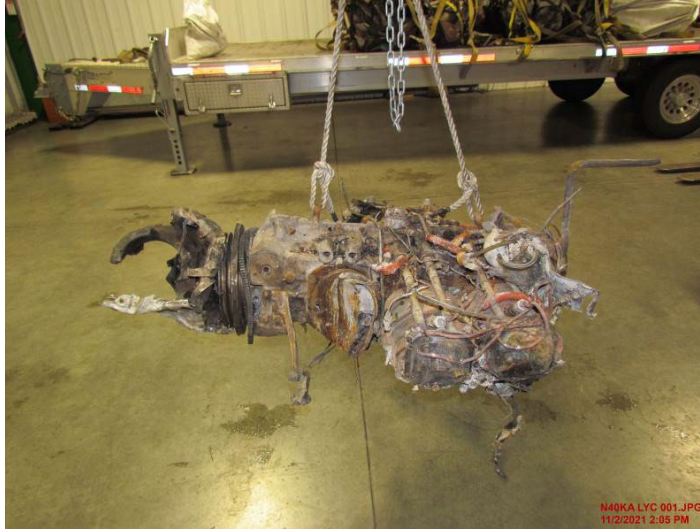
The engine was partially consumed and deformed by post-impact fire. The oil sump was consumed by post-impact fire. The accessory case was also partially consumed by post-impact fire and deformed. None of the accessories were available for the exam and were presumed destroyed by post-impact fire or not identifiable. The remaining top spark plugs were removed and cylinders 3,4,5, and 6 were borescope inspected, with no identifiable anomalies other than thermal damage was noted. Cylinders 1, and 2 were impact damaged with their cylinder heads separated. The cylinder heads were partially consumed and deformed by fire. The crankshaft was not rotatable due to thermal damage. Engine drive train continuity was confirmed visually, and borescope inspected.

Figure 3: Post-accident view of the engine

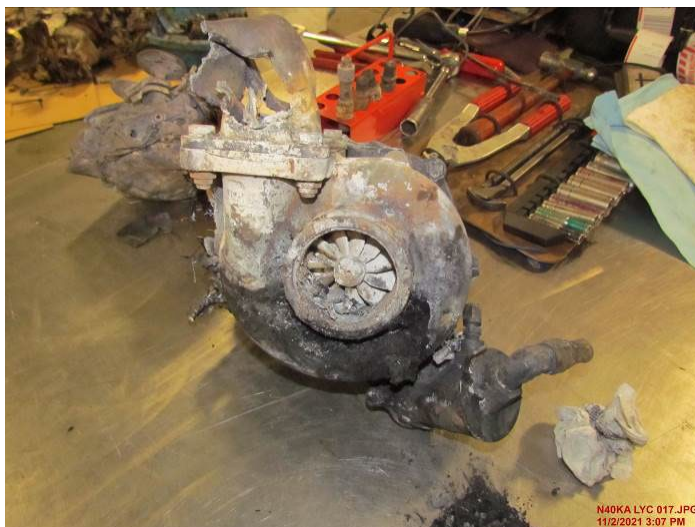
The right and left magneto were consumed by post-impact fire. The ignition harness was destroyed. The starter, the alternator, and the vacuum pump were destroyed. The lubrication system, to include the oil suction screen, the oil filter, and the oil sump were destroyed. The manufacture installed turbo charger sustained thermal damage, deformation and did not rotate. The density controller, differential controller, and the variable absolute controller were destroyed. The slope controller, the manifold pressure relief valve, and the exhaust bypass valve were destroyed.

Figure 4: Post-accident view of the turbo charger

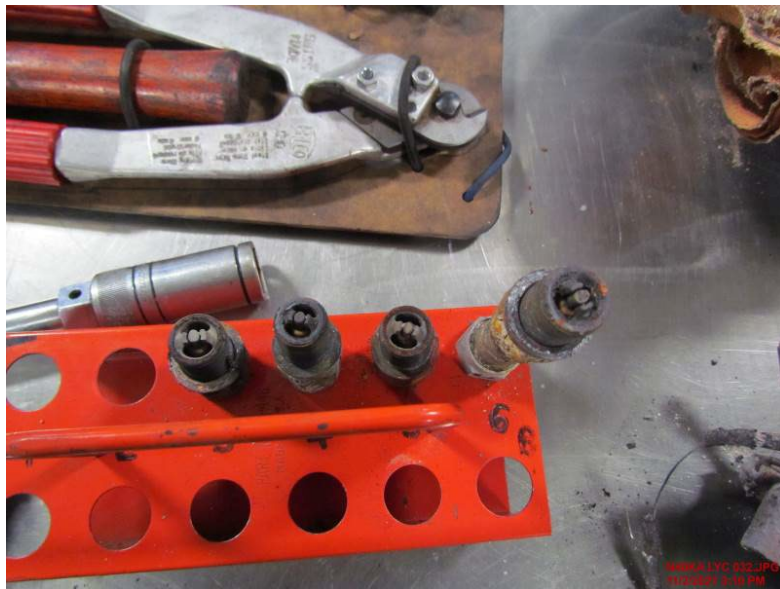
Spark Plug Condition (per Champion Aviation Check-A-Plug Card AV-27)

| 1 Top Destroyed | 1 Bottom Destroyed |
| 2 Top Destroyed | 2 Bottom Destroyed |
| 3 Top Worn Out/Normal | 3 Bottom Impact Damaged |
| 4 Top Worn Out/Normal | 4 Bottom Impact Damaged |
| 5 Top Worn Out/Severe | 5 Bottom Impact Damaged |
| 6 Top Worn Out/Severe | 6 Bottom Impact Damaged |

Figure 5: View of the intact spark plugs
