## **NATIONAL TRANSPORTATION SAFETY BOARD**

# **ONSITE EXAMINATION SUMMARY REPORT**

**WPR22FA026**

Location: Shafter, California  
Date/Time: November 3, 2021, 1130 PDT (1830Z)  
Aircraft: N8960Q; Ayers Corp./S-2R  
NTSB Investigator-in-Charge: Andrew Swick

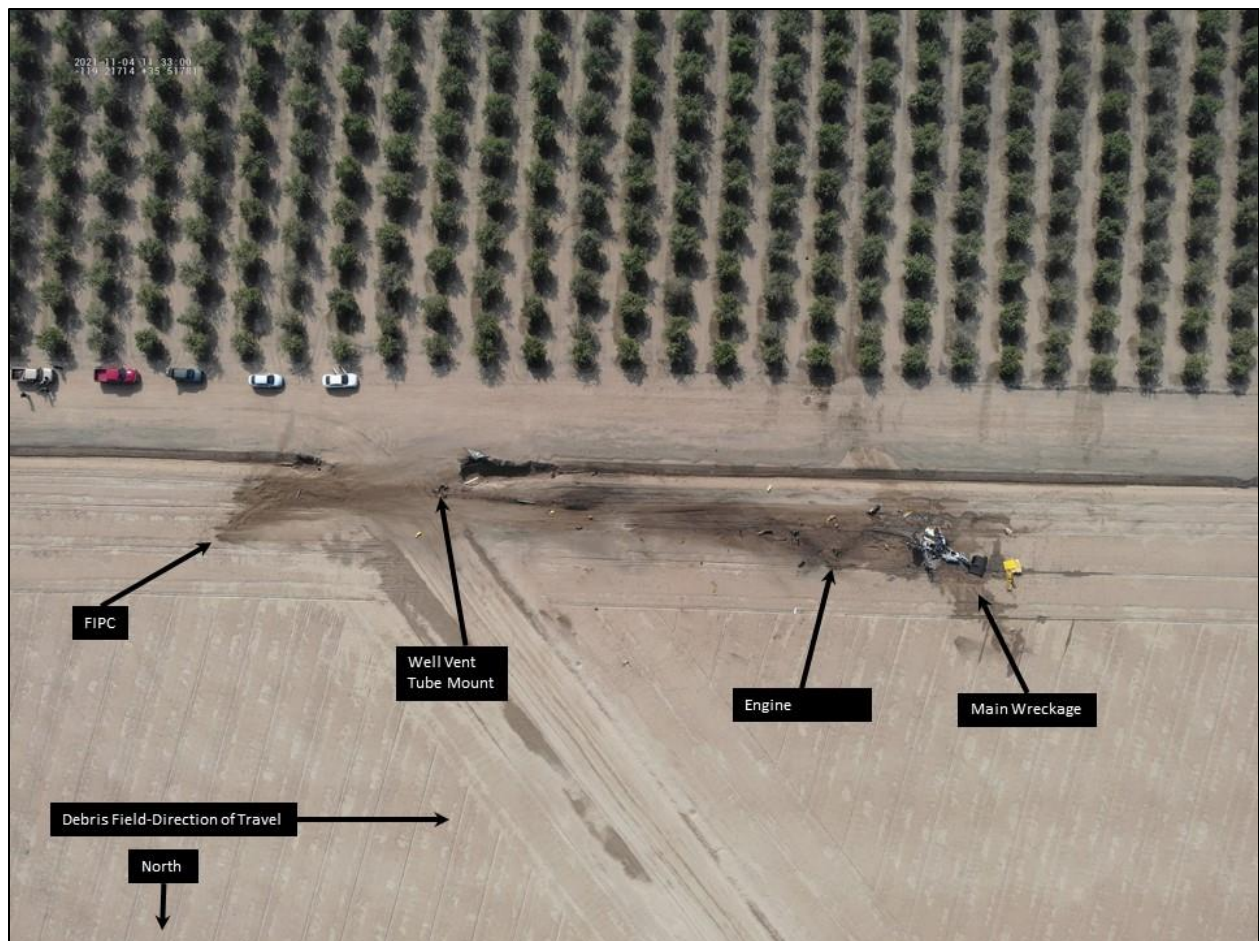
A postaccident examination of the accident site revealed that the airplane impacted terrain in a right wing low, nose-down, unusual attitude. The distance from the first identified point of contact (FIPC) with the ground, to the main wreckage was about 330 ft, and on a 268-degree heading. The full distance of the debris field was about 800 ft in length that paralleled a small ditch and access road.

Figure 1-Wreckage diagram. (Photo courtesy of the Kern County Sheriffs Office)

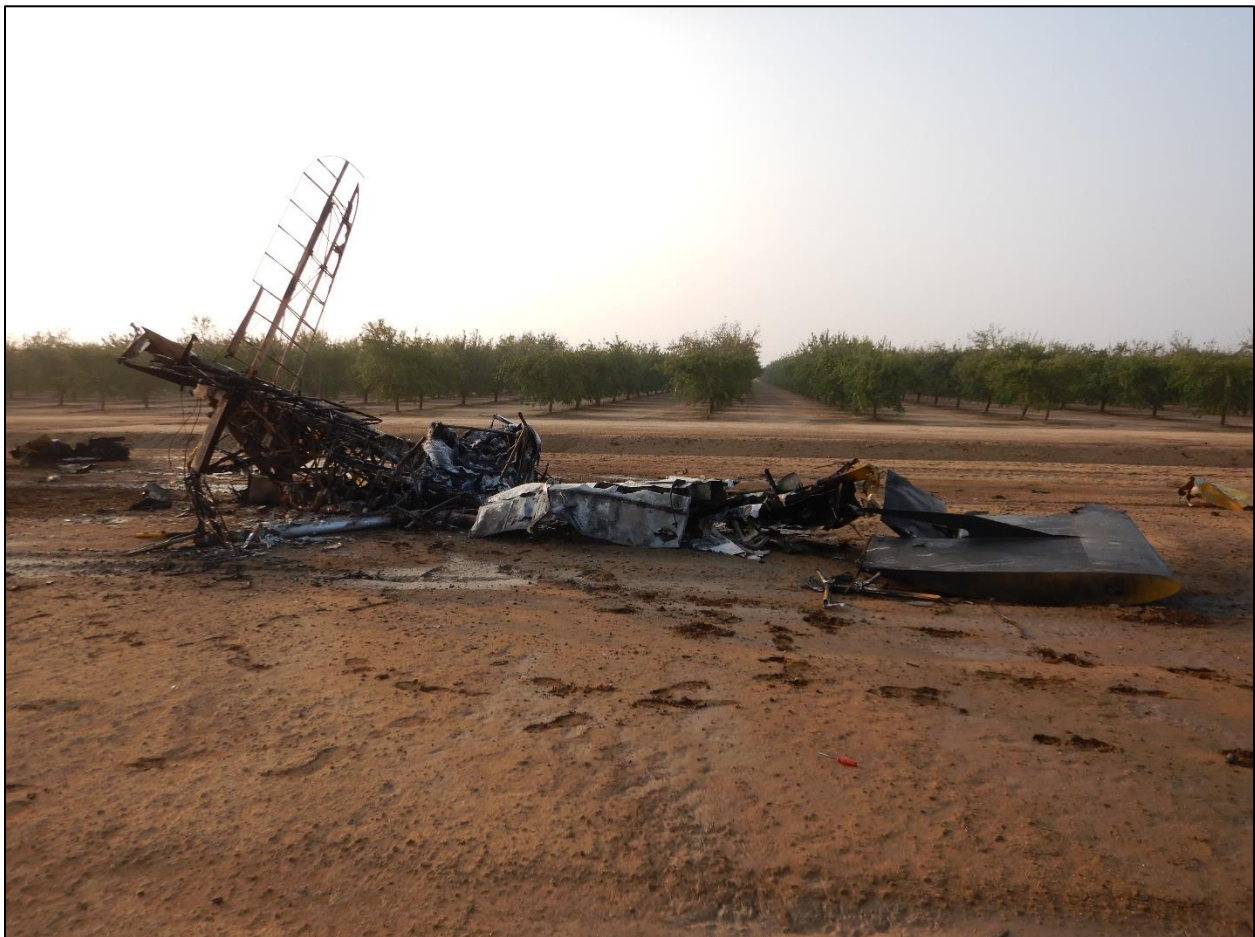
The FIPC with the ground was a yellow paint transfer mark on the top of the soil, followed by ground impact. The ground impact marks were consistent with the right-wing tip and spray boom support brackets on the wing's lower surface and flap hinge supports. A deep trough was noted near the FIPC, that spread throughout the disturbed ground in a diagonal direction from travel. Fuel saturated soil was noted near the center of the disturbed ground. About 80 ft from the FIPC was a slightly raised road that ran diagonally through the debris field. On the other side of the road, about 110 ft from the FIPC, was a well vent pipe. Other well vent pipes in the area stand about 20 ft tall and about 6 inches in diameter. The vent pipe is a heavy cast iron material and was mounted to the ground within a concrete base. The concrete base was damaged and the vent pipe was pulled from mount and separated into two sections. An 8 ft section of the vent pipe was found separated from the mount about 30 ft further in the debris field. The seed spreader was found on the south side of the ditch near the vent pipe mount. Various panels and fuselage skin were found throughout the debris field. The panels and the surrounding ground had sooting and thermal discoloration. The tailwheel separated from the main wreckage and was found about 130 ft from the debris field, to the south, in a neighboring orchard.

**Figure 2-Main wreckage, view to the south.**

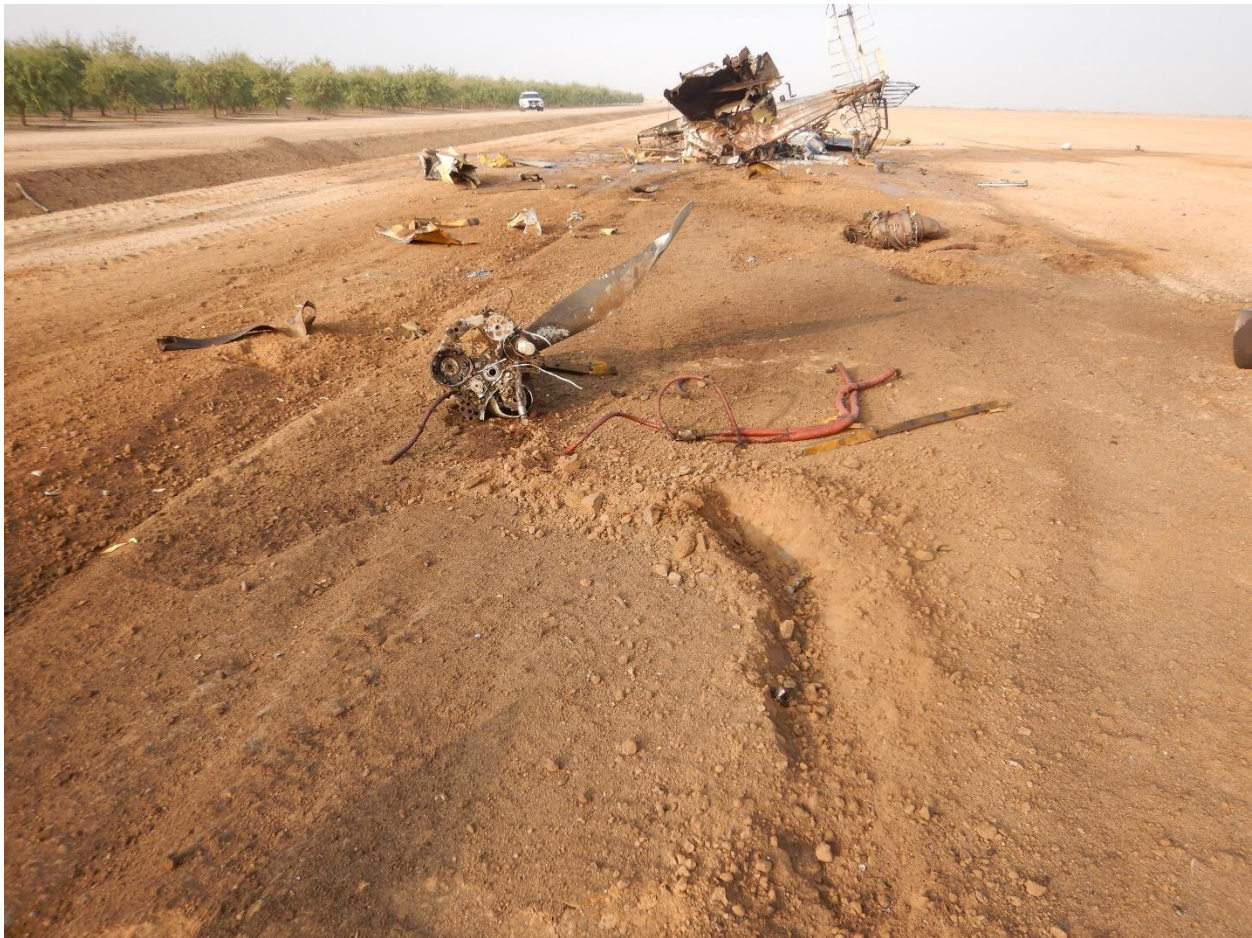
The engine found next in the debris field and was found in two large sections. The propeller assembly remained attached to the engine gearbox. The propeller spinner was crushed, and two blades separated from the hub. One blade was found near the engine and the other was found on the north side of the debris field near the raised road. A deep narrow ground depression was found about halfway through the debris field and continued in a slight left turn till reaching the main wreckage. The power section of the engine was found partially buried in its crater. Both cabin entry window sections separated from the main wreckage and were found on the north side of the debris field, one near the main wreckage.

**Figure 3-Debris field, propeller ground scars and engine sections.**

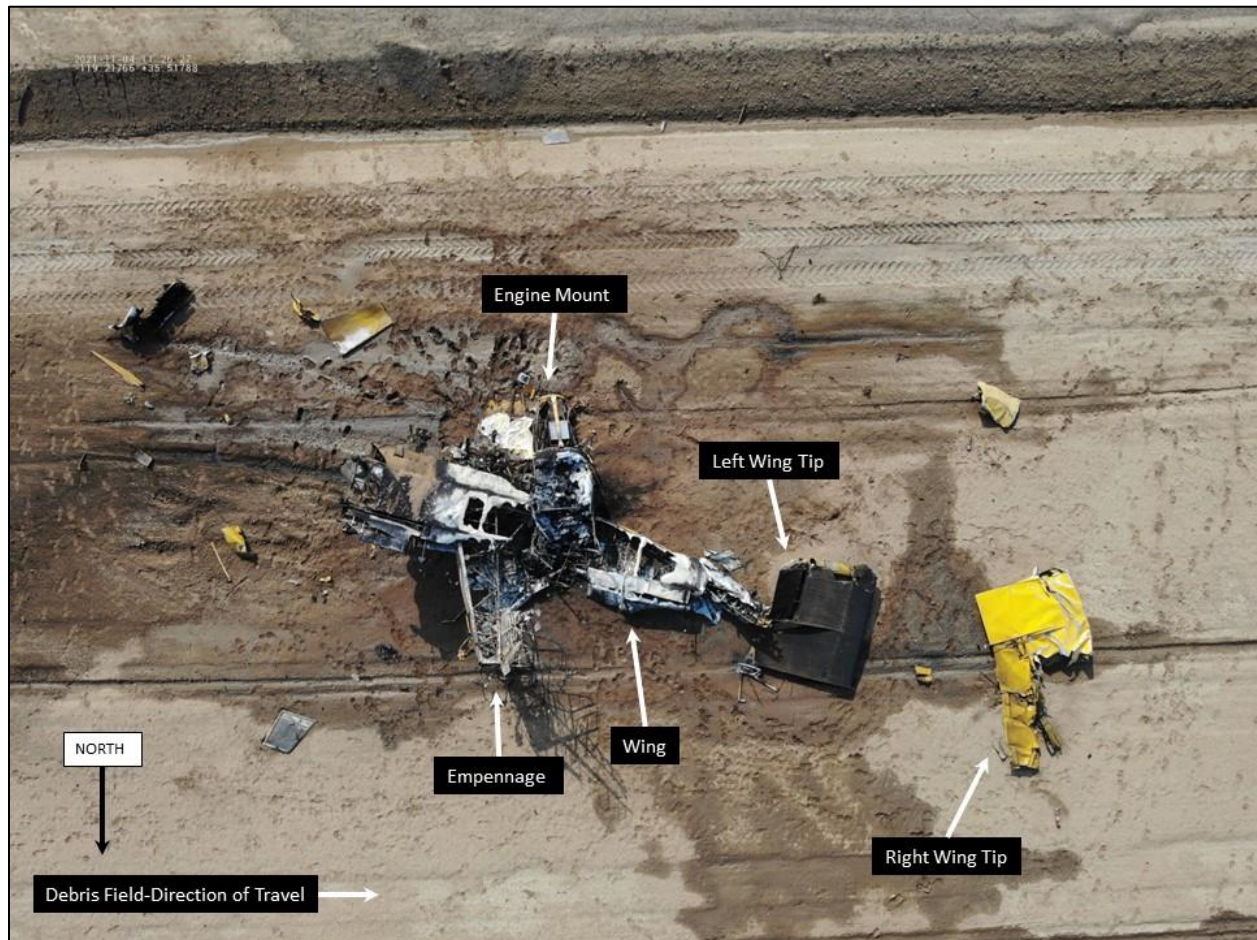
The main wreckage was partially consumed by postimpact fire. The fuselage was found in two sections; separated near the forward cabin area. The aft fuselage including the cabin seat, was found on its right side with buckling of the right horizontal stabilizer and elevator. The right rudder cable showed overload signatures near the aft cabin area. The left rudder cable length was intact to the cabin area. The rudder moved freely when control cables were pulled. The elevator control tube had thermal damage and had melted free from its elevator bellcrank and cabin linkage. The forward fuselage section was found upright and about 1 with buckling near the hopper and battery box area.

**Figure 4-Aerial view of the main wreckage. (Photo is courtesy of Kern County Sheriff's Office)**

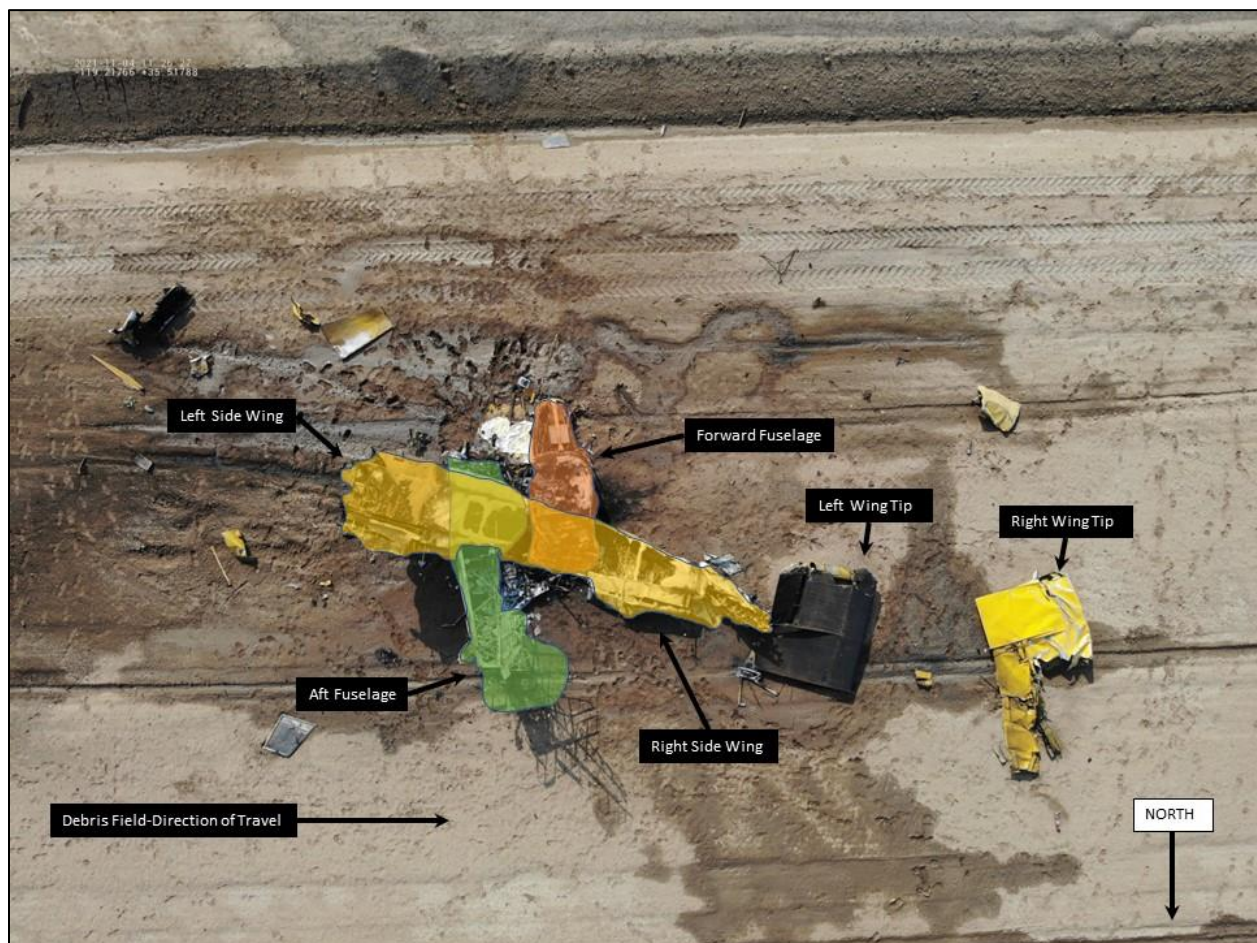
The wing spar outboard sections separated. The remained wing spar remained intact and was attached to the fuselage. The wing spar had aft bending on the right side. Both wing tips were found near the main wreckage. The left wing tip, about 5 ft long, was covered in a sooty residue, a 3 ft section of the aileron remained attached.. The left wing tip outboard surface was undamaged. The right wing tip was not covered in a sooty residue and had crushing near the leading edge consistent with ground impact. A large section of the right aileron remained attached to the wing tip.

Figure 5-Aerial view of the main wreckage with identified sections. (Photo is courtesy of Kern County Sheriff's Office)

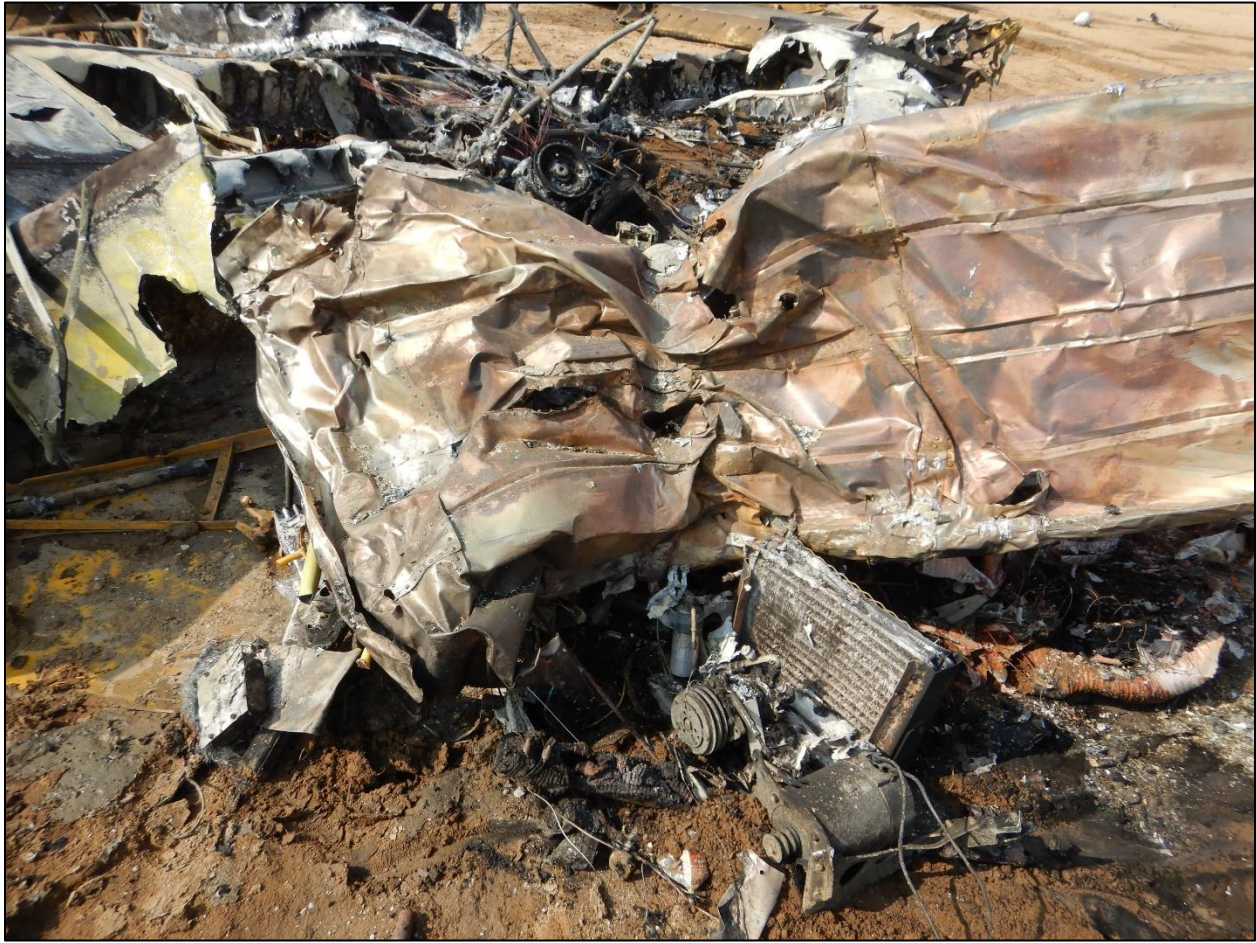
Impact damage was found on the left lower and side of the fuselage near the cabin seat area that is consistent in shape with the well vent tube diameter. The structural tubing on the left side of the seat area was pushed inward and the upper section of the seat, near the seat's left shoulder area was damaged.

Figure 6-Lower side of fuselage, impact damage.
