## **NATIONAL TRANSPORTATION SAFETY BOARD**

# **AIRFRAME EXAMINATION SUMMARY REPORT**

**WPR22FA026**

| Aircraft: | N8960Q; Ayers Corp./S-2R |

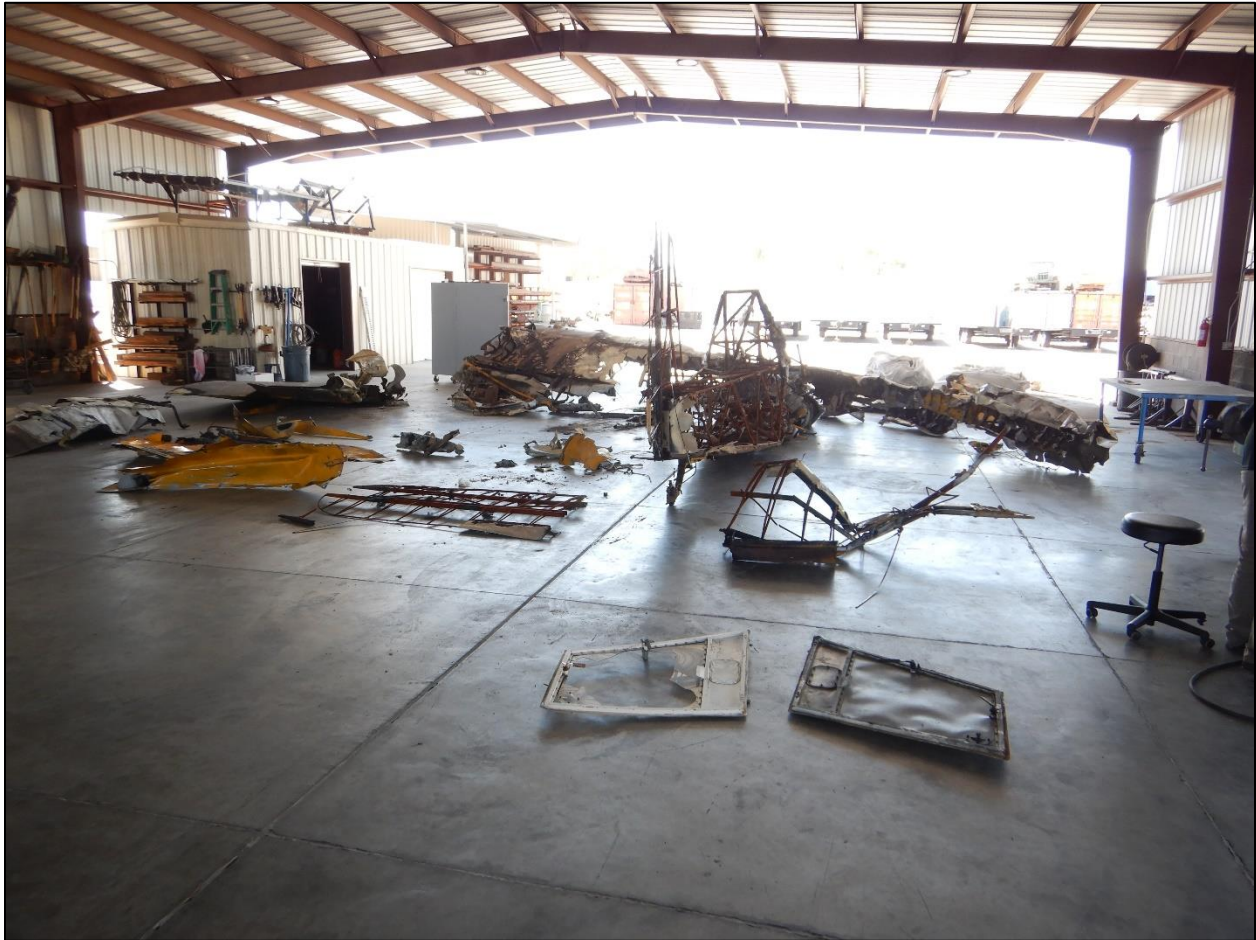
The airframe was found in numerous sections and only a couple sections of the forward fuselage and both horizontal stabilizers were cut to facilitate the recovery of the wreckage. All primary flight controls were identified during the examination. The fuselage including the empennage had thermal and impact damage revealing its internal structure and controls.

**Figure 1-Wreckage examination, wreckage layout.**

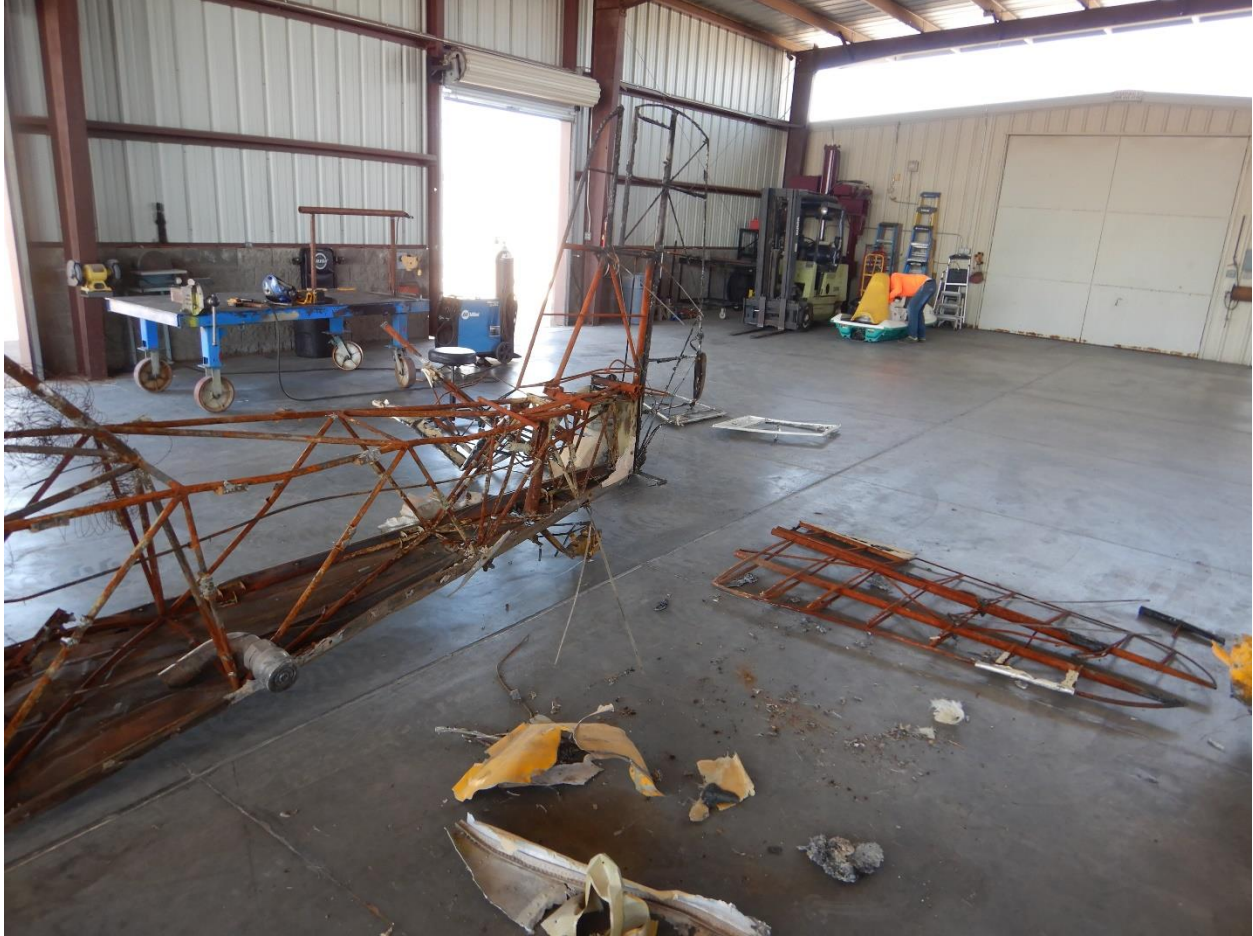
The rudder control cables remained attached to the rudder bellcrank and forward left attachment point. The right rudder cable separated near the cabin area and showed overload signatures. The forward right attachment point was not found during the examination. The elevator rear linkage remained attached to the empennage area. The elevator control rods located in the aft fuselage to the cabin area were not found during the examination.

**Figure 2-Wreckage examination, empennage.**

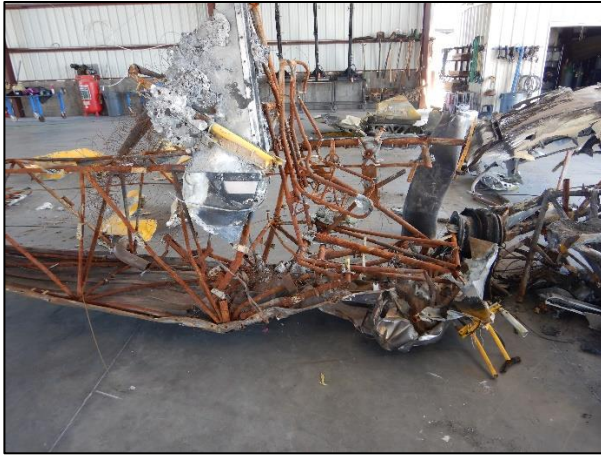
The cabin area had excessive impact damage and none of the forward cabin controls were identified. The lower fuselage pan remained attached to the cabin area and revealed a long circular impact signature. The circular impact signature was visible up the side of the cabin area on the left side of the pilot's seat and cabin structure area.

**Figure 3-Cabin area, right side view.**

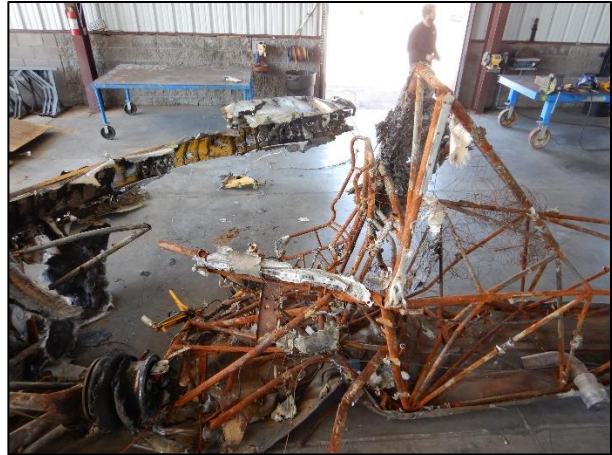
**Figure 4-Cabin area, left side view.**

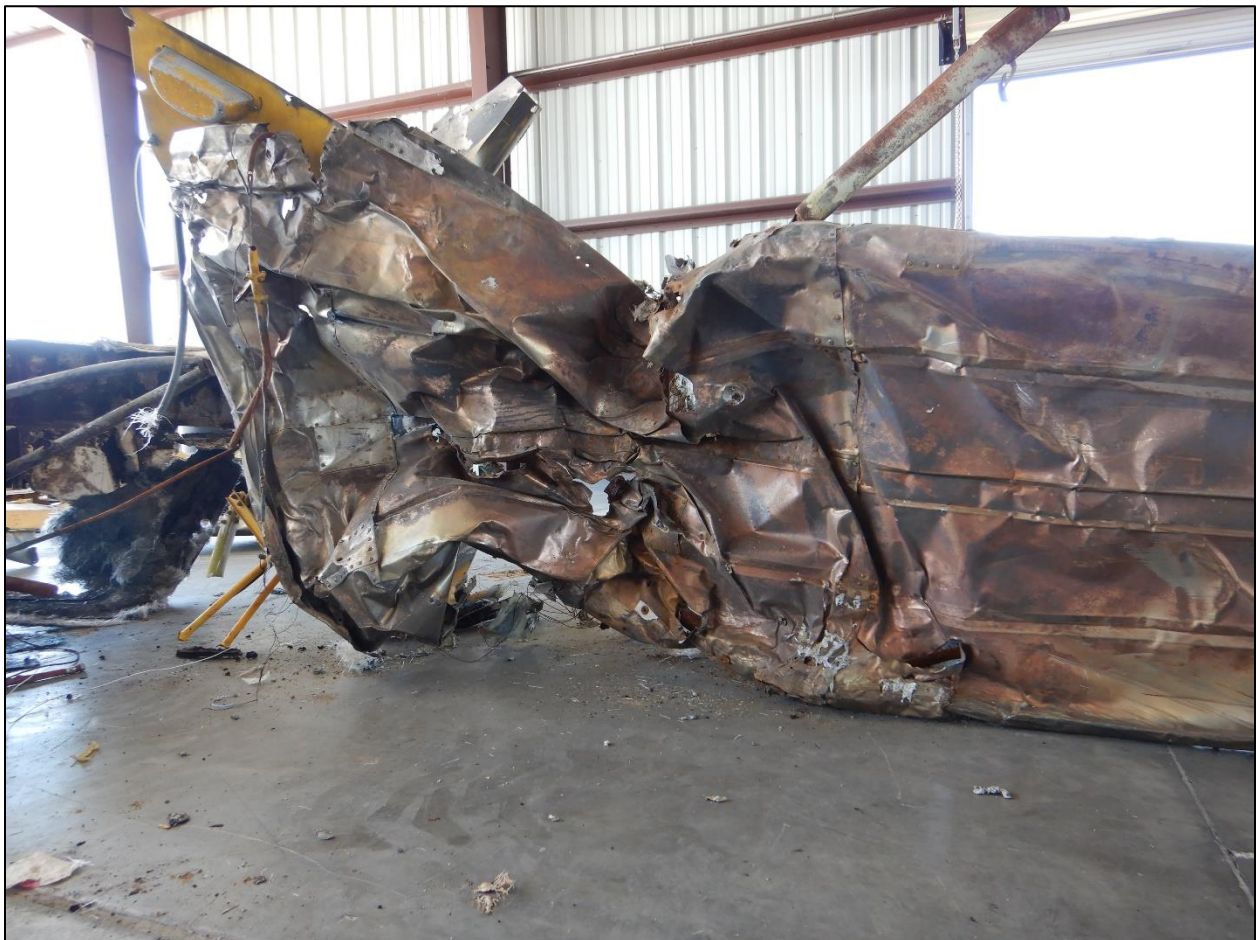
**Figure 5-Impact signature on cabin area, lower pan.**

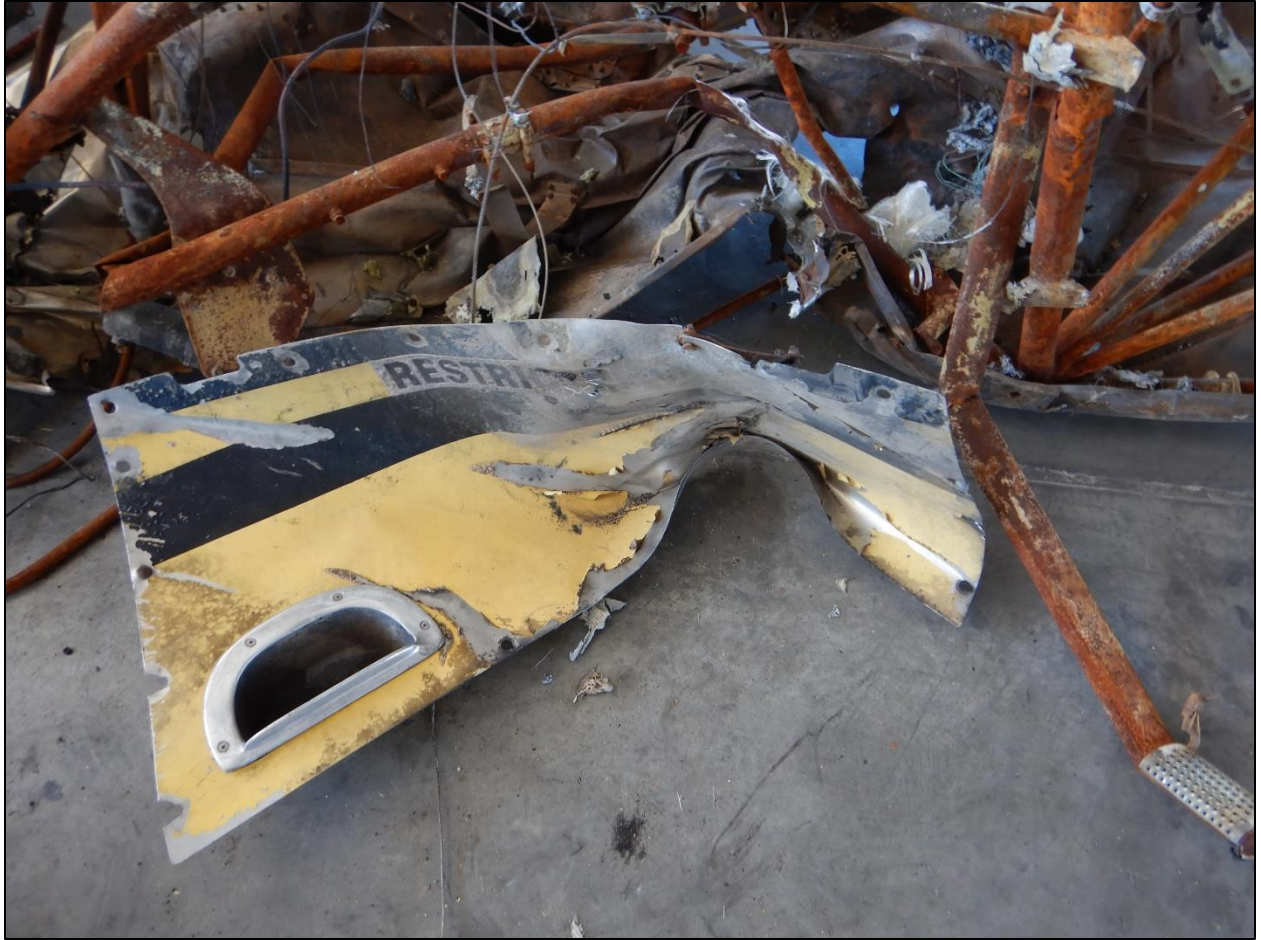
**Figure 6-Impact signature on fuselage skin panel and cabin area.**

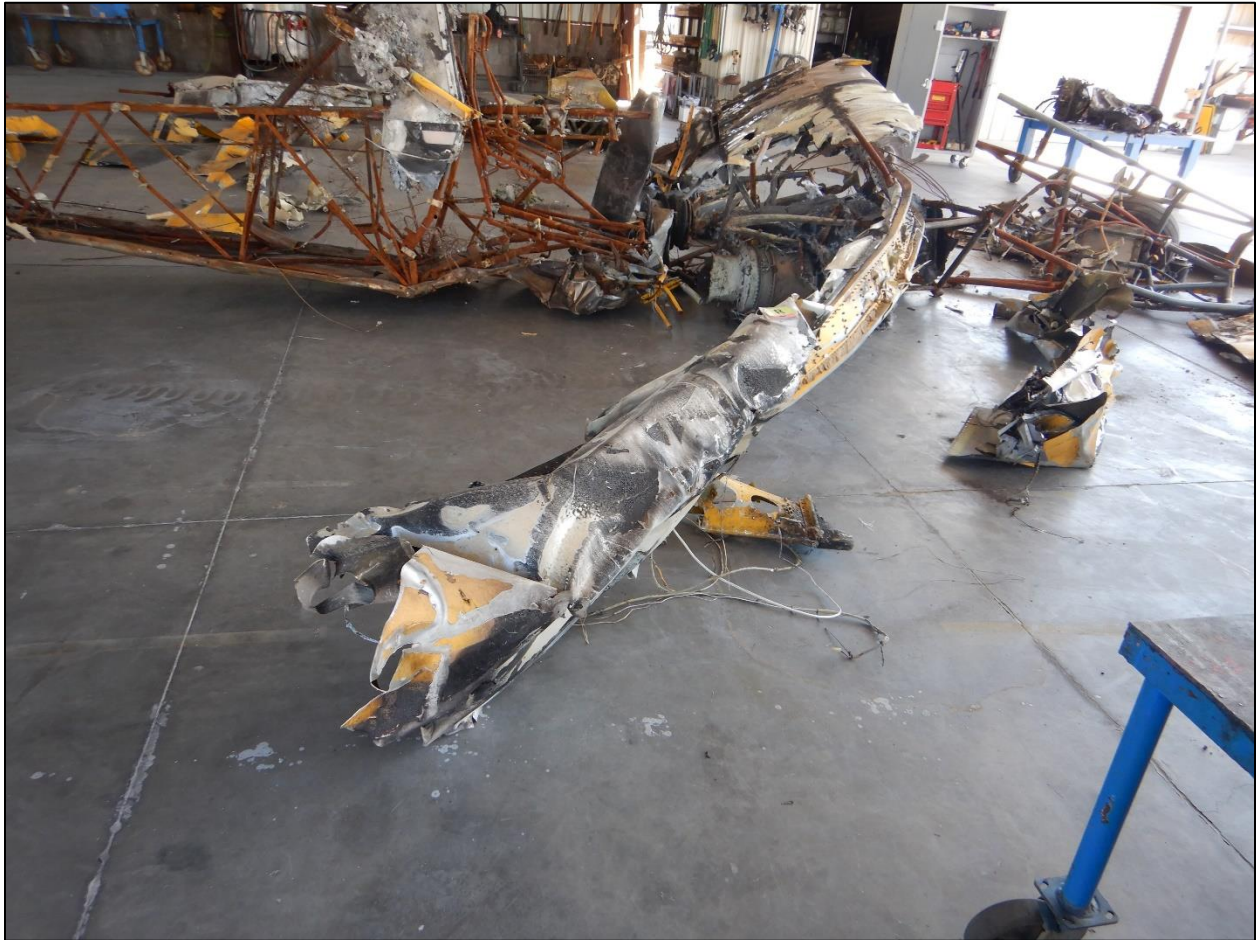
The forward fuselage, including the forward section of the cabin area, separated from the cabin area and remained partially attached to the wing spar. The forward hopper section and engine carriage separated from the wing spar. The wing tip sections (about 6 ft') separated from the wing during the accident sequence. The wing spar remained intact with excessive impact damage to the right wing. Only a small portion of wing structure and skin remained attached to the right wing spar. The aileron and flap assemblies were found with the wreckage. The right wing spar was bent aft from about the fuselage attach point to the tip, (about 8 ft aft from its original position at the tip.) The wings flight controls tubes were not found during the examination. Flap position was not determined. Aileron sections remained attached to the separated wing tip sections.

Figure 7-Main wreckage, right side view of the wing spar.

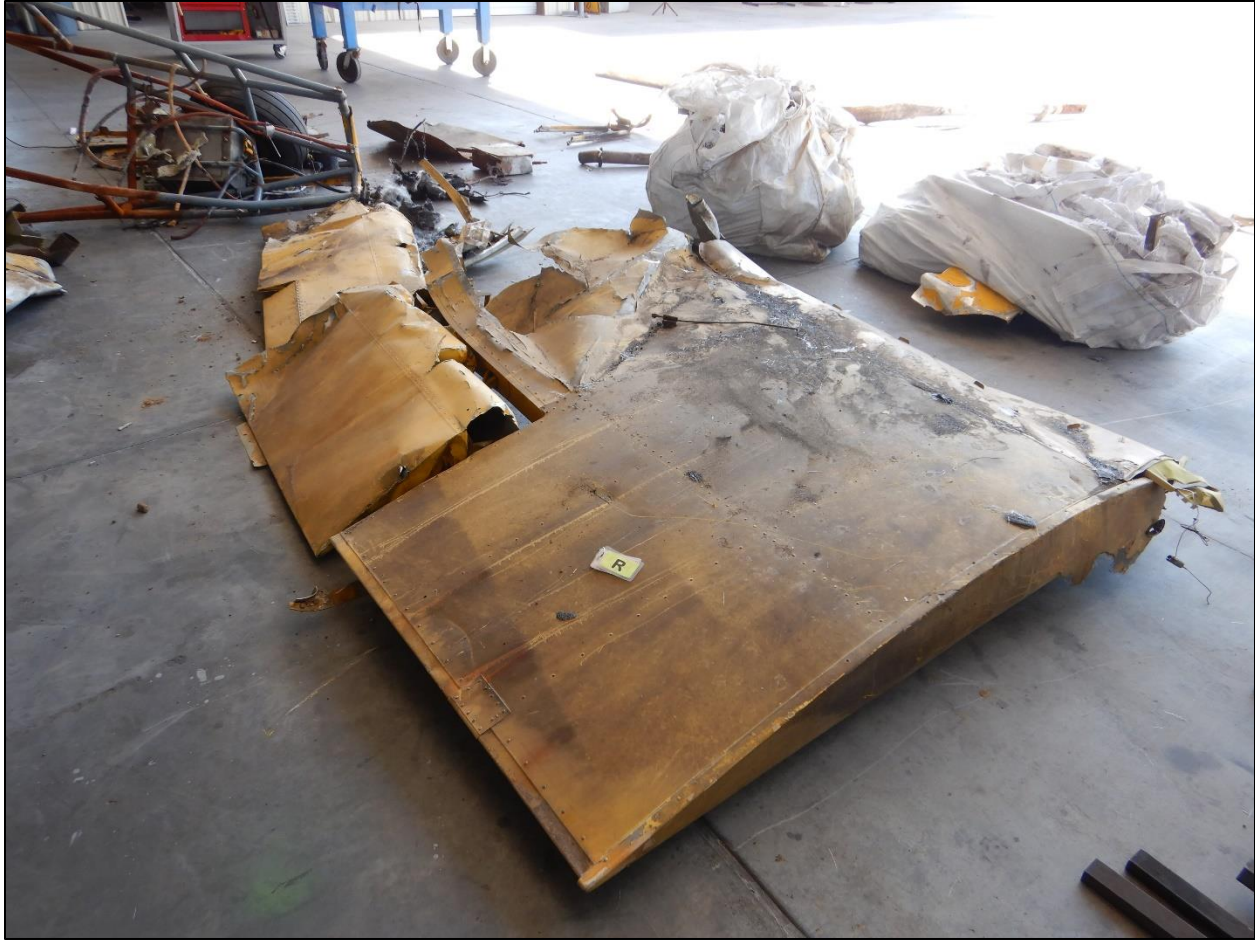
**Figure 8-Right wing tip and aileron.**

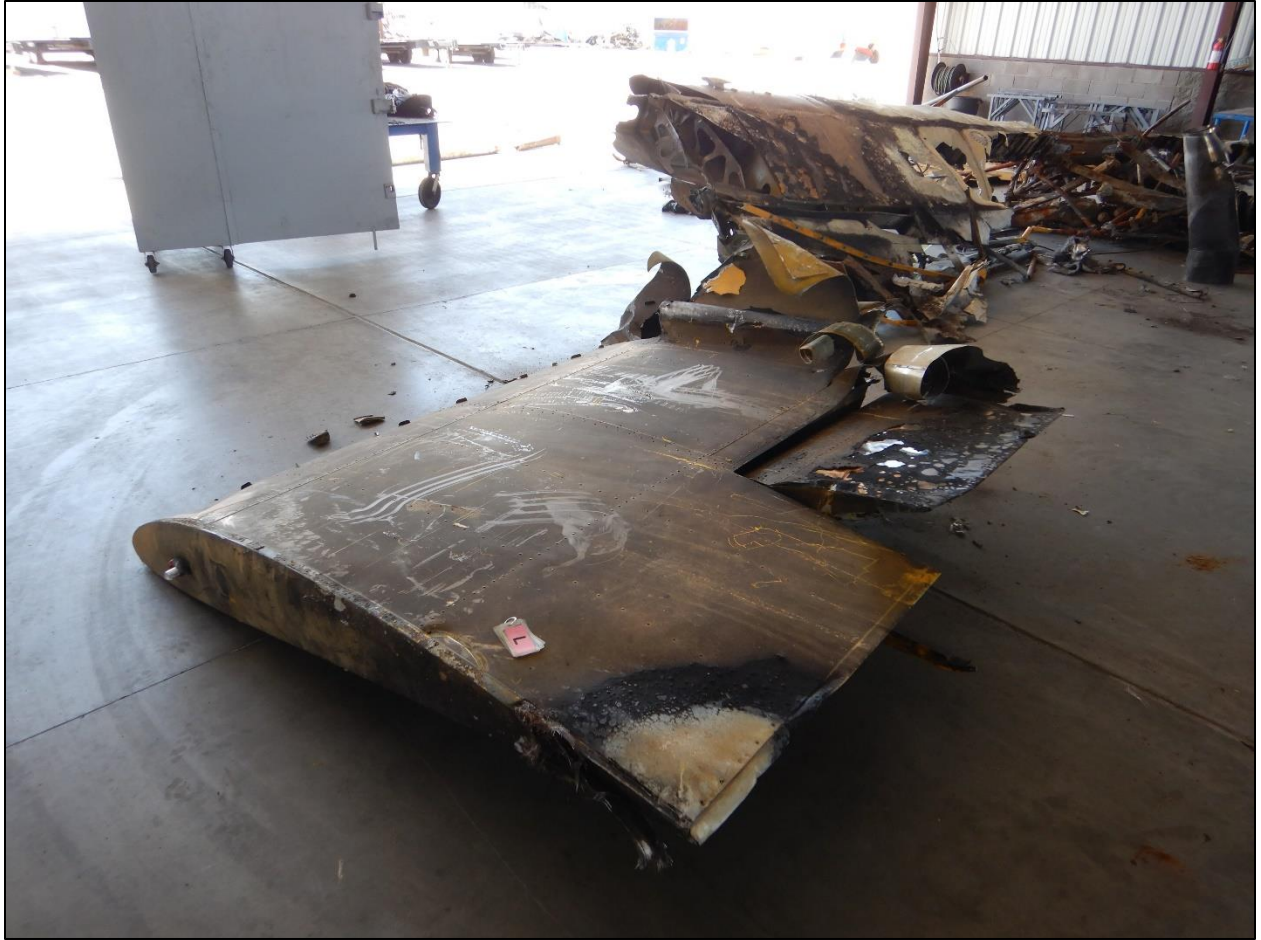
**Figure 9-Left wing tip and aileron.**

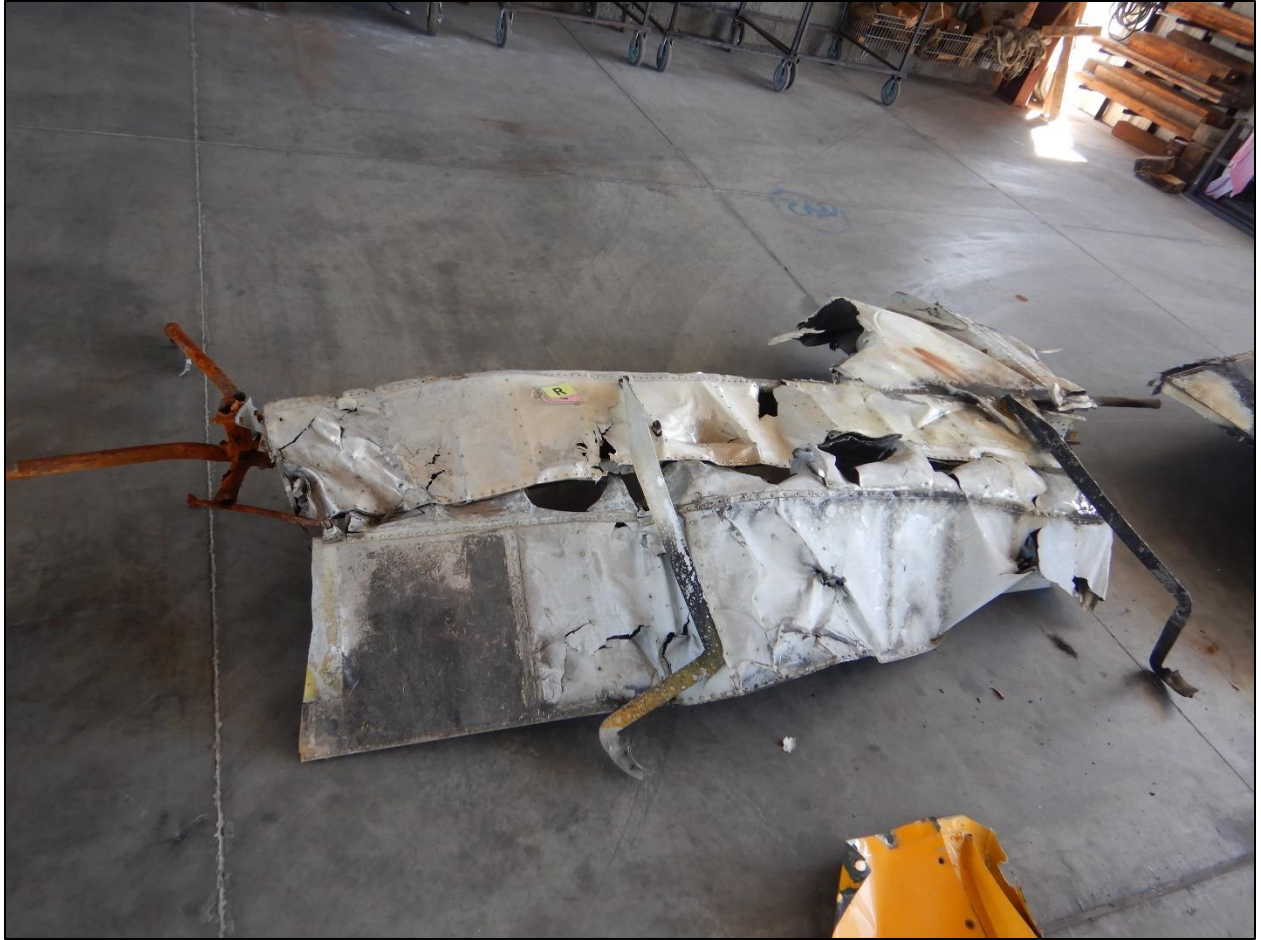
**Figure 10-Right wing and flap sections.**

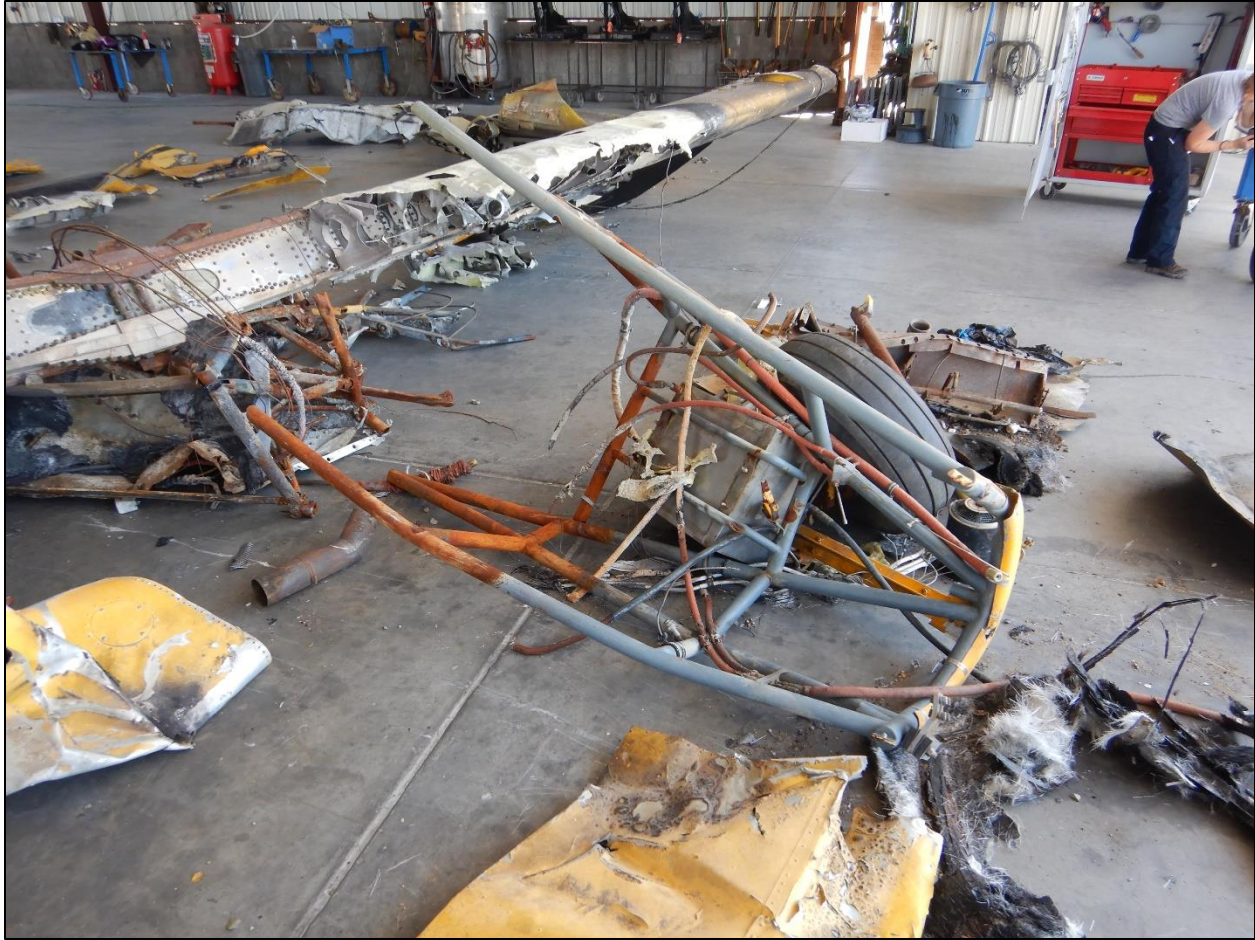
**Figure 11-Forward fuselage section.**

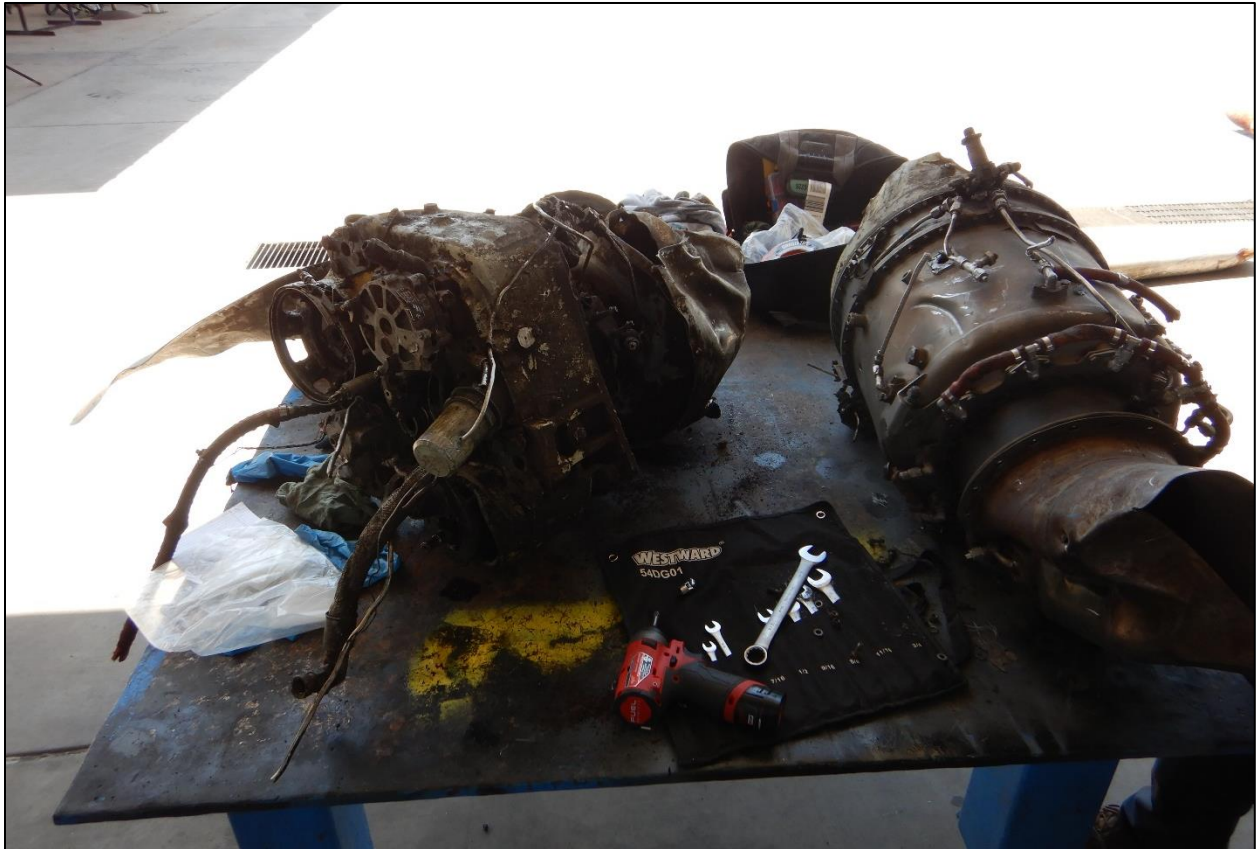
The engine was separated from its mount and found in two sections. The propeller remained attached to the gear box section of the engine. The power section was examined and showed some metal splatter on inner blade stages. The compressor inlet first stage showed impact damage to several blades. The turbine blades rotated freely by hand.

Figure 12-Engine sections.

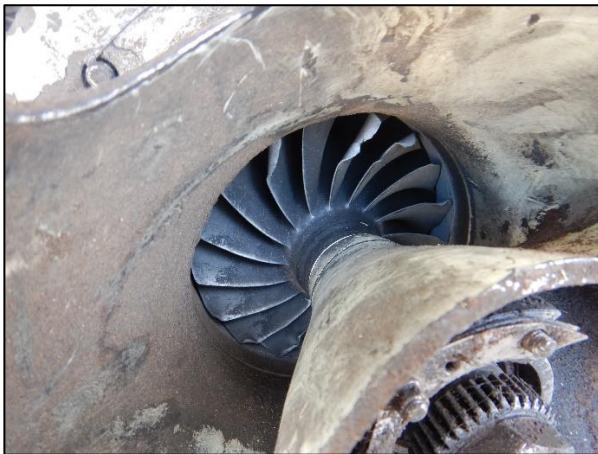
Figure 13-Engine compressor inlet.

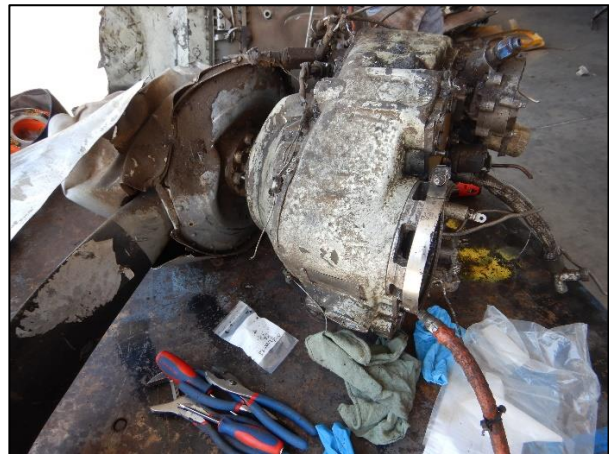
Figure 14-Propeller assembly and gearbox.

The propeller assembly remained attached to the gearbox and two blades separated from the hub. The blades showed s-type bending throughout the blade's lengths and chordwise scuffing and scratches.

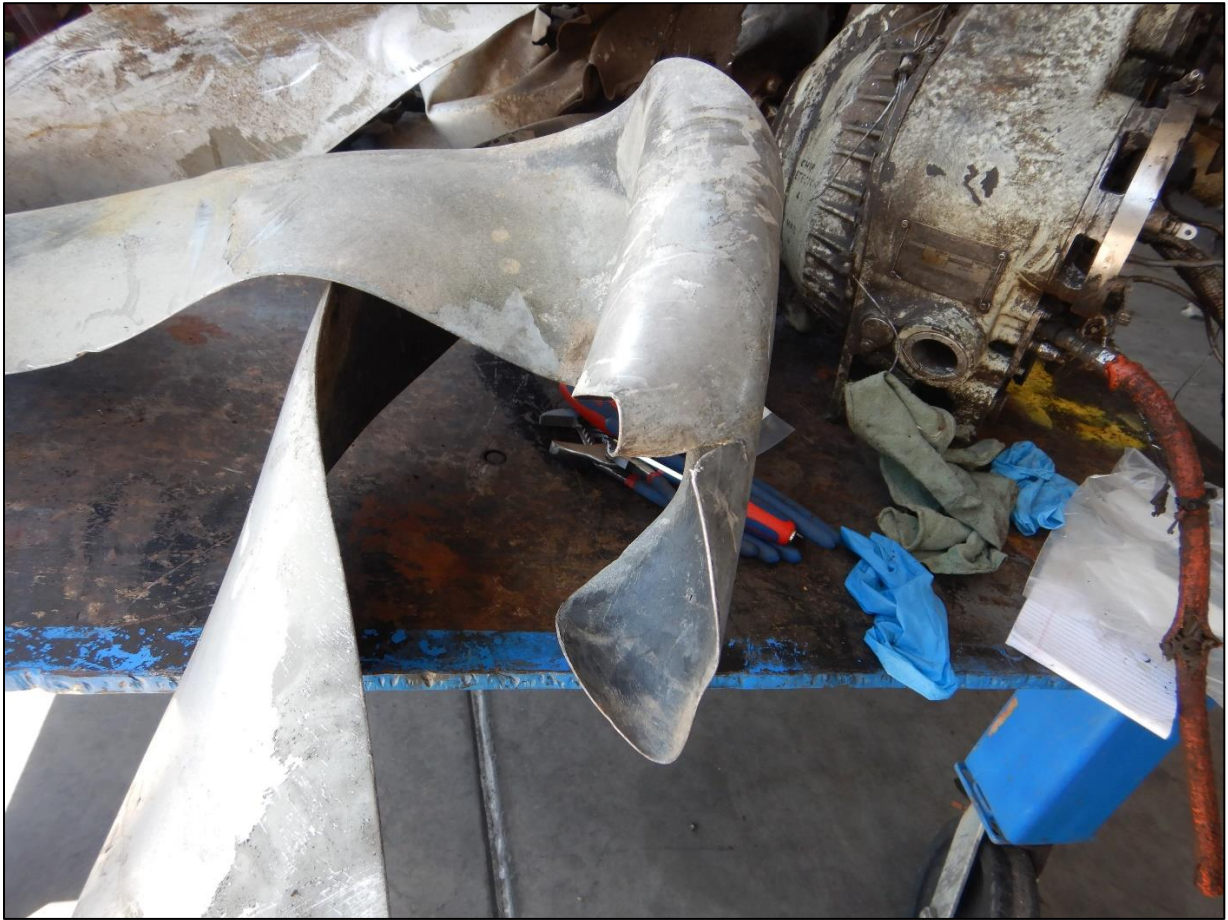
**Figure 15-Propeller blade damage.**

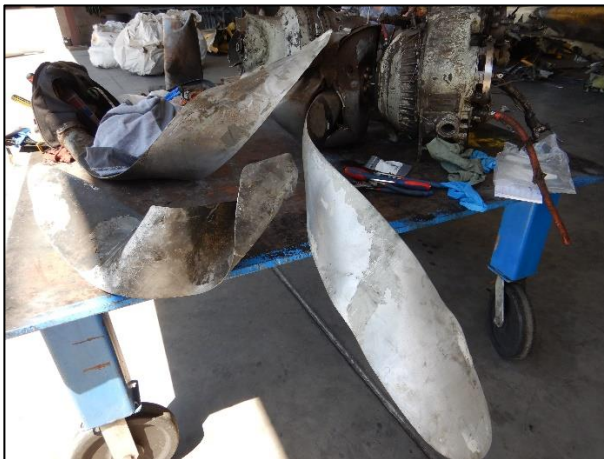
**Figure 16-Propeller blade.**

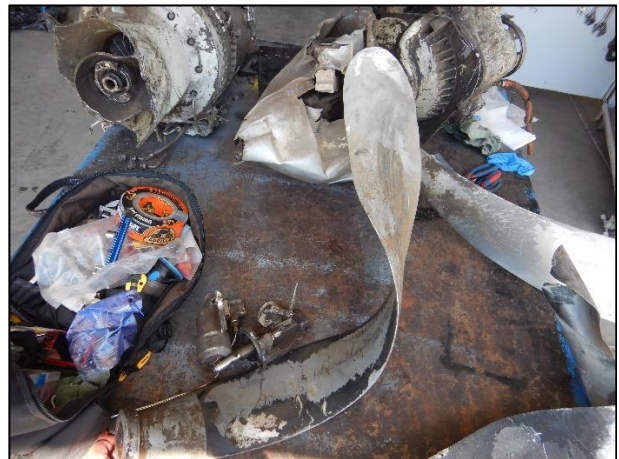
**Figure 17-Propeller blade.**
