## **NATIONAL TRANSPORTATION SAFETY BOARD**

# **ACCIDENT SITE EXAMINATION SUMMARY**

**WPR22FA044**

Location: Big Bear City, CA  
Date: November 20, 2021  
Aircraft: N291KT Experimental  
Amateur-built Glasair III  
NTSB IIC: Albert Nixon

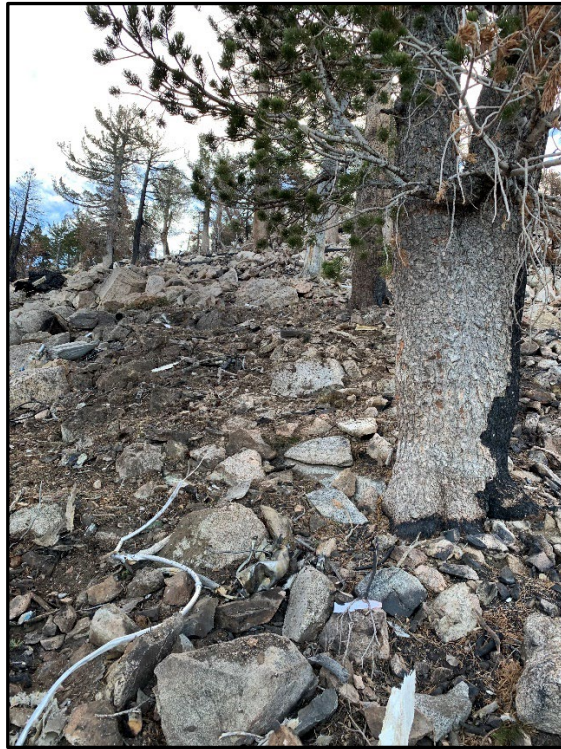
Figure 1: Airplane wreckage debris on ground and in tree.

Flight control continuity was unable to be established due to the extensive damage sustained by the airplane. Most of the wreckage debris, consisted of small fragments of the fuselage and wings.

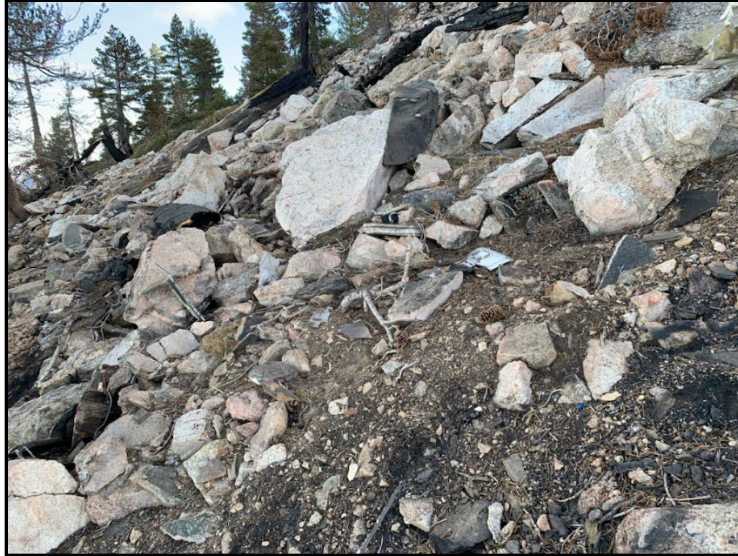
Fragments of the airplane were scattered about 200 ft upslope from the main wreckage and 100 ft below it. The debris trail was on about a 97° magnetic heading. The engine had separated from the fuselage and was located about 100 ft past and upslope of the main wreckage. The engine sustained substantial impact damage. The propeller blades and hub had separated. Damage to the airplane, the debris dispersal pattern, and impact markings, were all consistent with it impacting in a high-speed, level flight attitude.

**Figure 2: Airplane wreckage debris on side of mountain.**
