## **MANDATORY ACTION – SAFETY ALERT**

CH 601 and CH 650 series canopy secondary latch installation required.

## **RECREATIONAL AIRCRAFT AIRWORTHINESS NOTICE**

### **COMPULSORY FITMENT OF A SECONDARY CANOPY LOCKING DEVICE, ON ZODIAC/ZENAIR/ZENITH AIRCRAFT CANOPY**

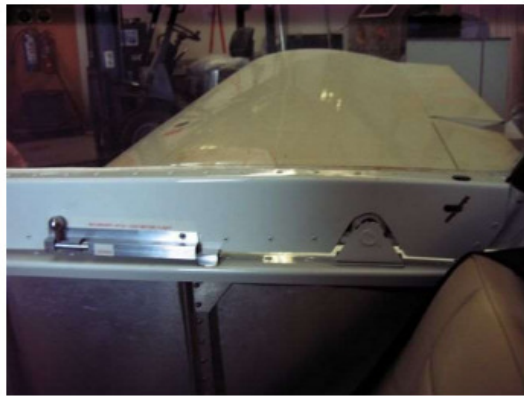
**Figure 2 above: a simple barrel latch fitted on both sides of the canopy.**

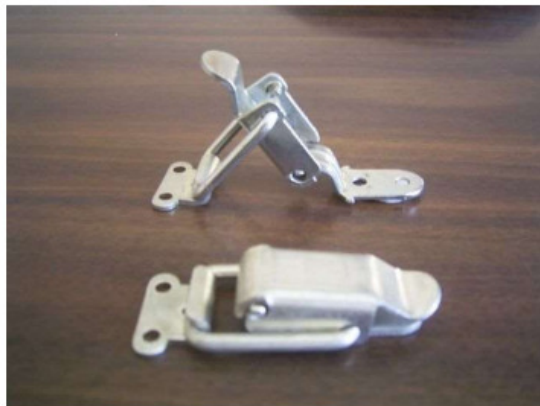
**Figure 3 above: Another type of quick release latch which could be fitted to each side of the canopy.**

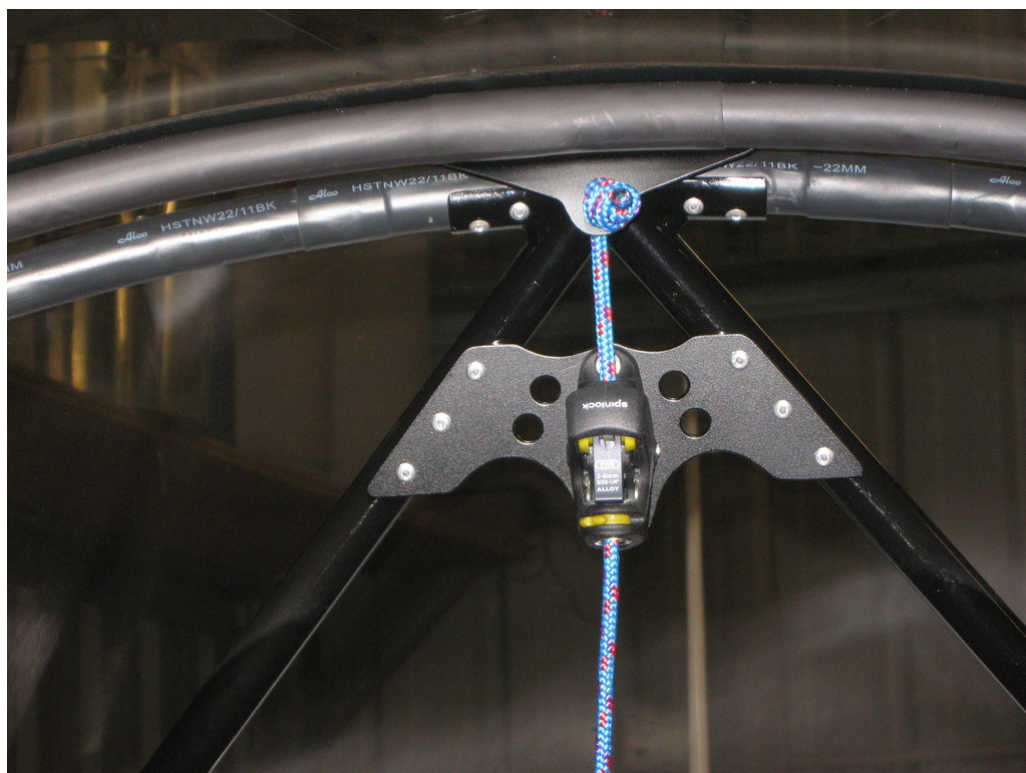
“A secondary latch is mandatory in Australia. Here is what I did using a sailing boat rope cleat. It's model is a Spinlock PXR0206 and a 6mm rope. Flick the rope firmly rearward to lock and forward to release”.
