# National Transportation Safety Board

WPR22FA048

## AIRFRAME EXAMINATION REPORT

Location: Temecula, California  
Date: November 23, 2021  
Time: 1033 LCL  
Airplane: Zenith Zodiac 601XL, N601KS

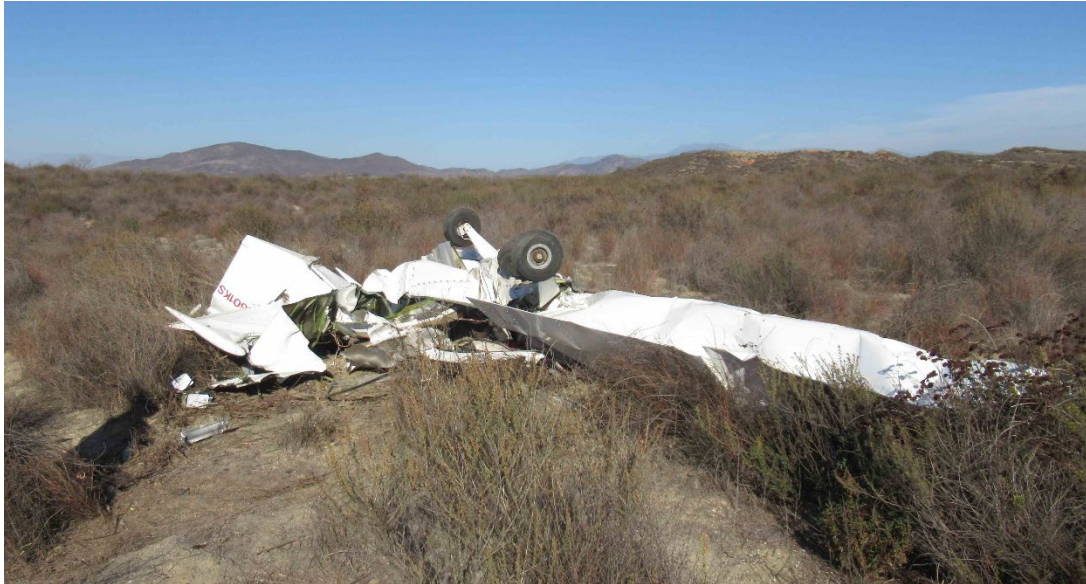
The airplane came to rest inverted and partially nose down on an east heading (figure 1), in a field about 250 ft north of a new housing development, and 2.75 miles southeast of French Valley Airport (F70).

**Figure 1 - Airplane at the accident site, facing northeast.**

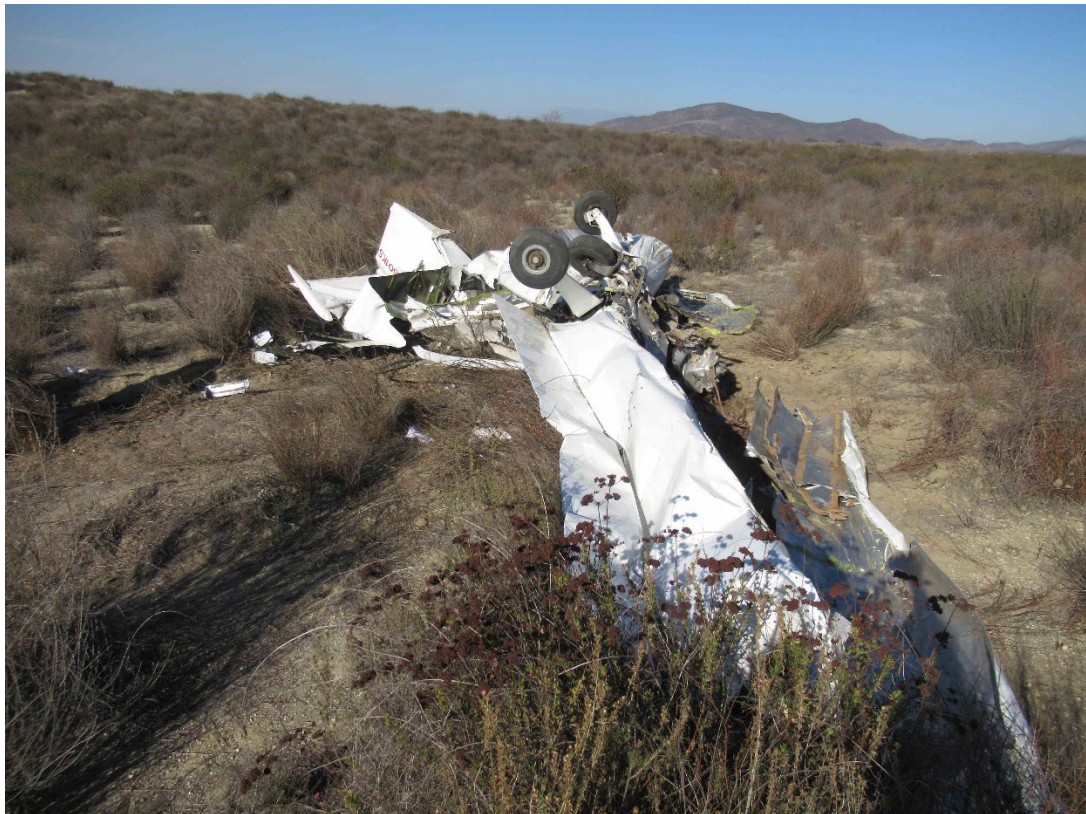
The airframe was compressed aft, such that the engine and firewall were in line with the trailing edge of the wings. Both wings sustained crush damage through to the aft spar, both fuel tanks had been breached and the smell of fuel was present in the soil immediately surrounding the site (figure 2).

The main landing gear legs remained attached to the cabin center section, and the nose landing gear strut was partially attached to the firewall, which had compressed aft such that it was in line with the main landing gear (figure 2). All wheels remained attached to their respective legs.

**Figure 2 - Airplane at the accident site, facing north.**

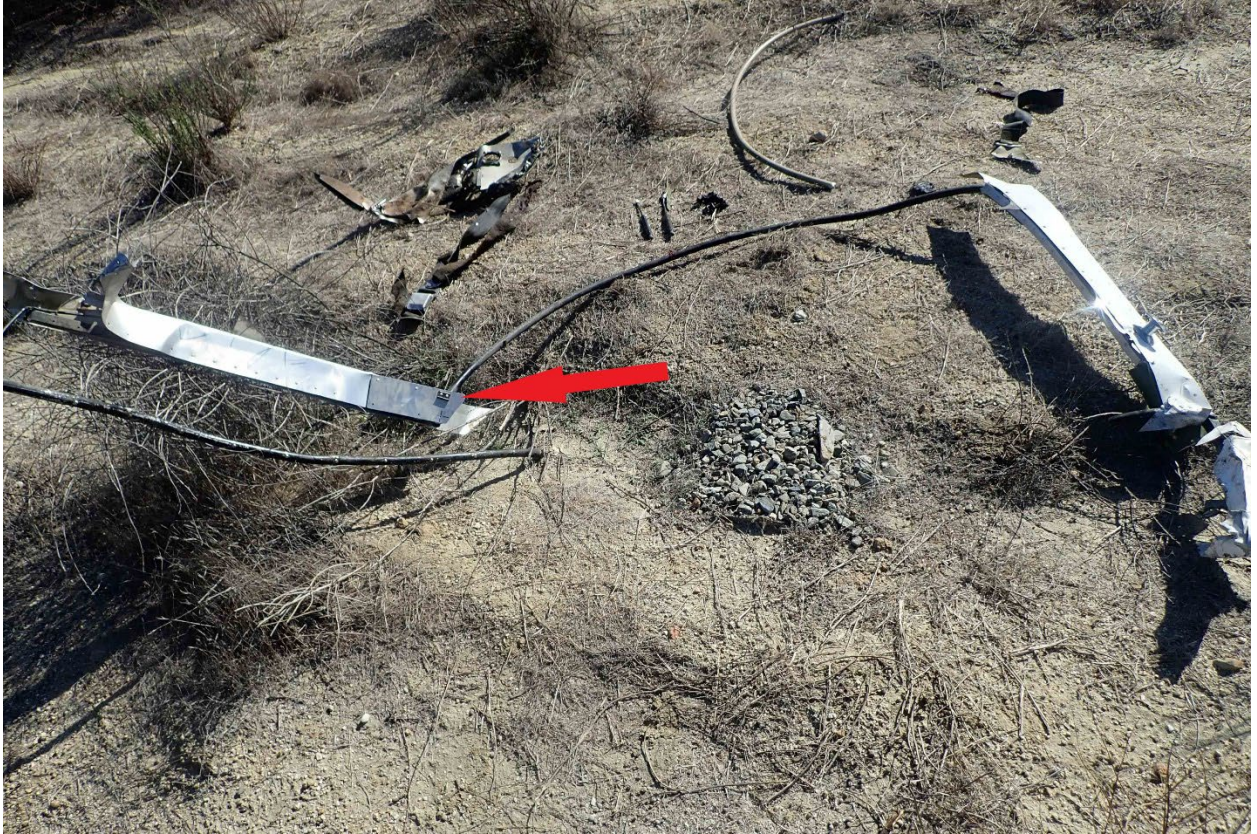
A large quantity of canopy fragments had dispersed from the initial impact point, and 70 ft west. The fragments varied in thickness between 1/16<sup>th</sup> and 1/8<sup>th</sup> inch. Remnants of the canopy frame were comingled with the main wreckage, and the gas struts had broken away from both structures. The canopy sides remained attached to the rear bow, and the forward bow had broken away from the left side structure (figure 3). The latch hooks remained attached to the sides of the rear canopy structure.

**Figure 3 - Canopy frame. (Latch hooks highlighted)**

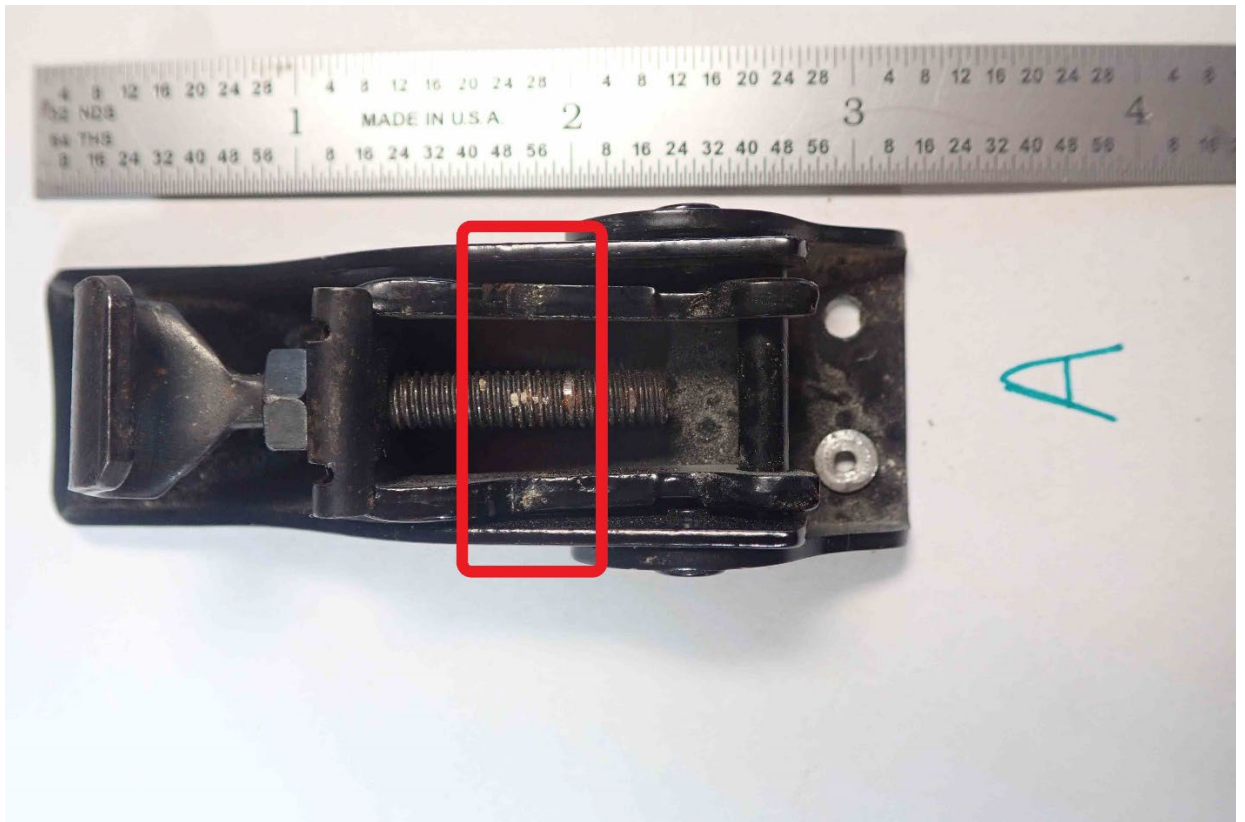
For latch A, the 7/32 inch head of a 1/8 inch diameter aluminum blind rivet was still in place, and appeared to have sheared from the rivet shank, which was not located. The other rivet was missing (figure 4). The inboard side of the over-centering arm and the corresponding threaded portion of the hook exhibited scratches and paint transfer marks (figure 4). The mating side of the mounting plate exhibited scratches and grooves in the vertical plane (figure 5), that were not present on latch B.

**Figure 4 - Latch A scratches and paint transfer marks and rivet head.**

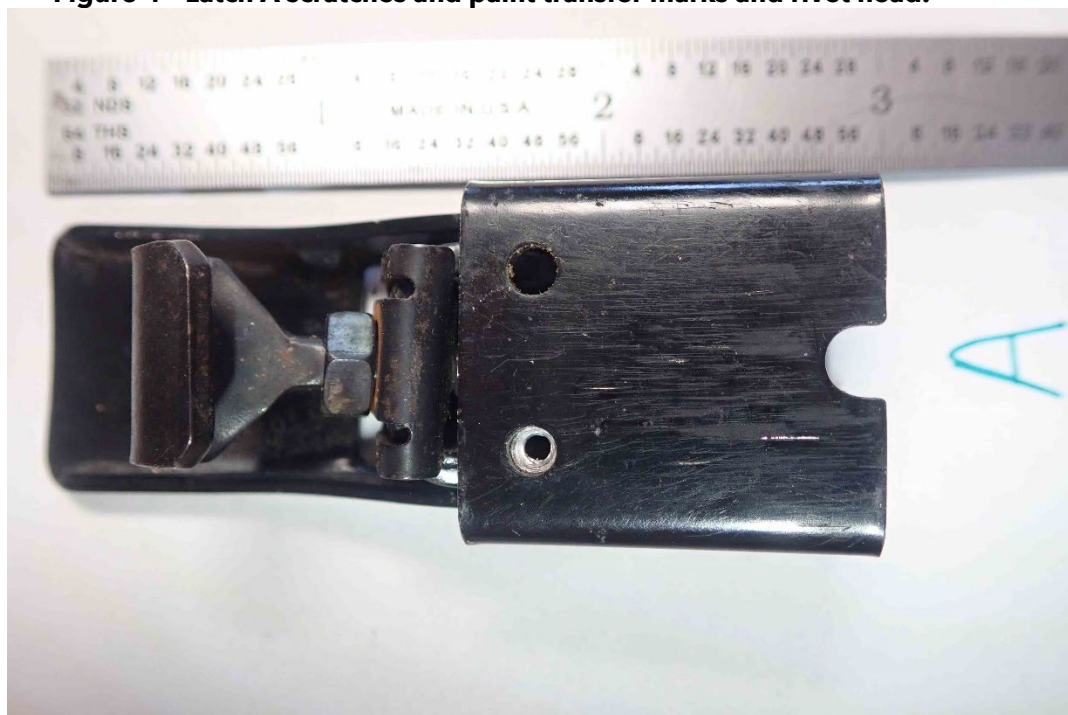
**Figure 5 - Latch A mating side of the mounting plate scratches and grooves in the vertical plane.**

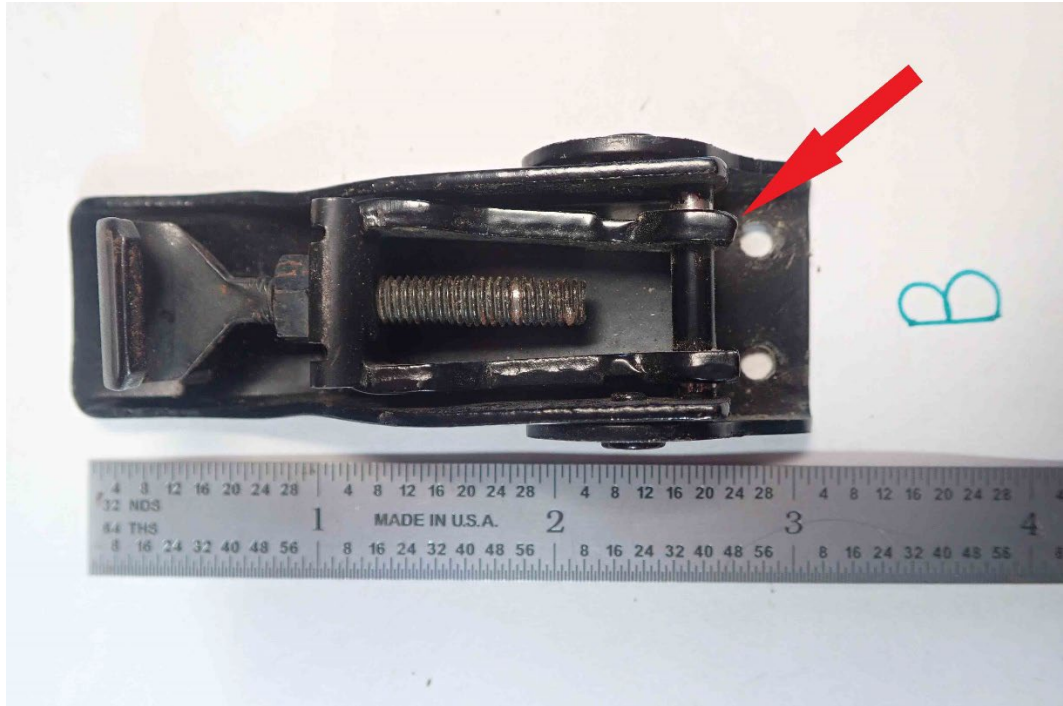
Both rivets were missing from latch B. The over-centering arm had deformed inward (figure 6), and the mounting plate was twisted (figure 7).

**Figure 6 - Latch B deformed over-centering arm.**

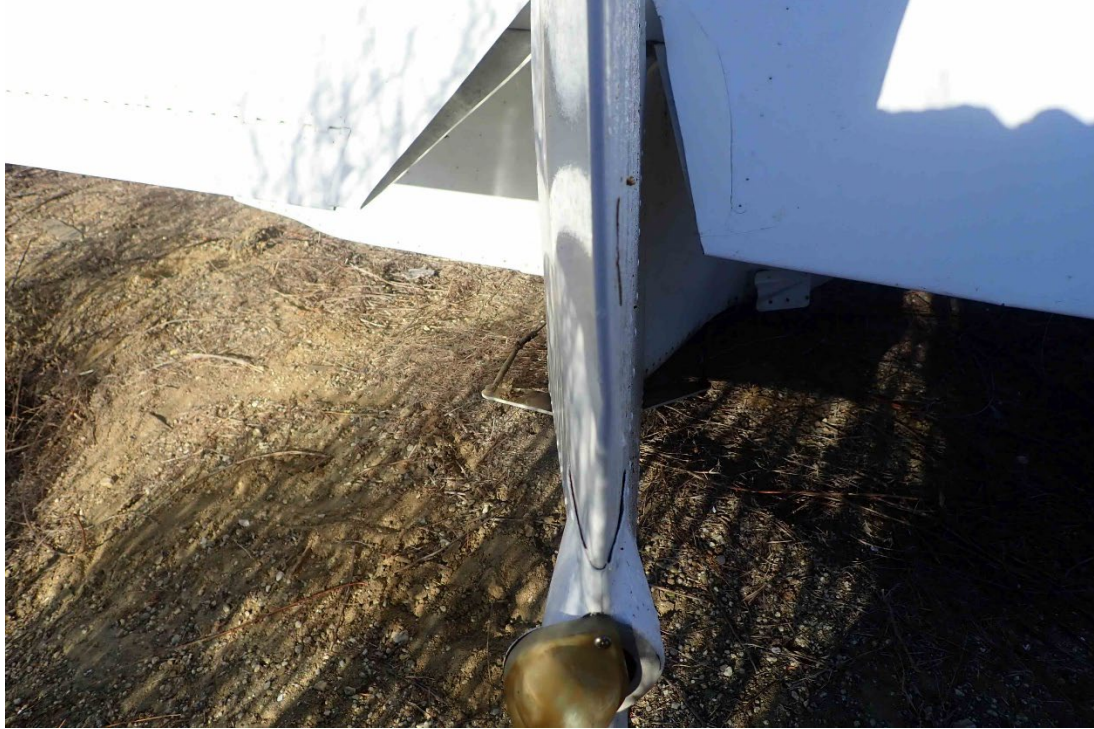
**Figure 8 - Rudder control arms.**

The empennage had detached from the tailcone just forward of the horizontal stabilizer. The moving vertical stabilizer/rudder assembly remained attached to the tailcone by its hinges, and the horizontal stabilizer remained attached to the upper deck of the tailcone. The rudder control cables were continuous from the control arms (figure 8) through to the crushed foot pedal assembly (although the cables had been cut by first response personnel). The elevator control cables were continuous from the control arms through to the center bellcrank. Forward of the bellcrank, the elevator push-pull cable was crushed and severed. The elevator trim tab remained attached to the control surface and its control actuator and was at about the 12° tab-down position.

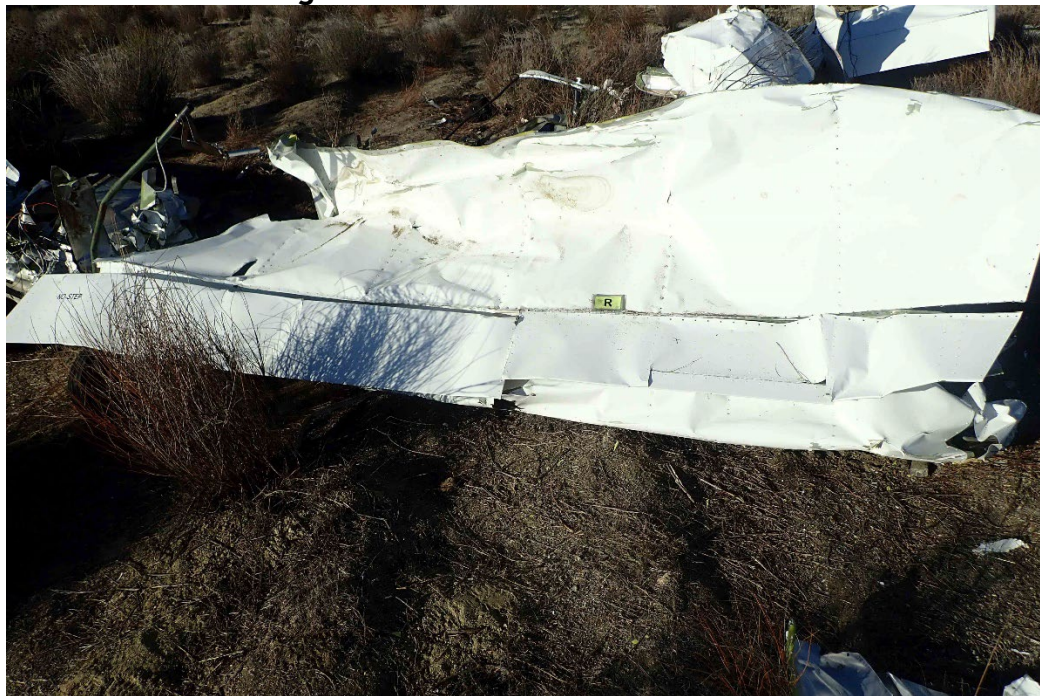
The right aileron remained attached to the wing by the inboard section of its piano hinge (figure 9). The trim tab sustained bending damage along with the aileron, but appeared to be generally flush with the control surface. The outboard aileron bellcrank remained attached to the wing structure. The aileron-to-bellcrank control arm was intact and connected at both ends (figure 10). The main pushrod remained attached to the bellcrank and was continuous to the cabin center where it was crushed and had separated from the rod end (figure 11). The rod end remained attached to the base of the control stick (figure 12). The right flap remained attached to the aft spar; the flap control slot was intact, and the flap torque tube had bent away from the fuselage but remained attached at its outboard right fitting.

**Figure 9 - Right wing aileron and flap.**

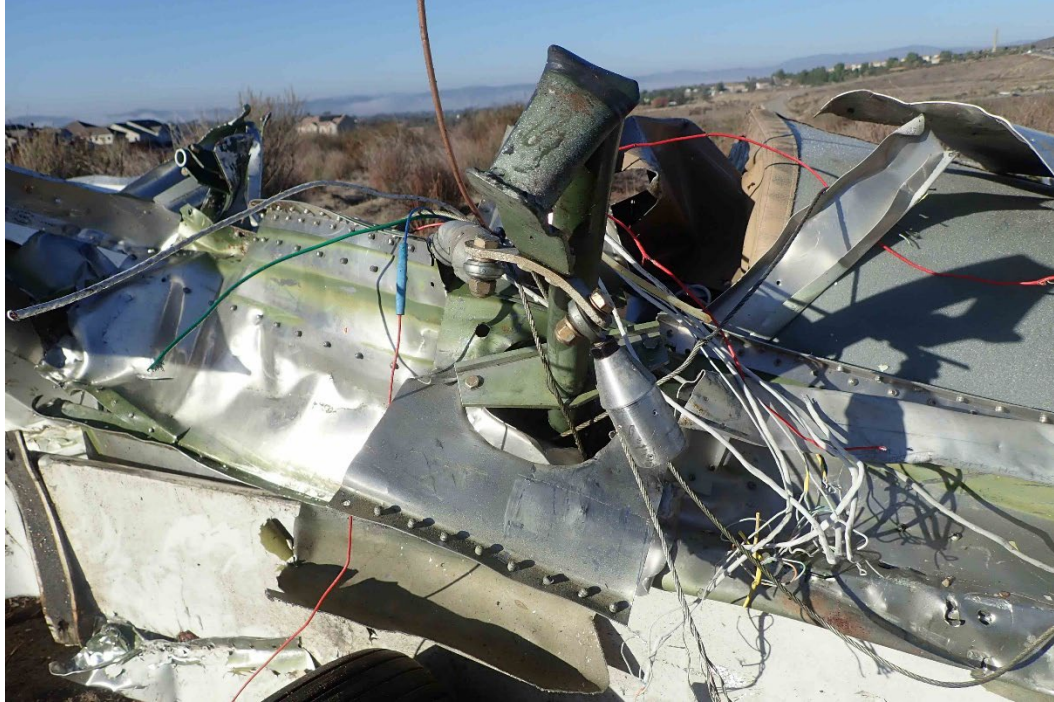
**Figure 12 - Control stick base.**

(figure 14). The main pushrod remained attached to the bellcrank but was crushed and separated mid-span (figure 15). The other end of the pushrod remained attached to the base of the control stick (figure 12). The left flap remained attached to the aft spar; the flap control slot was intact.

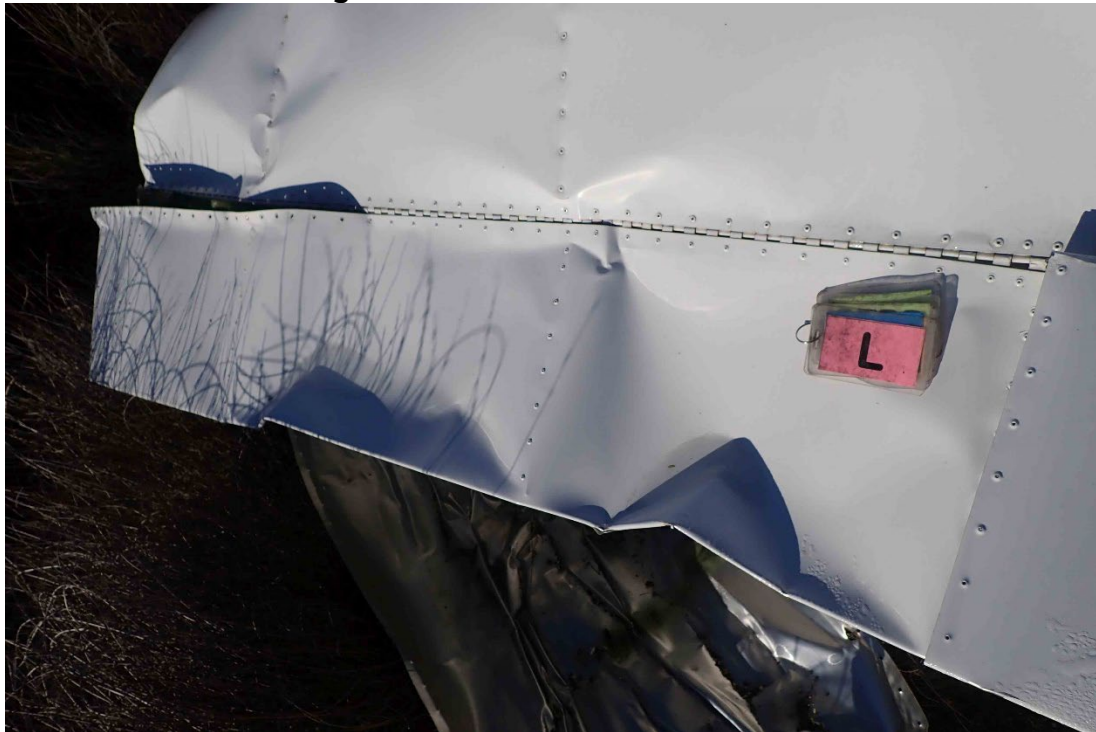
The left aileron remained attached to the wing by the inboard section of the piano hinge (figure 13). The outboard aileron bellcrank remained attached to the wing structure. The aileron-to-bellcrank control arm was intact and connected at both ends

**Figure 13 - Left aileron.**

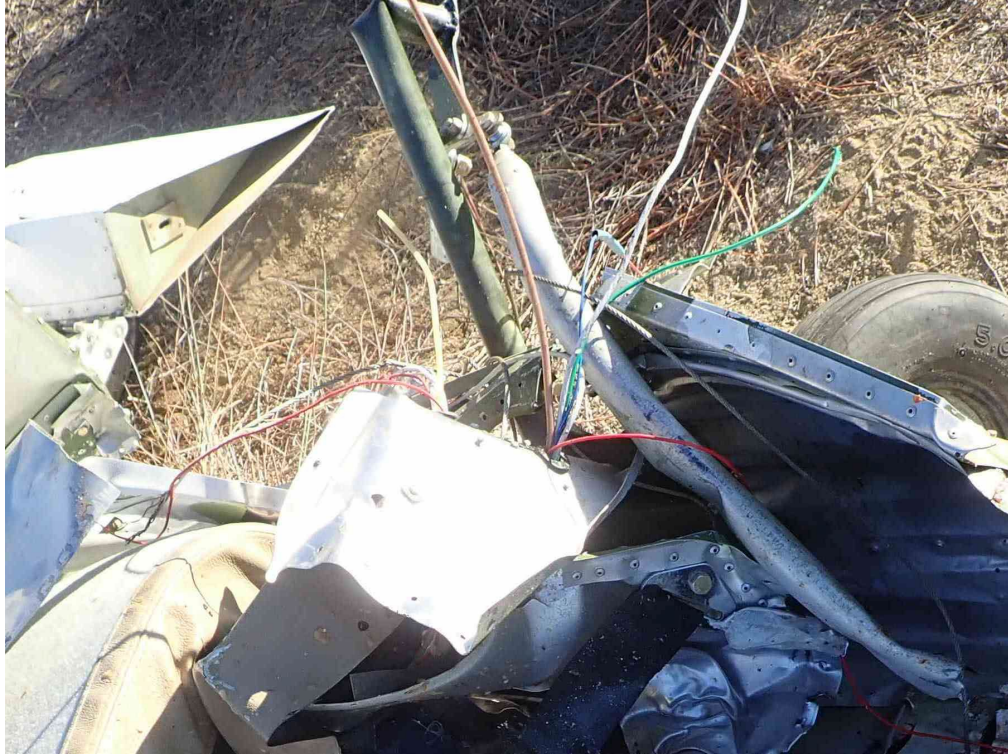
**Figure 15 - Left aileron pushrod.**

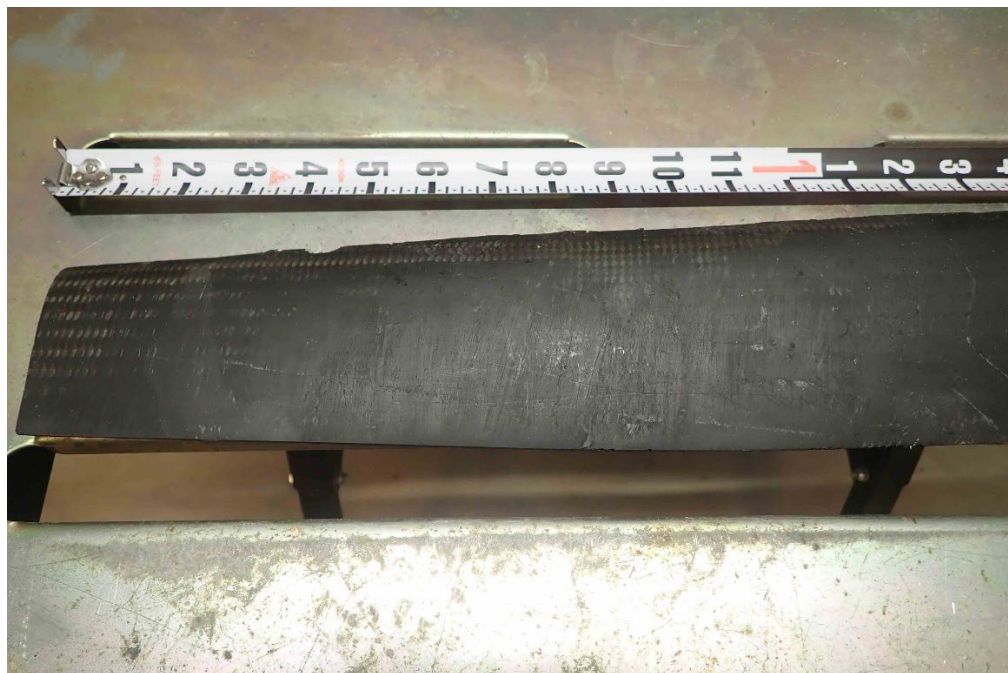
The propeller hub remained attached to the crankshaft, and both composite propeller blades had detached at their roots and were located on the ground with the main wreckage. One blade exhibited leading edge knicks and dents, and chordwise scratches (figure 16). The other blade was bent about 6 inches from the root, but otherwise intact.

**Figure 16 - Propeller blade.**

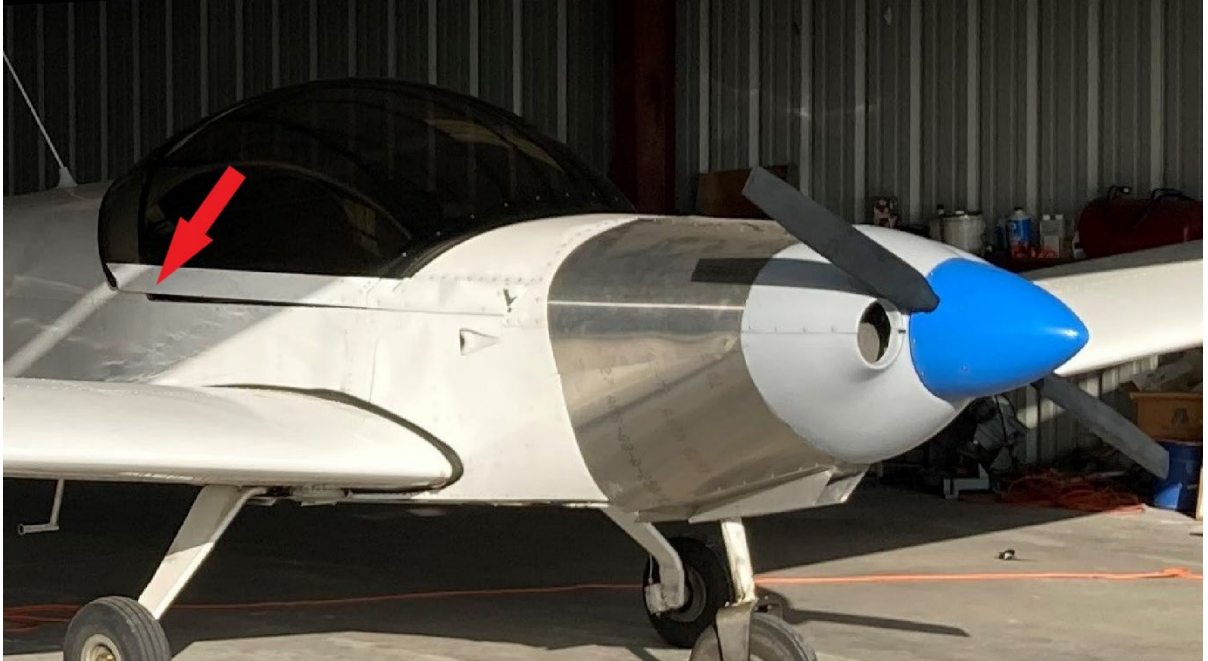
**Figure 17 - Location of canopy latches**

The airplane was equipped with a forward hinging tip-up canopy, that was comprised of an aluminum and steel frame structure with an acrylic bubble, supported in the open position by two gas struts. The original design used an automotive-style latch within the frame, that locked into a striker-pin on either side of the cabin sidewall canopy sill. The owner/builder had disabled the airplanes standard lock by removing the striker-pins mounted on the canopy sill and installed a lock that consisted of two over-center latches mounted to the rear canopy sill and frame (figure 17) with two 1/8 inch aluminum blind rivets per side. No secondary latch was installed.
