# National Transportation Safety Board

WPR23FA053

## **FOLLOW UP EXAMINATION REPORT**

Gyrocopter: Experimental Amateur-built, Vortex Gyrocopter, N425RD

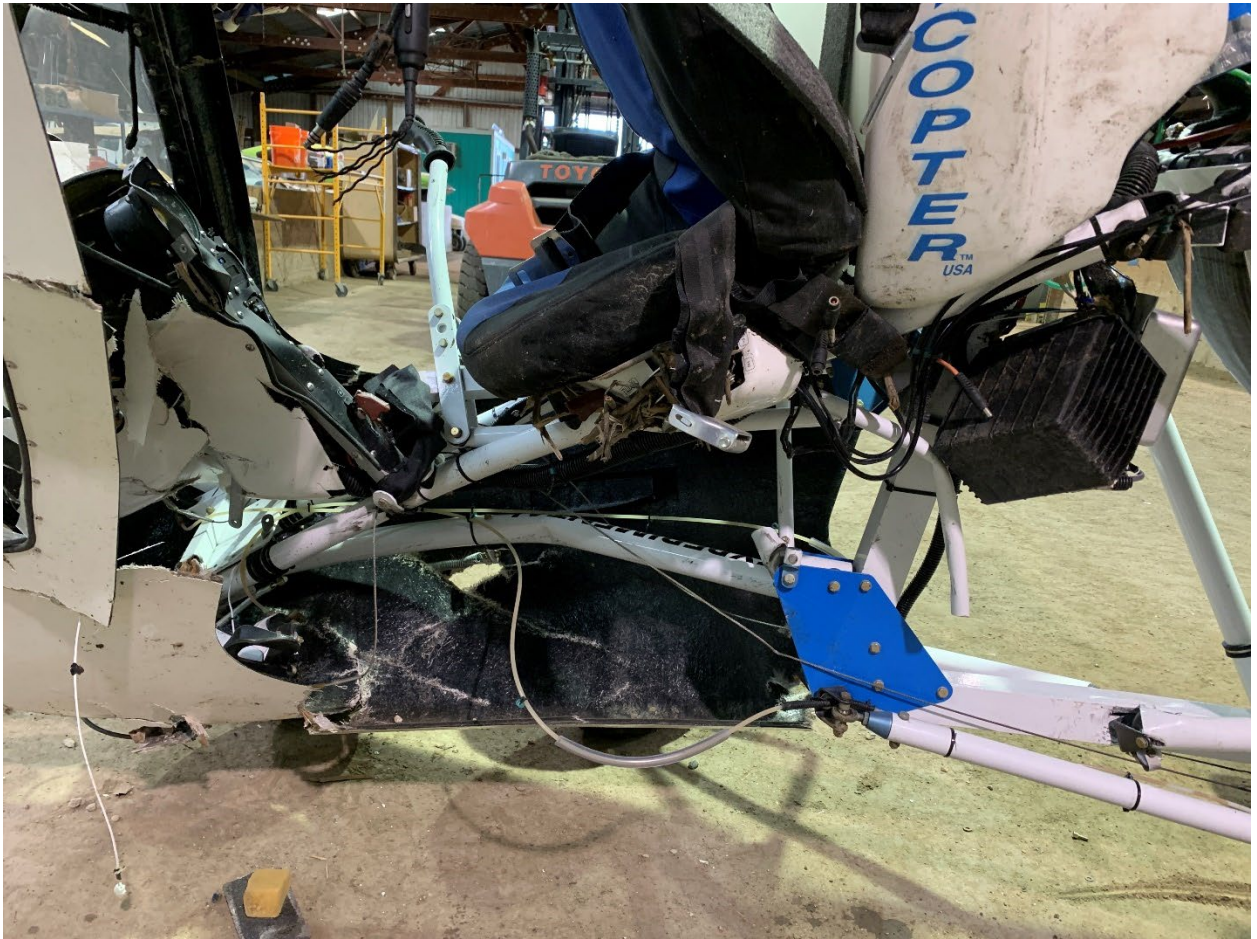
Photo 2. Left Side of Gyrocopter

The strut supports remained intact and connected. The gyrocopter has a tricycle landing gear set up, with an additional small wheel located at the tail for on ground moving. All 3-landing gear remained attached to the airframe. The left main landing gear support was broken. The right main cross tube had impact damage and was separated.

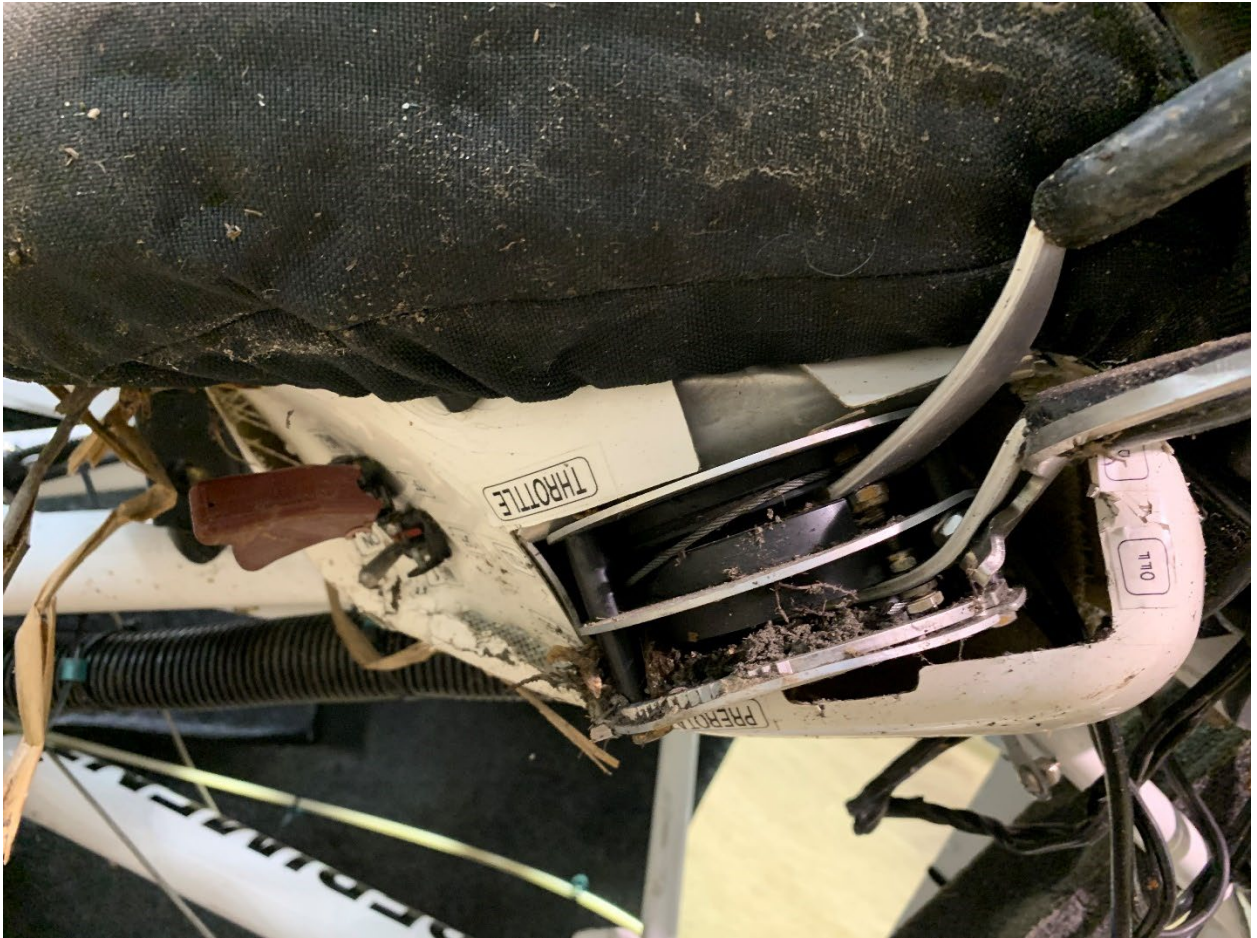
Photo 4. View of Flight Controls

Flight control continuity established from the cyclic through to the rotor mast, which could be moved freely from side-to-side and up-and-down.

The throttle was in the idle position and the pre-rotator was in the OFF position. Both levers were stuck in position and could not be moved. The No 1 mag was in the OFF position and the cover had separated. The No. 2 mag was in the OFF position, but the cover remained attached. The gold lever on the right side remained attached and the cable was connected from the cockpit to the main rotor head.

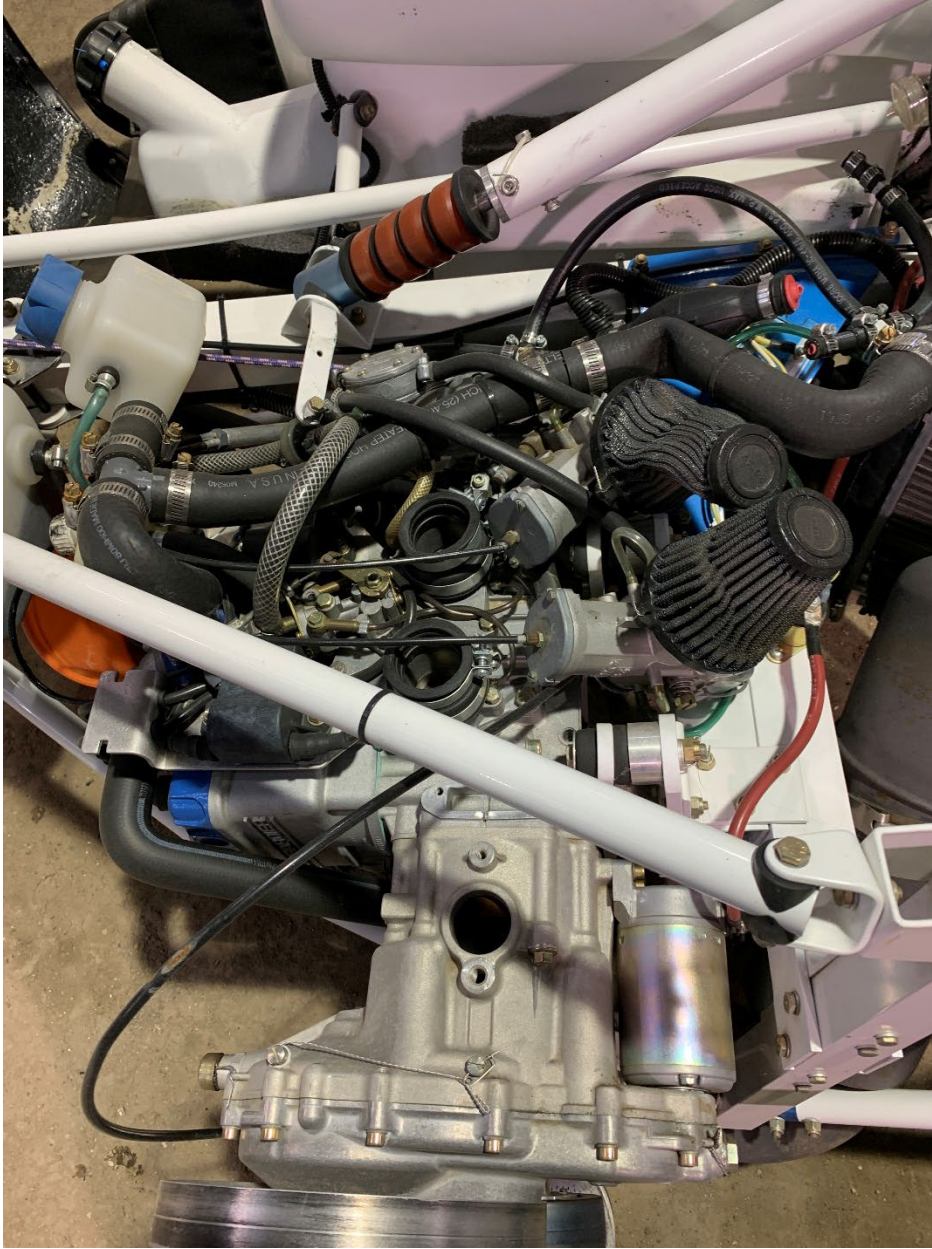
Photo 5. View of Engine Area

Engine valve train and mechanical continuity established through manual rotation of the engine via the propeller.

Both carburetors were separated from the engine due to impact damage. The magneto side carburetor was intact with a miniscule amount of fuel present in the bowl. The power takeoff side carburetor had some impact damage to the side of the carburetor. The floats of both carburetors were weighed and were within the 7oz range. The floats were undamaged.

The fuel tank was breached. The oil can was breached, but oil remained in the can. The rotor shaft lubricating oil sump had oil in it but the sump had sustained some damage. The coolant container had some coolant in it and was connected to the coolant line to the engine. However, the coolant area had been breached.

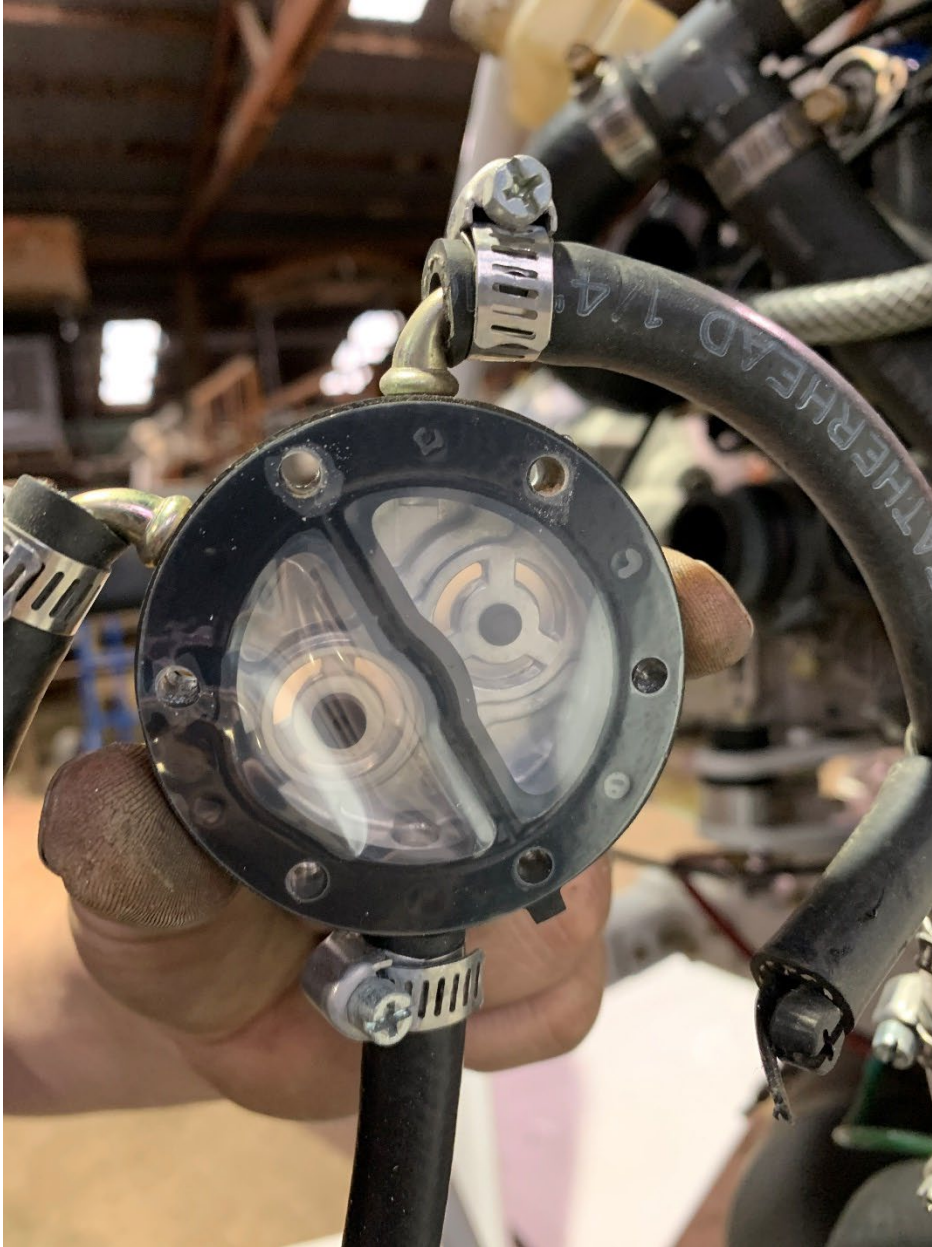
Photo 6. View of the Fuel Pump

The fuel pump was opened exposing the dual diaphragms - no tears or debris was inside the divider.

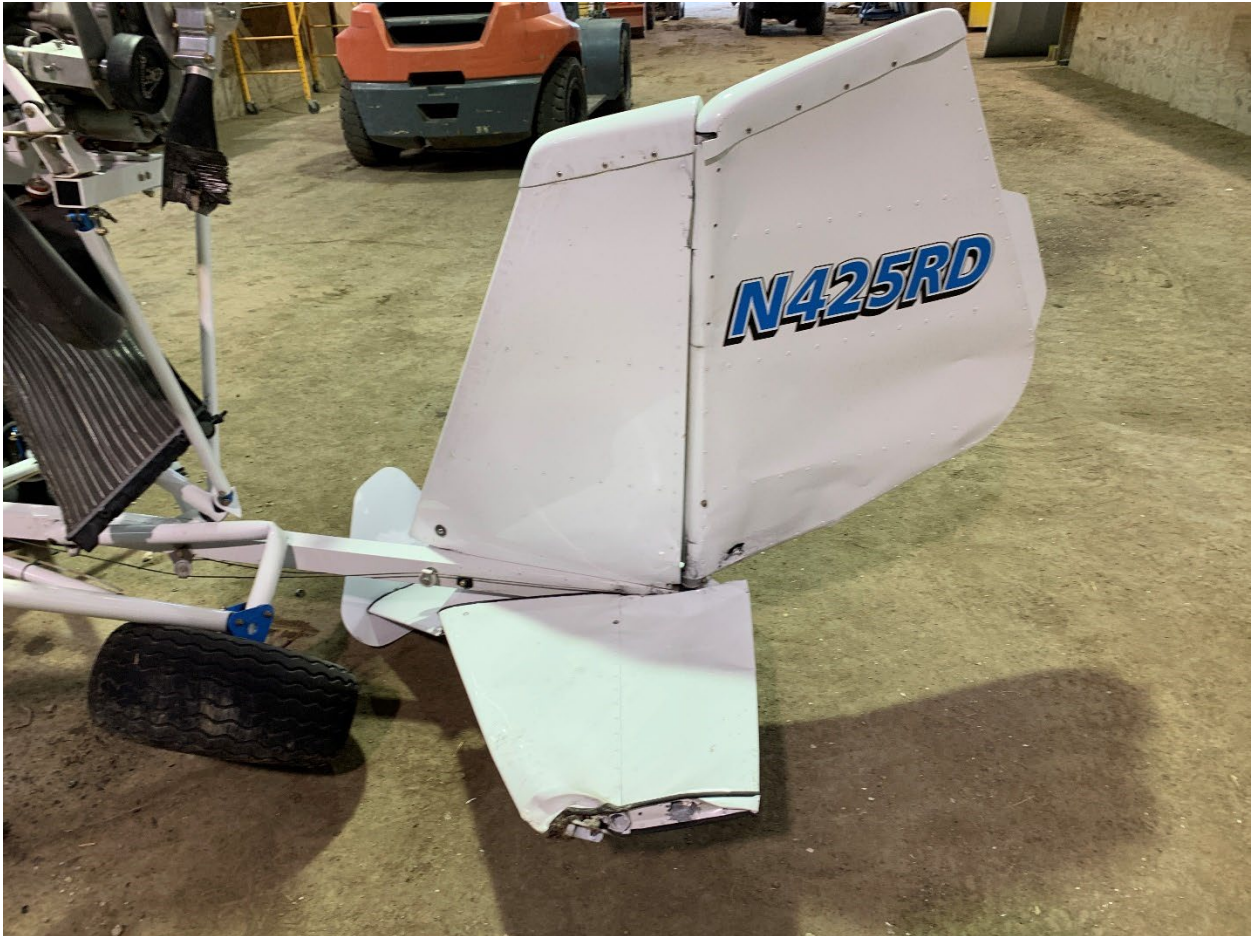
Photo 7. View of Tail Section

The rudder cables remained attached from the rudder pedals to the rudder horn and were free to move. The right-side rudder cable had some fraying on it near the tail section. The right-side rudder cable was trapped in the cockpit due to impact damage, however, the cable was continuous to the rudder pedal.

The tail section remained mostly intact and the rudder and left stabilizer were attached. The right stabilizer was mostly separated but remained connected.

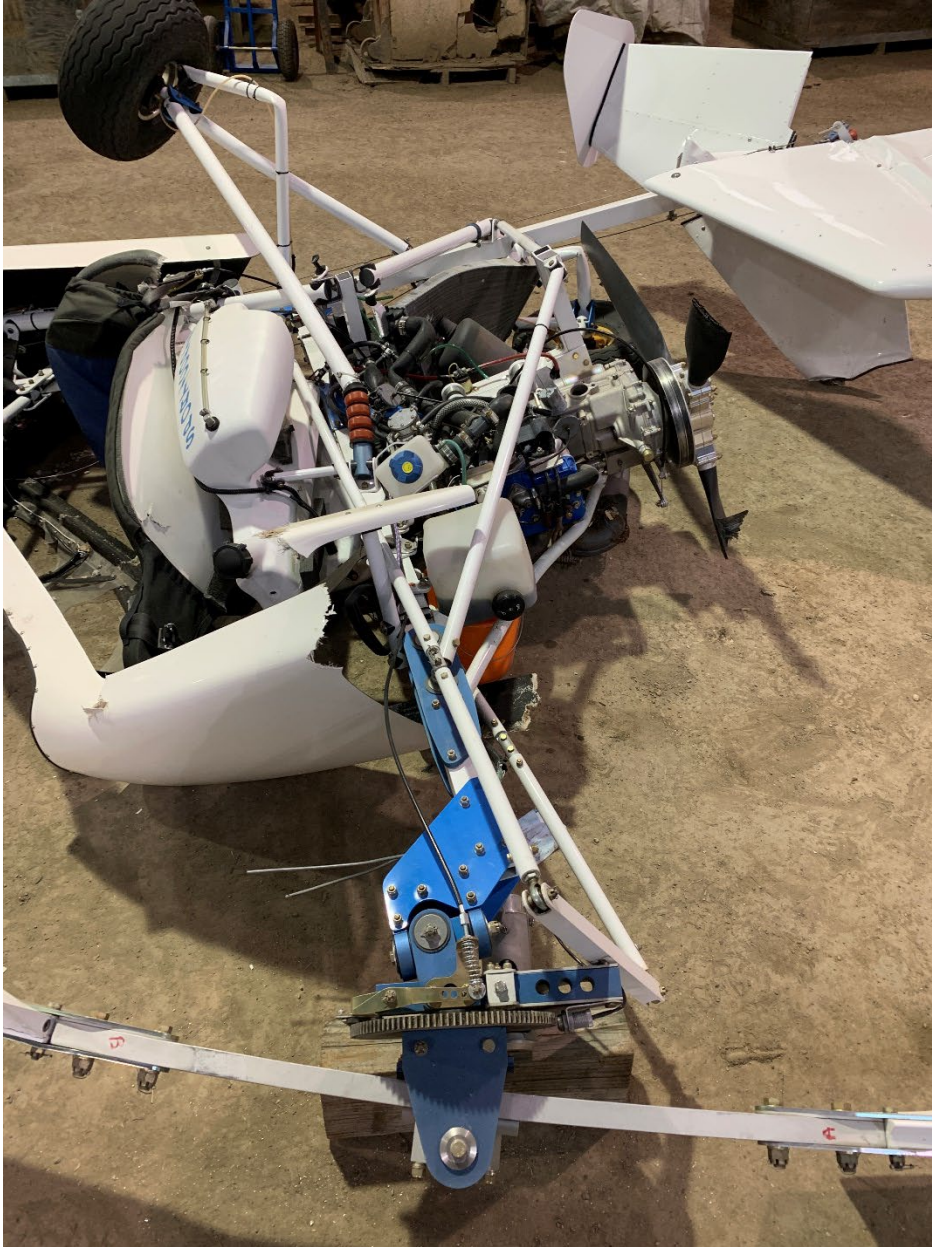
Photo 10. Main Rotor Systems

Both pitch change link/tubes remained attached to the main rotor system. One pitch change link/tube remained straight, while the other one was bent.

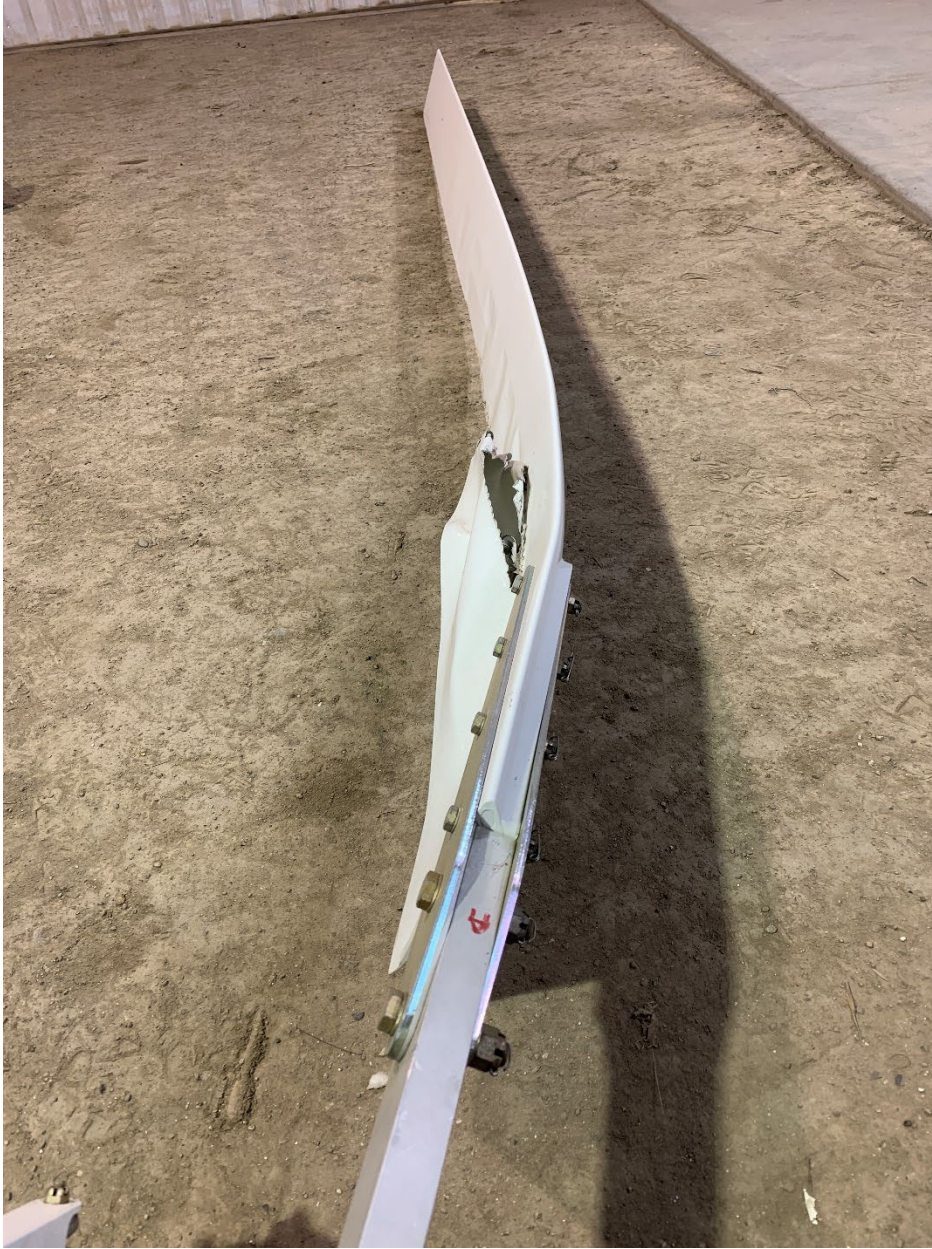
Photo 11. Main Rotor Blade "A"

The two main rotor blades remained intact and connected through the mast to the cockpit. The blades were marked A and B for the purposes of identification during the examination. Blade A was coned slight down about a-third of the way from the root – just past the plate with screws. The leading edge had no nicks or gouges and about 2 feet of the trailing edge was ripped/torn. The blade remained relatively intact with no S-bending.

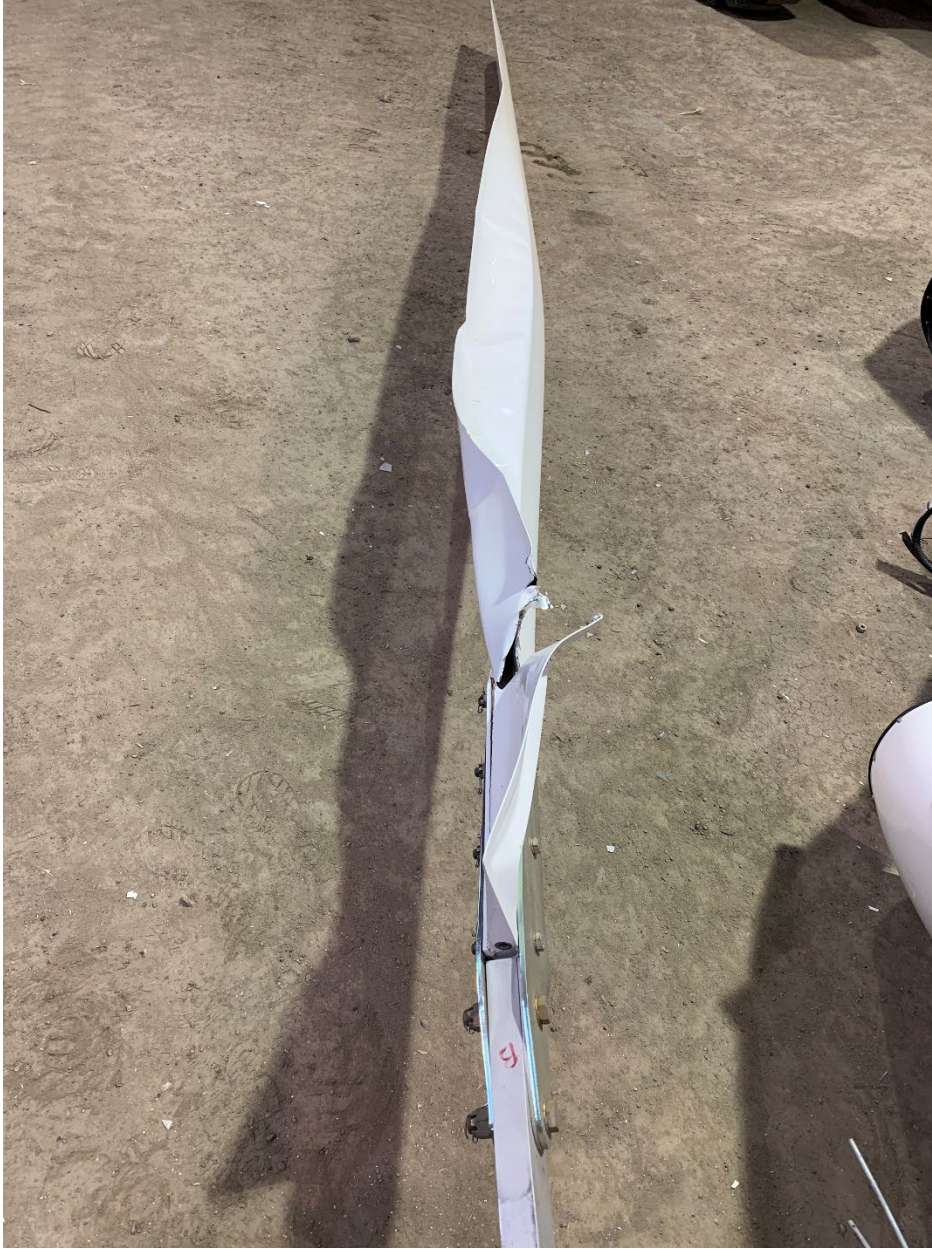
Photo 12. Main Rotor Blade "B"

Blade B - the leading was undamaged. The trailing edge near the bracket had ripped and had some s-bending from the root to more than halfway down the span of the blade. It was crushed from the trailing edge to the leading edge.
