# National Transportation Safety Board

WPR22FA053

## **ACCIDENT SITE REPORT**

Location: Lakeport, California  
Date: December 2, 2021  
Time: 1115 Pacific standard time  
Airplane: Experimental Amateur Built Russell W Dyer VORTEX, N425RD

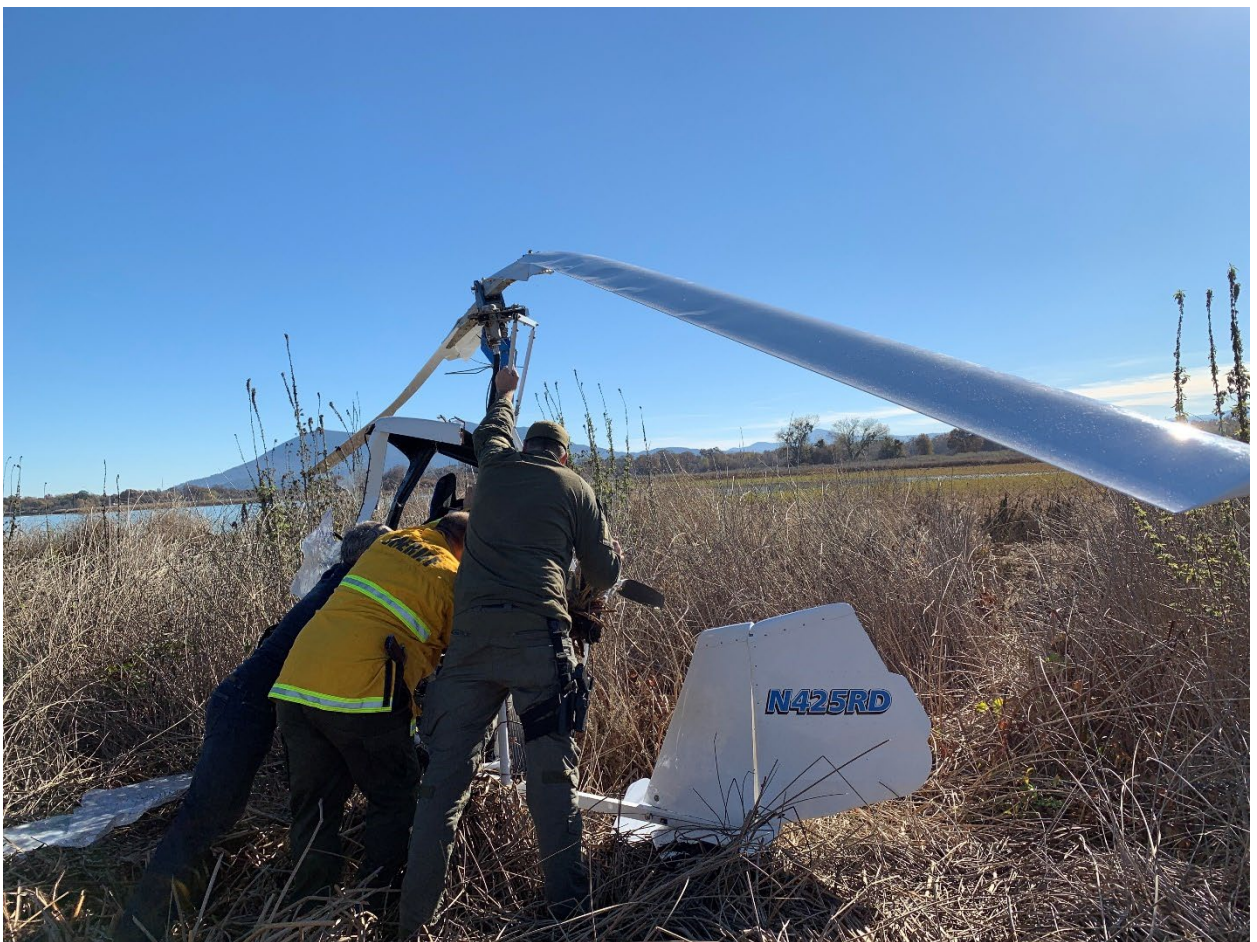
Photo 2: View of Main Rotor System

The gyrocopter came to rest on top of the Toole Weed on its left side. The entire gyrocopter was identified at the accident site. Visual examination of the airframe revealed no obvious disconnects with the flight controls and no holes in the engine case. The main rotor system remained connected; however, near the inboard hub and blade straps for each main rotor blade at the outboard edge were tears that were similar in appearance. One blade exhibited a diagonal black streak on its

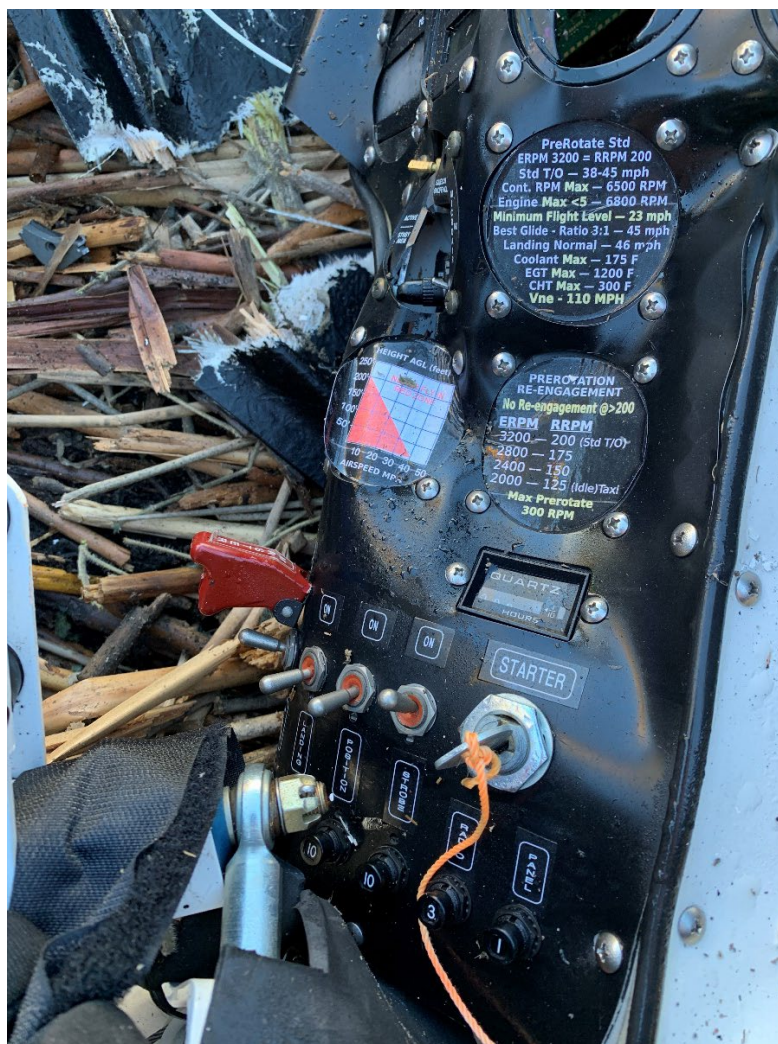
Photo 8: View of Instrument Panel

There were no circuit breakers tripped.
