## **NATIONAL TRANSPORTATION SAFETY BOARD**

# **ACCIDENT SITE EXAMINATION SUMMARY**

**WPR22FA054**

Location: Visalia, California  
Date: December 4, 2021  
Aircraft: Beech, V35, N7933M  
NTSB Investigator-in-Charge: Eric M. Gutierrez

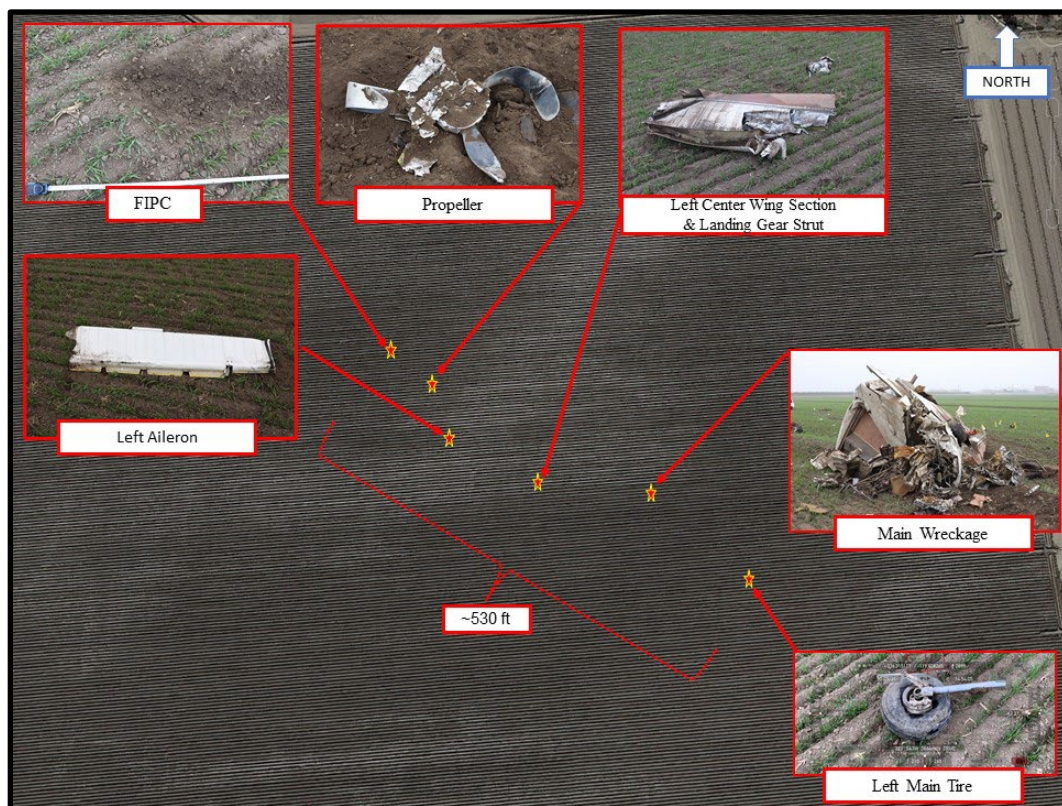
Examination of the accident site revealed that the airplane impacted terrain about 1 mile southwest of the departure end of runway 30. The airplane came to rest on its left side, on a heading of about 265° magnetic, at an altitude of 290 ft msl.

Figure 1: View of accident site diagram (photo courtesy of the NTSB)

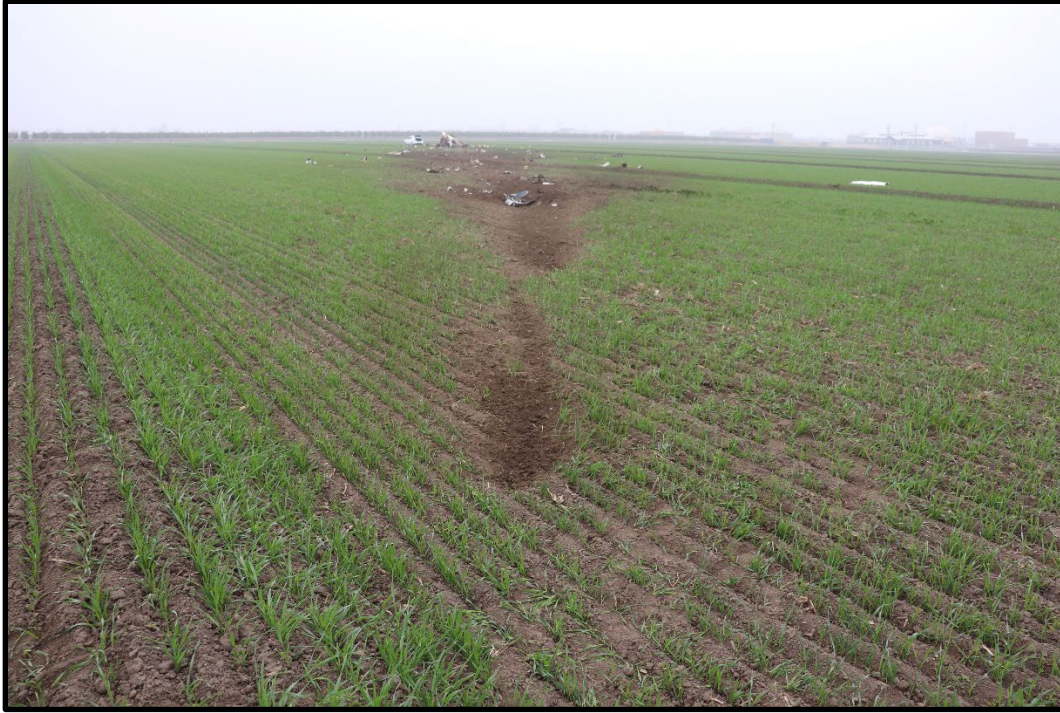
The debris field was located on a flat, open wheat field, on a magnetic heading of 285° degrees from the main wreckage, about 345 ft in length and 200 ft wide. The first identified point of contact (FIPC) with terrain was a ground scar/impression that was 285° magnetic and about 345 ft from the main wreckage. The ground scar/impression was about 14 ft long, 22 inches wide and 3 in deep.

**Figure 2: View of initial impact ground scar (photo courtesy of the NTSB)**

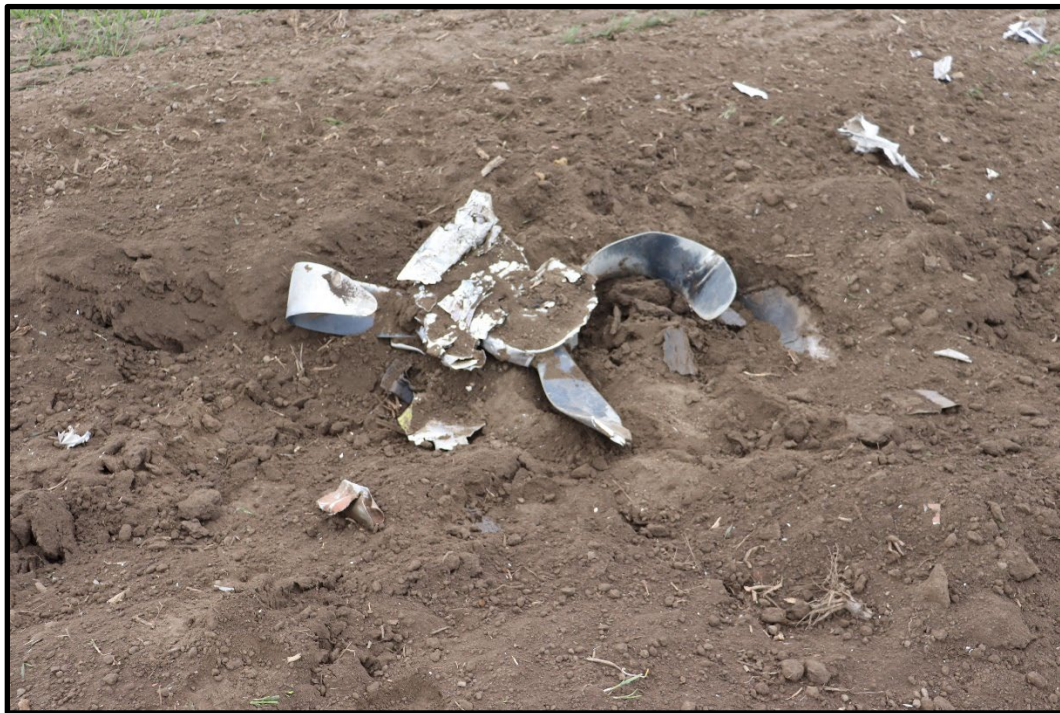
The first identified piece of wreckage was located about 330 ft from the airplane wreckage and consisted of the airplane propeller and propeller hub. Throughout the debris path, various portions of aluminum wing skin, left wing fragments, left aileron, engine, propeller blades, propeller hub, exhaust system, foam, and Plexiglass were observed.

**Figure 3: View of airplane propeller (photo courtesy of the NTSB)**

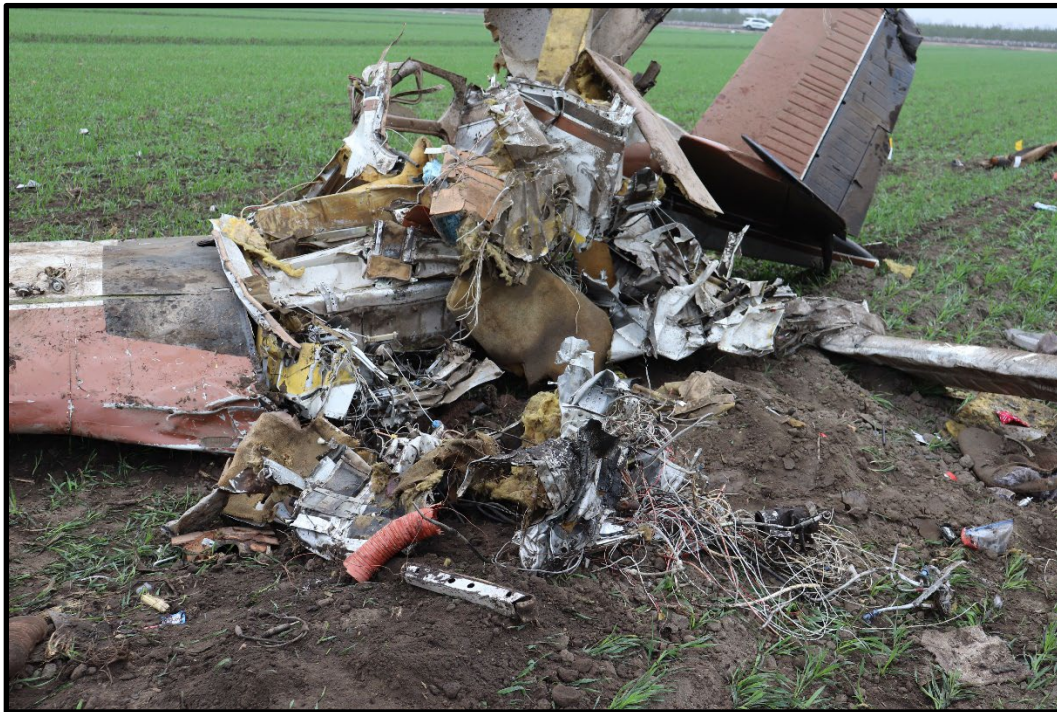
The forward section of the fuselage was heavily impact damaged and separated. The engine, engine mount, nose landing gear, firewall, instrument panel, cockpit, flight controls, and seats were separated and located within the debris field. The cabin area was separated behind the rear seatbacks, tethered by various wires. The instrument panel was recovered with various instruments separated. The cabin door was located within debris field. The engine mount had several fractures, consistent with impact damage. The aft section of the fuselage exhibited buckling and compression crushing throughout.

Figure 4: View of airplane fuselage (photo courtesy of the NTSB)

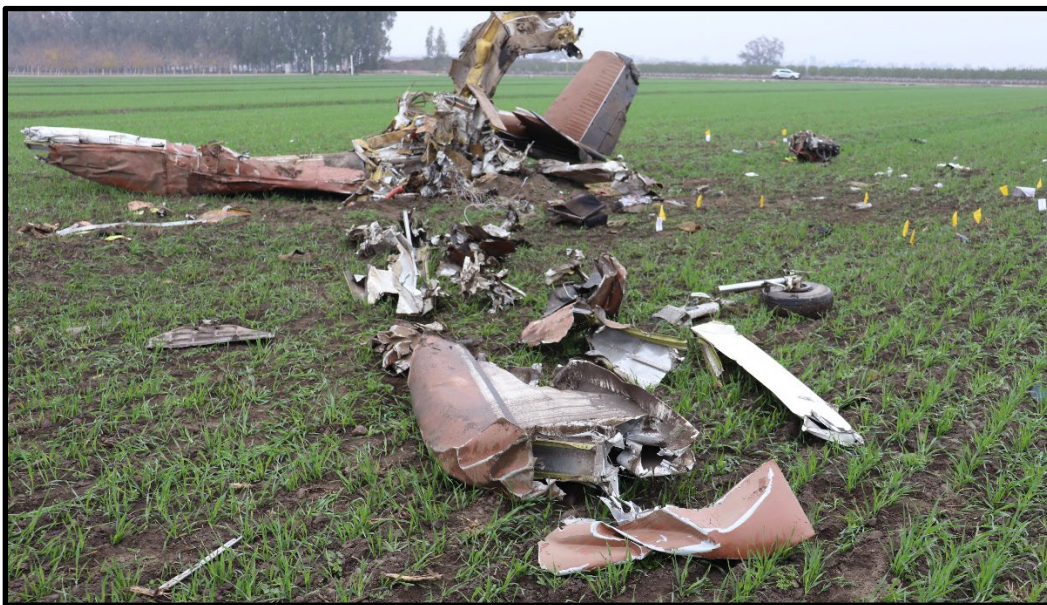
The left wing separated from the fuselage at the wing root and fragmented into numerous sections and was scattered throughout the debris field. Fragments of red navigational lens were identified near the beginning/middle/end of the ground scar. The pitot tube was located about 40 ft south-east of the initial ground scar. The left-wing aileron separated from the wing attachment points and was in the debris field, crushing and bending was observed at both ends. The left-wing flap was located with the main wreckage; crushing and bending was observed throughout the flap. The left main landing gear lift strut separated from the left-wing and was in the debris field. A portion of the center section of the left wing was located in the debris field; the fuel cap was found in place and secure.

Figure 6: View of airplane left wing (photo courtesy of the NTSB)

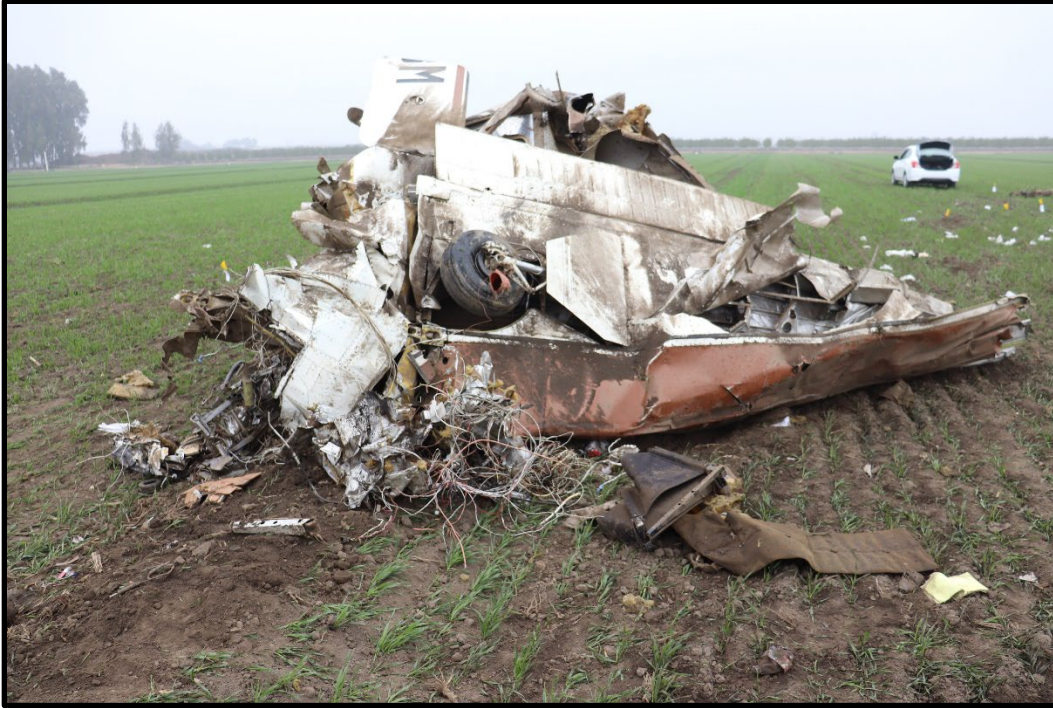
The right wing was partially separated at the wing root. The wing was twisted and came to rest in a leading-edge low attitude. The bottom side of the wing exhibited buckling and tearing of the skin from about mid span to the wing tip. Crushing and bending was observed throughout the wingspan. The right flap and aileron remained attached via their respective mounts. The flap was observed fully retracted. The right main landing gear remained attached via the wing mounts and was partly extended. The right-wing leading edge was displaced in a low attitude; the aileron control cable was observed exiting the fuselage near the wing root under significant tension. The right main fuel tank fuel cap was observed in place and secure.

Figure 8: View of airplane right wing (photo courtesy of the NTSB)

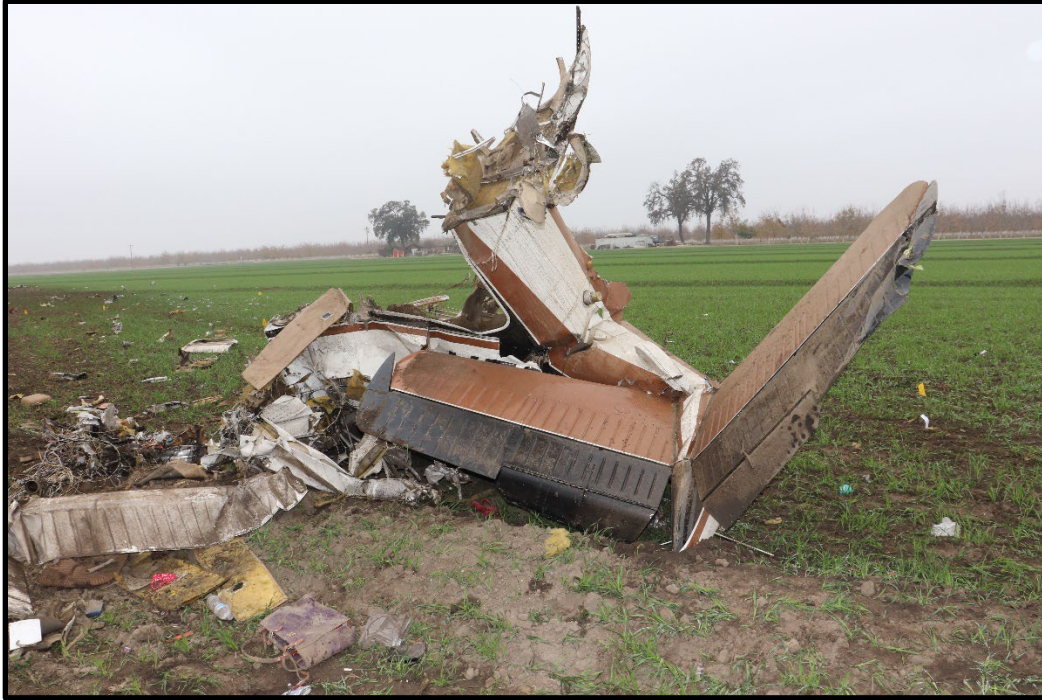
The empennage remained attached to the aft fuselage. The empennage was bent about 90° to the left and the left ruddervator came to rest along the aft fuselage. Both left and right ruddervators remained attached to their respective mounts. Crushing was observed on the left ruddervator leading edge near the root. Crushing and bending was observed on right ruddervator from mid

span to the top. Both ruddervator flight control cables remained attached to their respective mounts, the control cables were traced to the center of the fuselage, where they had separated from the flight controls. When the cables for the left and right ruddervator were manually pulled, corresponding movement was observed.

Figure 10: View of airplane empennage (photo courtesy of the NTSB)

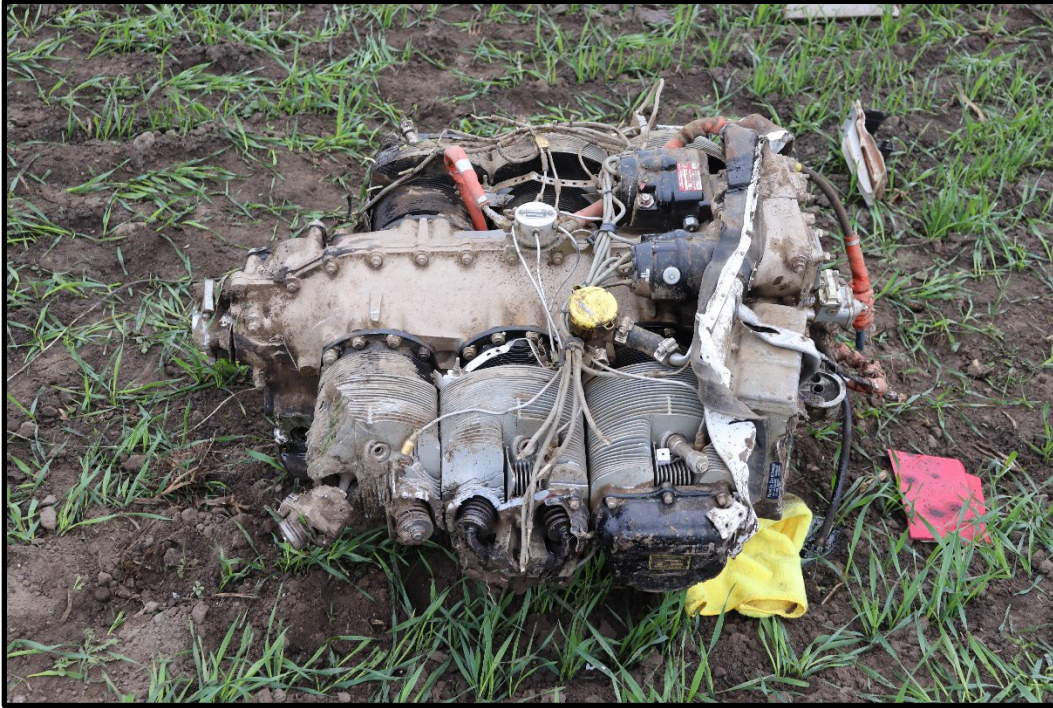
The engine separated from the engine mount and came to rest adjacent to the main wreckage. All four engine mounts had fractured and separated from the firewall. All six cylinders remained attached to the engine case and exhibited impact damage. The Nos 4- and 6-cylinder rocker box covers were separated.

Figure 11: View of airplane engine (photo courtesy of the NTSB)

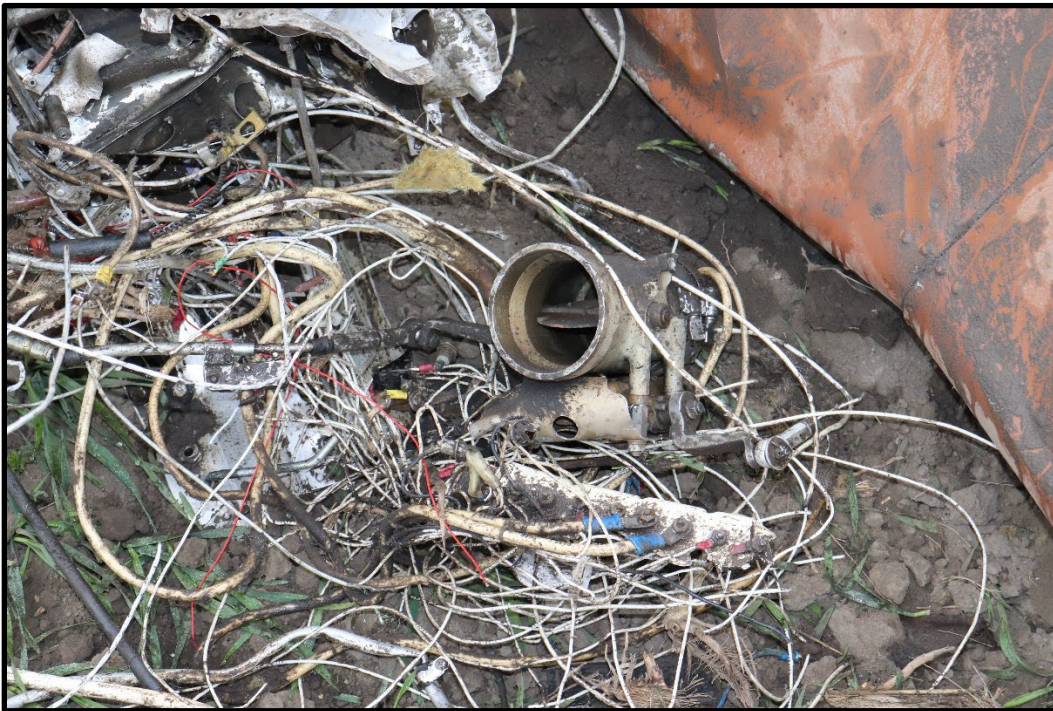
Both magnetos remained attached and did not exhibit impact damage. The fuel manifold valve remained attached to the engine and did not exhibit impact damage; however, the fuel lines going to the fuel injectors exhibited impact damage. The throttle body had separated from the engine and was in the OPEN position and exhibited impact damage. The intake and exhaust tubes separated and exhibited impact damage. The engine starter and propeller governor had separated from the engine and exhibited impact damage; they were both located in the debris field. The engine driven fuel pump and the starter adapter remained attached to the engine accessory case and were impact damaged.

Figure 12: View of throttle body (photo courtesy of the NTSB)

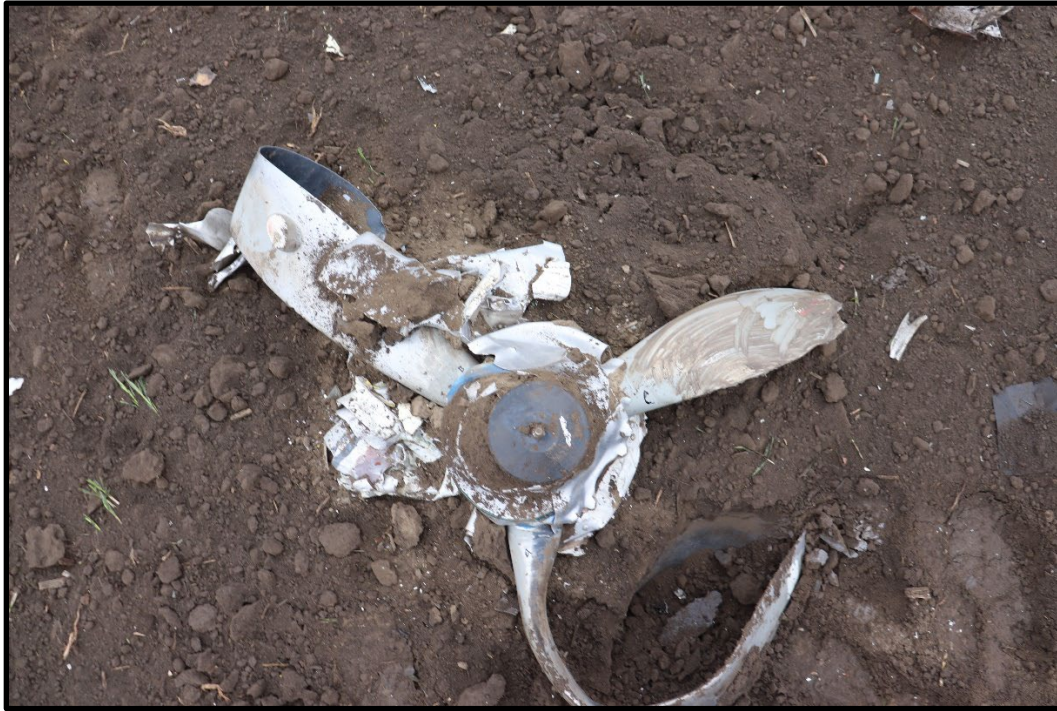
The airplane was equipped with a three blade Hartzell propeller; for the purposes of this report the propeller blades were labeled A, B, and C. The propeller hub along with all three blades separated from the engine Blade A exhibited S bending about mid span, with polishing along the leading edge, along with unidirectional striations on the cambered side of the blade. Additionally, blade A exhibited 2 distinct striations on the cambered side of the blade about mid

span. Blade B exhibited bending aft about mid span, with unidirectional striations on the cambered side of the blade. Blade C was fracture separated about mid span, with polishing along the leading edge and chordwise striations on the cambered side of the blade. The separated section was located about 20 ft from the propeller assembly, with a polished leading edge and chordwise striations on the cambered side of the blade.

Figure 13: View of airplane propeller (photo courtesy of the NTSB)
