## **NATIONAL TRANSPORTATION SAFETY BOARD**

### **AIRFRAME & ENGINE EXAMINATION SUMMARY**

**WPR22FA054**

| Aircraft: | Beech V35, N7933M |

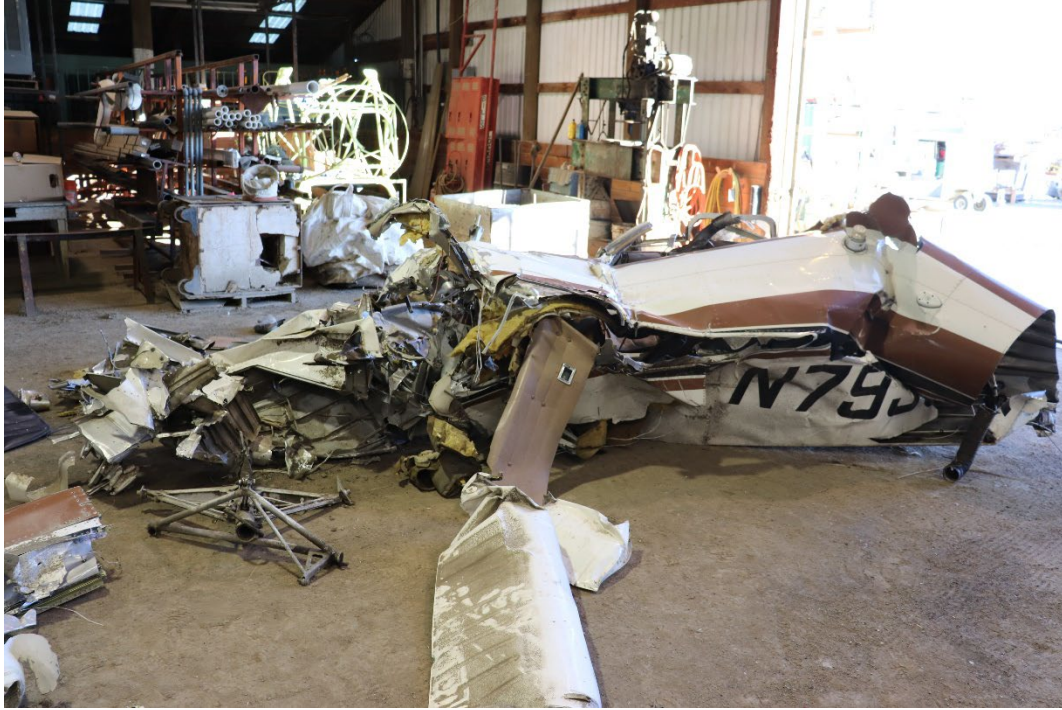
Examination of the recovered airframe revealed that the cockpit area was fragmented, and the forward fuselage structure was mostly destroyed. The engine, engine mount, firewall, nose landing gear, instrument panel, cockpit, flight controls, and seats were separated, and impact damaged. The single throw-over control column was separated and fragmented. The recovery organization had removed the right wing and empennage for transport. The aft section of the fuselage exhibited buckling and compression crushing throughout. Multiple instruments were separated from the instrument panel and exhibited impact damage. One instrument, which was heavily impact damaged, contained a gyro gimble. Rotational scoring and impact damage was observed on the gyro. The cockpit switch/circuit breaker panel was separated and exhibited impact damage.

**Figure 1: View of airplane cockpit area with impact damage. (Photo courtesy of NTSB)**

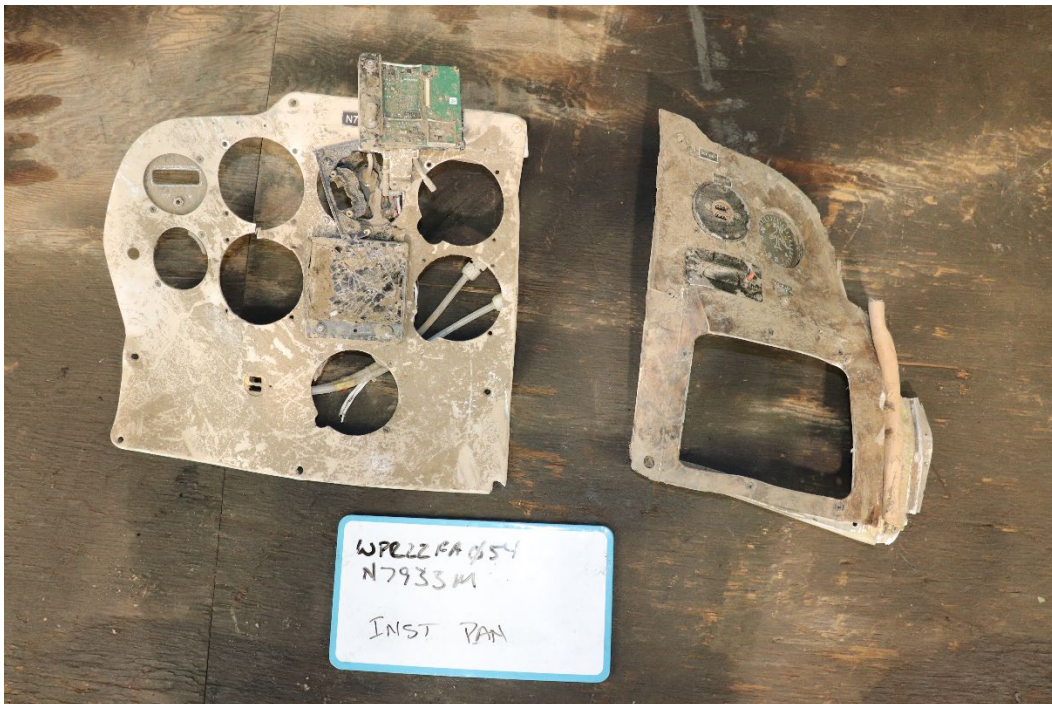
**Figure 2: View of airplane instrument panel with various instruments separated. (Photo courtesy of the NTSB)**

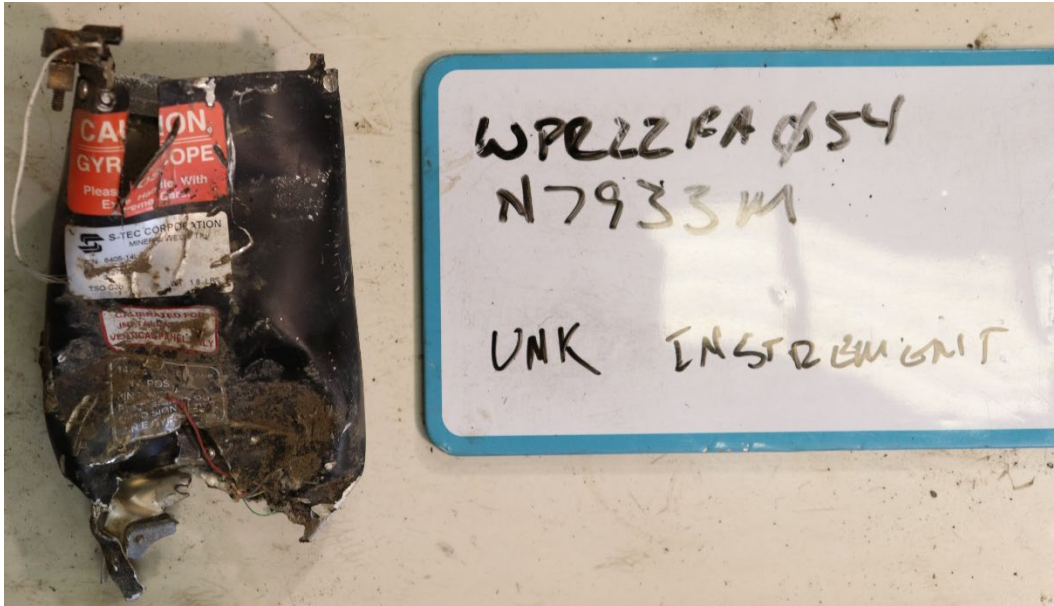
**Figure 3: View of unknown instrument with impact damage. (Photo courtesy of the NTSB)**

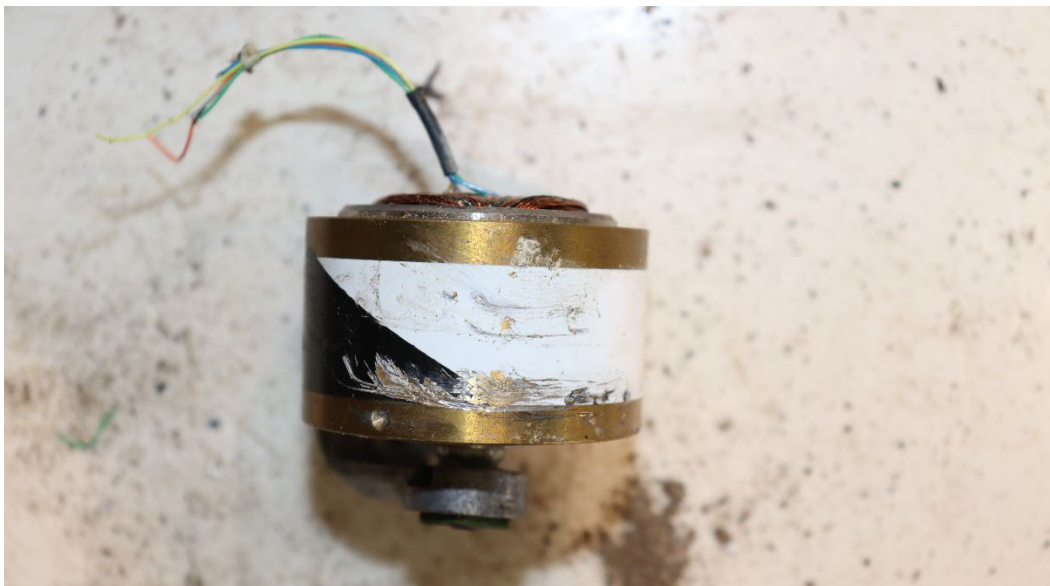
**Figure 4: View of unknown instrument gyro gimble with rotational scoring and impact damage. (Photo courtesy of the NTSB)**

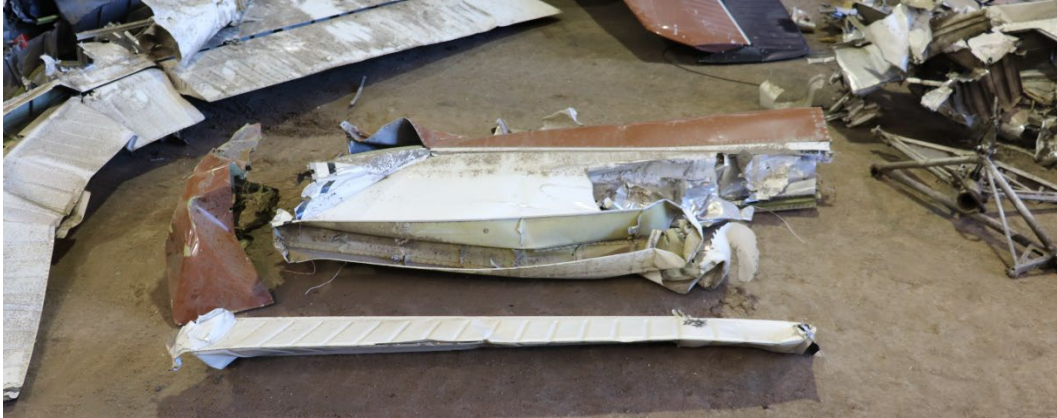
The left wing separated from the fuselage at the wing root and fragmented into numerous sections. The left-wing aileron separated from the wing attachment points, crushing and bending was observed at both ends. The left-wing flap was separated from the wing attachment points; crushing and bending was observed throughout the flap. The left main landing gear lift strut separated from the left-wing and was impact damaged. A portion of the center section of the left wing was in the wreckage; the fuel cap was found secure and its normal place on the wing.

**Figure 5: View of left wing with impact damage. (Photo courtesy of the NTSB)**

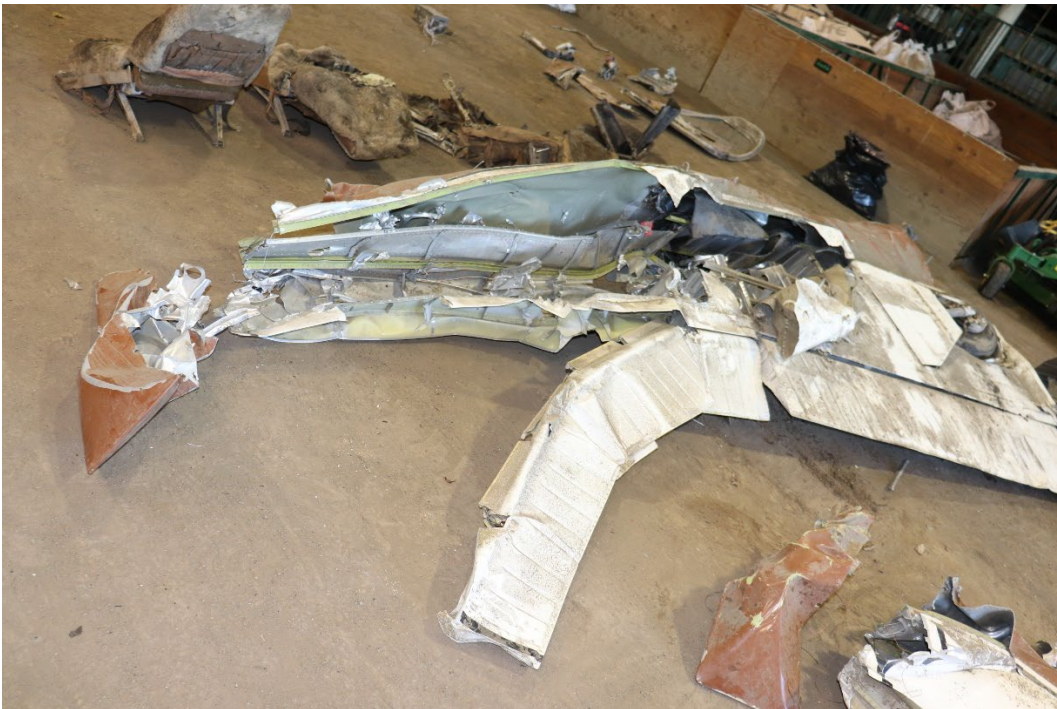
The right wing was partially separated at the wing root, the remaining attachment points were cut by recovery personnel to facilitate recovery. Crushing and bending was observed throughout the wingspan. The wing leading edge was crushed aft from mid span to the wing tip. The bottom side of the wing exhibited buckling and tearing of the skin from about mid span to the wing tip. The right aileron remained attached via its inboard attachment points. The right flap remained attached via its attachment points and was in the fully retracted position. The right main landing gear remained attached via the wing mounts and was in the fully retracted position. The right main fuel tank fuel cap was secure and its normal place on the wing.

**Figure 6: View of right wing with impact damage. (Photo courtesy of the NTSB)**

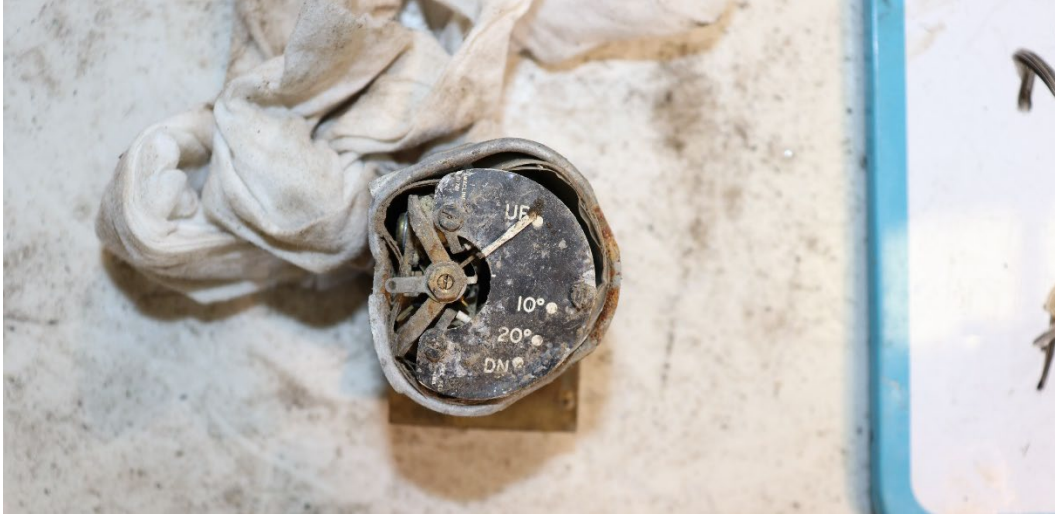
The left and right flap actuators remained attached to their respective wing attachment points. Both flap actuators extensions measured to be approximately 1 5/8 inches which correlates to approximate 0 degree. The flap position indicator was recovered with wreckage and displayed 0° position.

**Figure 7: View of flap position indicator. (Photo courtesy of the NTSB)**

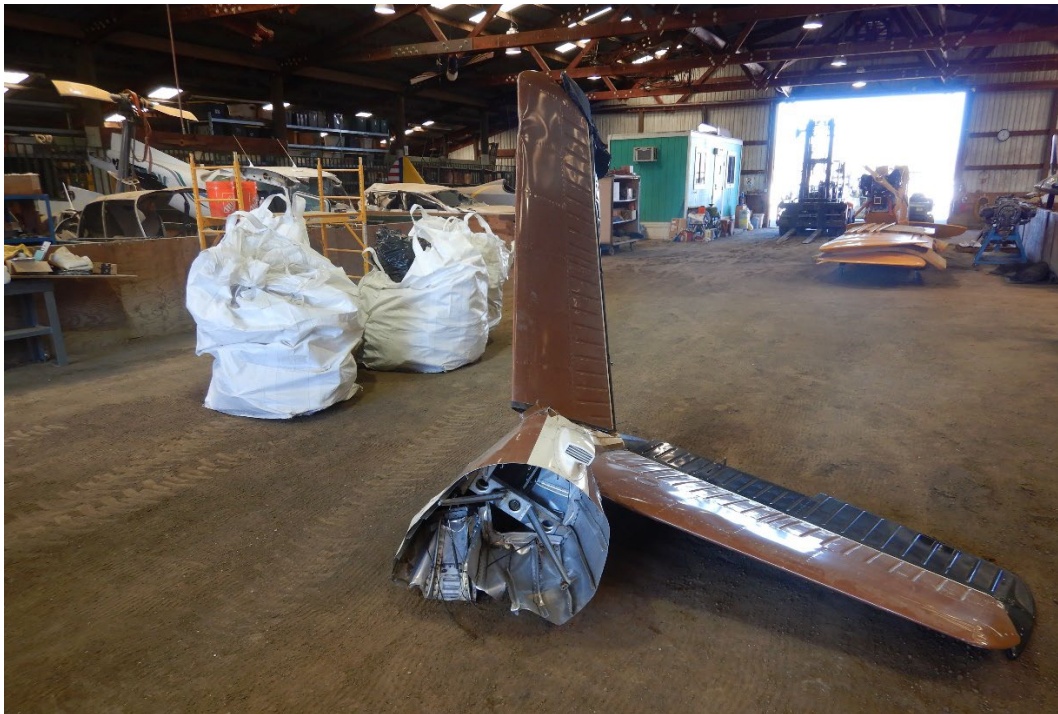
The empennage was cut between fuselage station 207 to 233 by recovery personnel to facilitate recovery. Both left and right ruddervators and flight control cables remained attached to their respective attachment mounts. Crushing was observed on the left ruddervator leading edge near the root. Crushing and bending was observed on right ruddervator from mid span to the tip.

**Figure 8: View of empennage with impact damage. (Photo courtesy of Textron Aviation)**

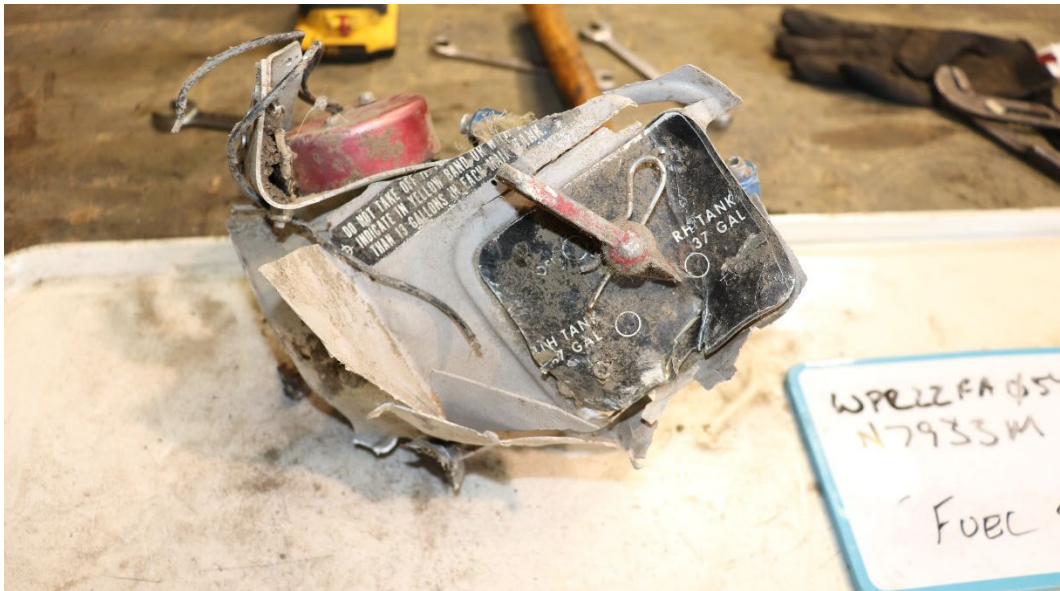
The fuel selector valve separated from the cockpit and was impact damage. The fuel selector valve was a 3-position system, right hand (RH), left hand (LH) and OFF. The fuel selector valve was observed in the RH fuel tank position. Shop air was applied to the RH Tank inlet port and air was felt at the port to the engine.; the other LH Tank and OFF ports were closed. The fuel

selector valve was then placed in the LH Tank position and air was felt at the port to the engine. The fuel selector valve was placed in the OFF position. Shop air was applied to the RH and LH Tank inlet ports and no air could be felt at the port to the engine.

**Figure 9: View of fuel selector lever in the right tank position. (Photo courtesy of the NTSB)**

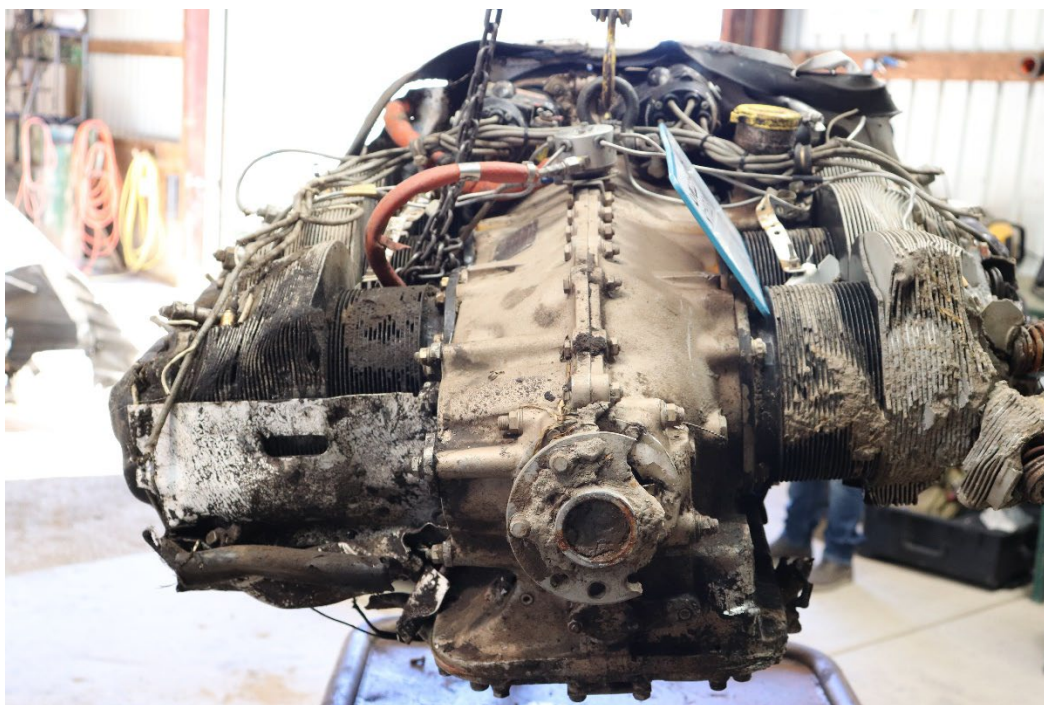
The engine separated from the engine mount and sustained impact damage. The propeller hub assembly and a section of the propeller flange separated from the engine crankshaft. The intake and exhaust systems were separated. The oil cooler remained attached and was impact damaged.

**Figure 10: Front view of engine with impact damage. (Photo courtesy of the NTSB)**

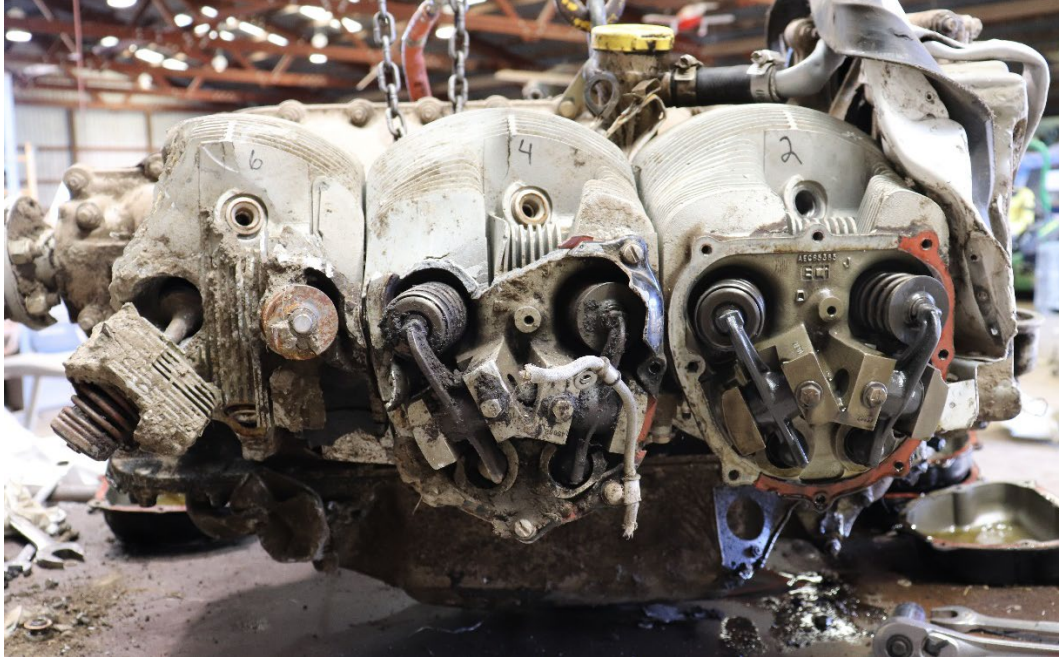
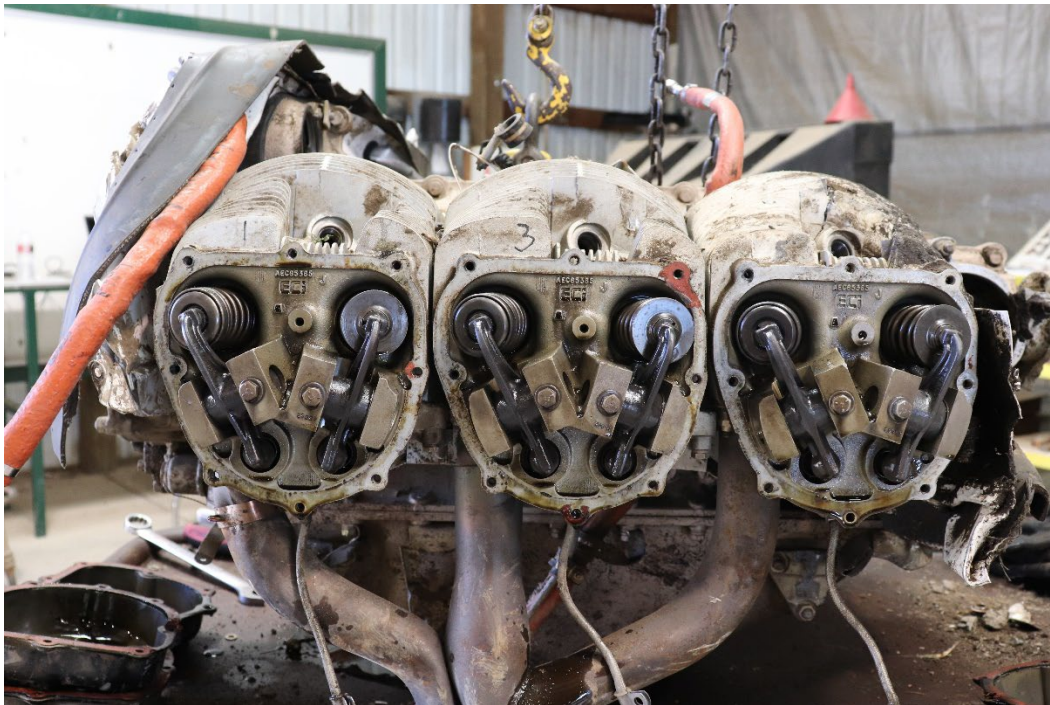
All six cylinders remained attached and exhibited varying degrees of impact damage. The rocker box cover was separated from the No. 4 cylinder. The rocker box cover, rocker arms, push rod tube, and push rods, and portions of the cylinder head were separated from the No. 6 cylinder. The rocker box covers were removed from the Nos. 1, 2, 3, and 5 cylinders; the intake and exhaust rocker arms were intact and oil coated. The top spark plugs were removed from the Nos. 1, 2, 3 and 5 cylinders. The bottom spark plug was removed from the No. 4 cylinder. All six cylinders were examined internally using a lighted borescope. All the cylinders exhibited a normal amount of combustion deposits within the combustion dome of each cylinder and piston face. The crankshaft was rotated by hand using a hand tool connected to the starter adapter. Rotational continuity was established throughout the engine and valve train. Thumb compression and suction was obtained for cylinders 1 through 5. Due to impact damage to the No. 6 cylinder, thumb compression and suction were not obtained.

**Figure 11: View of engine cylinders 2, 4, and 6. (Photo courtesy of the NTSB)**

**Figure 12: View of engine cylinders 1, 3, and 5. (Photo courtesy of the NTSB)**

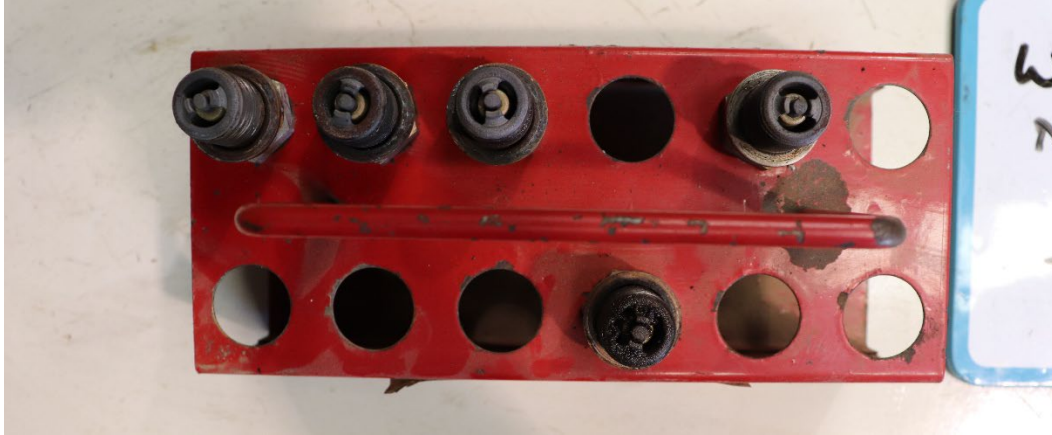
The top spark plugs from the No. 1, 2, 3 and 5 cylinders and exhibited signatures consistent with worn-normal when compared to the Champion Aviation Check-A-Plug chart AV-27. The bottom sparkplug from the number 4 cylinder, had debris within the electrode area and oil soaked. All spark plugs were massive electrode type.

**Figure 13: View of engine spark plugs. (Photo courtesy of the NTSB)**

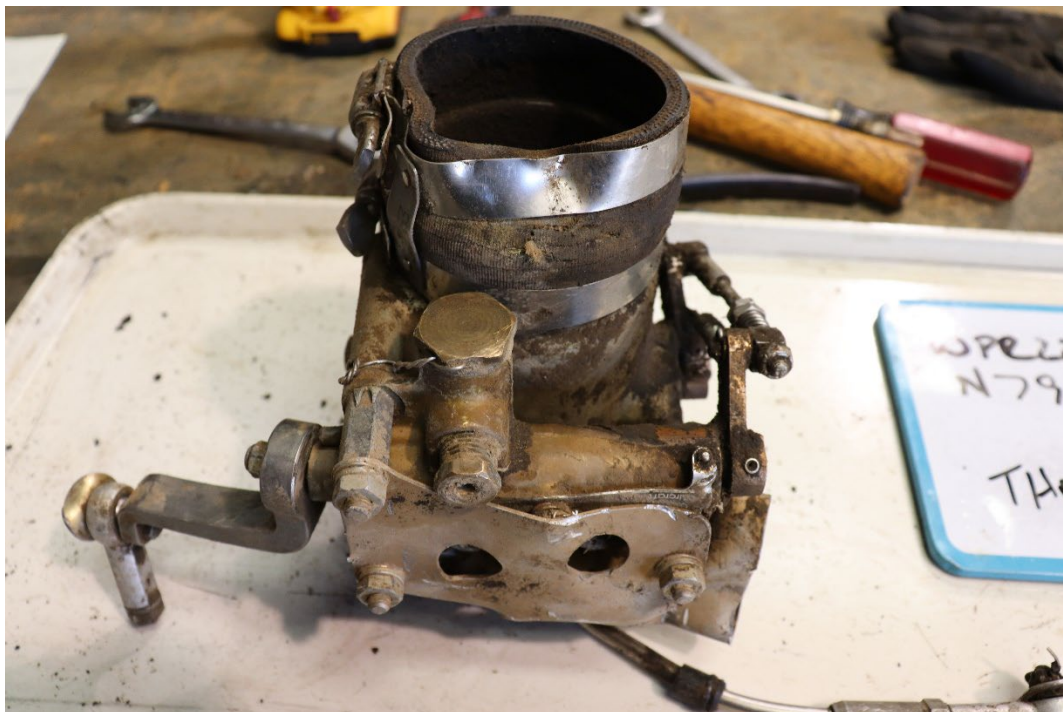
The throttle body separated and was located within the wreckage, and sustained impact damage throughout the throttle body. The throttle plate was in the fully open position. The throttle lever was intact and moved freely. The throttle plate shaft was bent about 15° and both the splines to the throttle body arm and throttle plate shaft were intact and undamaged. The connecting linkage to the throttle cable was fracture separated, consistent with impact damage. The mixture control arm was intact and moved freely. The mixture control shaft was bent about 10° and both the splines to the mixture control arm and mixture control shaft were intact and undamaged. The connecting linkage to the mixture control was fracture separated, consistent with impact damage. The fuel inlet fuel screen was removed, and a small amount of debris observed.

**Figure 14: View of throttle body with impact damage. (Photo courtesy of the NTSB)**

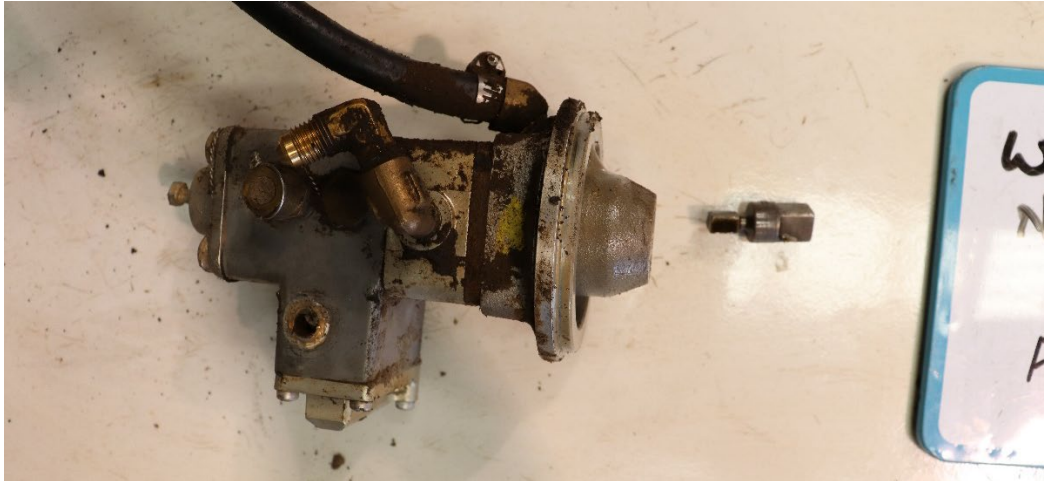
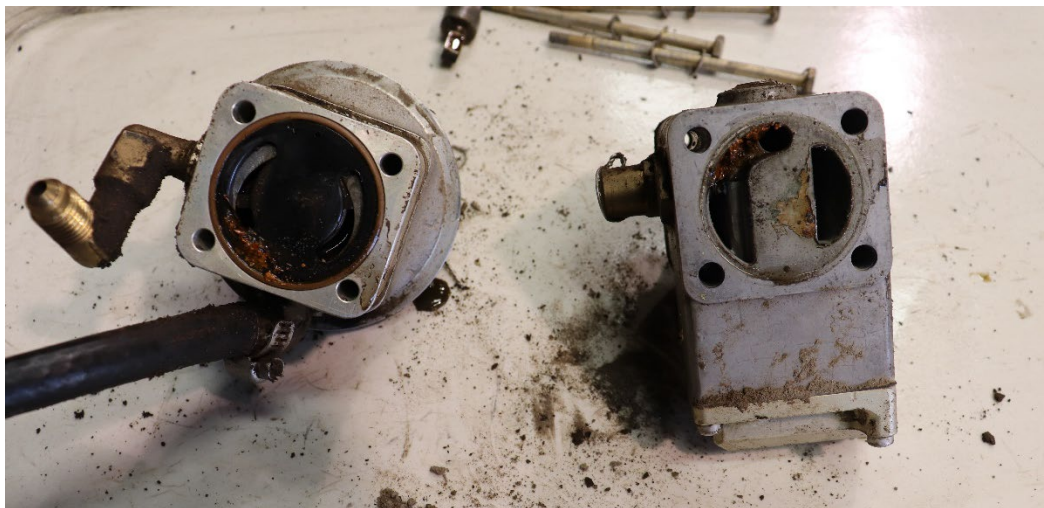
The engine driven fuel pump remained attached to the engine, and was intact and undamaged. The engine driven fuel pump was removed and disassembled. The drive coupling was intact and undamaged. The fuel pump rotated freely without binding when rotated by hand. All fuel fittings removed were tight. The drive coupling was intact. Debris and corrosion were observed within the fuel pump was consistent with prolonged storage.

**Figure 15: View of engine driven fuel pump with drive coupling. (Photo courtesy of the NTSB)**

**Figure 16: View of engine driven fuel pump with debris and corrosion. (Photo courtesy of the NTSB)**

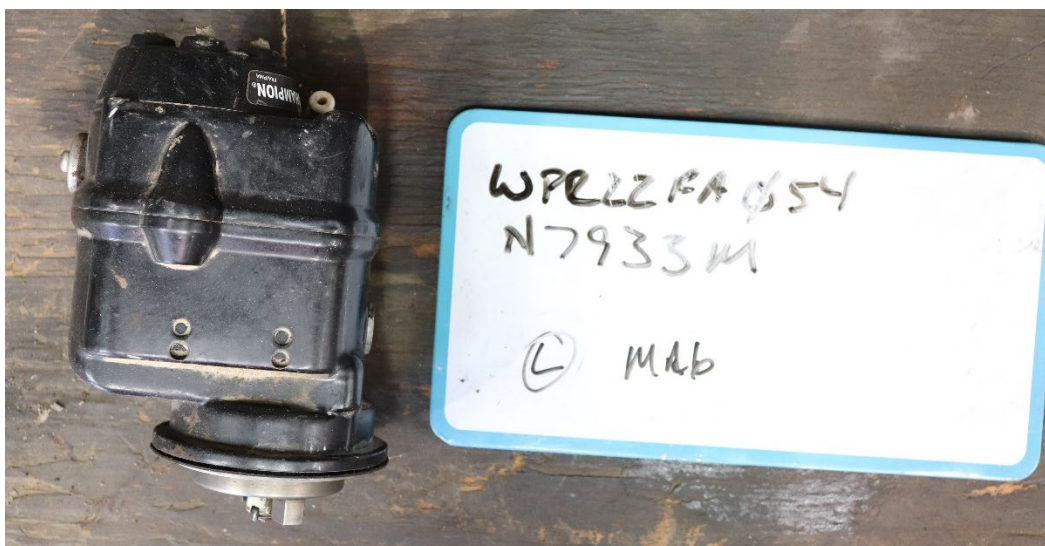
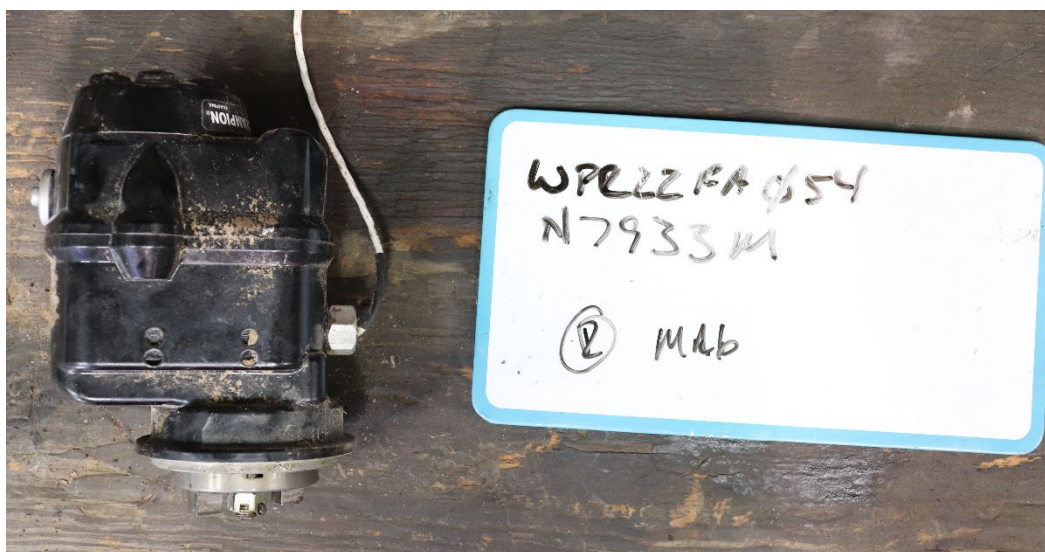
The left and right magnetos remained attached to the engine accessory case with no external damage noted. Both magnetos were removed and utilizing a hand tool the magnetos were rotated, and spark was produced at each ignition lead, and impulse coupling engagement was heard.

Figure 17: View of left magneto. (Photo courtesy of the NTSB)

Figure 18: View of right magneto. (Photo courtesy of the NTSB)

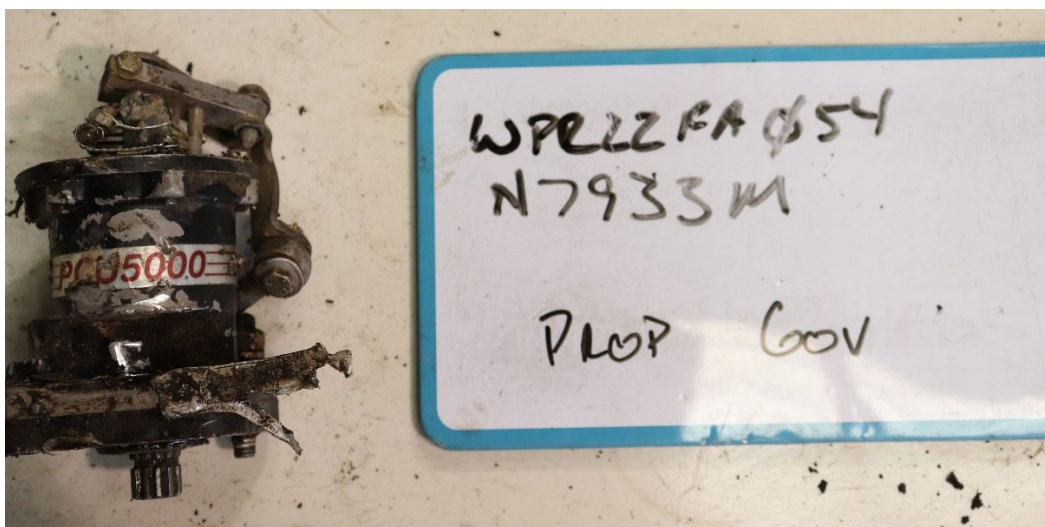
The propeller governor separated and was located with the wreckage. Damage consistent with impact damage was observed throughout the propeller governor. The drive shaft would not rotate when rotated by hand.

**Figure 19: View of propeller governor with impact damage. (Photo courtesy of the NTSB)**

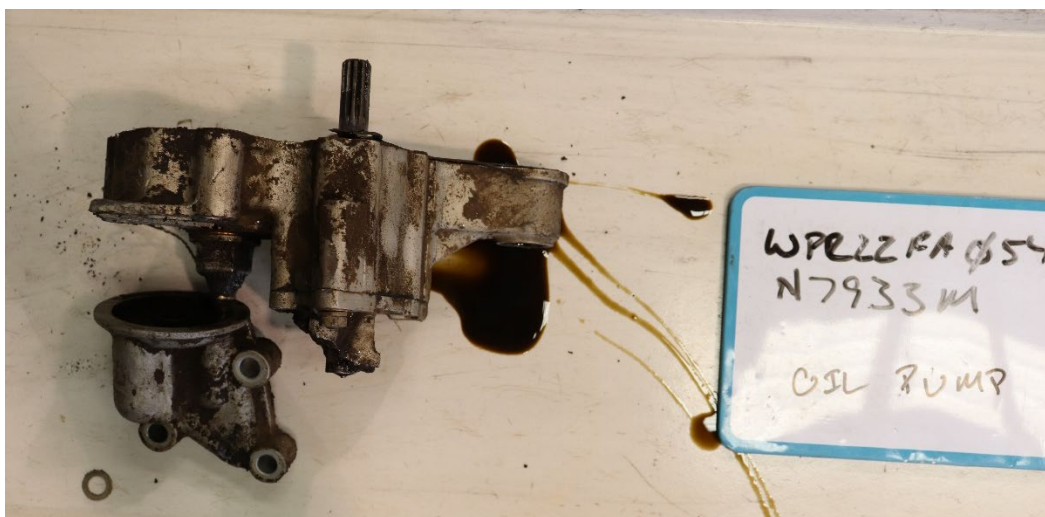
The engine oil pump remained attached to the engine with no external damage noted. The oil pump was removed, disassembled and free of debris. The oil pump drive shaft rotated freely when rotated by hand.

**Figure 20: View of engine oil pump. (Photo courtesy of the NTSB)**
