## Air Safety Investigations Aircraft Incident/Accident Technical Report

| Aircraft Incident/<br>Accident Information | Year: 1966 | Make: Beechcraft | Model: V35 |
| | Serial number: D-8265 | | Registration: N7933M |
| Senior Air Safety Investigator: Ernest C. Hall | | Report #: ASI-22-AE-T | Report date: 03-23-22 |

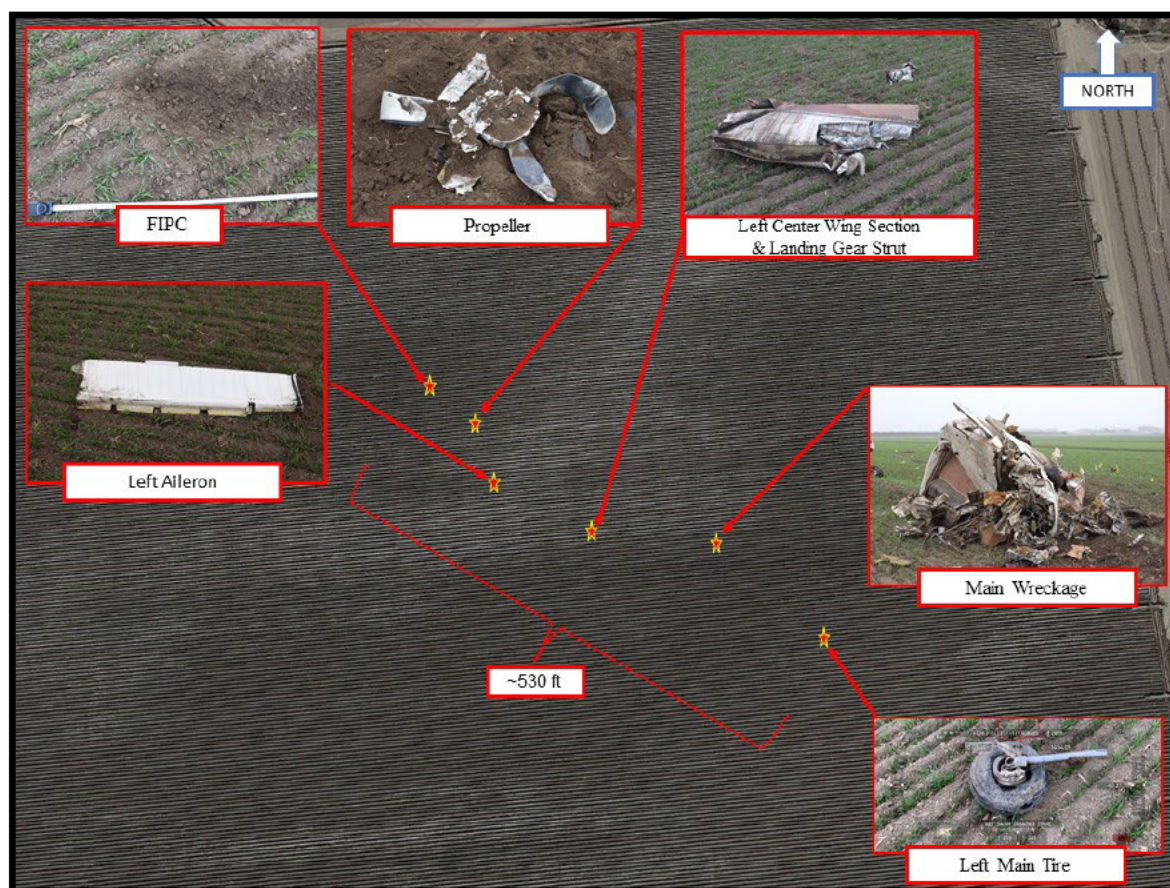
According to the NTSB-IIC, the aircraft collided with open, flat terrain approximately 1 mile southwest of the departure end of Runway 30. The ground scars and debris field were on an approximate magnetic heading of 285°. The main wreckage, consisting of the fuselage, right wing, fragmented left wing, and empennage, came to rest on its left side on a magnetic heading of approximately 265°. The ground scars/debris field extended approximately 530'.

The first aircraft wreckage in the debris field was the propeller assembly located about 330' from the main wreckage. Continuing in the debris field toward the main wreckage was the left aileron and then a mid-section of the left wing. The left main landing gear (MLG) oleo struct connected to the wheel/brake assembly traveled beyond the main wreckage.

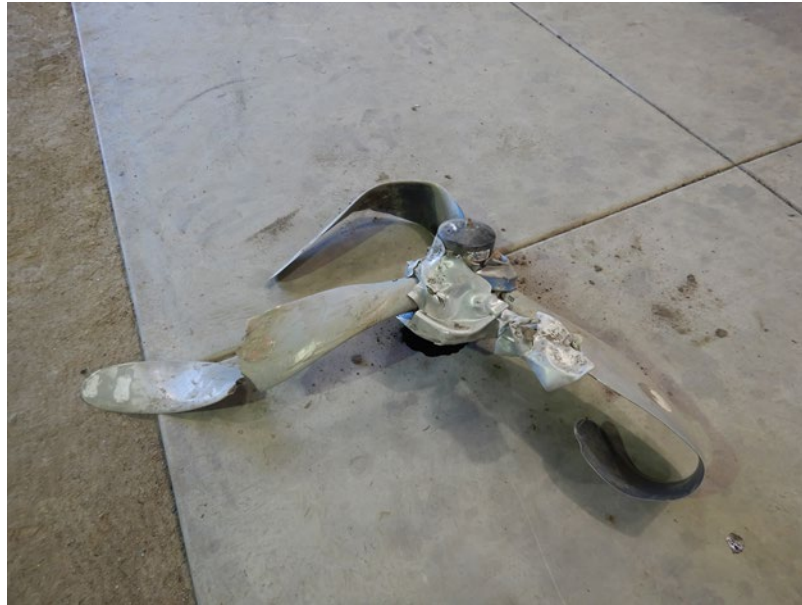
TAI Off Site ASI-AE-109.JPG

The NTSB-IIC performed the propeller examination. The propeller assembly separated from the engine at the propeller flange. The propeller blades remained attached to propeller hub. Each blade was identified with A, B, and C for documentation purposes. Blade A exhibited S-bending about mid span, with polishing along the leading edge, and along with unidirectional striations on the cambered side of

the blade. Additionally, blade A exhibited 2 distinct striations on the cambered side of the blade about mid span. Blade B exhibited aft bending about mid span, with unidirectional striations on the cambered side of the blade. Blade C was separated about mid span, with polishing along the leading edge and chordwise striations on the cambered side of the blade. The separated blade section of the propeller exhibited polishing along the leading edge and chordwise striations on the cambered side of the blade.
