## **NATIONAL TRANSPORTATION SAFETY BOARD**

# **AIRFRAME AND ENGINE EXAMINATION SUMMARY**

**WPR22FA067**

Location: Show Low, AZ  
Date: December 22, 2021  
Aircraft: N6000Z  
NTSB IIC: Albert Nixon

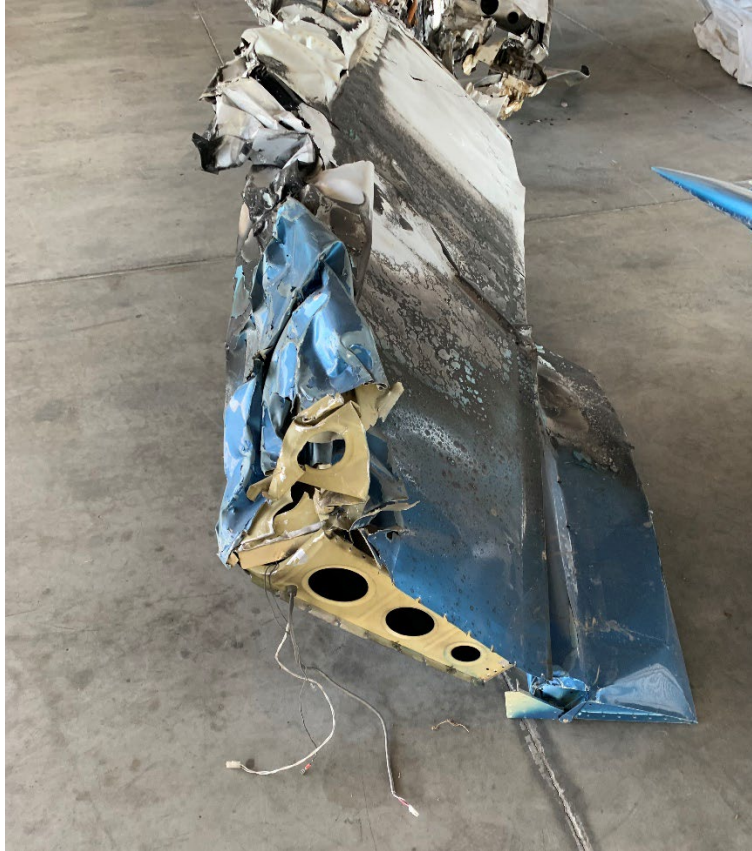
The leading edges of the wings sustained impact damage and were separated from the fuselage. The left and right ailerons and flaps were attached. Flight control continuity was established to all flight control surfaces.

Figure 1: Airplane's wing as viewed from the left side.

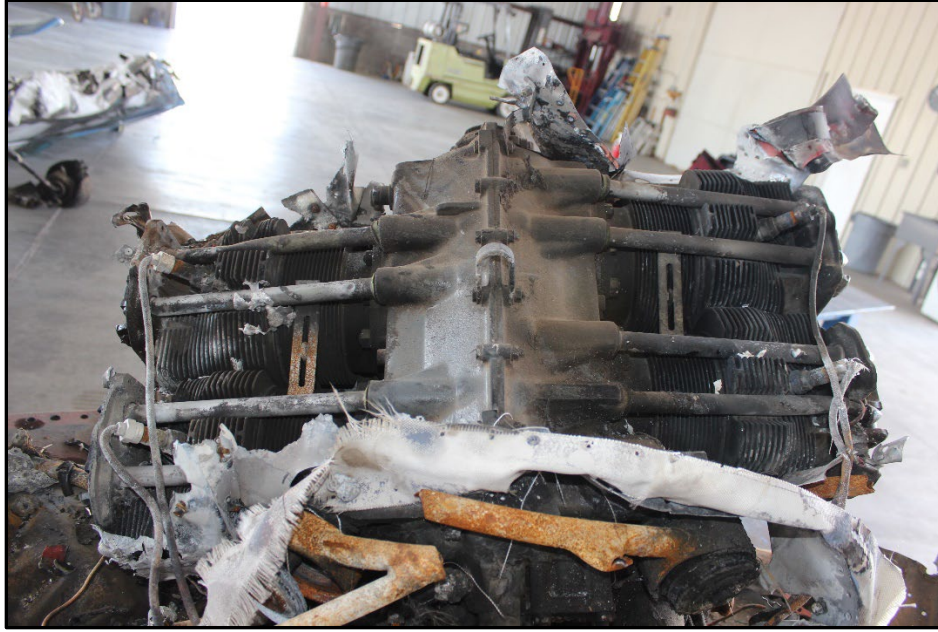
The Lycoming O-320 series engine was attached to the engine mount and firewall which had separated from the fuselage. There was no data plate attached to the engine. Exterior examination of the engine revealed that the engine sustained impact and thermal damage. Furthermore, the oil sump sustained impact damage and a hole was observed in the right rear section.

The crankshaft was unable to be rotated due to the impact damage at the engine case and crankshaft in the front of the engine. The rocker covers were removed, and examination of the rocker box areas revealed no preimpact mechanical malfunctions. The combustion chambers and engine case interior were examined with a lighted borescope and revealed normal operating signatures.

Figure 2: The engine as viewed from the top back side during the examination.
