# National Transportation Safety Board

WPR22FA068

## **AIRPLANE PERFORMANCE GROUP**

Location: El Cajon, California  
Date: December 27, 2021  
Time: 1914 PST  
0314 GMT (December 28, 2021)  
Airplane: LearJet 35A, N880Z

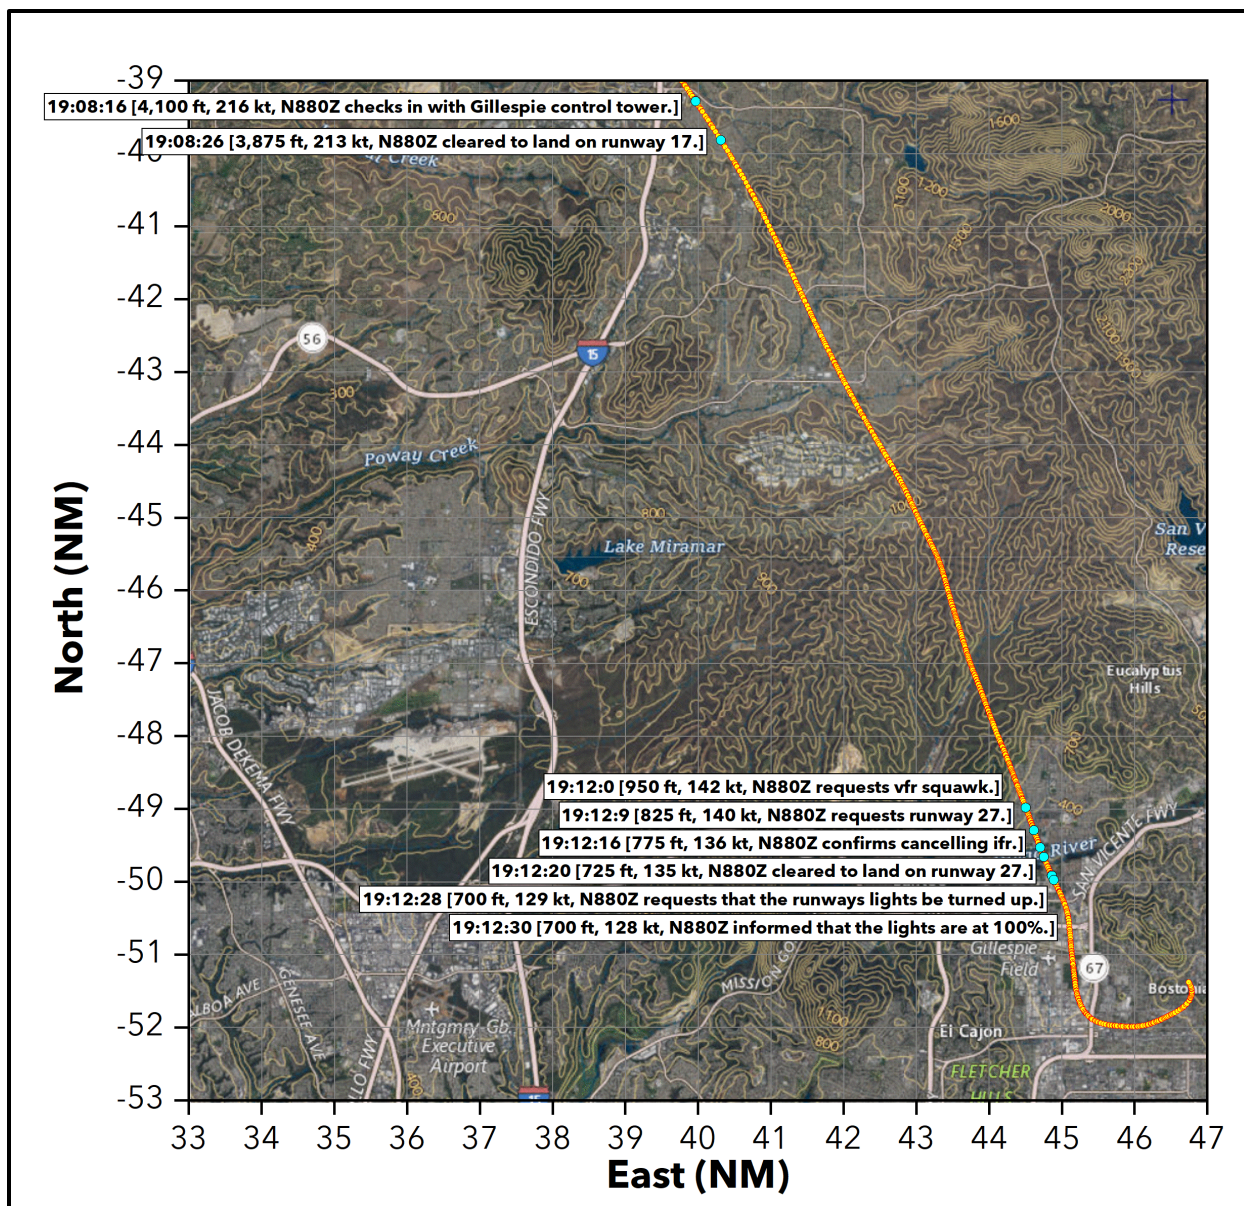
Figure 4 shows the ADS-B ground track, altitude, and estimated airspeed for the final six minutes of the flight, beginning with N880Z checking in with the Gillespie control tower. N880Z was initially cleared to land on runway 17 at approximately 1908:26 by means of the area navigation, GPS, RNAV17 instrument approach<sup>1</sup>; however, N880Z subsequently requested a visual approach to runway 27R about three and a half minutes later at 1912:00<sup>2</sup>. ADS-B data show the airplane at 950 ft msl and approximately 2 NM north of the airport at 1912:00.

**Figure 4: ADS-B Ground Track for Accident Flight with Select Times (PST), Altitudes (ft, msl), and Estimated Airspeeds**

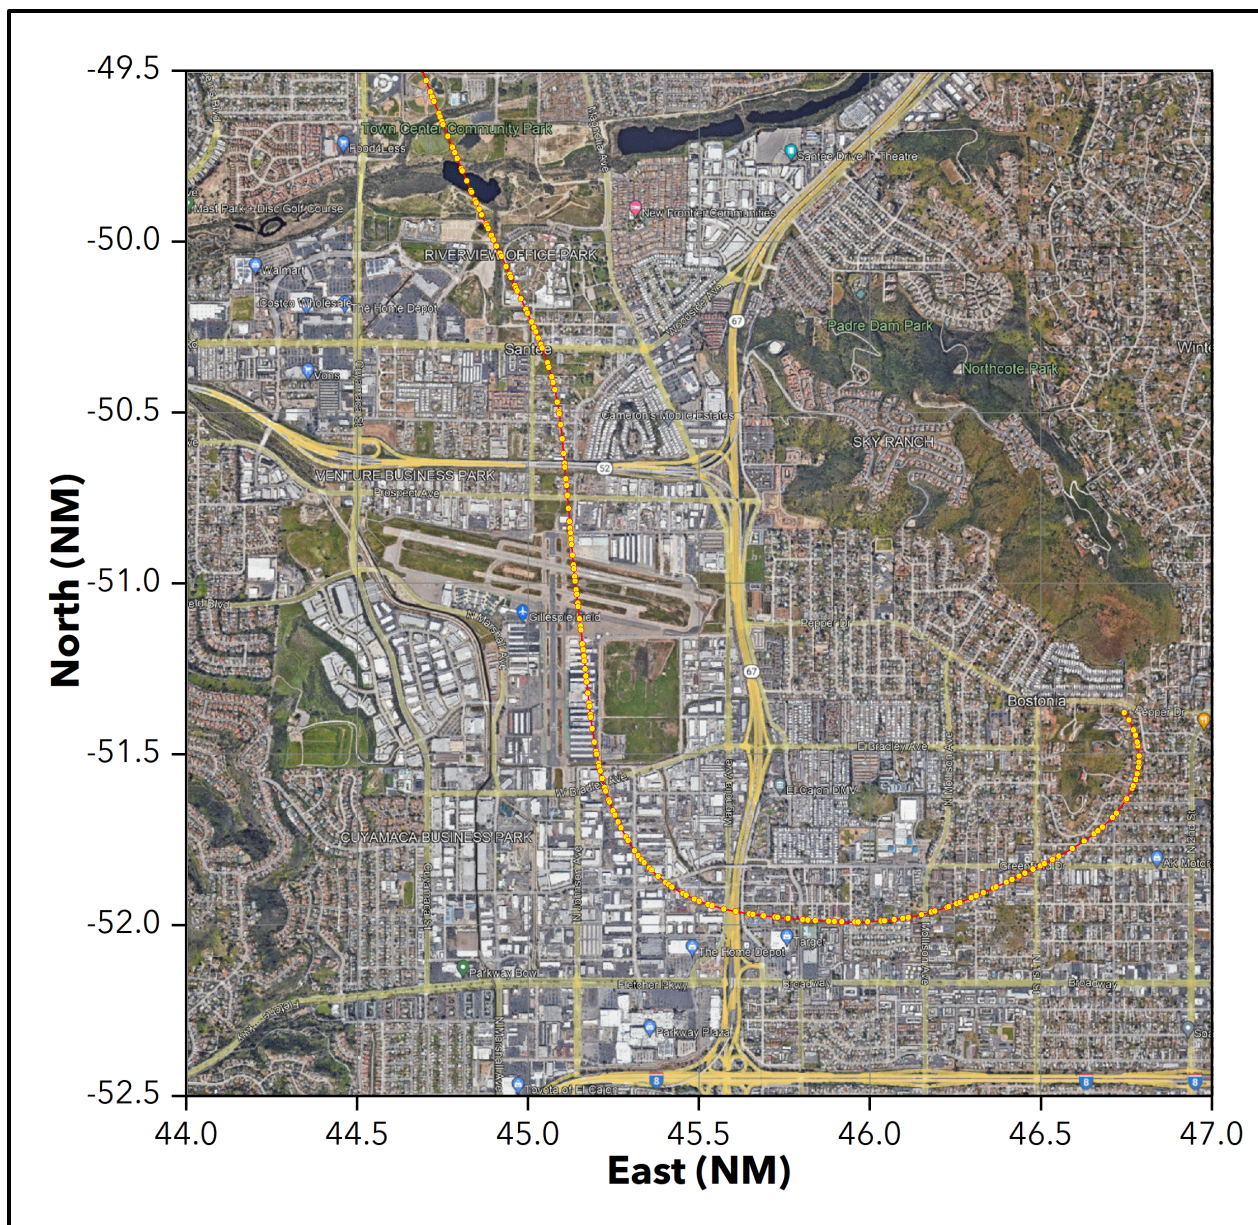
**Figure 5: ADS-B Ground Track for Final Two Minutes**

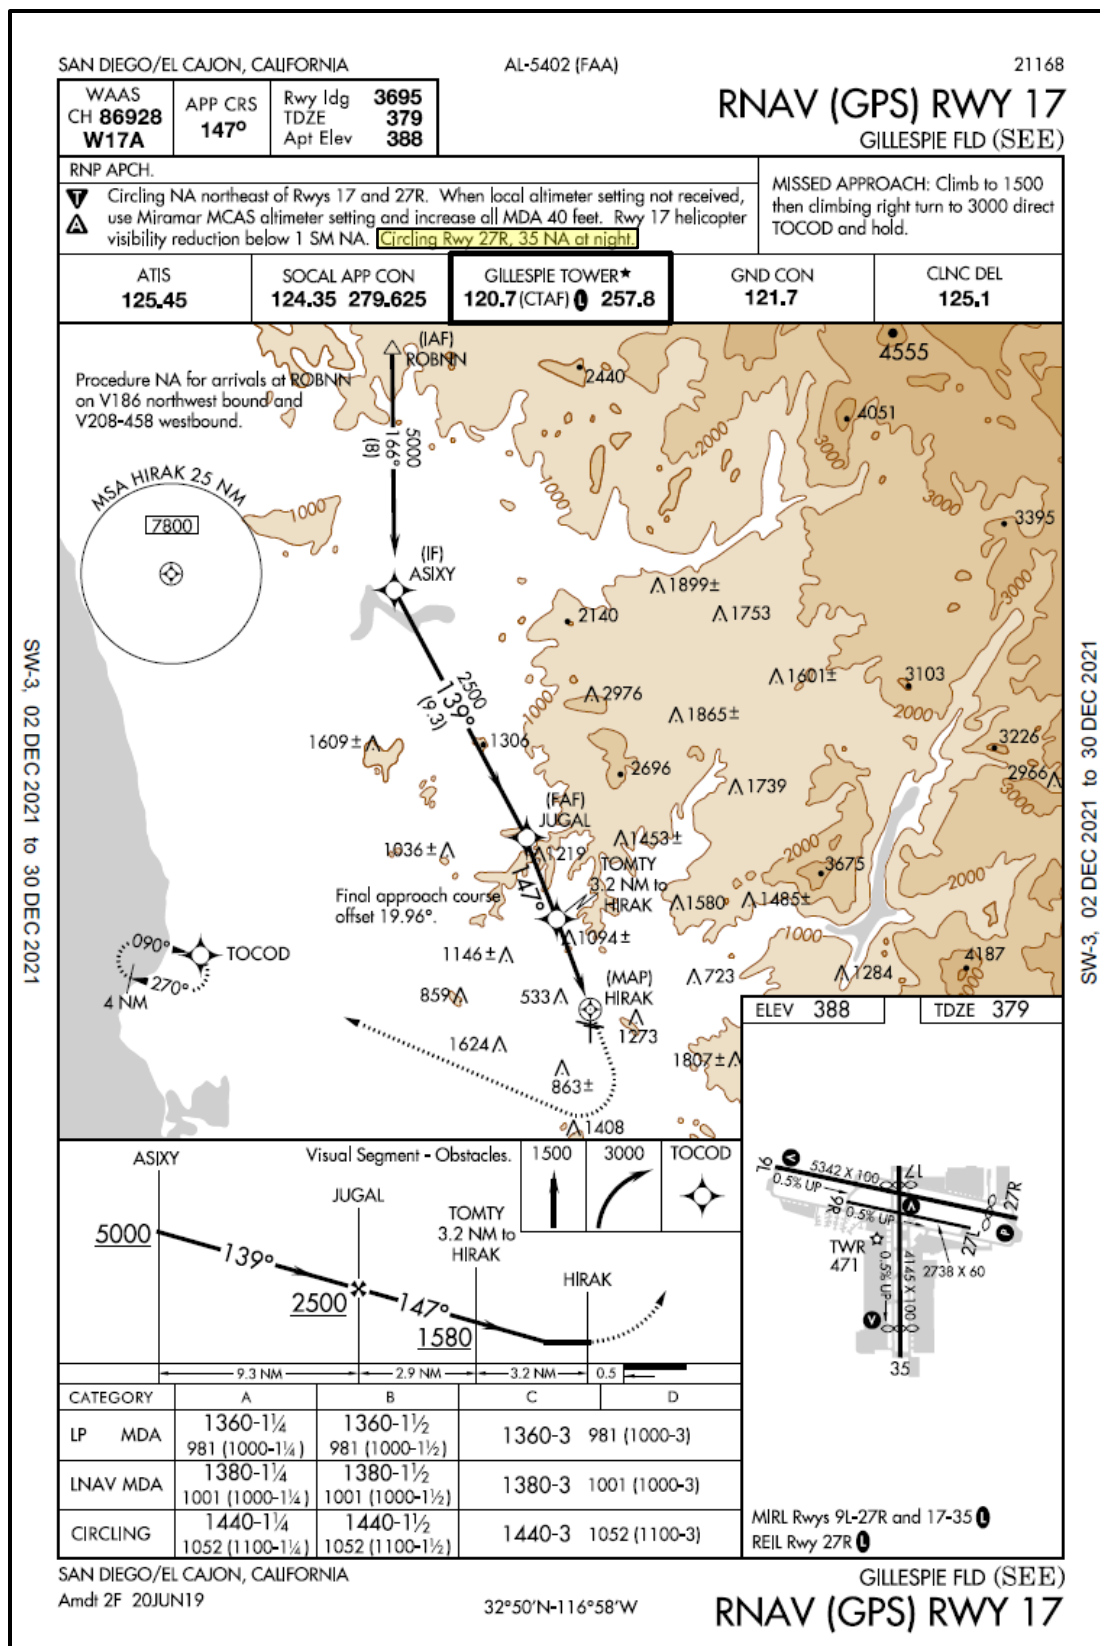
After confirming the request, the Gillespie tower told N880Z to overfly the field, to make left traffic, and then cleared N880Z to land on runway 27R. The RNAV 17 instrument approach procedure is shown in Figure 5, including a restriction that circling approaches to runway 27R or runway 35 are not allowed at night. The left circling visual approach to runway 27R that was flown is shown in Figure 6.

**Figure 6: Instrument Approach Plate for KSEE RNAV Runway 17**

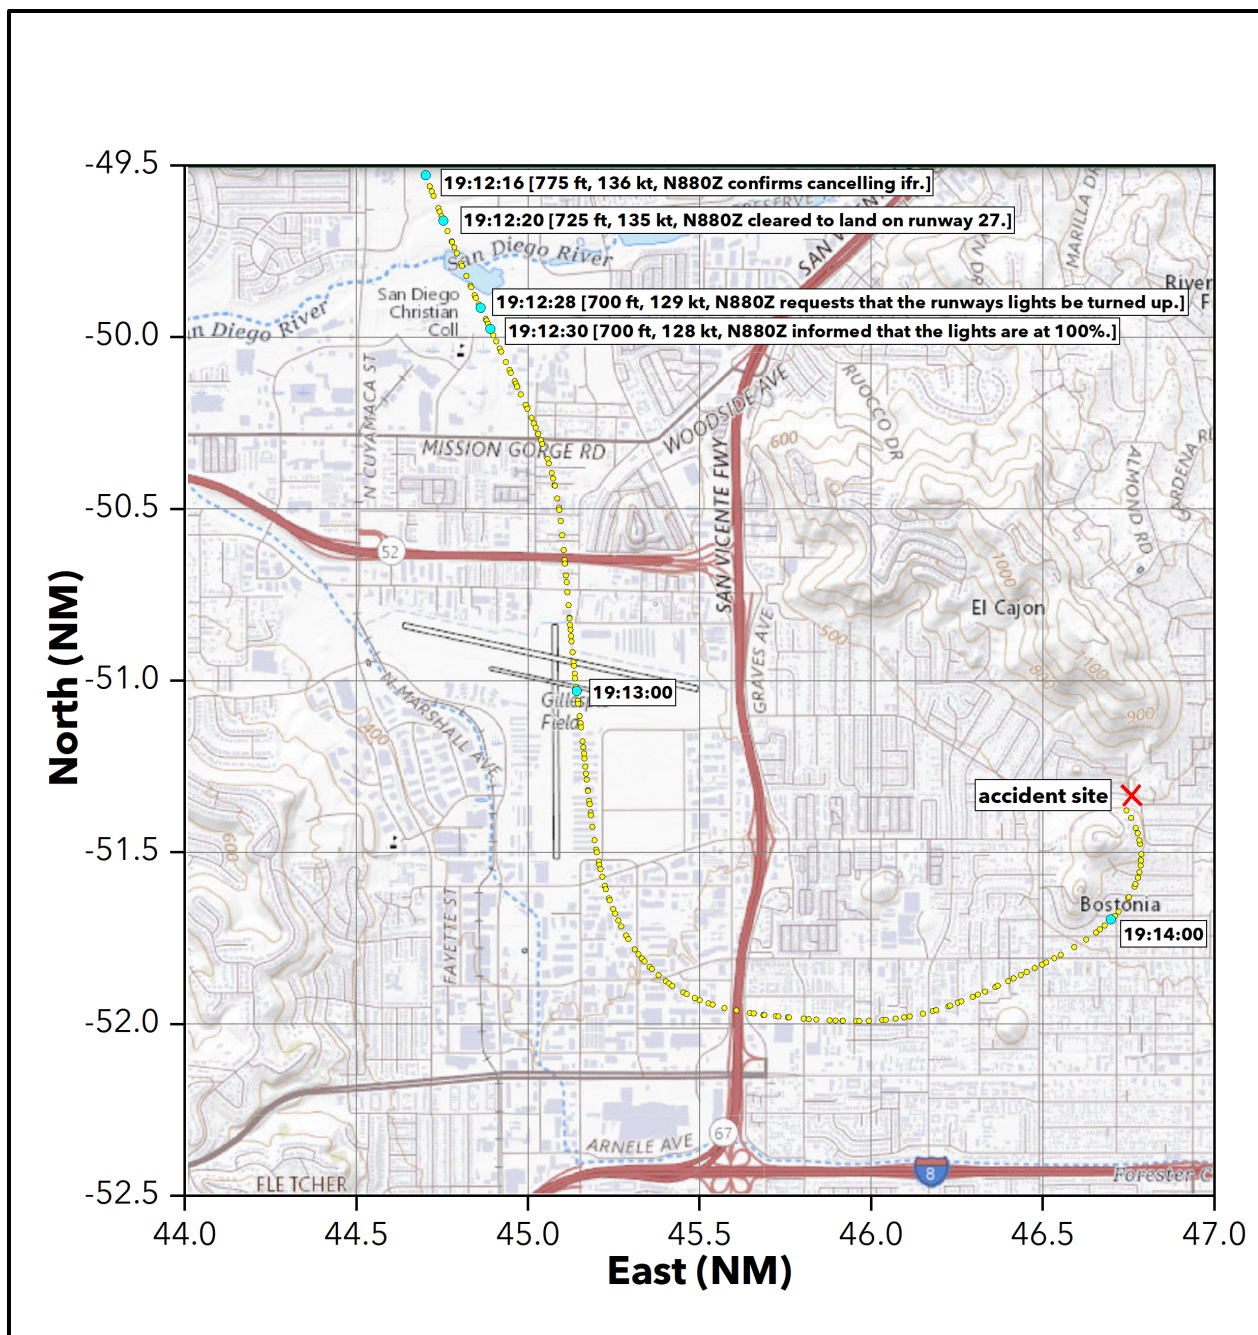
Figure 7 also shows the circling approach but on a topographic map of the area surrounding the airport. The airport elevation is approximately 388 ft above mean sea level (msl) with terrain as high as 1,100 ft msl to the east of the airport and close to the accident site. While the terrain would likely have been visible with the reported cloud ceiling of 2,000 ft agl at SEE, the clouds may have been lower than reported<sup>3</sup>.

**Figure 7: ADS-B Ground Track for Final Two Minutes with Select Times (PST), Altitudes (ft, msl), and Estimated Airspeeds**

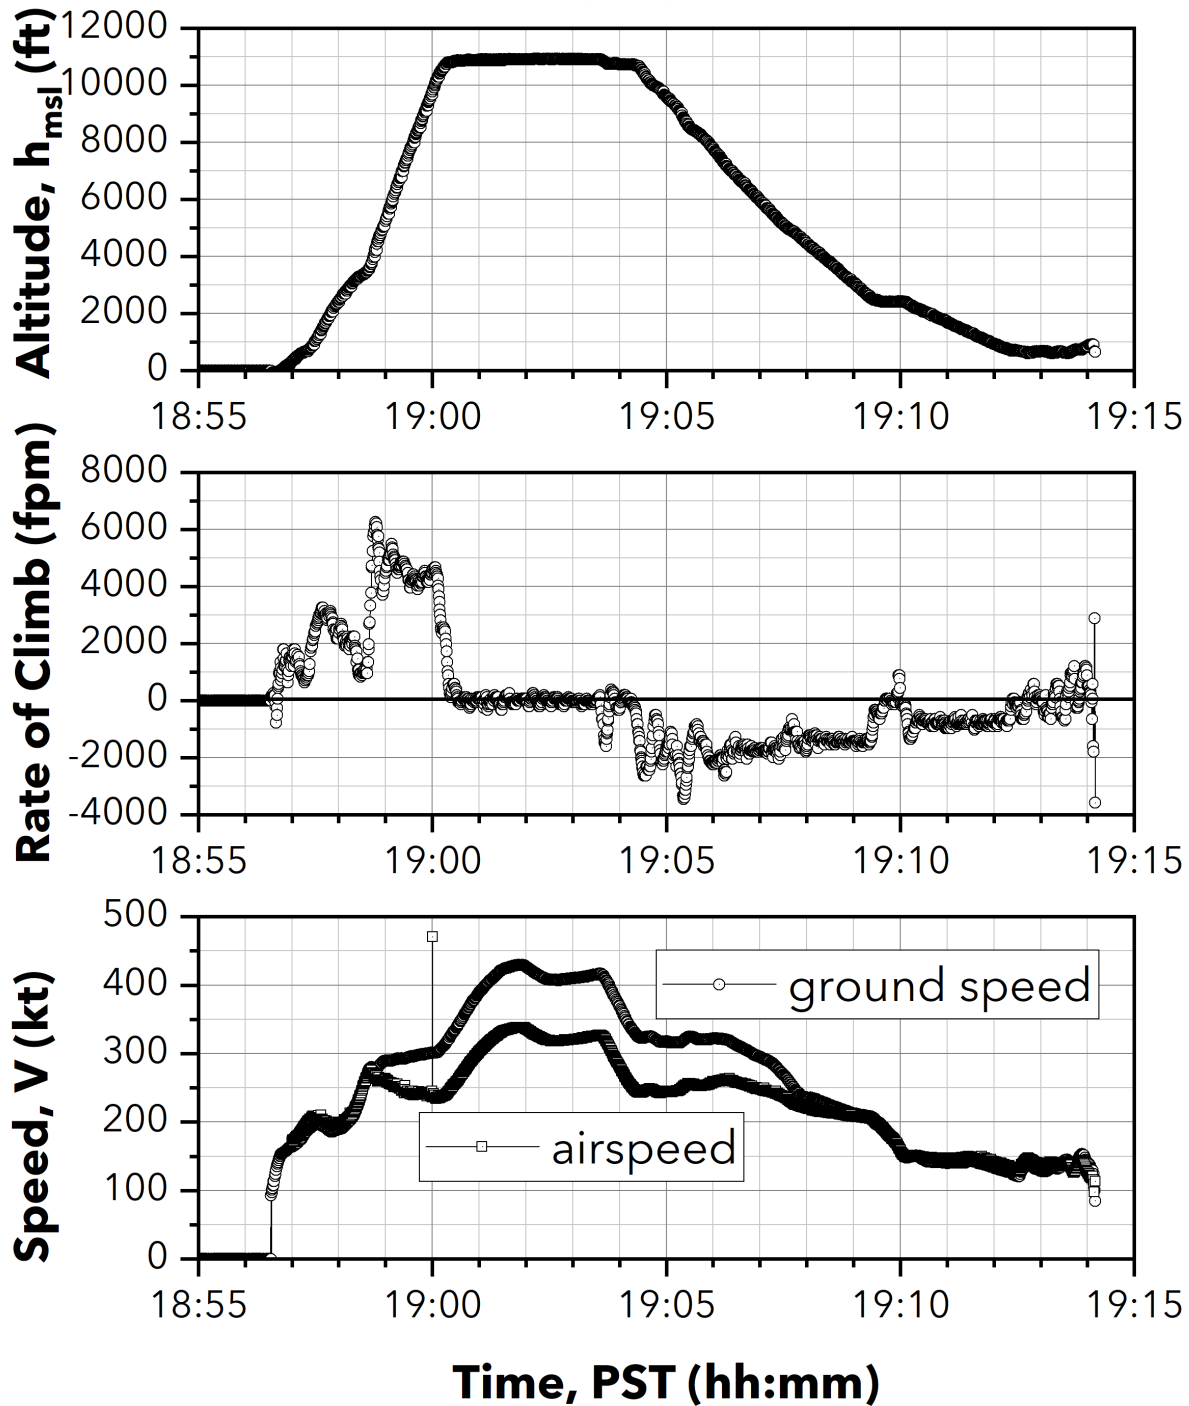
**Figure 8: ADS-B Altitude, Ground Speed and Estimated Airspeed for the 18 Minute Flight**

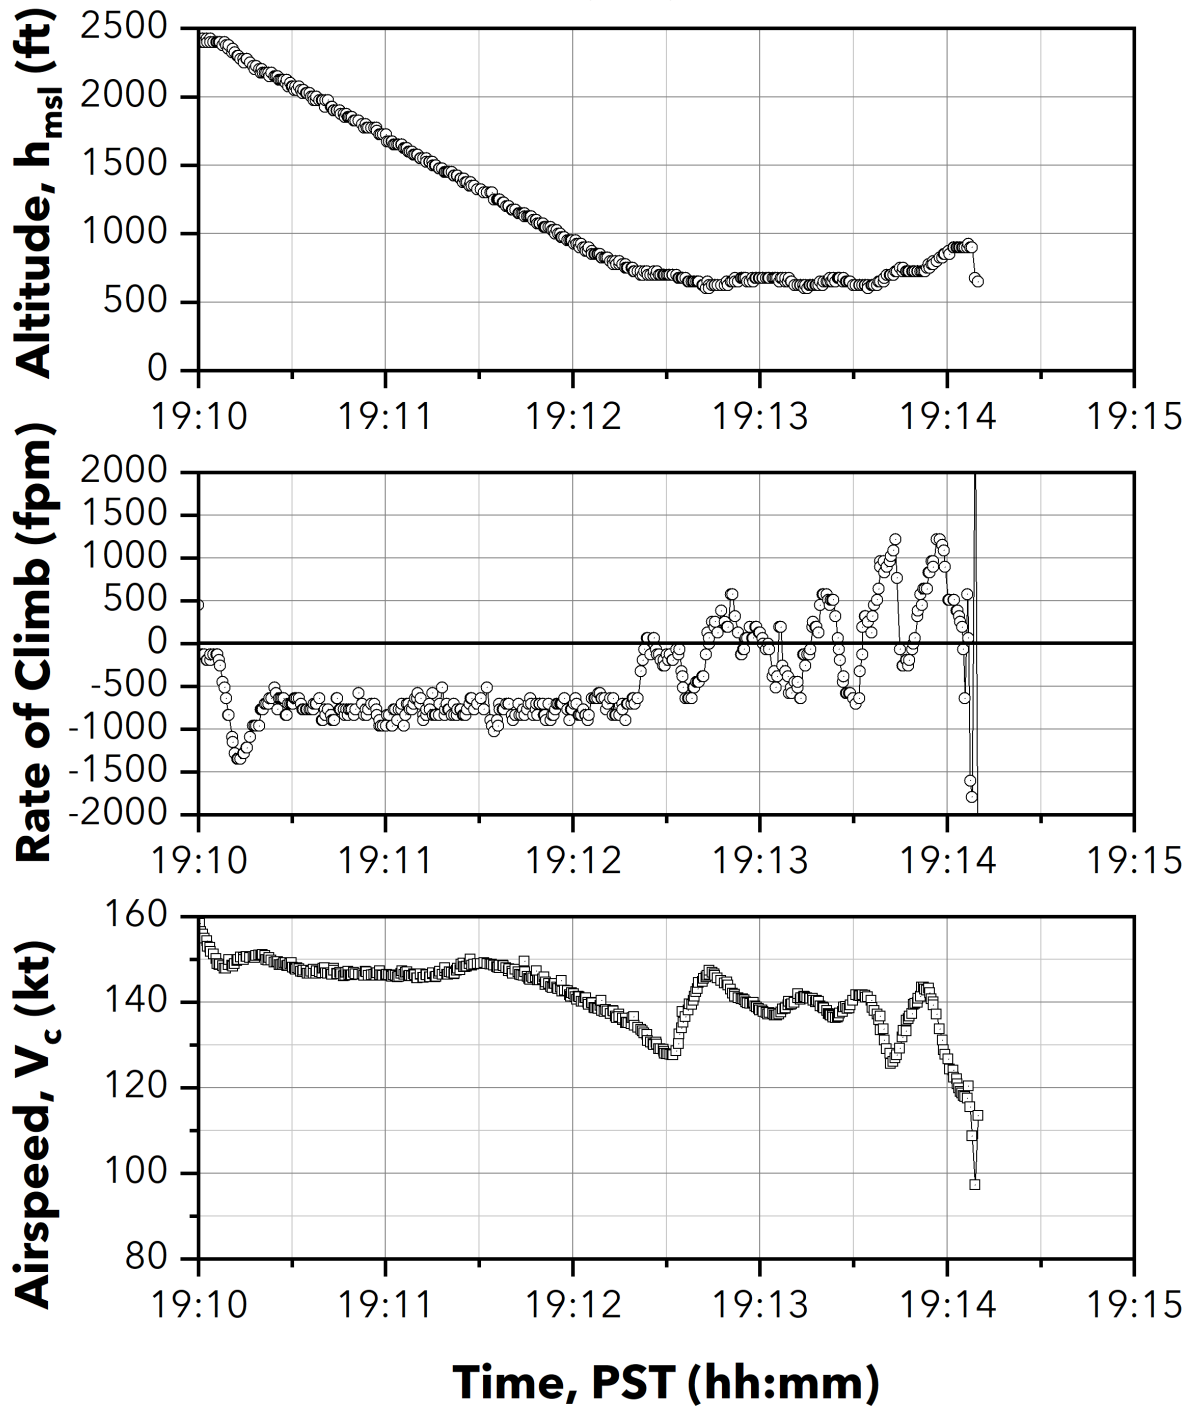
Time histories of ADS-B altitude, ground speed and estimated airspeed for the 18 min flight are shown in Figure 8. Figure 9 shows the same parameters but highlights the final four minutes. N880Z crossed the airport at approximately 785 ft msl (about 400 ft agl) and 138 kt airspeed<sup>4</sup> before circling to the left to land on runway 27R. The airspeed slowed to 126 kt at 1913:41 and as slow as 119 kt at 1914:04.

**Figure 9: ADS-B Altitude, Ground Speed and Estimated Airspeed  
for the Final Four Minutes**

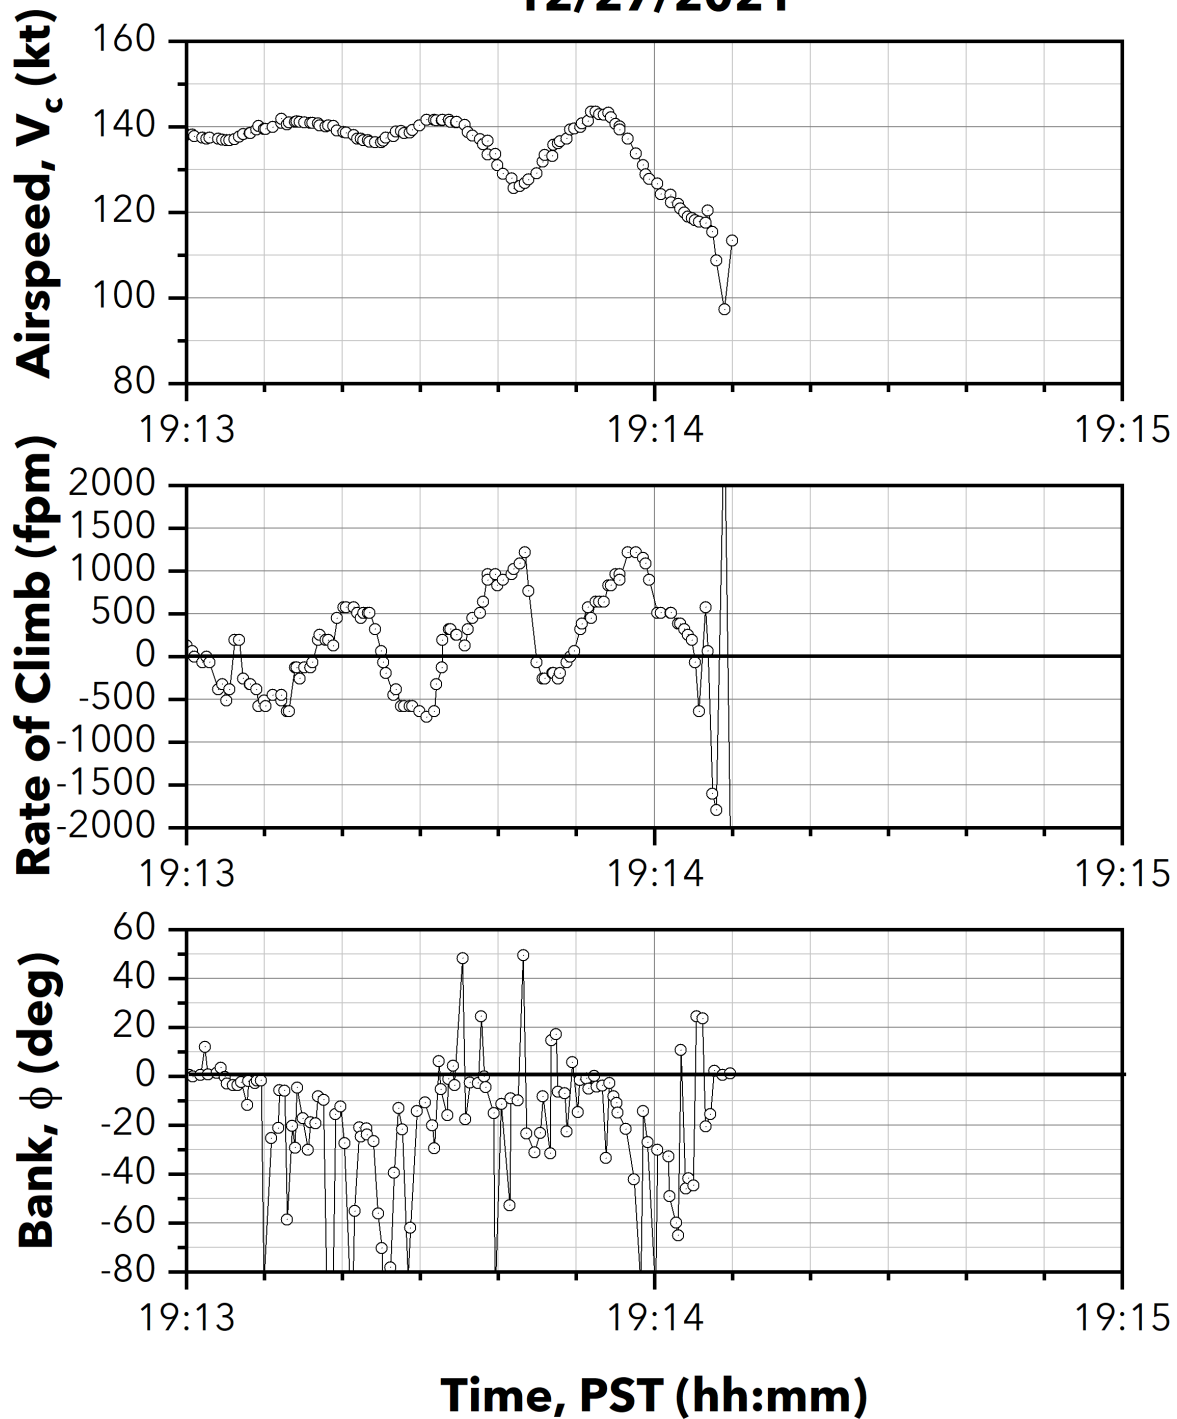
Figures 10 and 11 show the estimated bank angle and angle-of-attack during the circling approach in the final minute of the flight. The maximum left bank angle likely exceeded 60° as the estimated angle-of-attack approached 20°.

**Figure 10: Estimated Airspeed and Bank Angle  
During Circling Approach to Runway 27R**

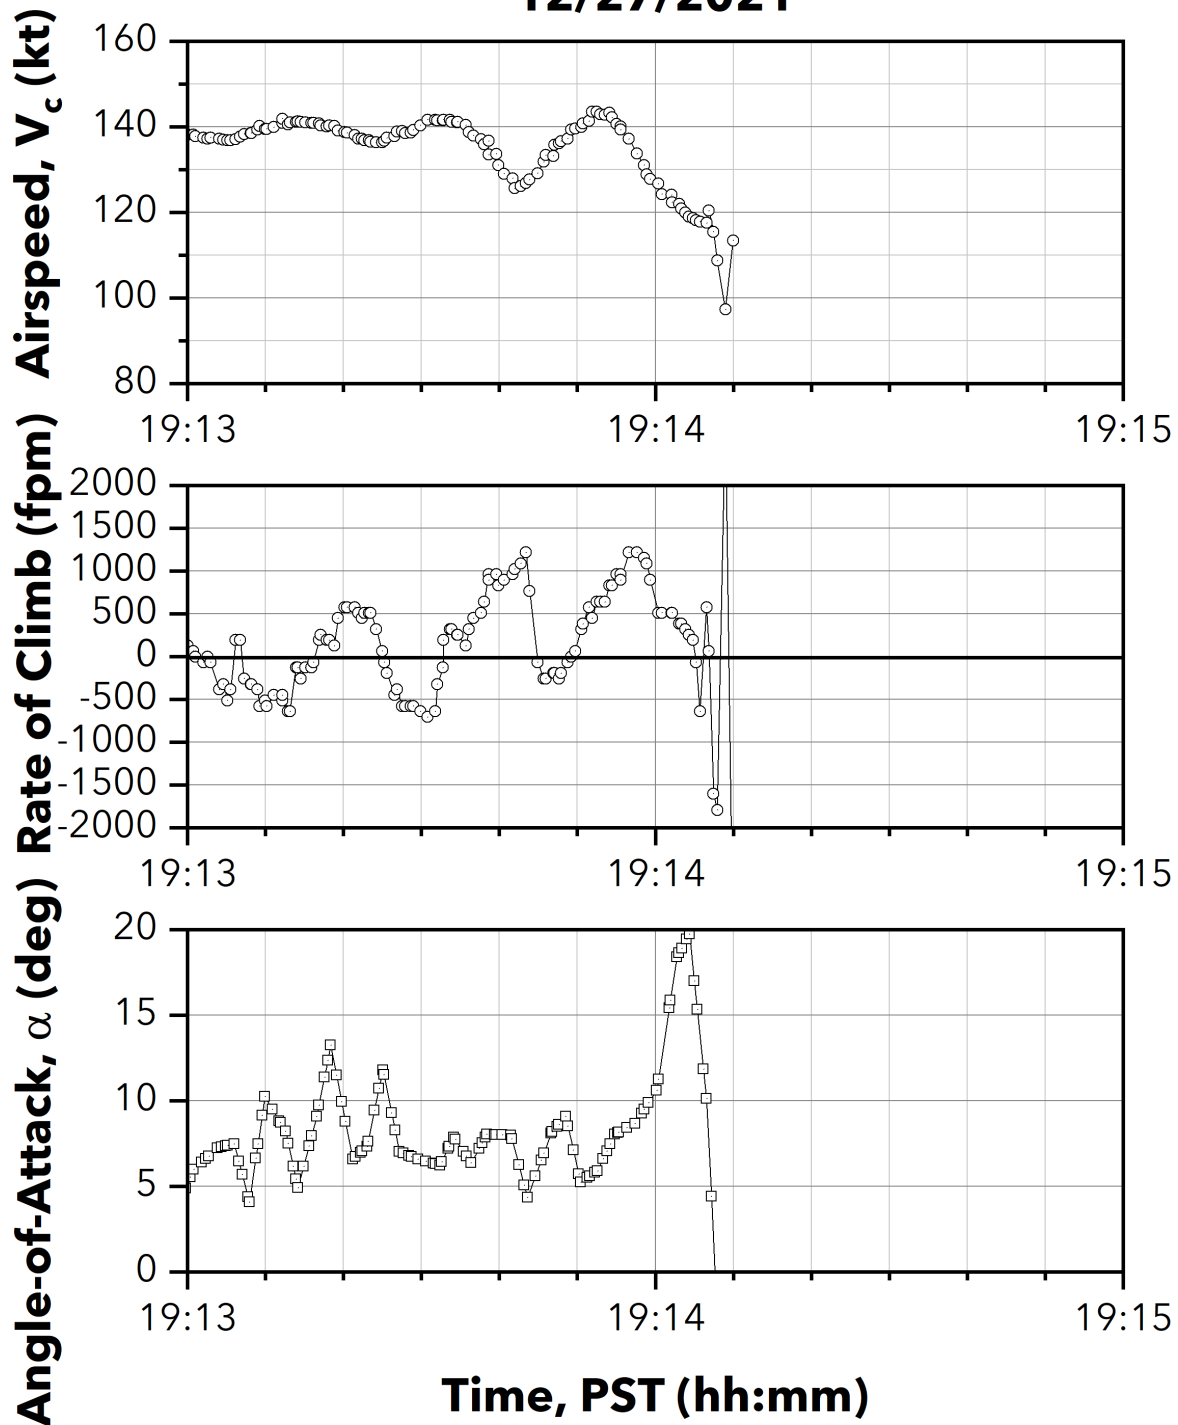
**Figure 11: Estimated Airspeed and Angle-of-Attack  
 During Circling Approach to Runway 27R**

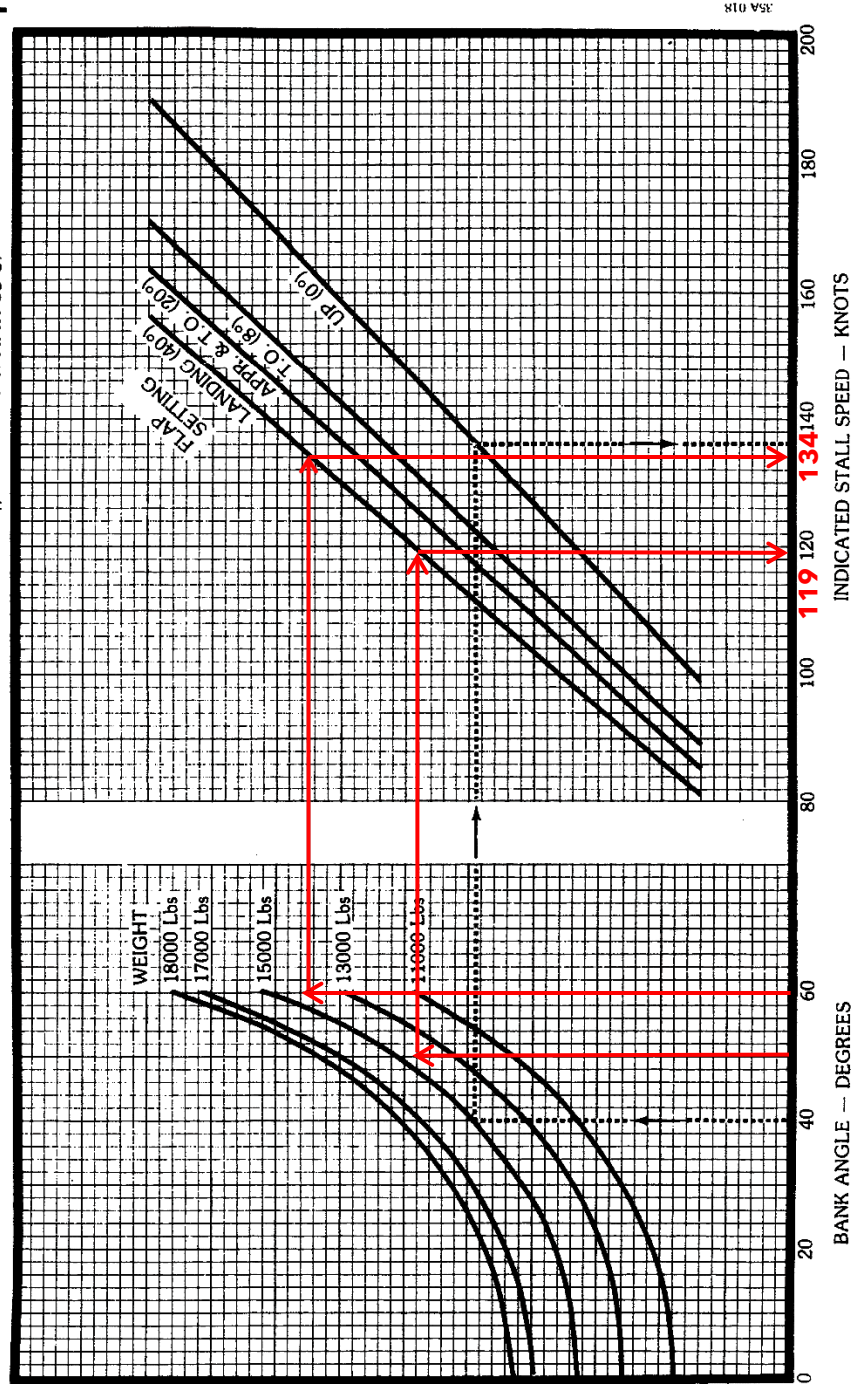
The wings-level stall speed published in the LearJet 35A FAA Approved Airplane Flight Manual (AFM) at the landing flap<sup>5</sup> setting and a gross weight of 14,350 lb is approximately 96 kt. The stall speed increases to 119 kt in a level 50° banked turn and to 134 kt in a 60° banked turn. See Figure 12.

**Figure 12: Estimated Stall Speed from LearJet 35A FAA Approved AFM**
