# National Transportation Safety Board

WPR22FA068

## **ACCIDENT SITE, AIRFRAME, AND ENGINES EXAMINATION**

Location: El Cajon, California  
Date: December 7, 2021  
Time: 1914 Pacific standard time  
Airplane: N880Z, Gates Learjet Corporation 35A

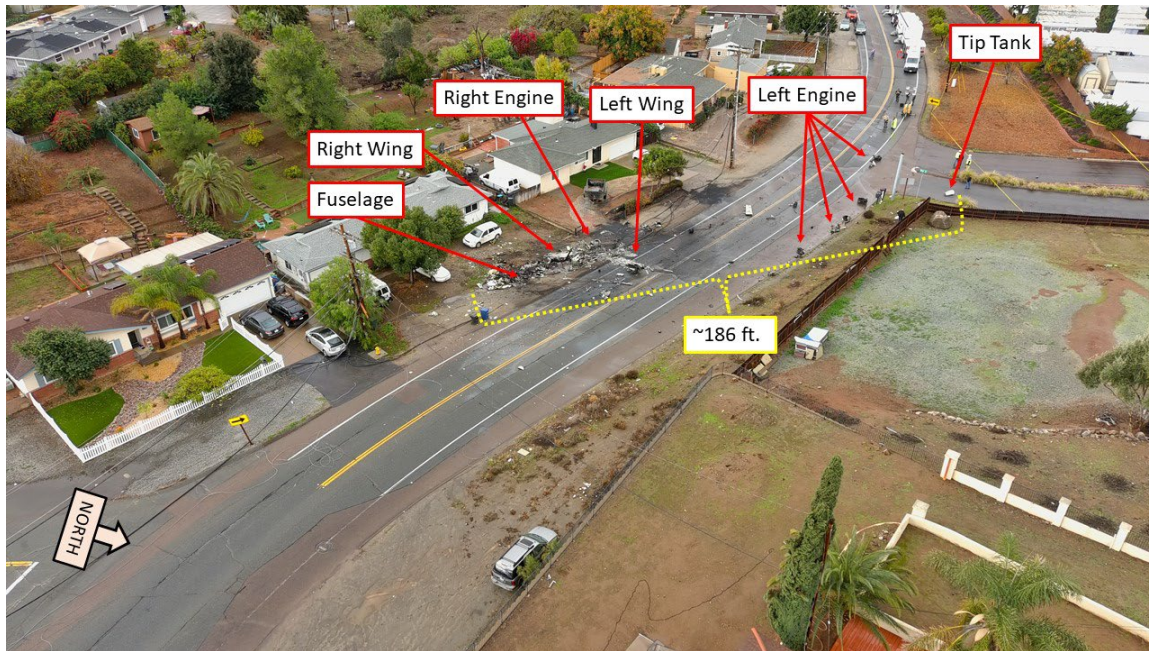
Examination of the accident site revealed that the airplane struck a set of power lines and subsequently impacted the yard of a residential home about 1.43 nautical miles east of the approach end of runway 27R. The airplane came to rest upright on a heading of about 118° magnetic, at an elevation of about 595 ft msl. The wreckage debris path was oriented on a heading of about 310° magnetic and was about 186 ft long and 90 ft wide.

**Figure 1: Accident site aerial photo (San Diego Sheriff Office) with annotations.**

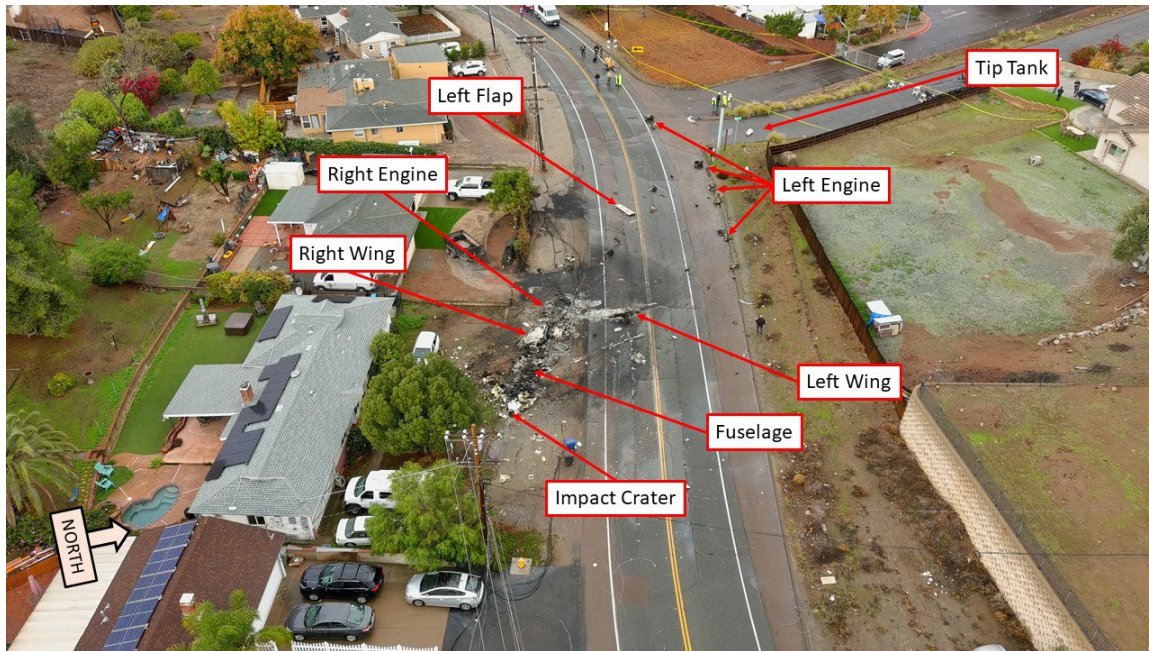
The first identified point of impact was a large crater, which contained the forward portion of the fuselage, including the nose cone area, portions of the instrument panel, and the upper windscreen structure was located within the crater. Extending from the crater, the remains of the fuselage extended about 42 ft to the elevator control horn. The right wing was immediately next to and in a parallel orientation to the fuselage. The left wing was located aft area of the fuselage. Portions of the left and right horizontal stabilizer and elevators, rudder, and right engine were located adjacent to the elevator control horn.

Extending from the fuselage, various debris including both main landing gear, left flap, portions of the left engine, and tip tank. All major structural components were located within the wreckage debris path.

**Figure 2: Accident site aerial photo (San Diego Sheriff Office) with annotations.**

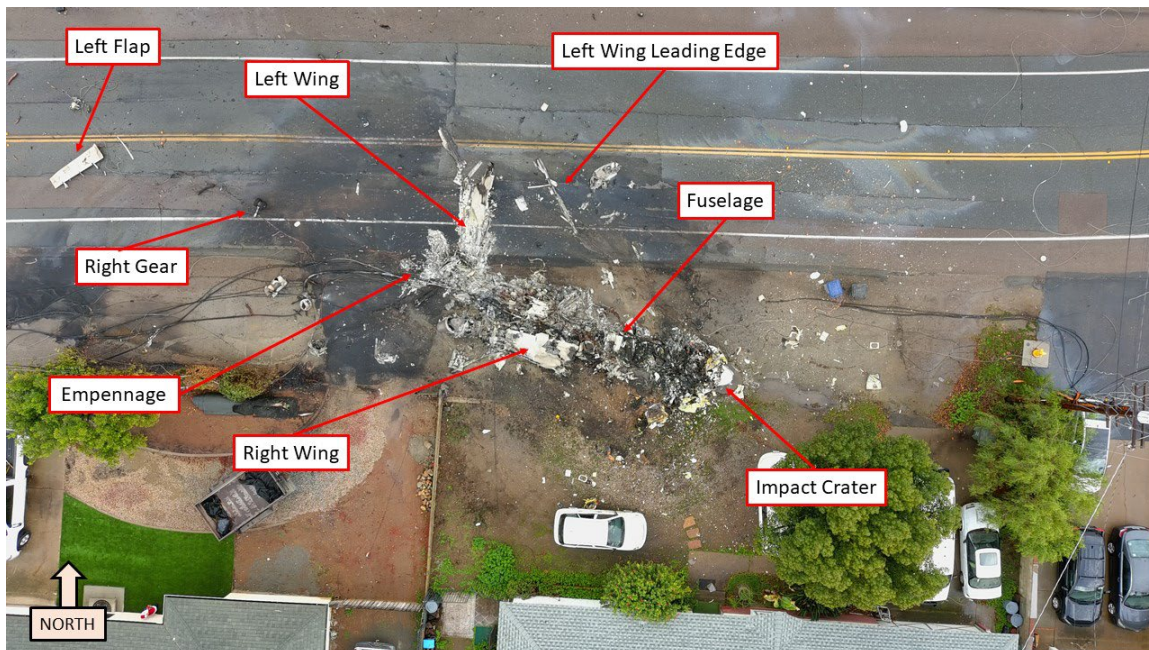
**Figure 3: Accident site aerial photo (San Diego Sheriff Office) with annotations.**
