## **NATIONAL TRANSPORTATION SAFETY BOARD**

# **ACCIDENT SITE EXAMINATION SUMMARY**

**WPR22FA073**

Location: Manana, Arizona  
Date: January 4, 2022  
Aircraft: Mooney, M20C, N6796N  
NTSB Investigator-in-Charge: Eric M. Gutierrez

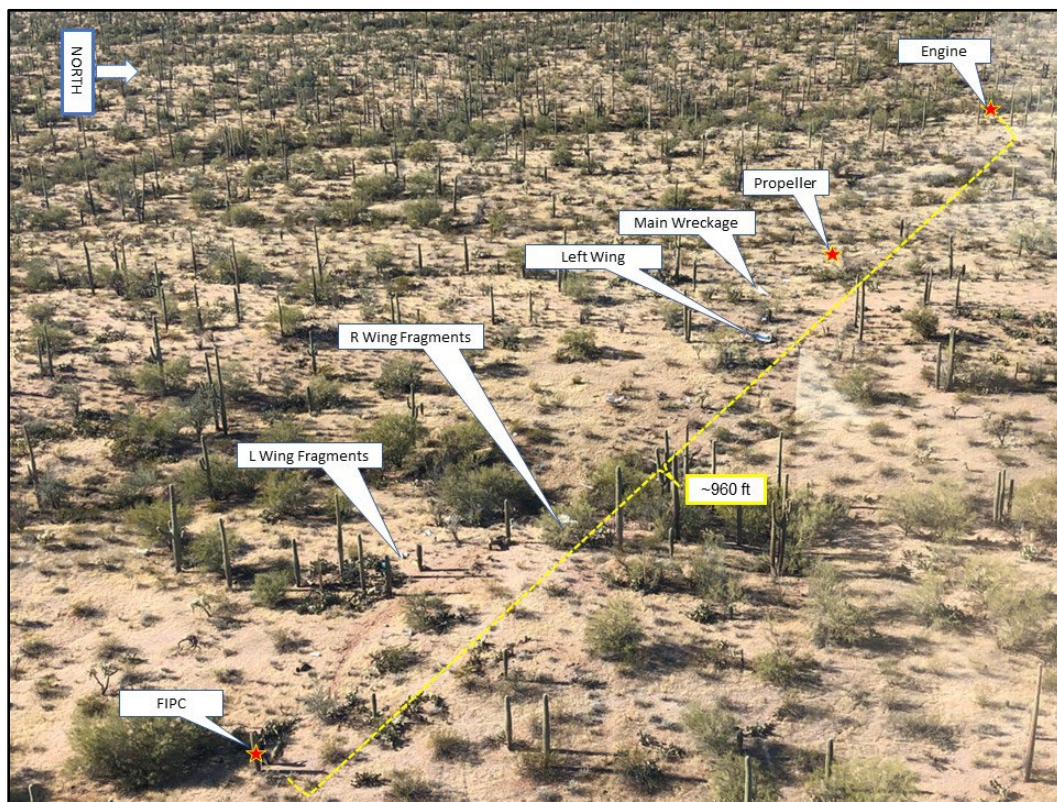
Examination of the accident site revealed that, the airplane impacted hilly, desert terrain. The main wreckage (aft fuselage and empennage) came to rest on its left side, on a heading of about 255° magnetic, at an altitude of 2162 ft mean sea level.

Figure 1: View of accident site diagram.

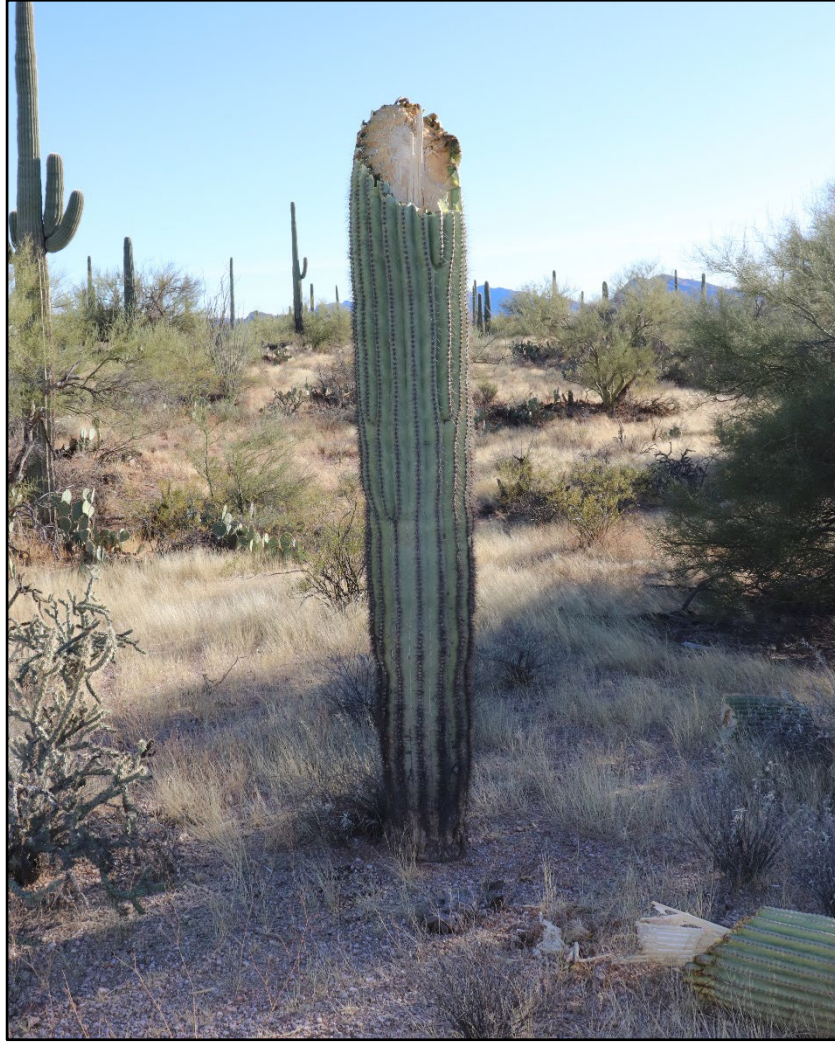
The first identified point of contact (FIPC) with terrain was an impact mark a saguaro cactus that was 128° magnetic and about 381 ft from the main wreckage. The impact made on the saguaro cactus was about 10 ft high and detached the remaining cactus. The debris field was located on flat, uneven desert terrain, on a magnetic heading of 308° degrees from FIPC, about 960 ft in length and 250 ft wide.

**Figure 2: View of impact on saguaro cactus.**

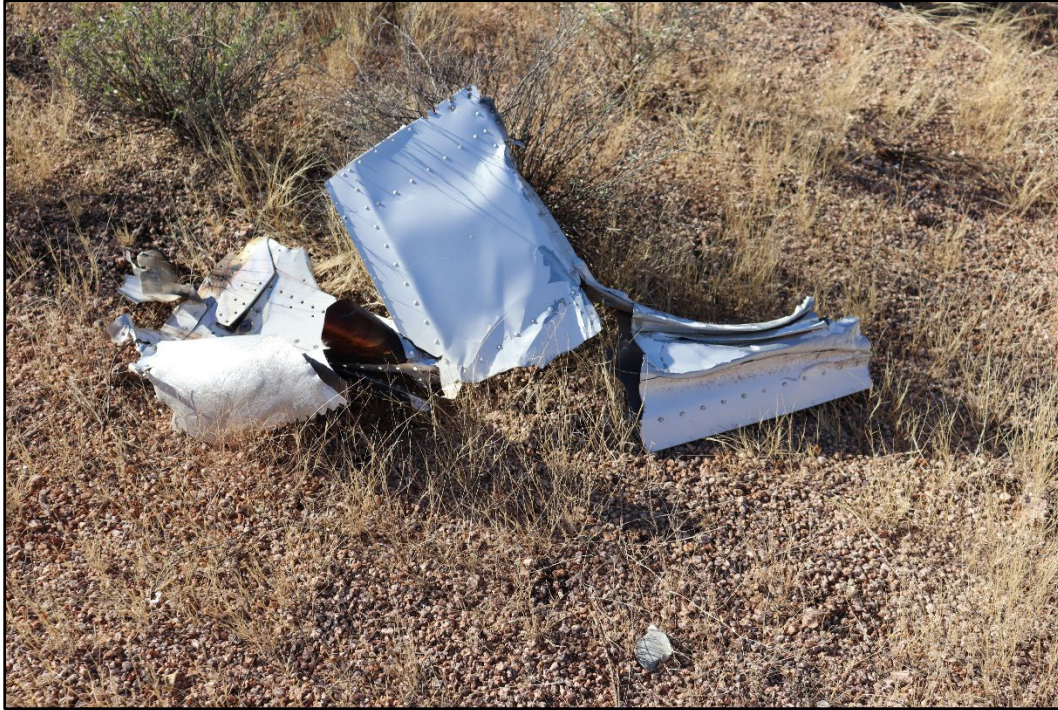
The first identified piece of wreckage was located near the FIPC and consisted of left wing fragments. Throughout the debris path, various portions of aluminum wing skin, left and right wing fragments, left and right ailerons, engine, propeller, exhaust system, foam, and plexi glass were observed.

Figure 3: View of left wing fragments near FIPC.

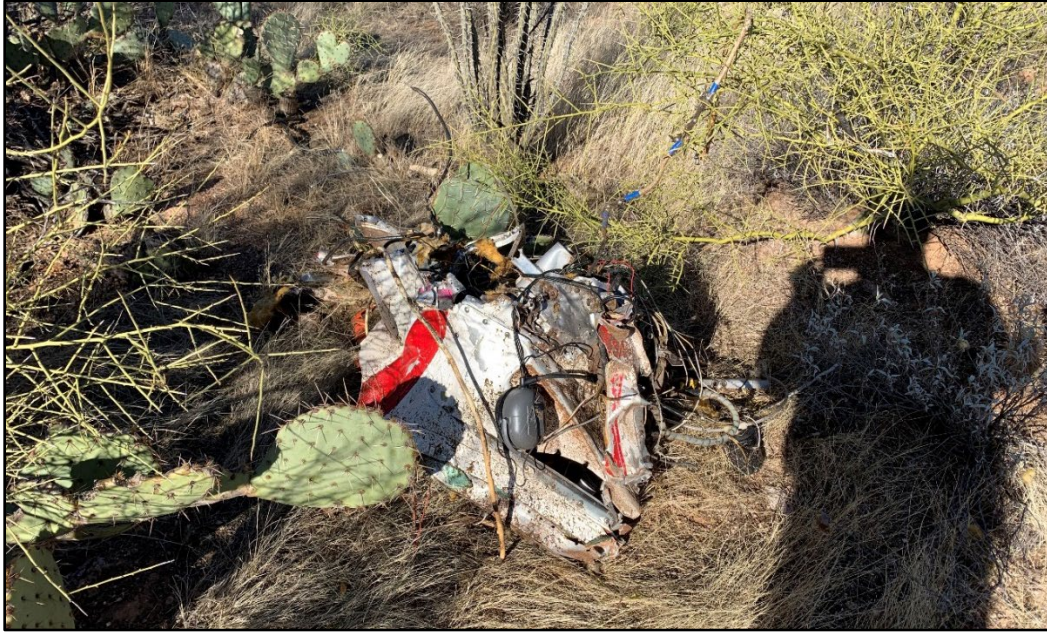
The forward section of the fuselage was heavily impact damaged and separated. The engine, engine mount, nose landing gear, firewall, instrument panel, cockpit, flight controls, and seats were separated and located within debris field. The cabin area was separated behind the rear seatbacks. The instrument panel was recovered with various instruments separated. The cabin door was recovered. The engine mount had several fractures, consistent with impact damage. The aft section of the fuselage exhibited buckling and compression crushing throughout.

Flight control continuity was not established due to impact damage and multiple separations of the flight control cables throughout the entire airplane.

Figure 4: View of firewall and instrument panel.

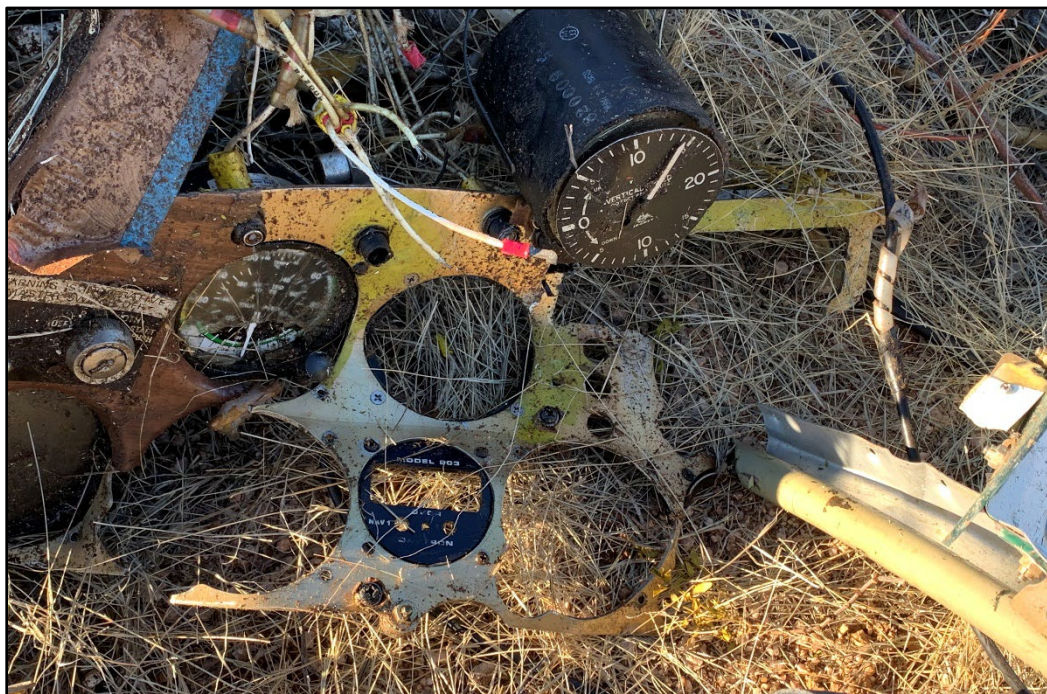
Figure 5: View of airplane instrument panel.

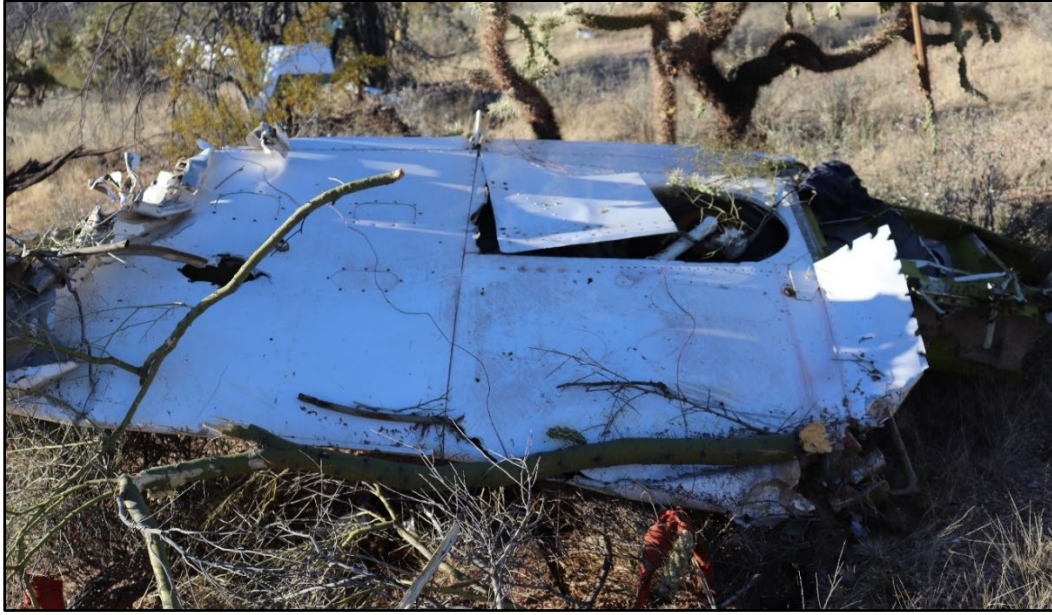
The left wing separated from the fuselage at the wing root and fragmented into numerous sections and were scattered throughout the debris field. The left wing aileron separated from the wing attachment points and was located in the debris field, crushing and bending was observed on both ends. The left aileron bell crank remained attached with about a 1 in section of push rod control tub attached. The left main landing gear remained attached via the wing mounts and was retracted. The left main fuel tank fuel cap was observed in place and secure.

Figure 6: View of left wing

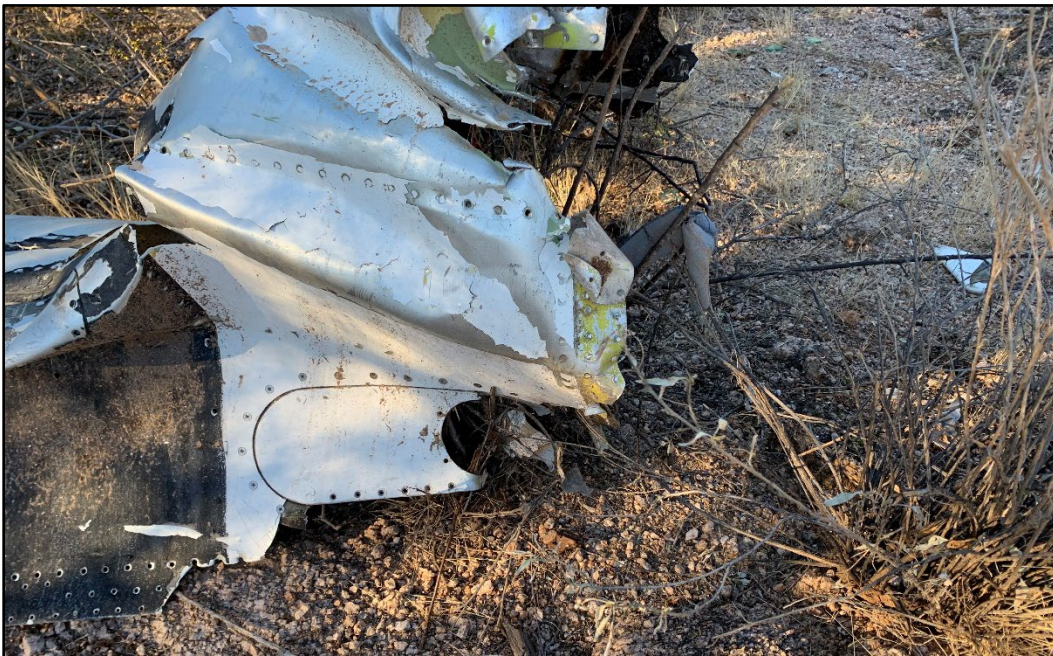
The right wing separated from the fuselage at the wing root and fragmented into numerous sections and were scattered throughout the debris field. The right wing aileron separated from the wing attachment points and was located in the debris field, crushing and bending was observed on both ends. The right aileron bell crank remained attached to the aileron with about a 1 in section of push rod control tub attached. The right main landing gear lift strut separated from the right wing and was located in the debris field.

Figure 7: View of right wing fragment.

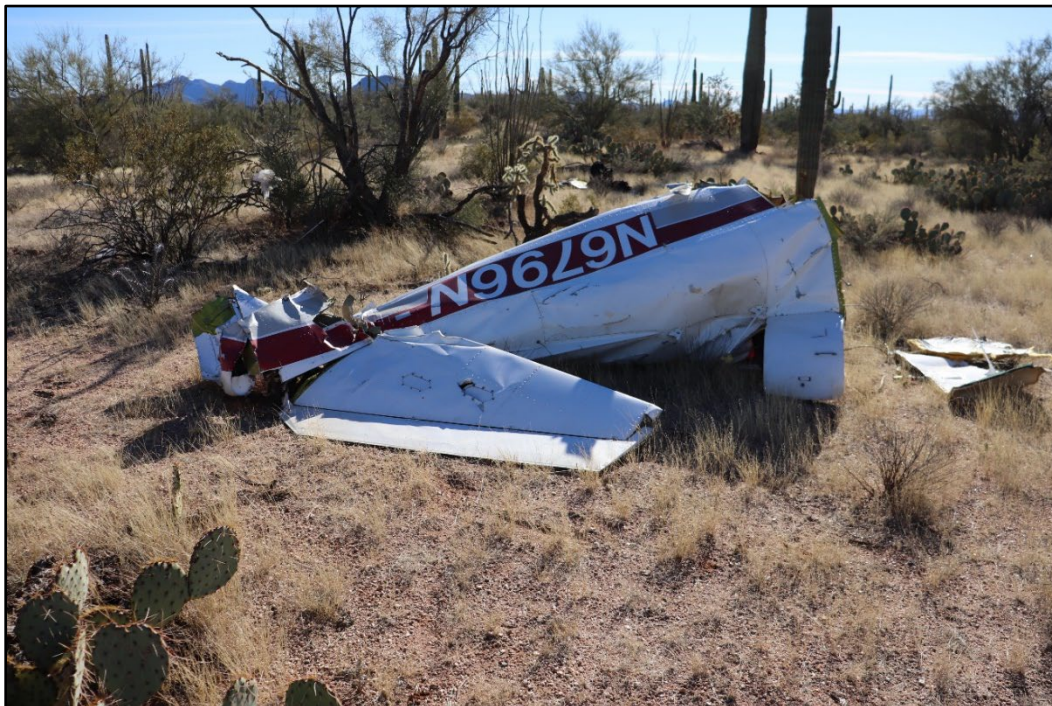
The empennage remained attached to the aft fuselage. The vertical stabilizer was separated from the empennage, exhibited impact damage, crushing and bending throughout. The rudder separated from the vertical stabilizer and exhibited impact damage, crushing, and bending throughout. The left horizontal stabilizer was partially separated from the empennage, the elevator remained attached to their respective attachment points and the control tubes were traced to the center of the fuselage, where they were separated from the flight controls. The right horizontal stabilizer was separated from the empennage, the elevator remained attached to their respective attachment points.

Figure 8: View of airplane empennage.

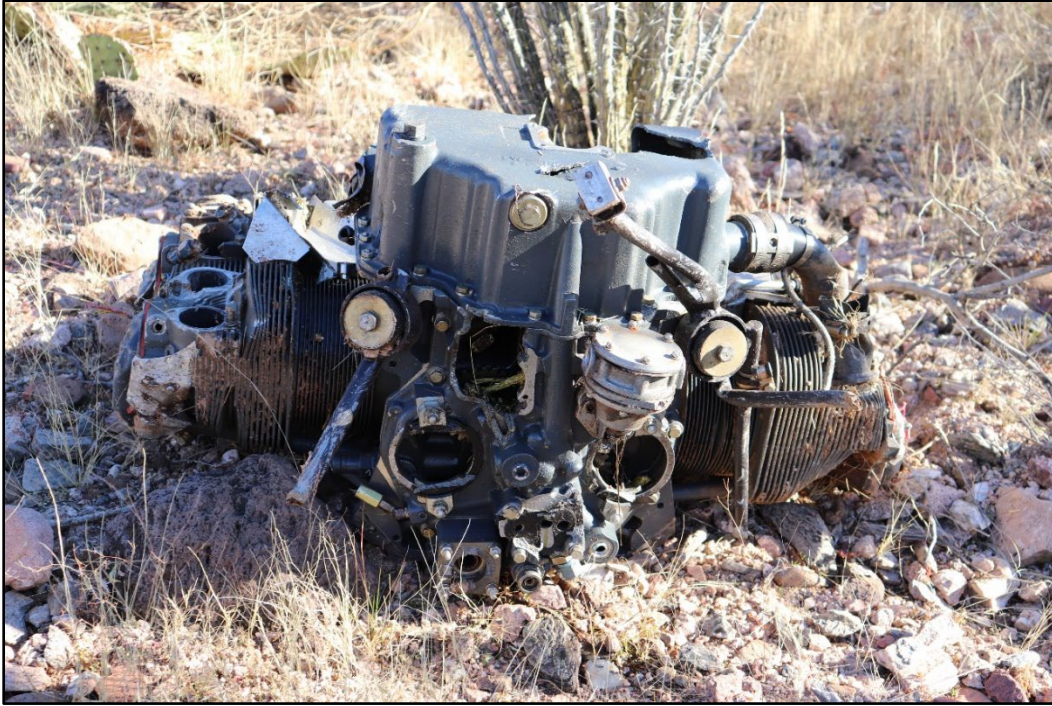
The engine was separated from the engine mount and came to rest about 565 ft, northwest of the main wreckage. All four engine mounts had fracture separated. All four cylinders remained attached and exhibited impact damage. The cylinder rocker box covers remained attached to the cylinder and exhibited impact damage. The intake and exhaust were separated and exhibited impact damage. The propeller governor was separated from the engine, exhibited impact damage and located in the debris field. The engine driven fuel pump remained attached to the engine accessories case and was impact damaged. The oil suction screen was removed and free of visible contaminants.

Figure 9: View of airplane engine.

The crankcase sustained impact damage at the nose section and crankshaft. The crankshaft could be rotated approximately 270 degrees. Accessory gear movement was observed during crankshaft rotation. The pushrod tubes at each cylinder remained undamaged. There was no evidence of pre-impact catastrophic mechanical malfunction or fire.

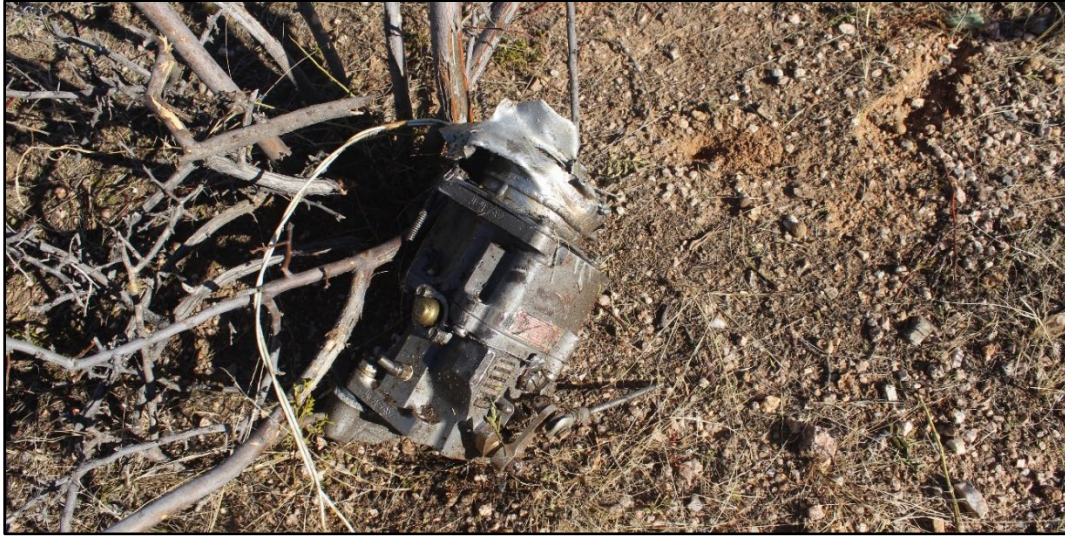
The carburetor with an attached portion of the plenum had been separated from the engine and was located in the debris field near the main wreckage. The fracture surfaces exhibited signatures consistent with overload. The fuel inlet line was removed, and the fuel screen was free of debris and found unremarkable. The throttle lever was intact, undamaged, and freely from stop to stop.

Figure 10: View of carburetor.

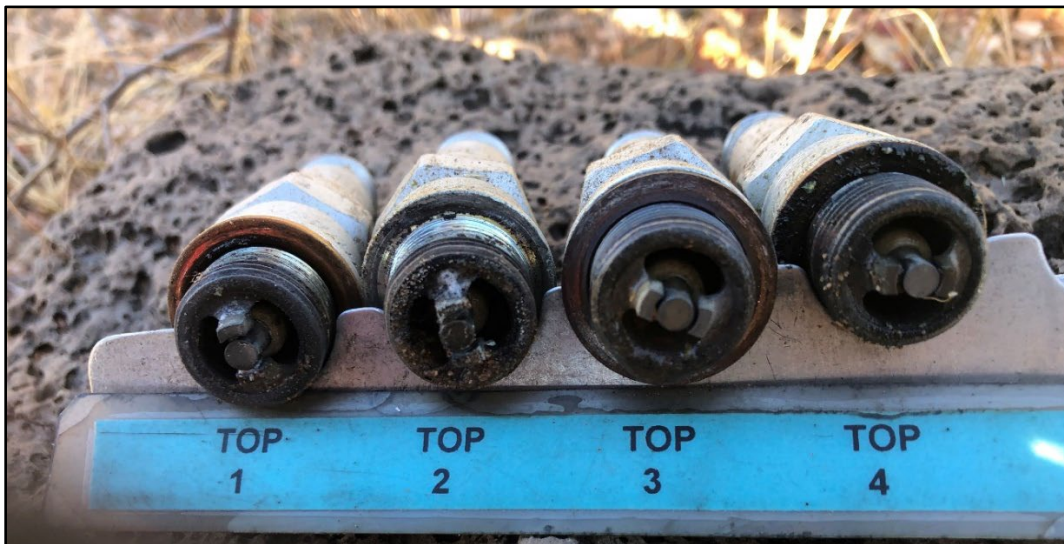
The top spark plugs were removed from the engine, and they were the massive electrode type. The spark plugs from the 1 and 2 cylinders were oil soaked, consistent with engine positioning at the accident location. The spark plugs from the 3 and 4 cylinders, when compared to the Champion Check-A-Plug chart, the sparkplugs were light grey in color, exhibited “NORMAL.”

Figure 11: View of top spark plugs (photo courtesy of Lycoming Engines)

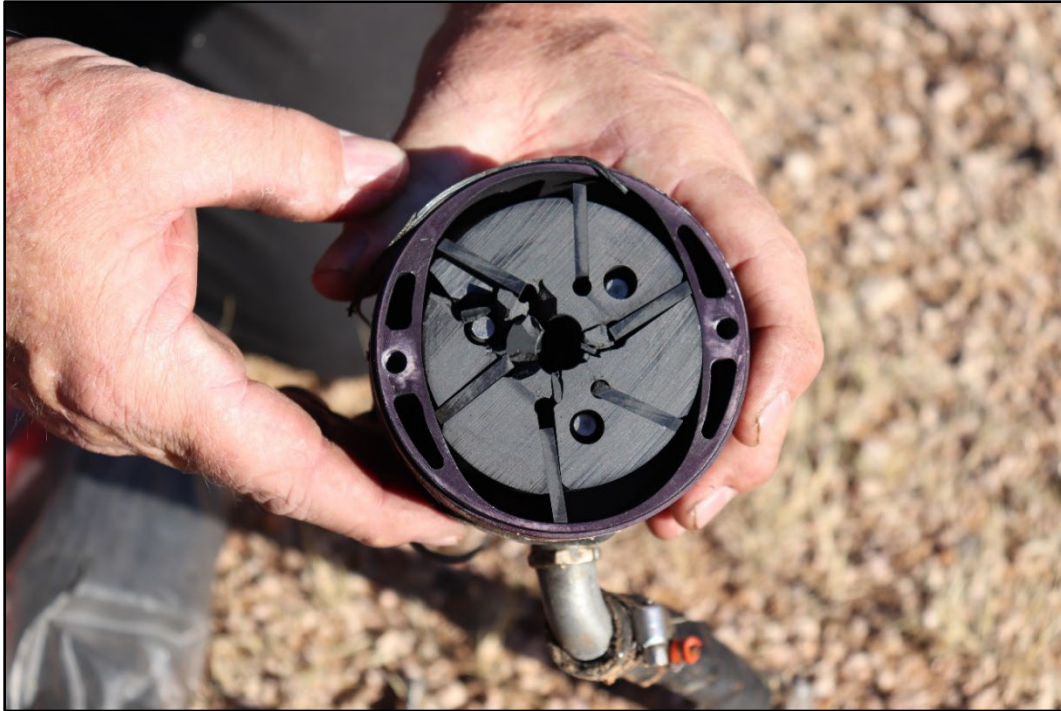
The vacuum pump was separated and located in the debris field near the main wreckage. The vacuum pump exhibited impact damage. The vacuum pump was disassembled. The rotor and veins were fragmented. The vacuum pump drive was impact damaged.

Figure 12: View of vacuum pump.

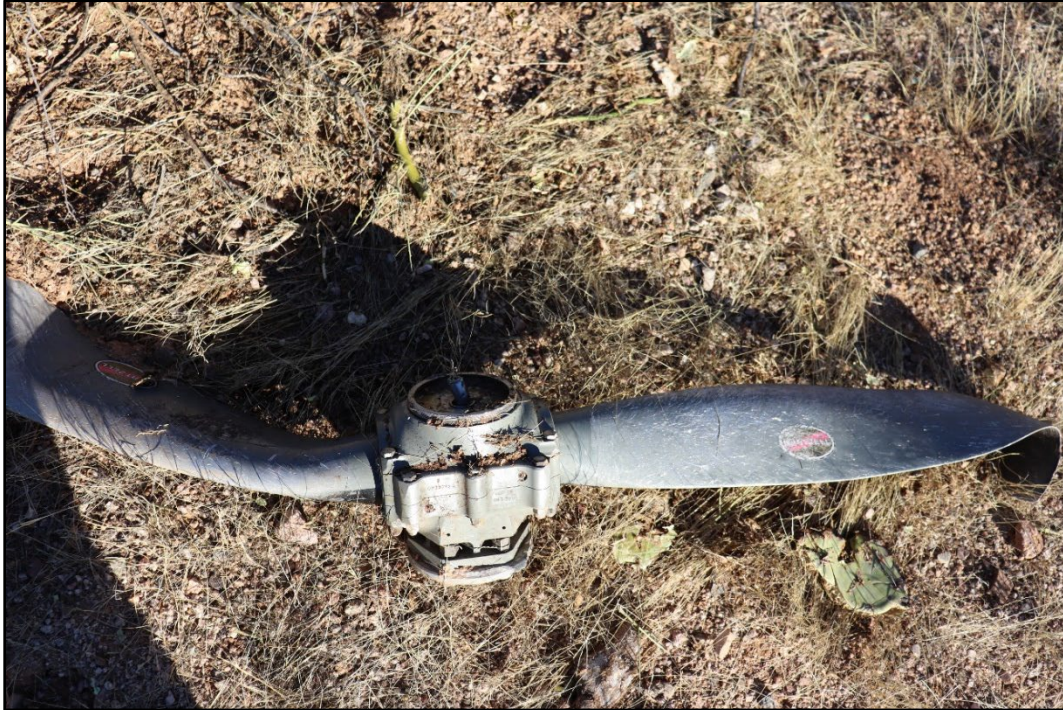
The airplane was equipped with a two blade Hartzell propeller. The propeller and attached crankshaft flange separated from the engine at the crankshaft. Both blades remained attached to the propeller hub. Propeller blade A exhibited 90° bend near the propeller tip, with polishing along the leading edge, with unidirectional striations on the cambered side of the blade. Propeller blade B exhibited bending forward about mid span, with unidirectional striations on the cambered side of the blade.

Figure 13: View of airplane propeller.
