# National Transportation Safety Board

WPR22FA098

## **AIRFRAME AND ENGINE EXAMINATION REPORT**

Location: Coalinga, California  
Date: February 16, 2022  
Time: 2140 Pacific standard time  
Helicopter: UH-1H / N72297

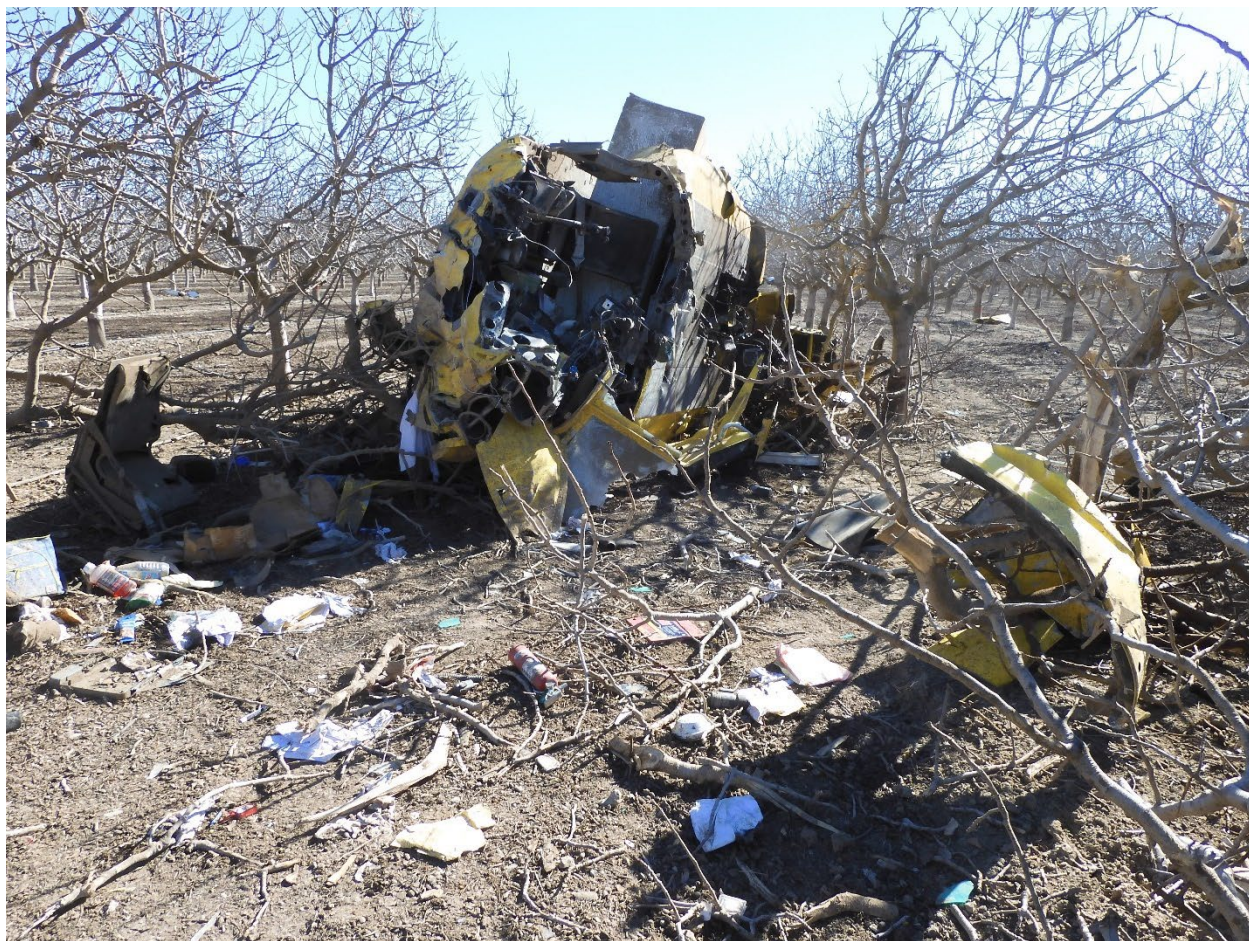
The helicopter came to rest on its left side, in an orchard, as shown in Figure 2. The orchard was at an elevation of about 385 ft mean sea level, and consisted of trees, spaced about 15 ft apart, at a height of about 12 ft. An area of disturbed ground and felled trees extended back from the helicopter about 120 ft, on a bearing of 170° magnetic. The fuselage had rotated about 180° to face the direction of travel.

Figure 1. N72297 at the accident site. Front view.

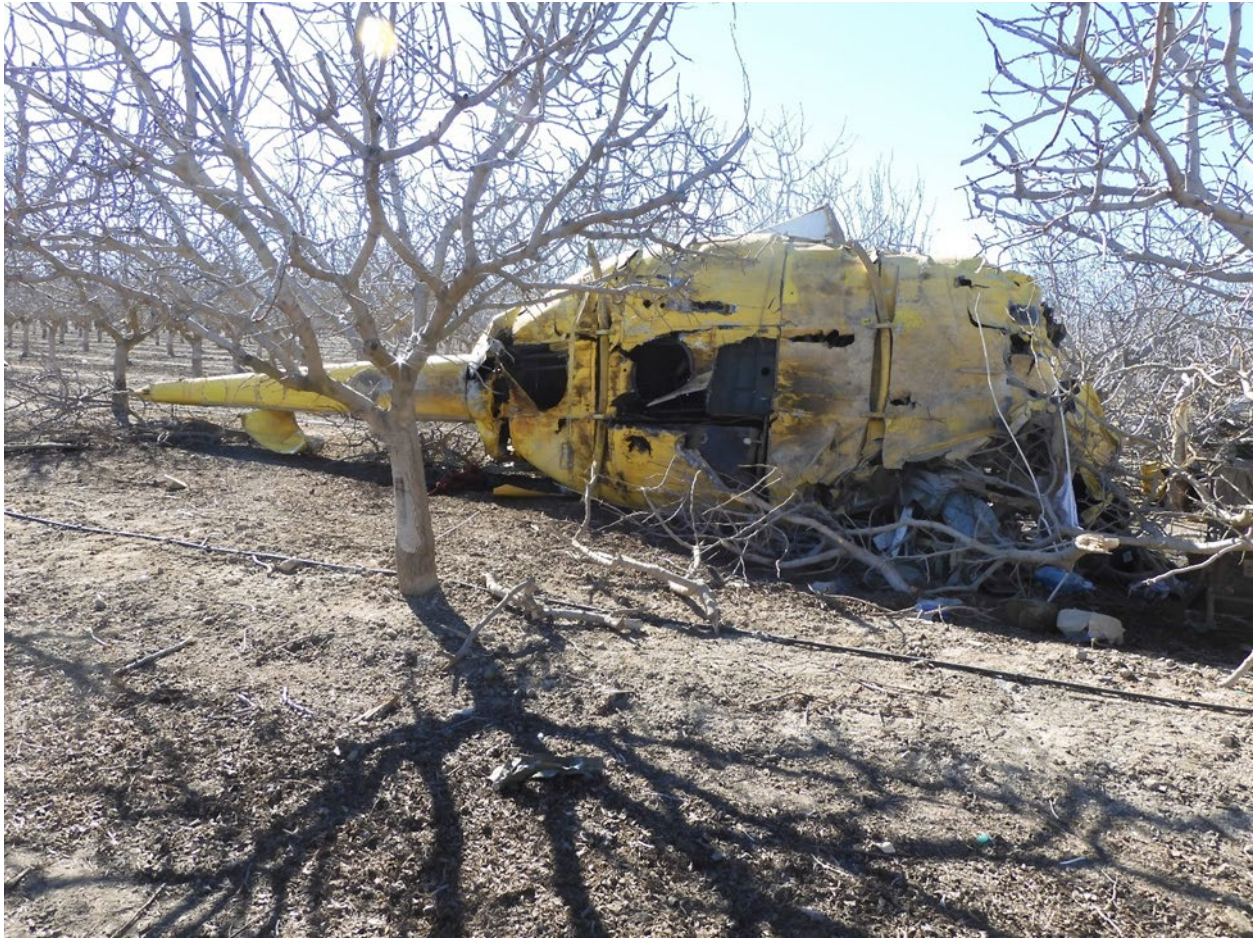
The underside of the helicopter exhibited substantial damage with upward crushing near the nose area. The left, forward section had been crushed inward. The mid-section of the belly sheet metal exhibited upward crushing, tearing and absence of large amounts of sheet metal near the fuel bladders. An area aft of the rear cross tube exhibited a large tear in the sheet metal. The entire underside of the helicopter exhibited the appearance of contacting and scraping the terrain. The junction of the underside of the fuselage and the tailboom exhibited a gray appearance along with some upward crushing of the sheet metal.

Figure 2. Underside view.

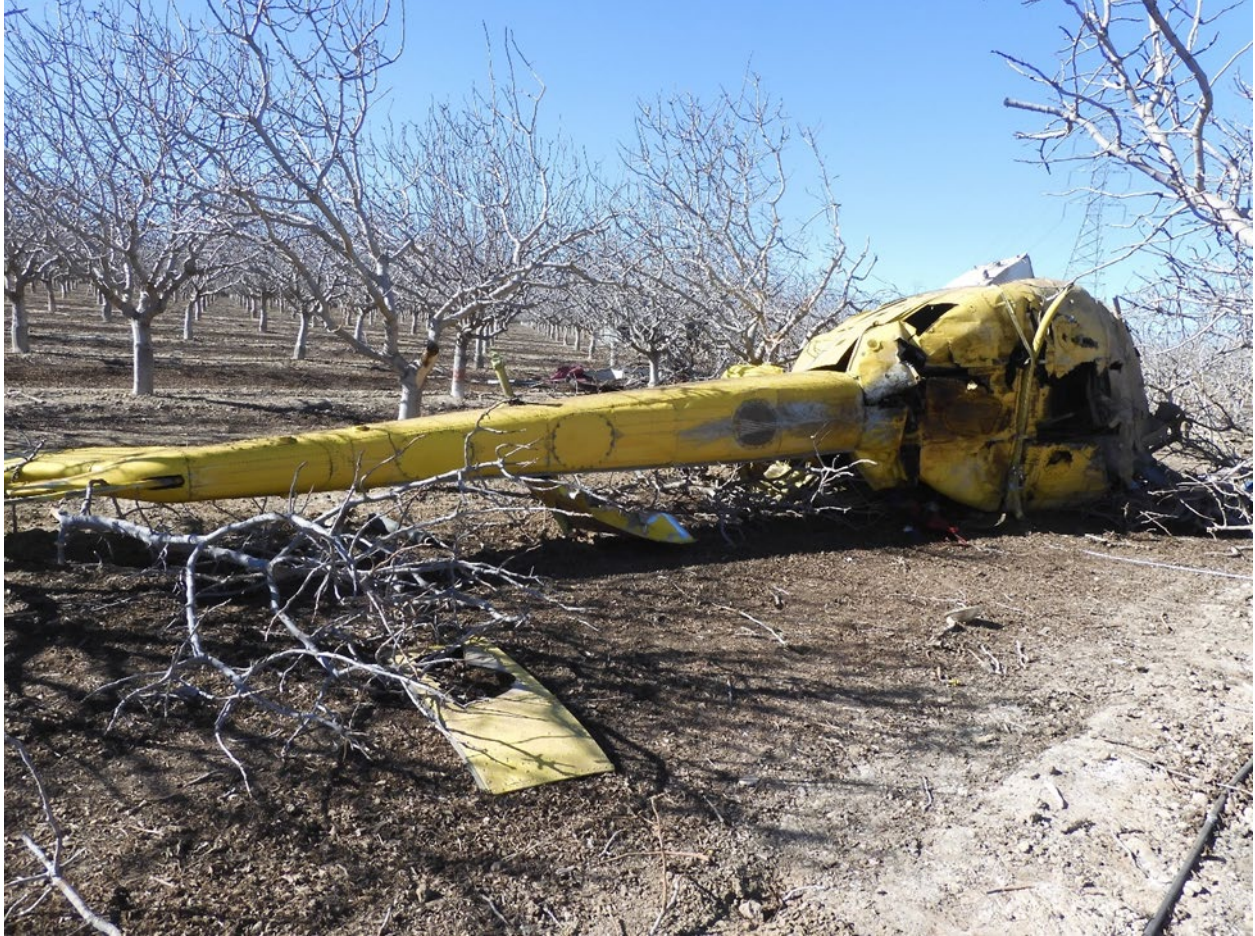
Figure 3. Rear underside view.

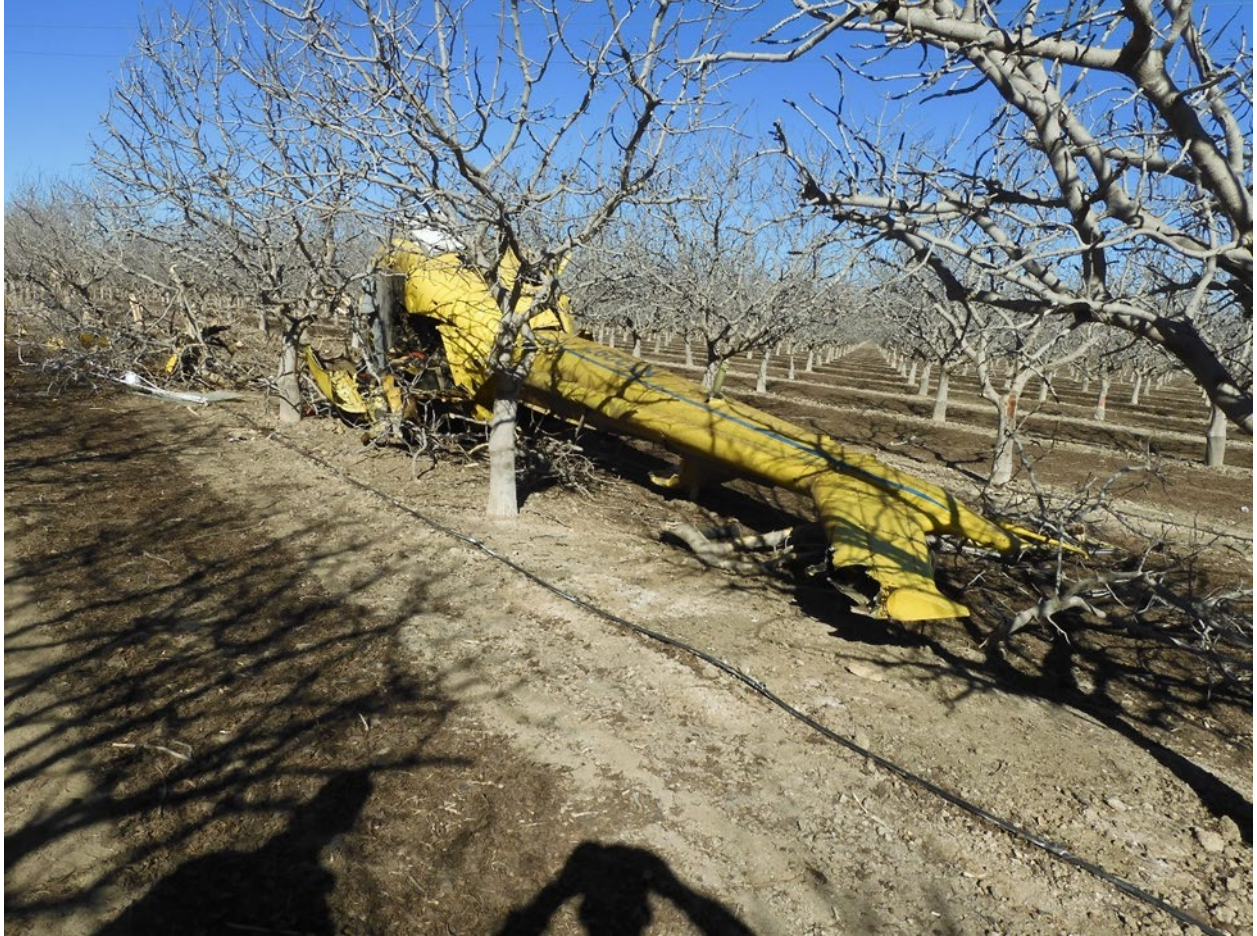
Figure 4. Rear topside view.

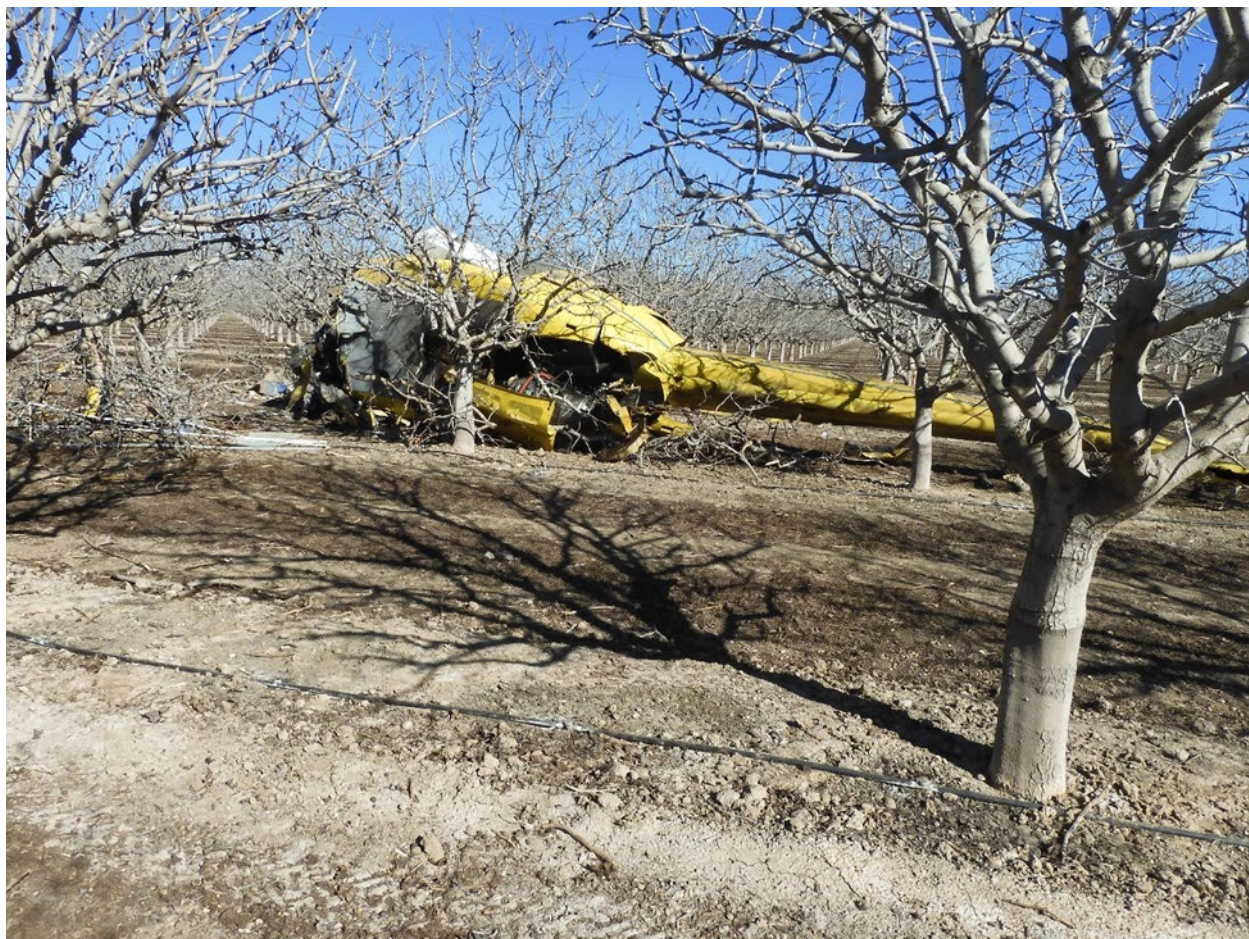
The top of the helicopter exhibited substantial damage with downward crushing in the forward section above the pilot's stations. The area forward of the greenhouse windscreens was absent. The doghouse engine cowlings were absent. The transmission separated from the fuselage above mounts, leaving the transmission mounts attached to the fuselage. The transmission was located near the wreckage. The base flange of the transmission had areas where the flange was missing. The input quill retained parts of the driveshaft remaining attached. When tested at the examination facility, the transmission rotated smoothly with no noise or metal to metal sounds. The overrunning clutch operated normally.

Figure 5. Topside view.

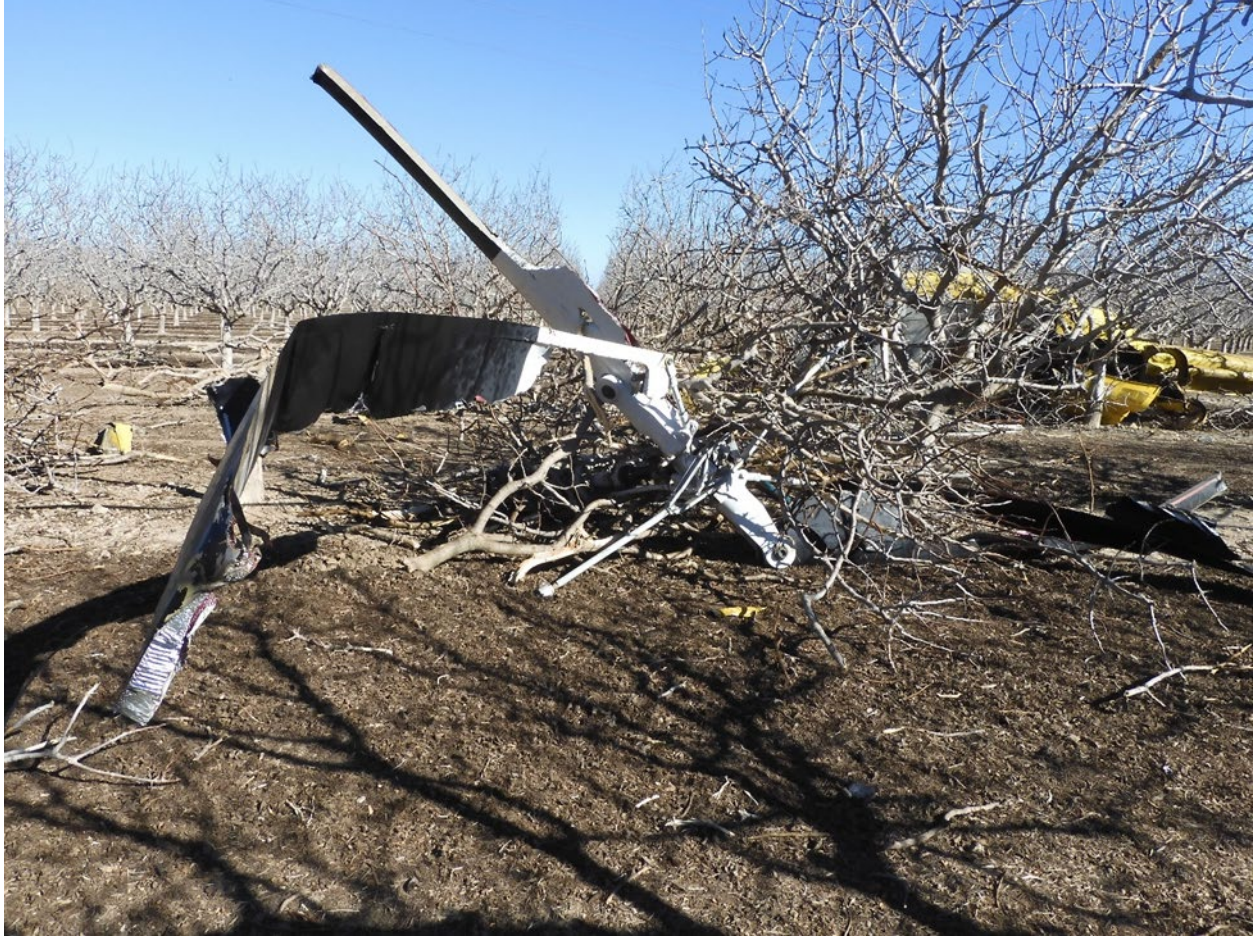
The main rotor assembly remained attached to the transmission. The swashplate support, and swashplate exhibited minor damage.

Figure 6. Main rotor system.

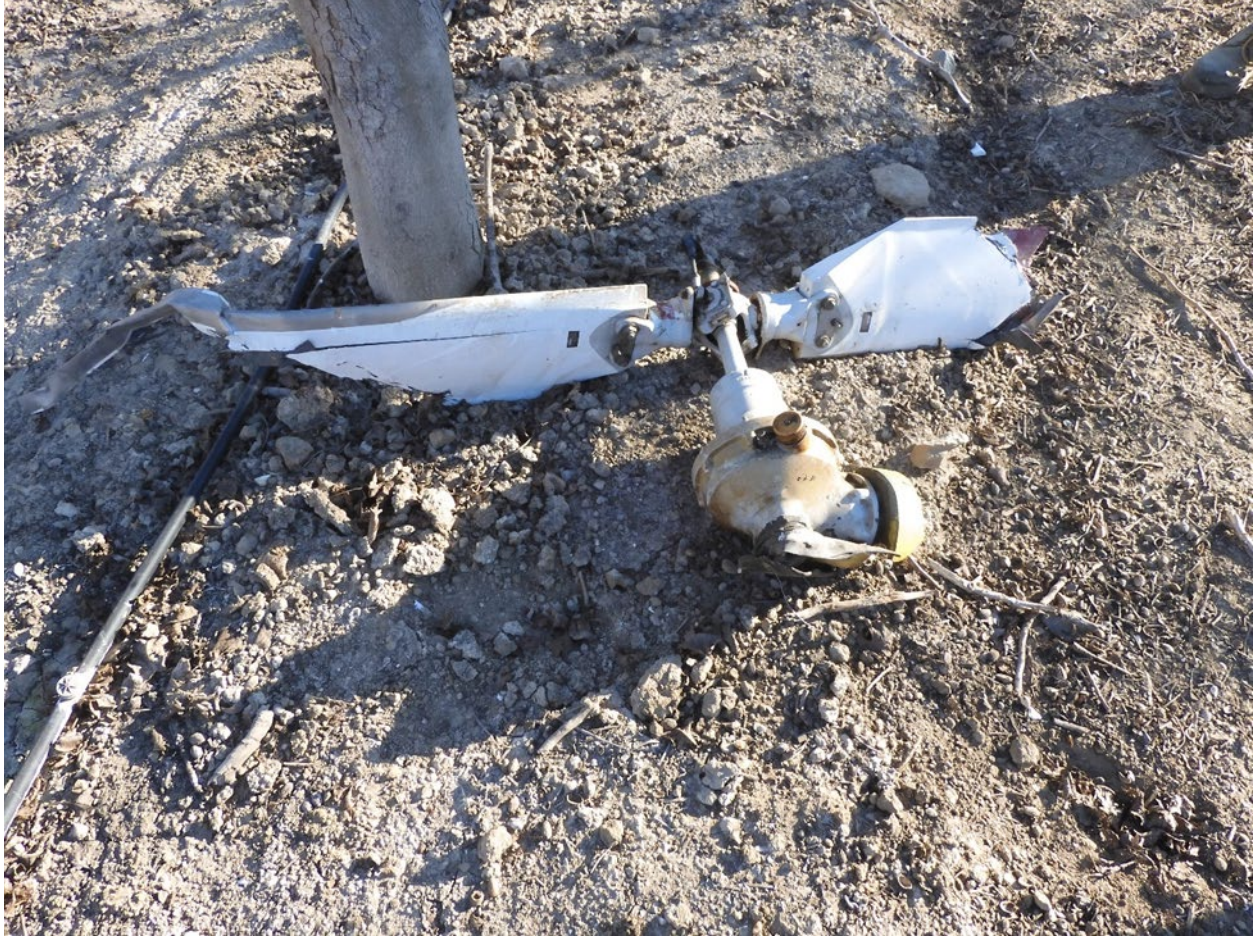
The tail rotor assembly separated from the top of the vertical stabilizer. Both blades exhibited heavy damage with fracturing of the composited blade material. Both blade roots remained attached to the hub. One blade retained most of its leading edge. The leading edge exhibited heavy chordwise bending. The other blade lost all material about 10 inches from the blade root. Most of the composite blade fragments were accounted for. The hub remained attached to the drive shaft, which remained attached to the 90° gearbox. Both pitch change links remained attached at both ends.

Figure 7. Tail rotor system.

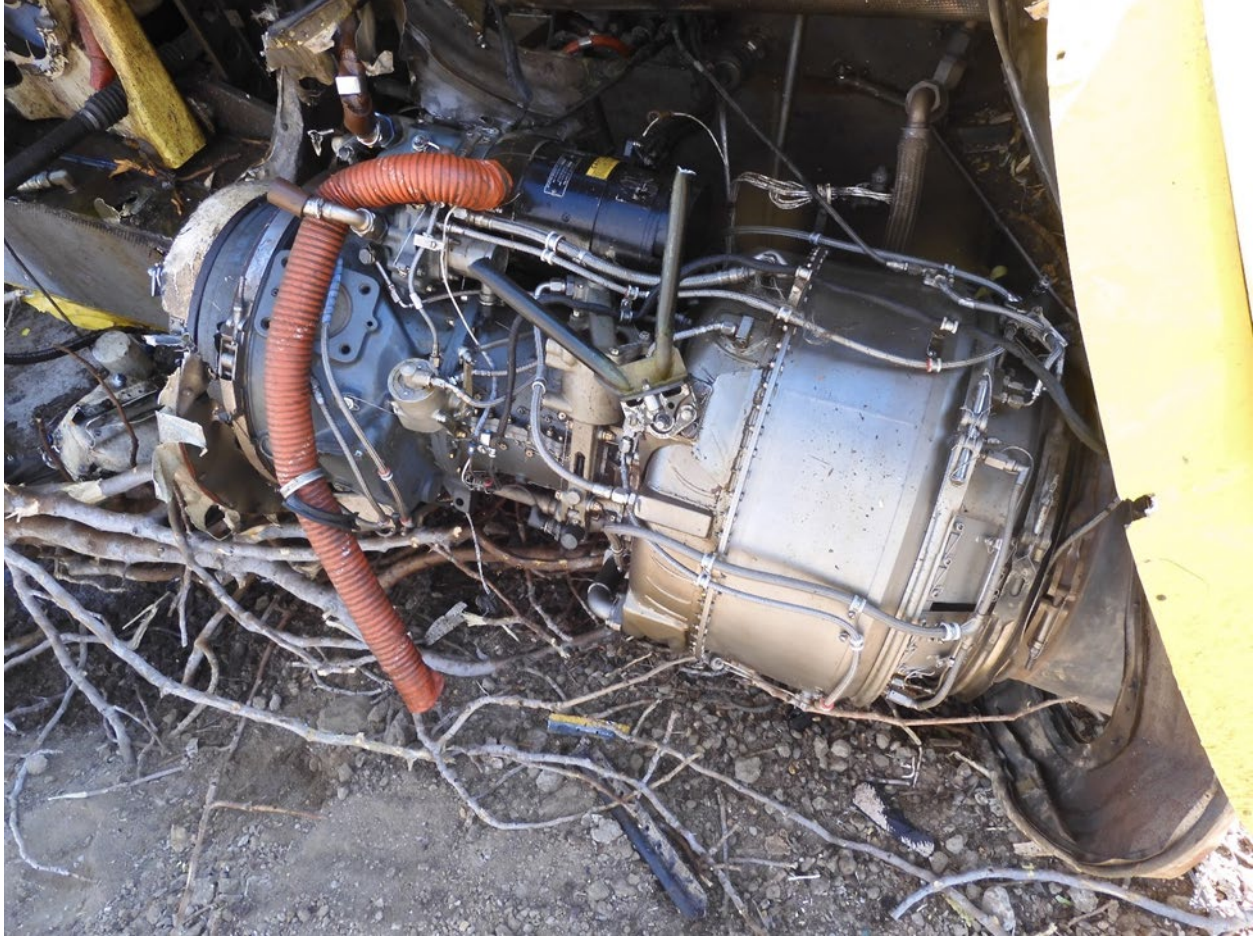
Figure 8. T-53-L13

The engine remained partially attached to the fuselage at the mounts. The 4<sup>th</sup> stage turbine did not exhibit damage but would not turn unless heavy force was used. The 1<sup>st</sup> stage compressor blades exhibited damage to the leading edge. A thin piece of titanium fire wall had wrapped around the output shaft. The engine was shipped to the manufacturer's laboratory when it underwent additional examination under oversight of the NTSB. According to the NTSB investigator in attendance, "We found tree debris and airframe wire braid between the compressor inlet guide vanes consistent with ingestion at impact. When we half cased the axial compressor, all rotor blade stages exhibited hard body impact damage and trailing edge tip bending opposite the direction of rotation, both of which are strong indications of power. We also reviewed the photos of the firewall wrapped around the PTO/short shaft and agree that's further evidence of power at impact."

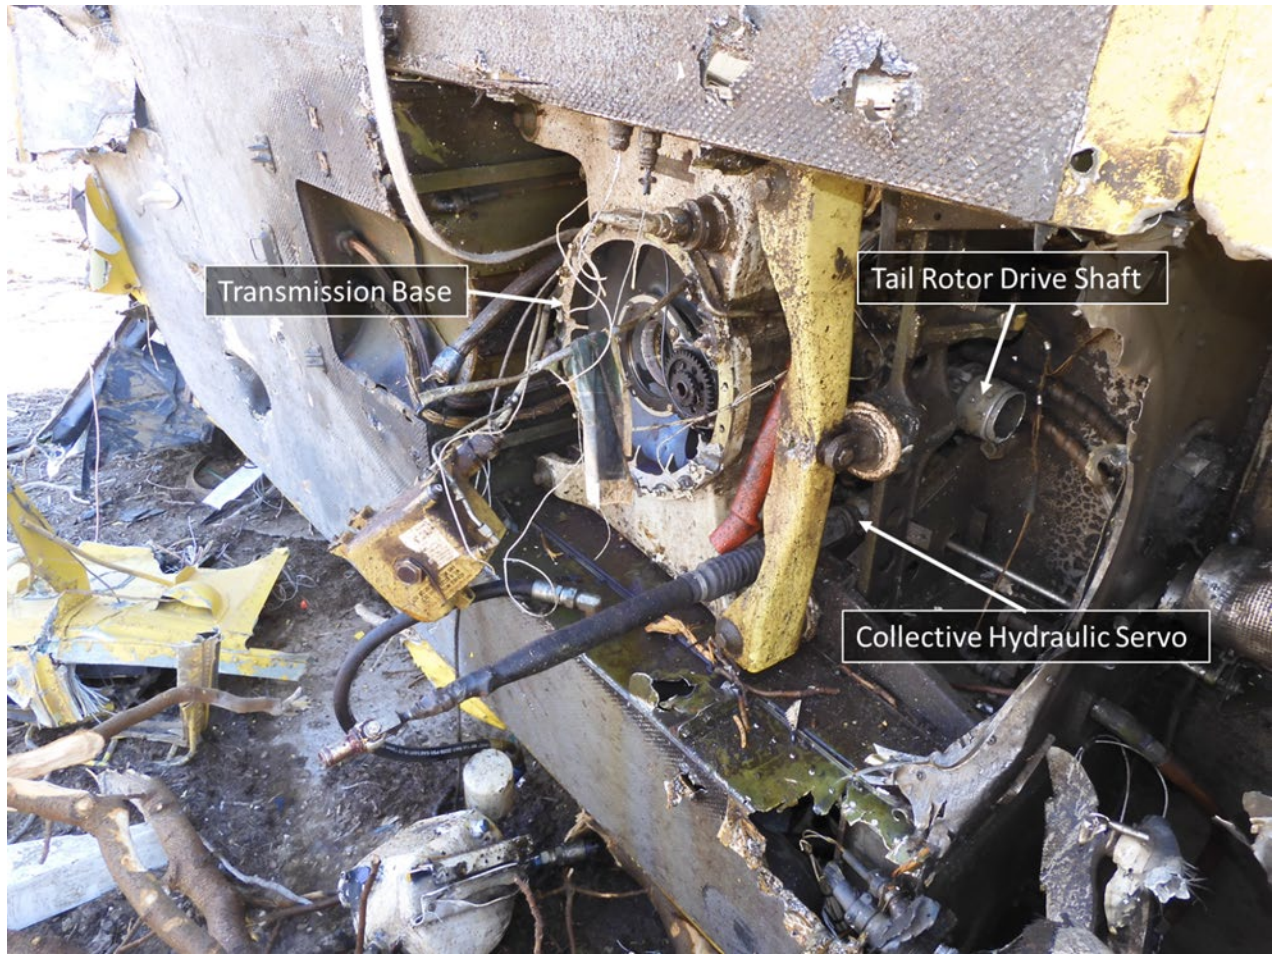
Figure 9. Lower transmission and the mounts.

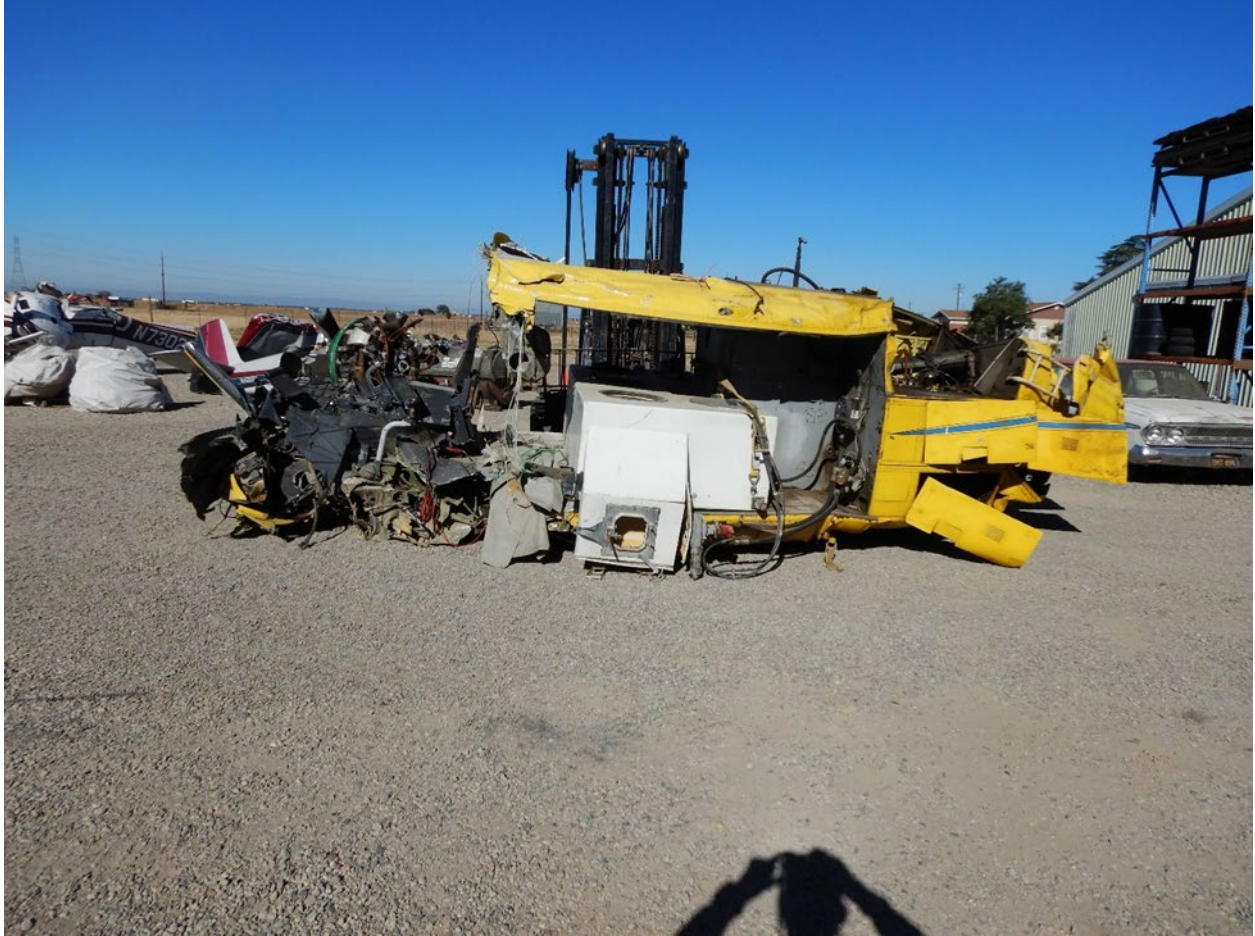
The left side of the fuselage was substantially damaged, beginning at the heavily damaged nose section which was unrecognizable. The pillar aft of the pilot's station and in from of the small jump door had separated at both the top and bottom. The

Figure 11. Left-side view.

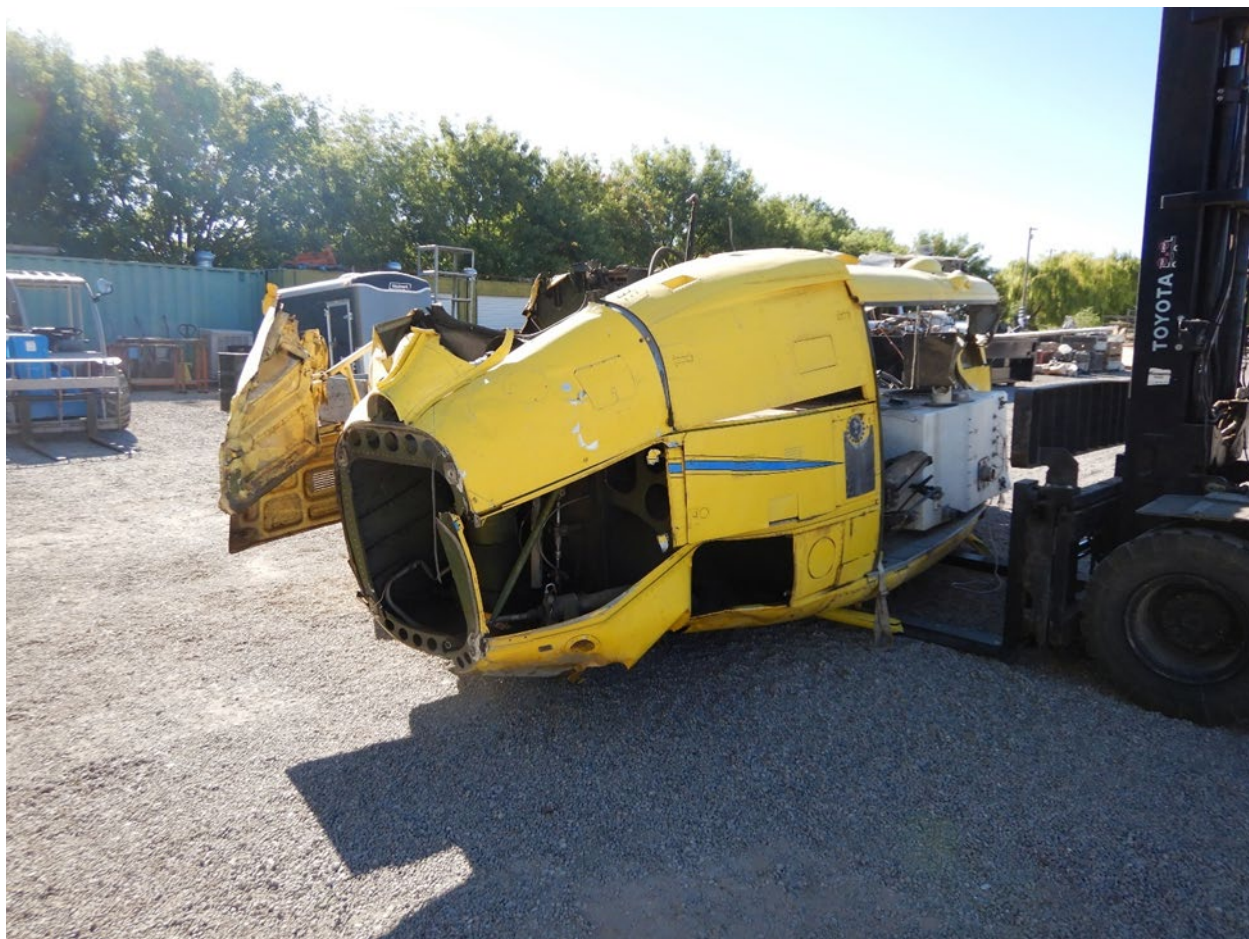
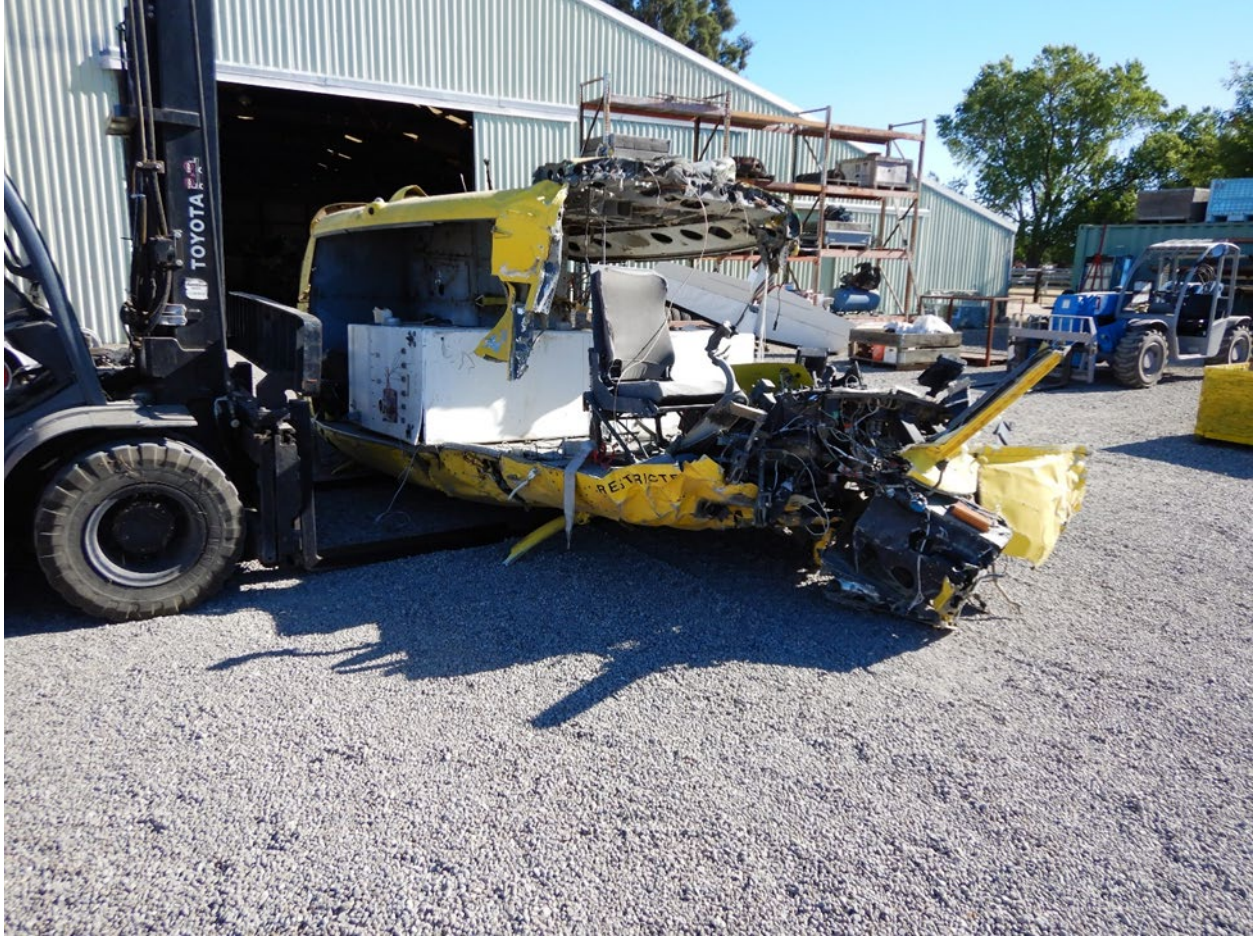
The right side of the helicopter exhibited upward crushing from the pilot's crew station to the forward area of the cabin. The floor remained elevated from the upwards crushing. The right-side door separated from the fuselage. The pillar aft of the pilot's door and forward of the jump door, separated from the floor, fractured in two, and remained attached at the ceiling. The jump door separated from the fuselage. The right-side sliding cargo door had been removed prior to the accident flight. A large dent was present just above the forward cross tube. The upper and lower fuselage sections above and below the sliding cabin doors, kept their integrity and exhibited little deformation.

Figure 13. Right-side view.

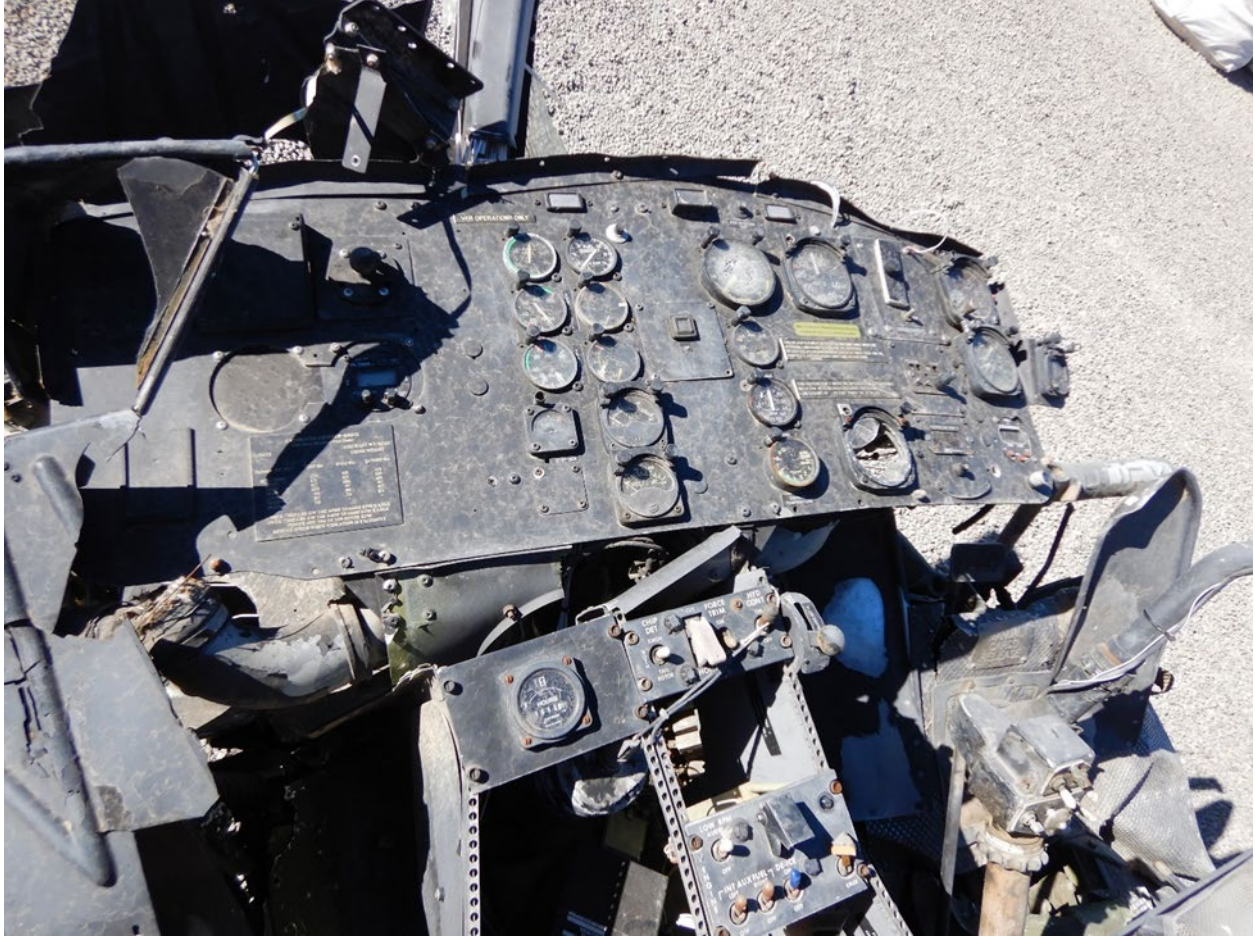
Figure 17. Instrument panel.

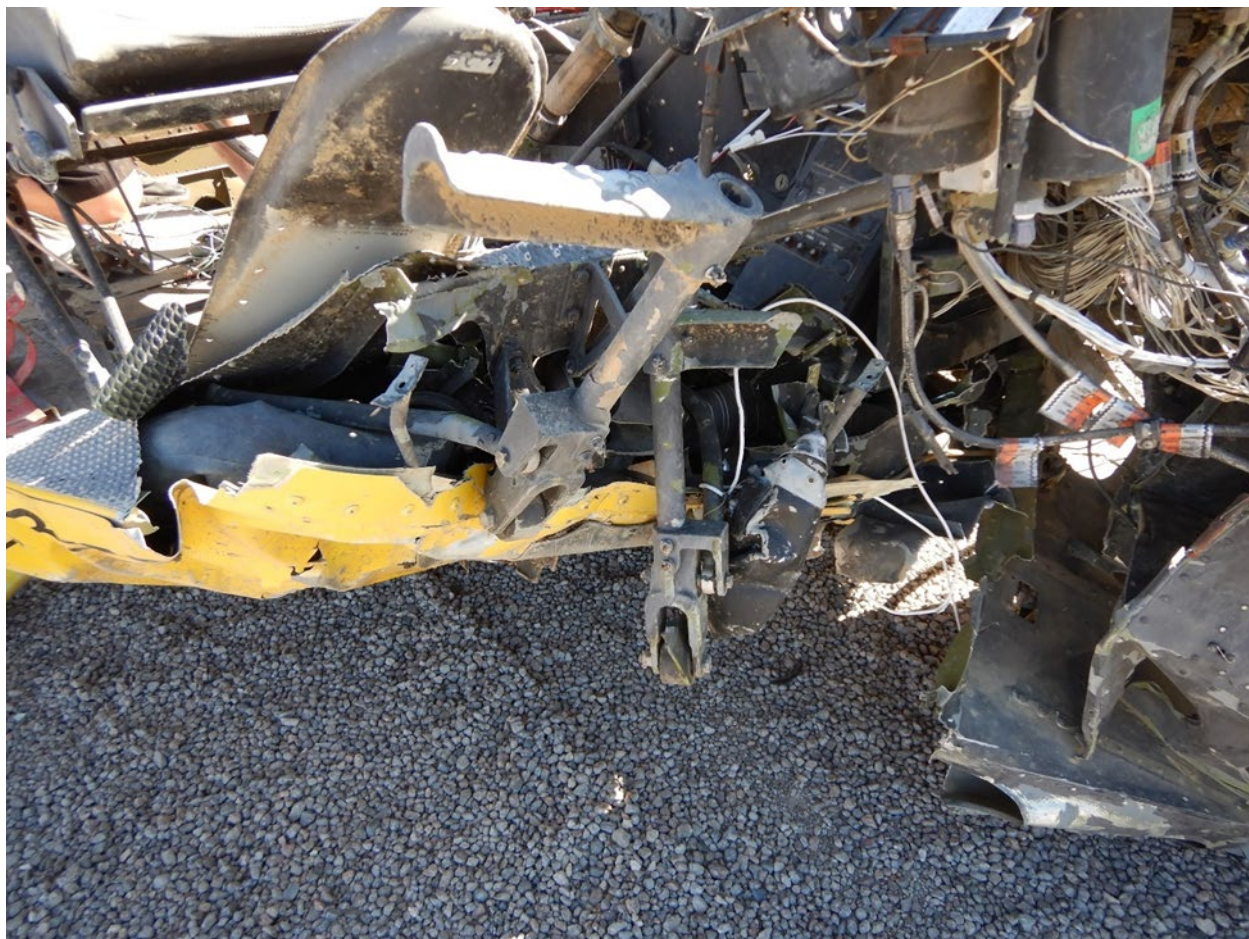
Figure 18. Right-side anti-torque pedals.

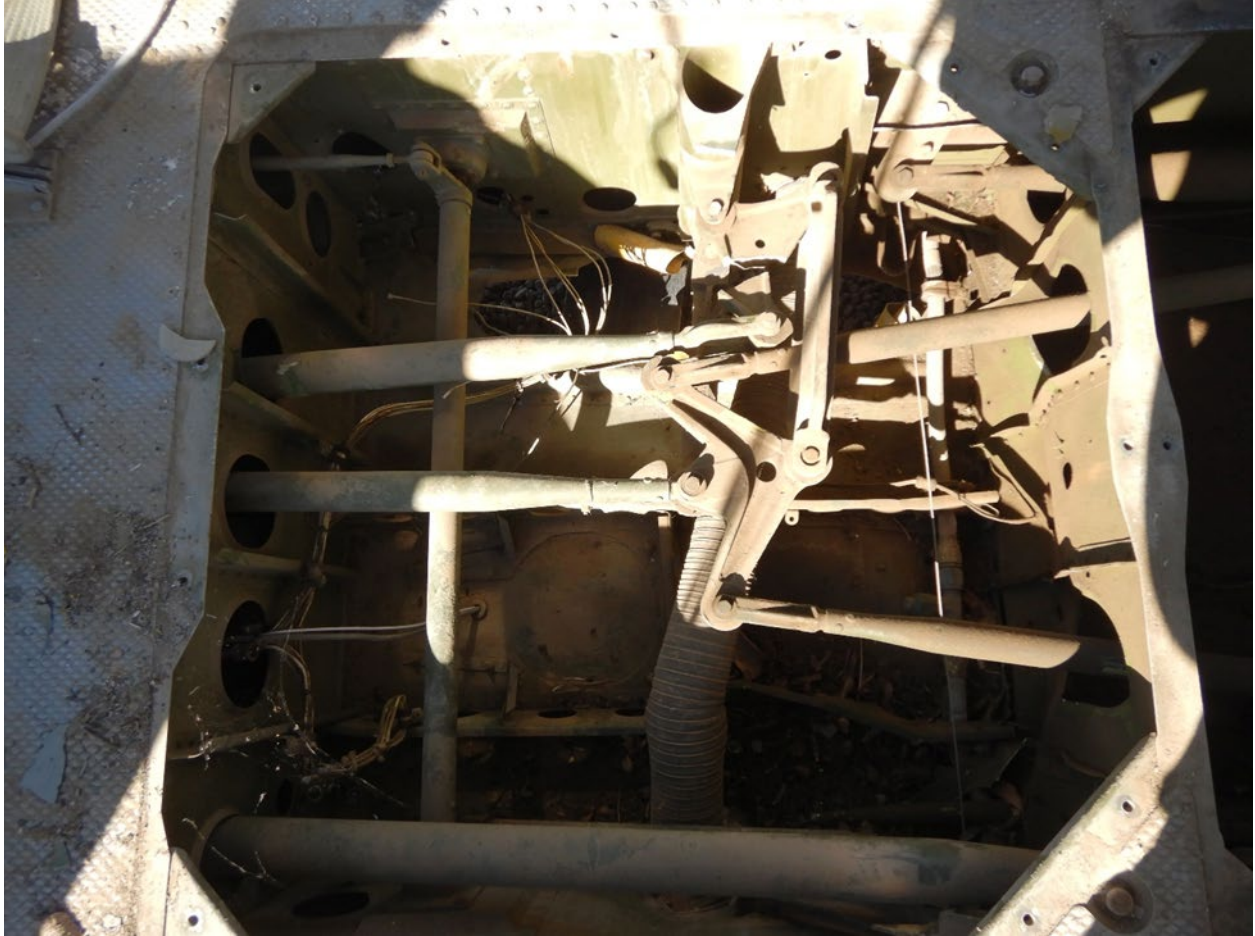
Flight control continuity was established for the cyclic and the collective, from both pilot stations to the respective hydraulic servos. The cyclic control system exhibited fractures in the vicinity of the cyclic mixing unit at the center floor flight control bay. Cyclic continuity was reestablished from the flight control bay to the lateral hydraulic servo (left side) and longitudinal hydraulic servo (right side). Both cyclic hydraulic servo rods remained secured to the non-rotating swashplate but separated from the hydraulic servos.

Figure 21. Center floor, flight control bay.

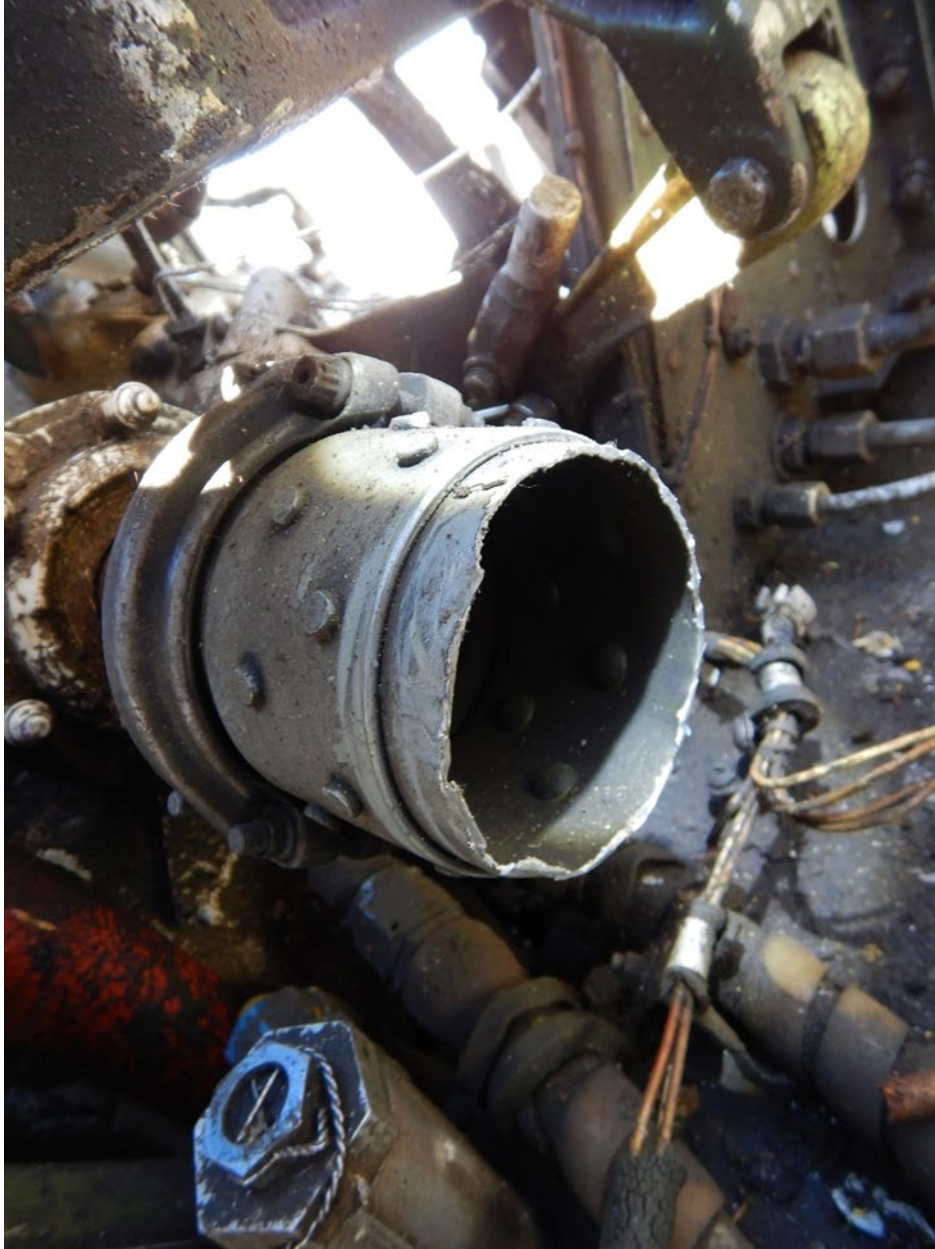
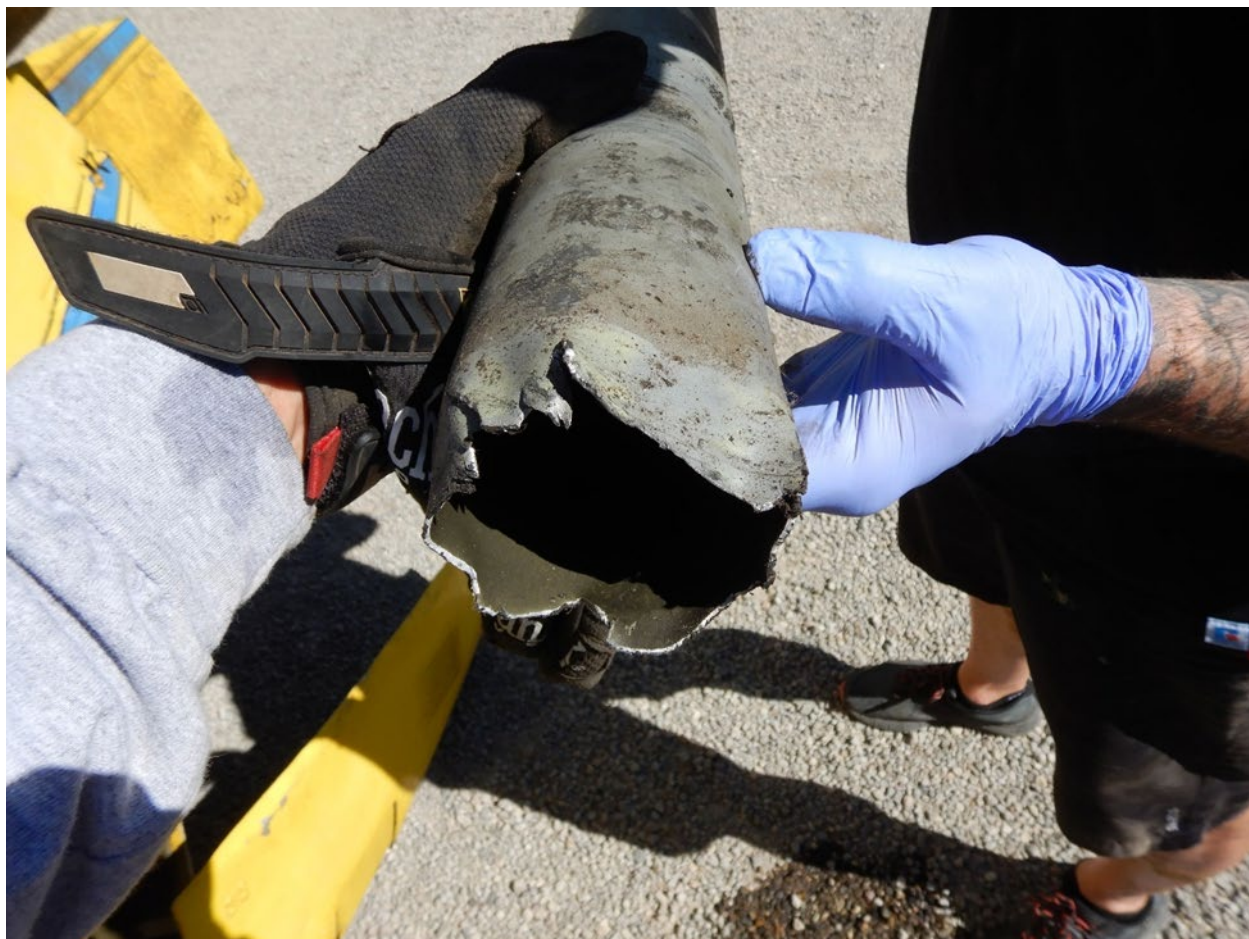
The tail rotor drive shaft disconnected near the transmission output quill. The fracture was uniform around the driveshaft but did not appear to have been cut by a foreign object.

Figure 23. Tail rotor drive shaft, at the transmission output quill.

Figure 24. Tail rotor drive shaft that was connected to the transmission output quill. See photo 23.

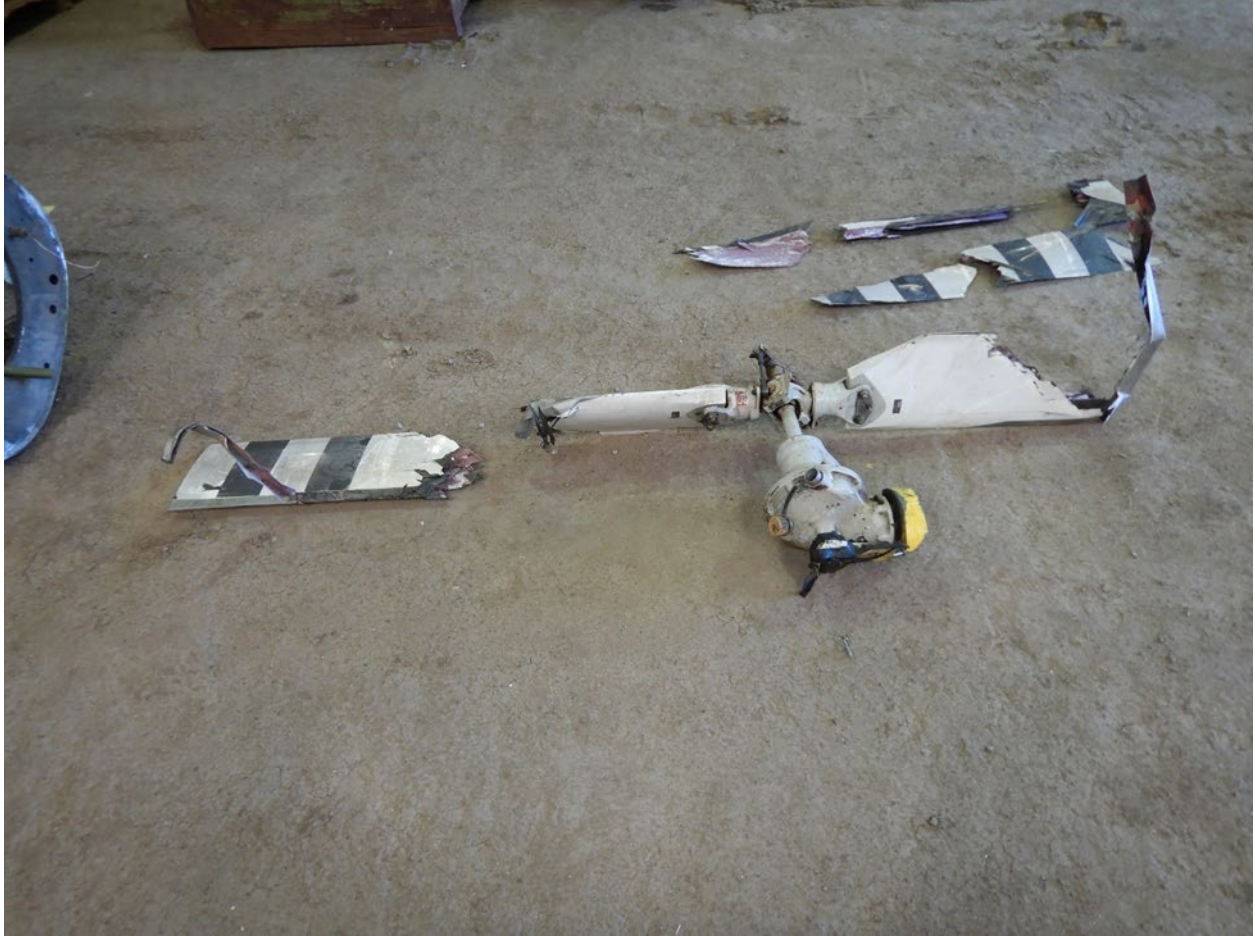
The 90° gearbox remained intact. No oil was observed leaking from it. The oil filler cap was secure at the port. The 42° gearbox remained attached to the tailboom. All driveshaft sections.

Figure 25. Tail rotor and 90° gear box.
