# National Transportation Safety Board

WPR22FA098

## **AIRFRAME AND ENGINE EXAMINATION REPORT**

Location: Coalinga, California  
Date: February 16, 2022  
Time: 2140 Pacific standard time  
Helicopter: UH-1H / N72297

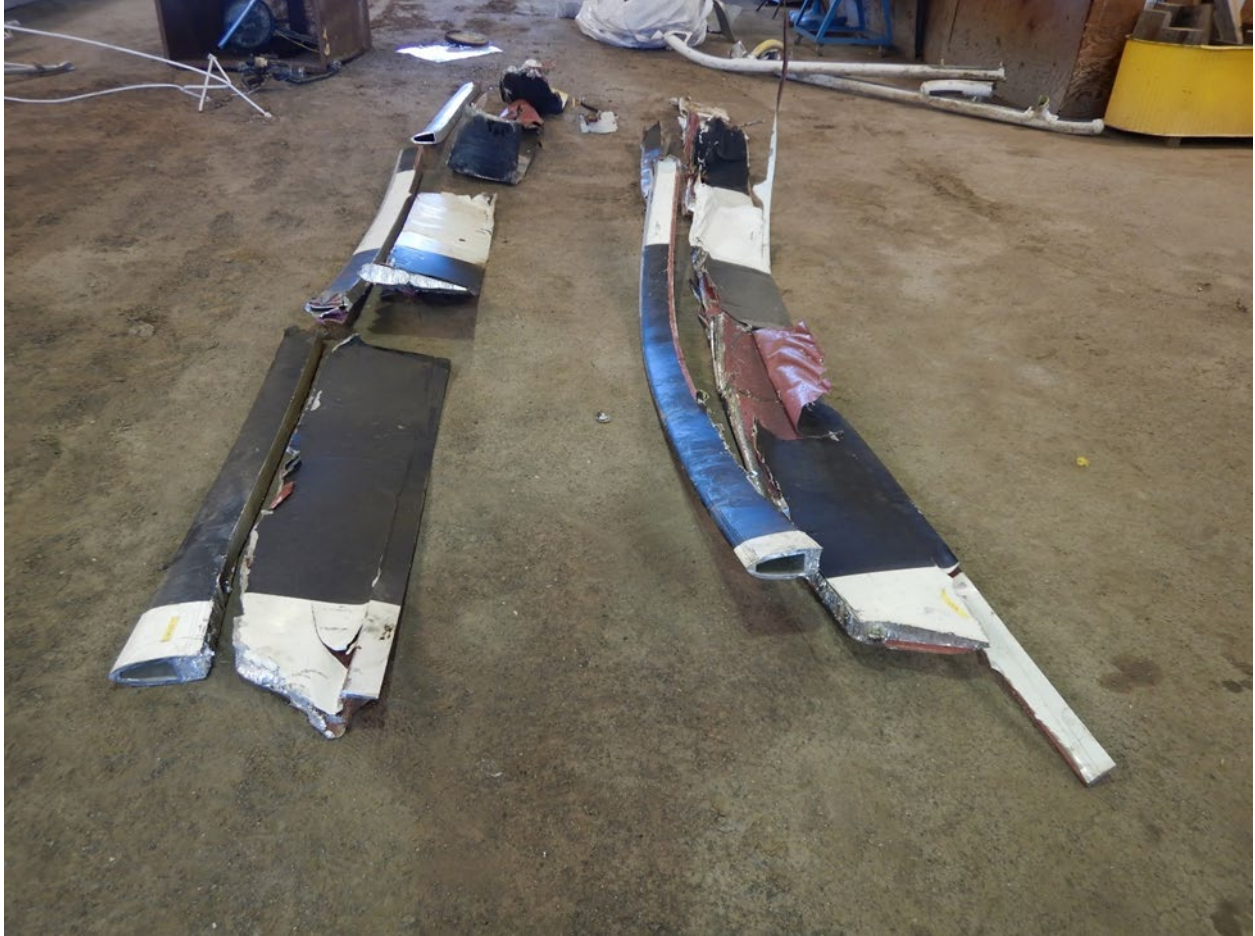
The helicopter was equipped with original equipment manufacturer (OEM) main rotor blades. (Serial numbers: A-143, and A-145). A-143 appeared to have more damage than A-145. About 4 ft of A-143 was not recovered. Both blade spars separated from their respective afterbodies and exhibited significant upward bending, consistent with excessive blade coning. Both blades exhibited chord-wise striations consistent with contact with trees. Both blades remained attached at their respective blade grips and drag braces. The stabilizer bar assembly remained attached to the mast and exhibited minor damage. All control tubes and pitch change links remained attached to their attachment points on the stabilizer bar or mixer. One stabilizer bar control tube remained secured to the separated scissor. The scissor exhibited a fracture of the bearing race. The associated swashplate drive link had separated from the swashplate but remained attached to the scissor. The trunnion bearing that secures the separated drive link remained attached to the drive link at the clevis. The associated swashplate race for the separated trunnion exhibited a fracture at the trunnion bearing hole. The opposite side main rotor control

Figure 29. Main rotor blades.

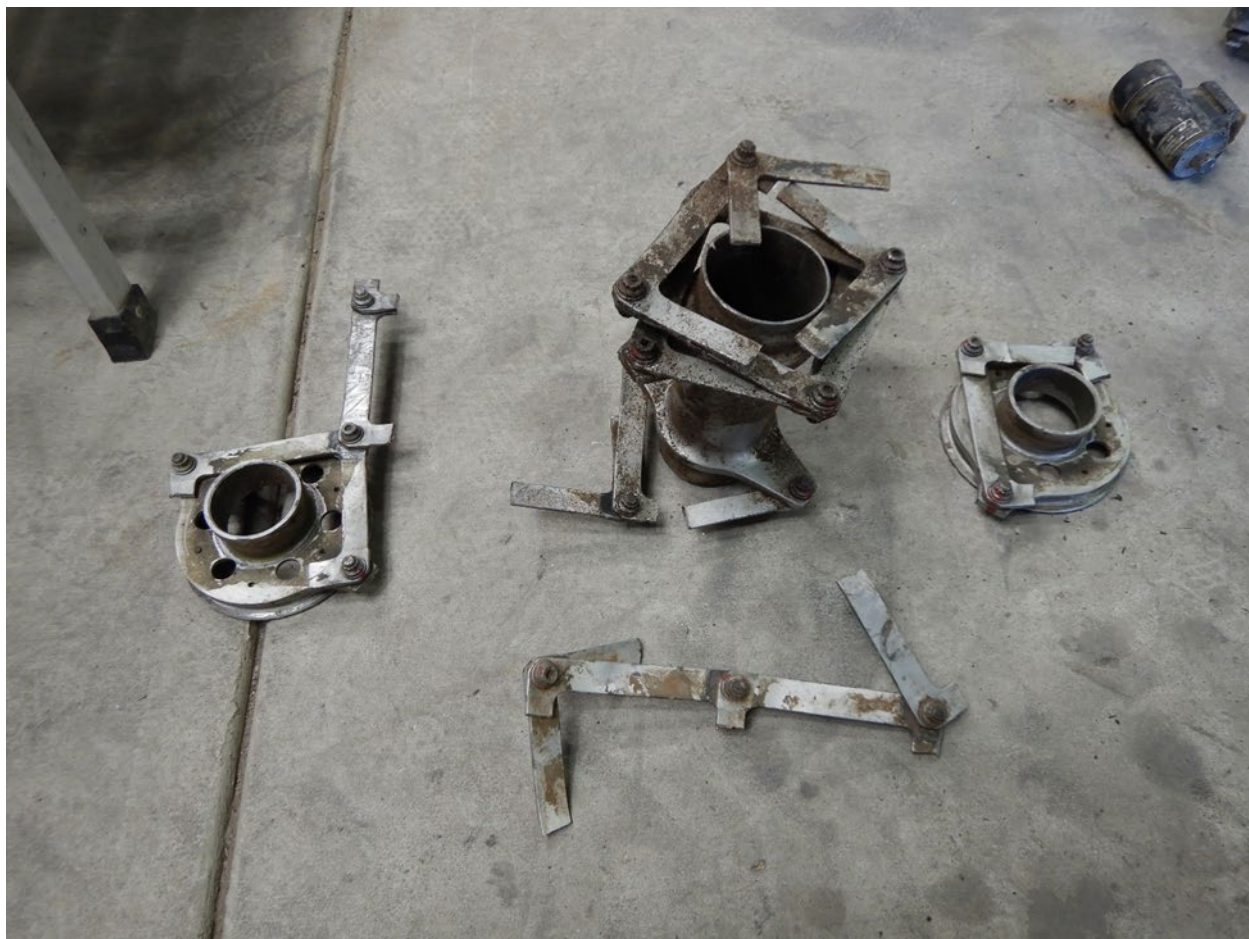
The engine to transmission driveshaft (K-Flex) separated from the helicopter. All pieces were accounted for. All breaks in the flexors appeared to have a rough grainy texture along with battering on some.

Figure 30. K-flex drive shaft.

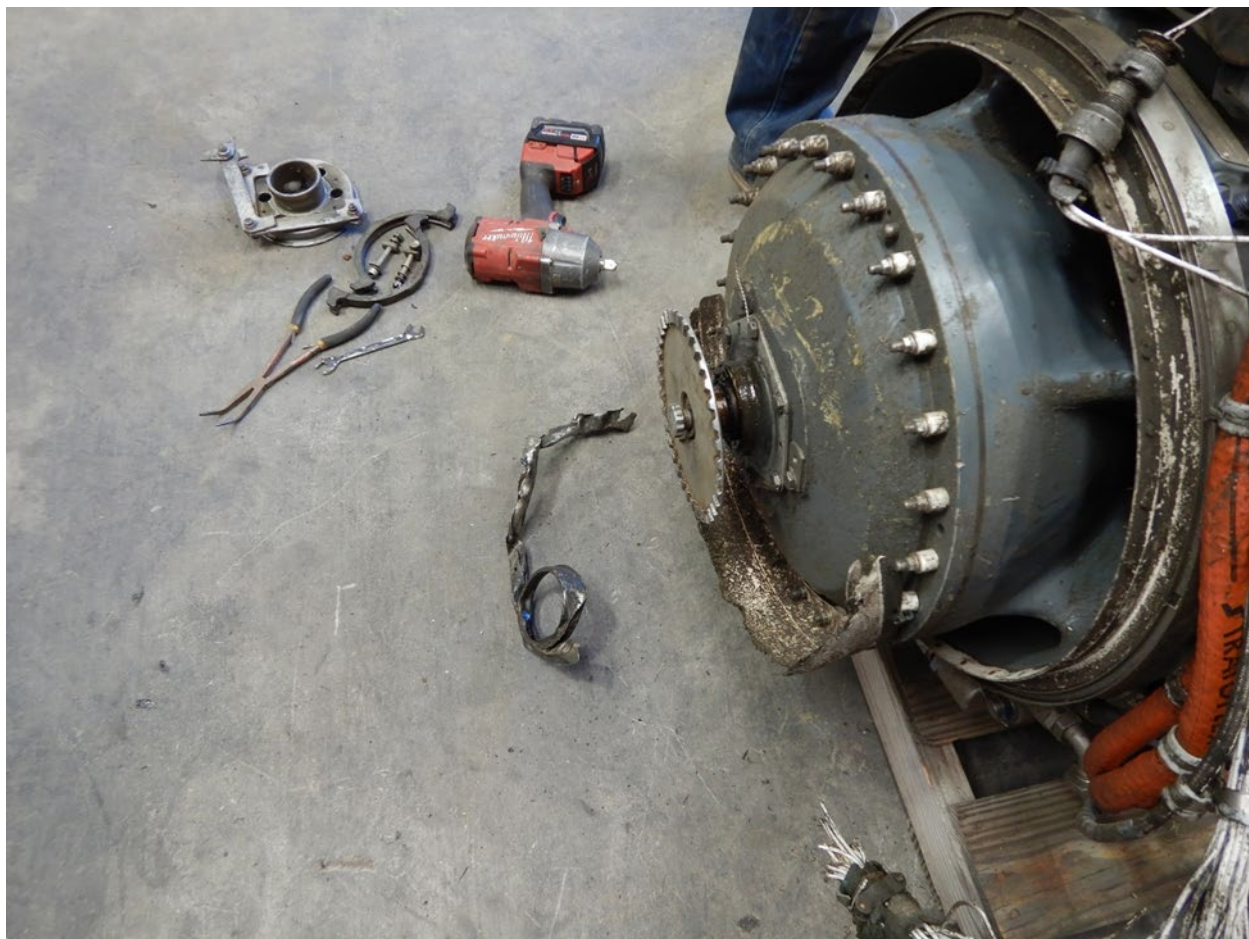
The engine remained partially attached to the fuselage at the mounts. The 4<sup>th</sup> stage turbine did not exhibit damage but would not turn unless heavy force was used. The 1<sup>st</sup> stage compressor blades exhibited damage to the leading edge. A thin piece of titanium fire wall had wrapped around the output shaft. The engine was shipped to the manufacturer's laboratory when it underwent additional examination under oversight of the NTSB. According to the NTSB investigator in attendance, "We found tree debris and airframe wire braid between the compressor inlet guide vanes consistent with ingestion at impact. When we half cased the axial compressor, all rotor blade stages exhibited hard body impact damage and trailing edge tip bending opposite the direction of rotation, both of which are strong indications of power. We also reviewed the photos of the firewall wrapped around the PTO/short shaft and agree that's further evidence of power at impact."

Figure 31. Front of engine with a piece of fire wall removed from around the output shaft.

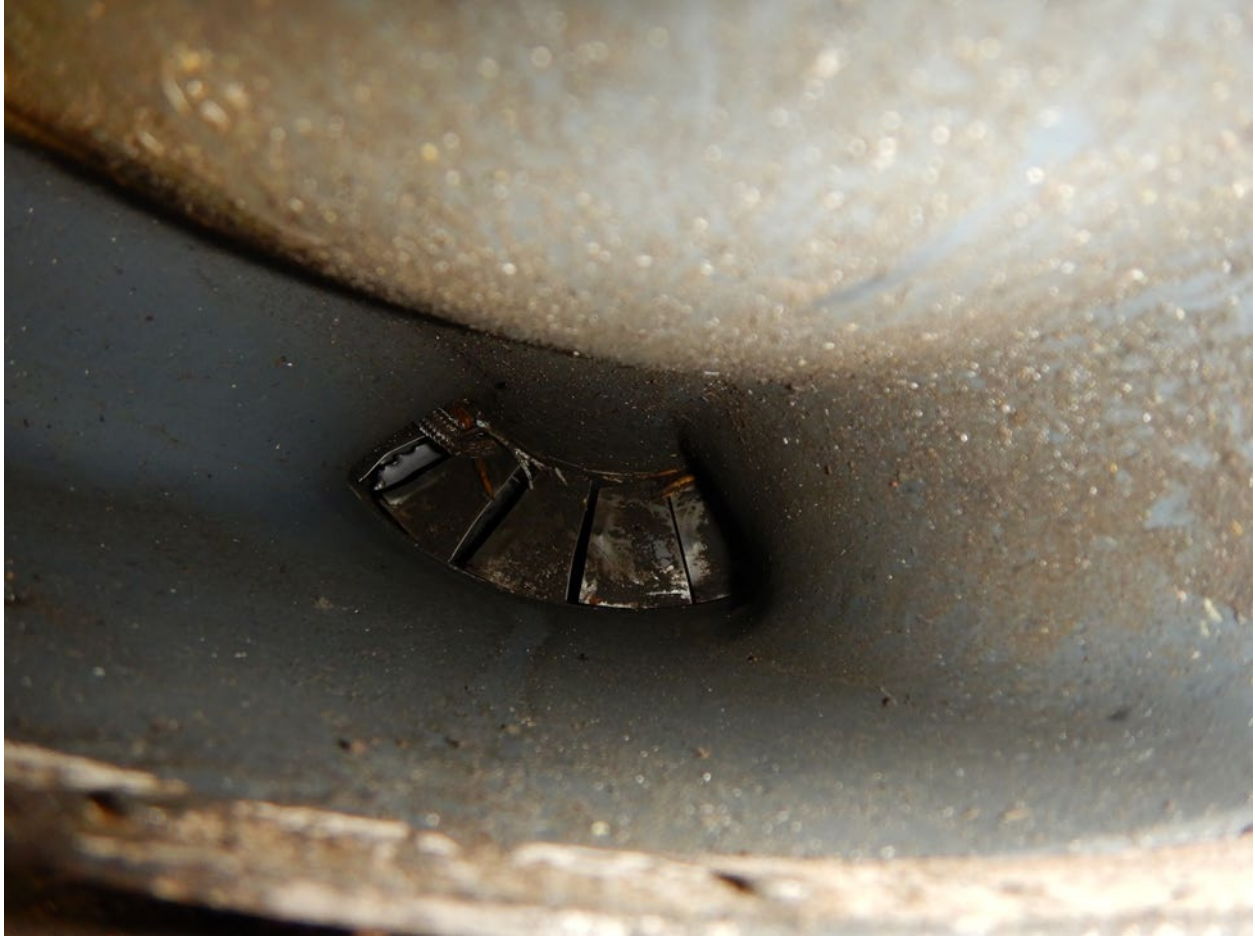
Figure 33. Engine inlet showing damage to a 1st stage compressor blade and the variable inlet guide vanes.

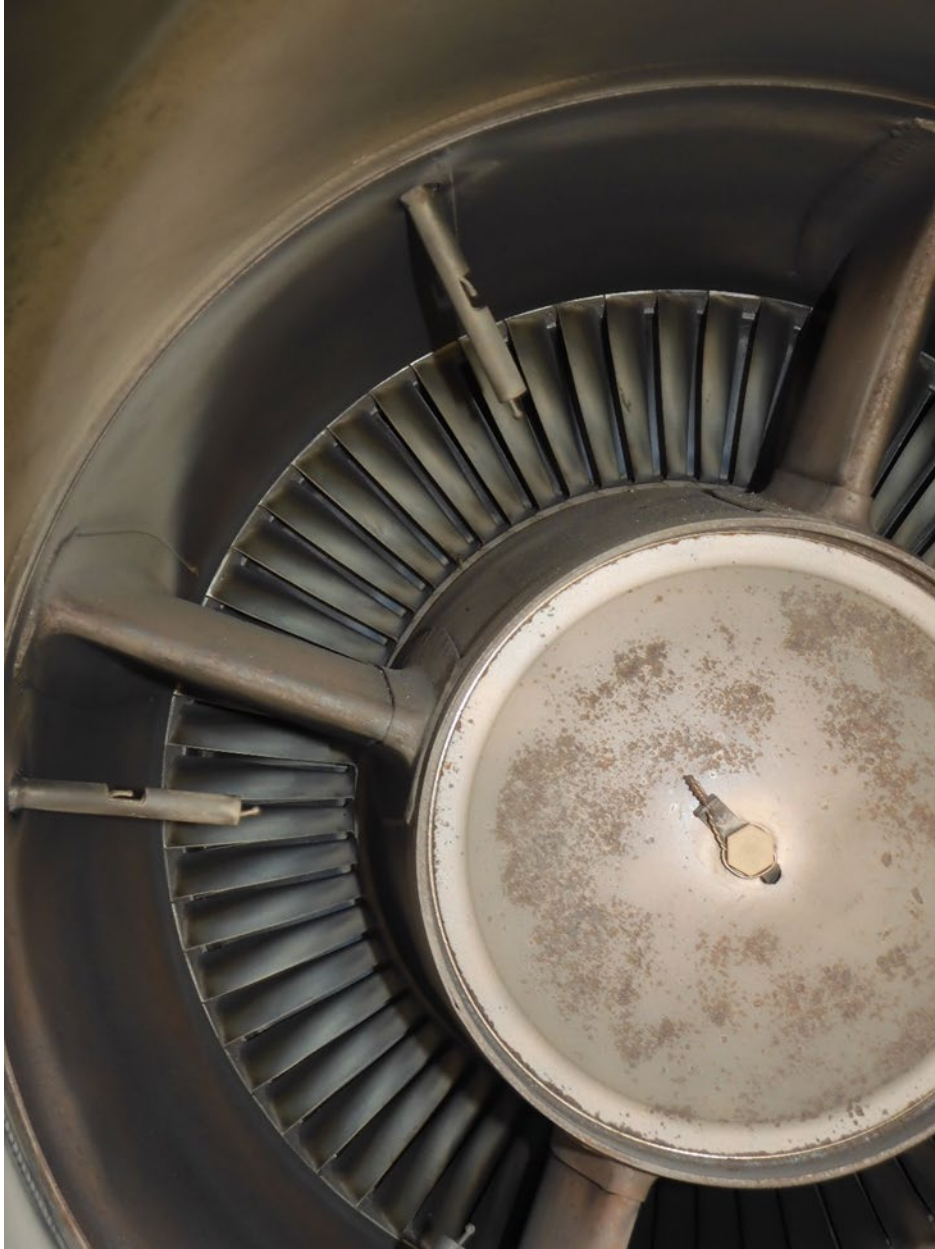
Figure 34. Rear view of engine, showing no damage to the 4th stage turbine wheel.

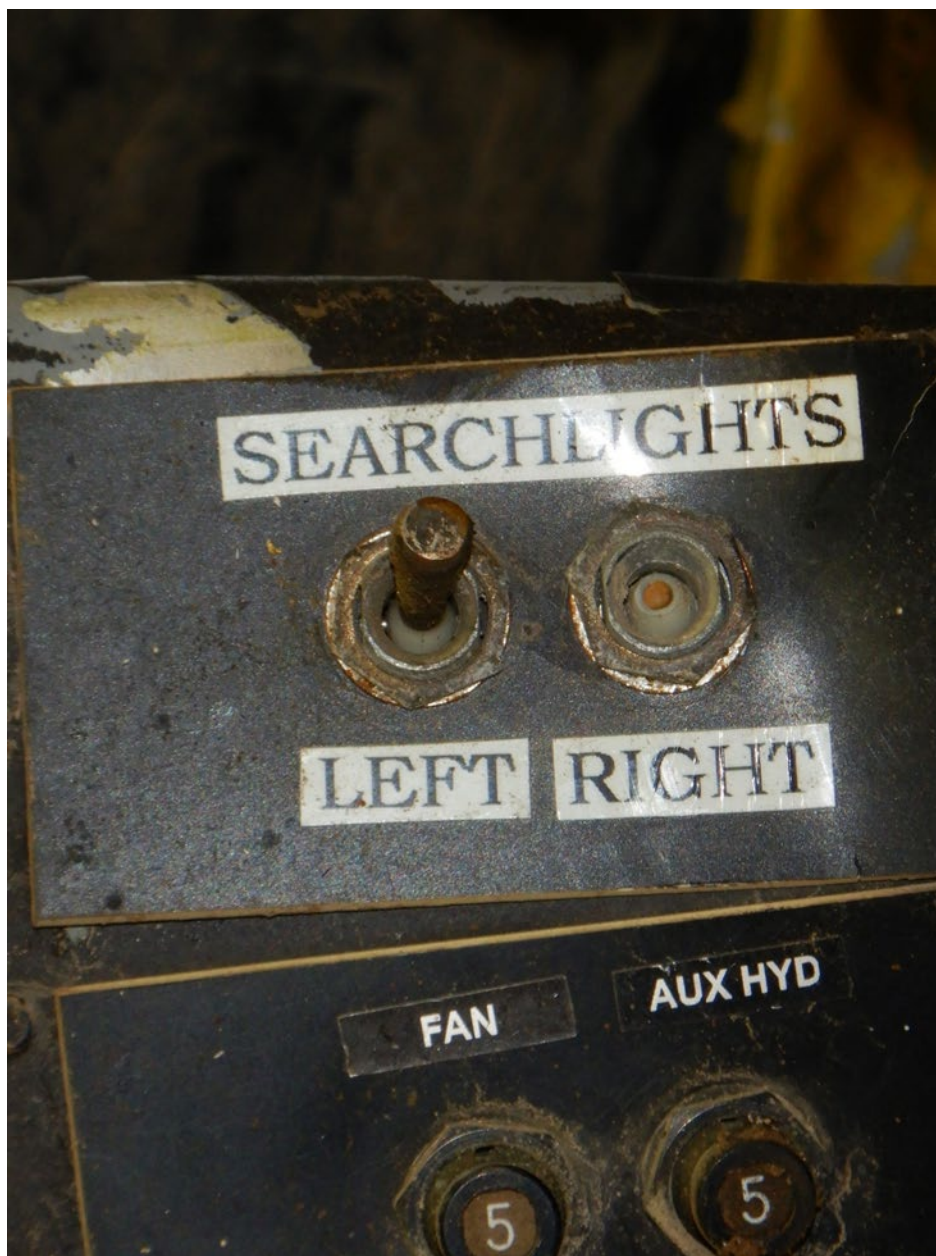
Search Lights: Left: ON; Right Side: switch broken but appears to be ON.

Figure 35. Search lights switches in the ON position.
