## **NATIONAL TRANSPORTATION SAFETY BOARD**

# **ACCIDENT SITE EXAMINATION SUMMARY REPORT**

**WPR22FA100**

Location: White Hills, Arizona  
Date: February 19, 2022  
Aircraft: N787NV; Vans RV-7  
NTSB Investigator-in-Charge: Andrew Swick

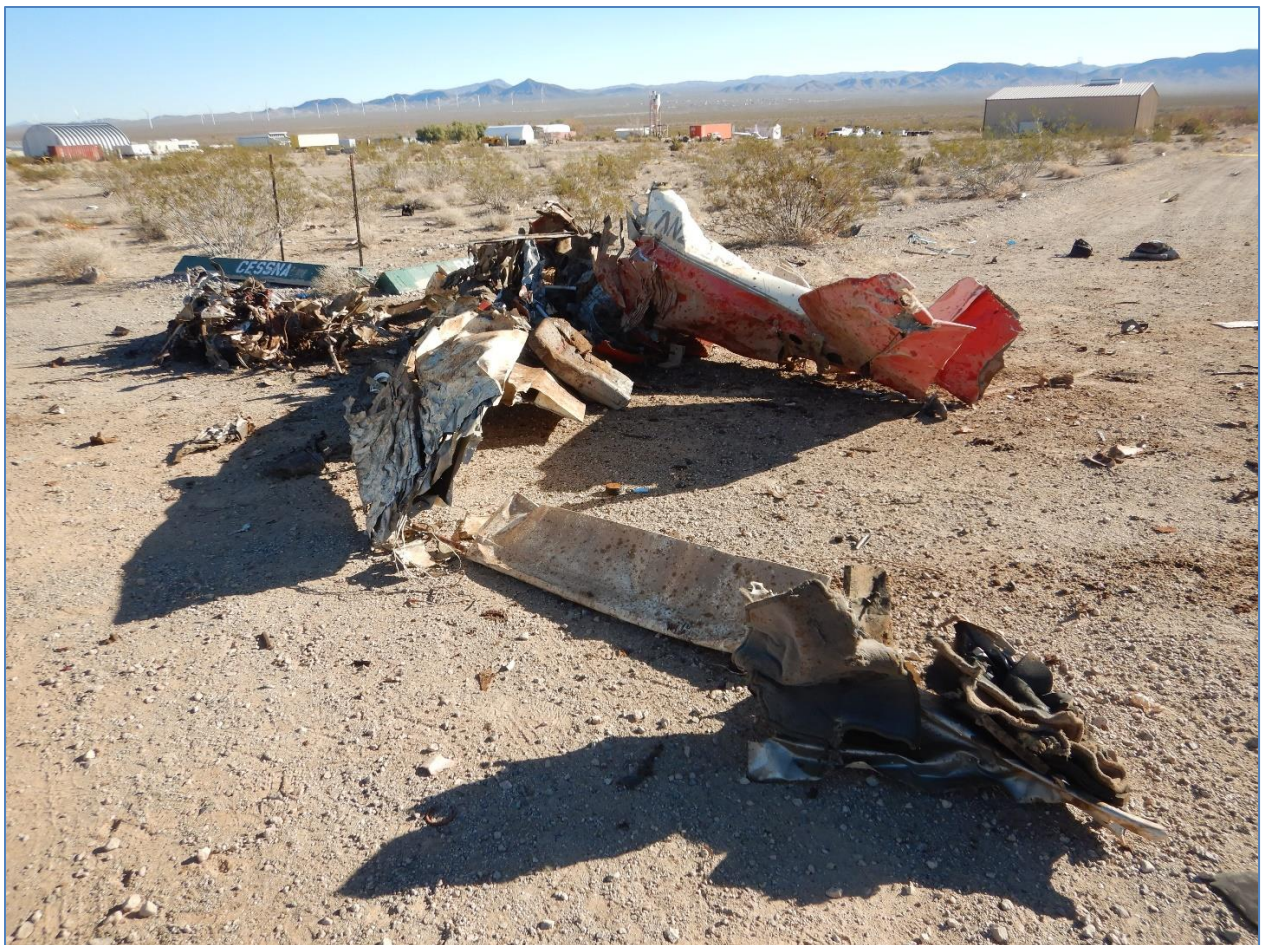
Examination of the accident site was conducted on February 19-20, 2022. All major structural components of the airplane were located at the accident site. Radar track data revealed a track consistent with the accident airplane which departed from Boulder City Municipal Airport (BVU), Boulder City, Nevada, then tracked east above the highway west of the Triangle Airpark (AS50), White Hills, Arizona. The track then made a slight right turn before sharply descending to the left near the accident site. Security video from a nearby gas station showed the airplane descending in a nose down attitude while parts are separating from the airplane before impacting the ground.

Figure 1-Accident site, left side view of the main wreckage.

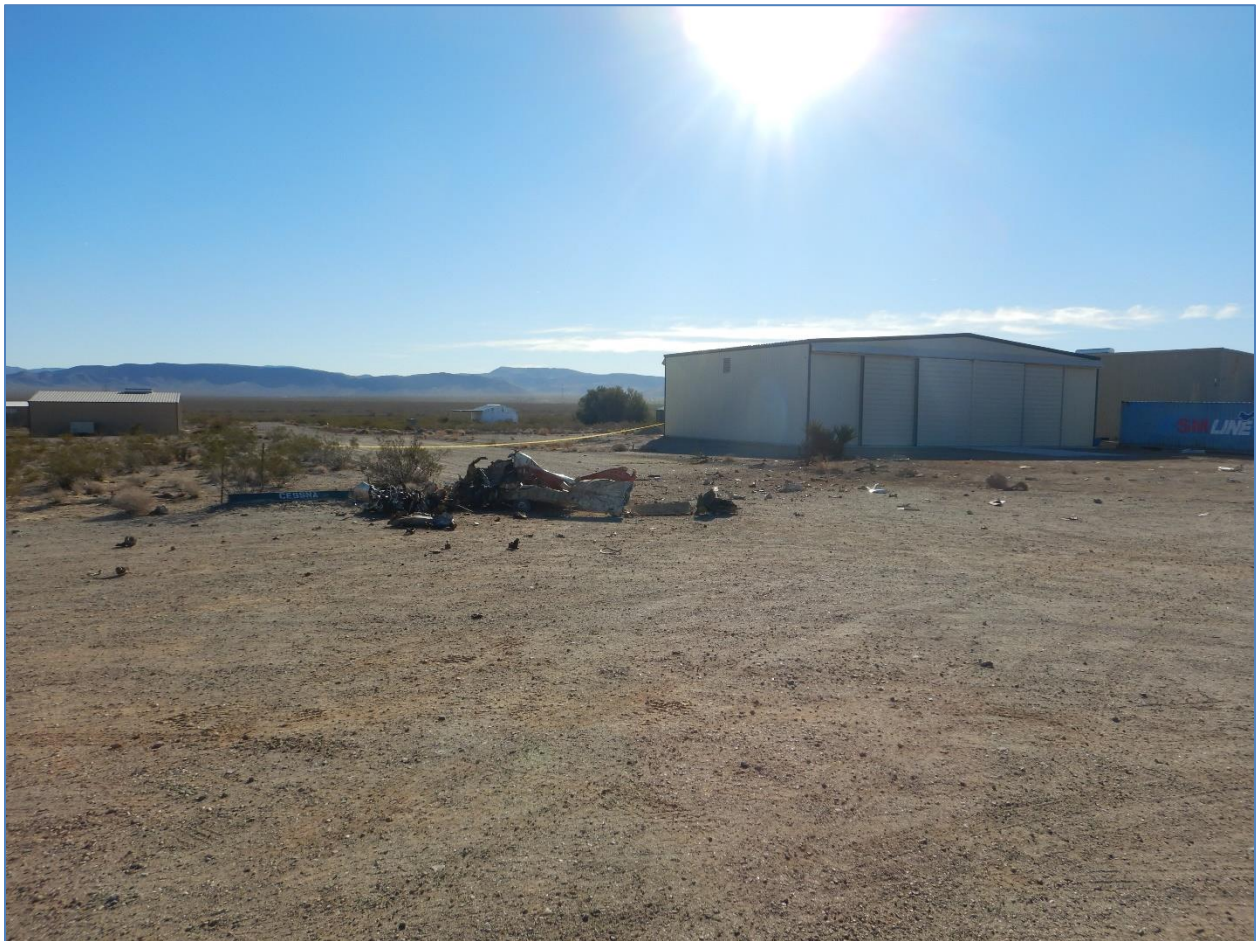
The FIPC with the ground was a large crater in hard dry soil near a hangar. Extending from the crater to the south was a shallow trough of disturbed dirt approximately 12 ft in length, consistent with a wing strike. The crater was about 1-1/2 ft deep and about 5 ft in diameter. Oil saturated soil and fiberglass fragments were found in the crater. HR was found from the crater to the furthest point in the debris field, about 200 ft. To the left in the debris field from the FIPC, the right aileron and several unidentified metal fragments and sections of fiberglass fairings. Down the center of the debris field from the FIPC, was the propeller assembly, metal and fiberglass fragments and the main wreckage. The propeller assembly remained intact and had impact damage to both blades. One blade was bent aft and had multiple bending. The hub had impact damage. The other blade was intact and had scuff marks. The spinner separated and was not identified in the debris. To the right in the debris field from the FIPC, the canopy structural beam and unidentified parts were found. Wheel pant fragments were found between the propeller assembly and the main wreckage.

Figure 3-Accident site, FIPC, debris field and main wreckage.

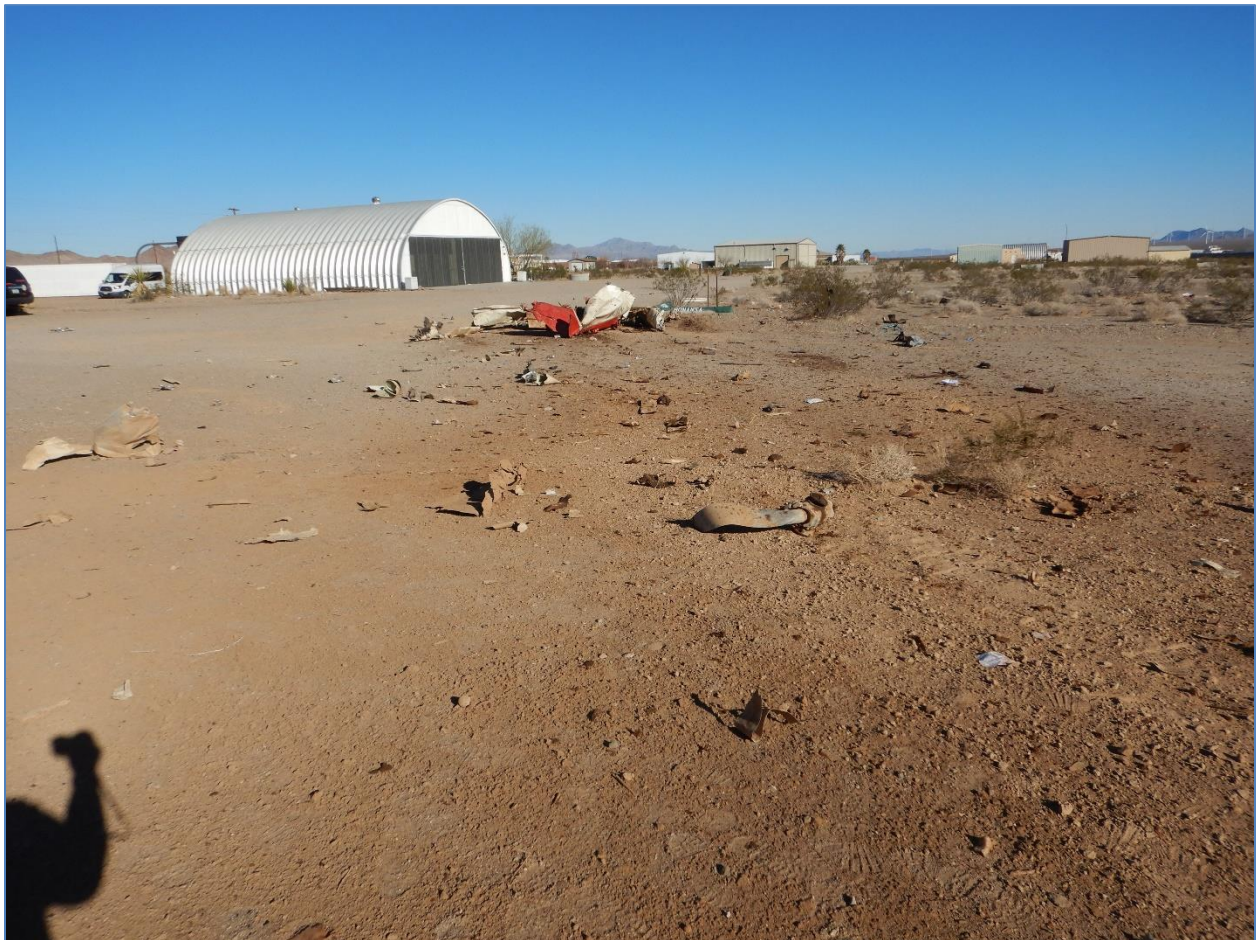
The main wreckage was found about 100 ft from the FIPC. Most of the wing skin and all of the fairings separated from both wings, revealing a bent main spar and crushed internal wing structure. Wing torque tubes and linkage had impact damage. The left wing flap remained attached to the wing and had impact damage. The left aileron and right flap were found near the main wreckage and was impact damaged. The aft fuselage was buckled and remained partially attached to the wing structure. The right horizontal stabilizer and elevator remained attached to the aft fuselage structure. The lower side of the rudder remained attached to its lower attachment hinge and both control cables and their hardware remained attached to the rudder.

Figure 4-Accident site, view of the debris field and main wreckage near the FIPC with the ground.

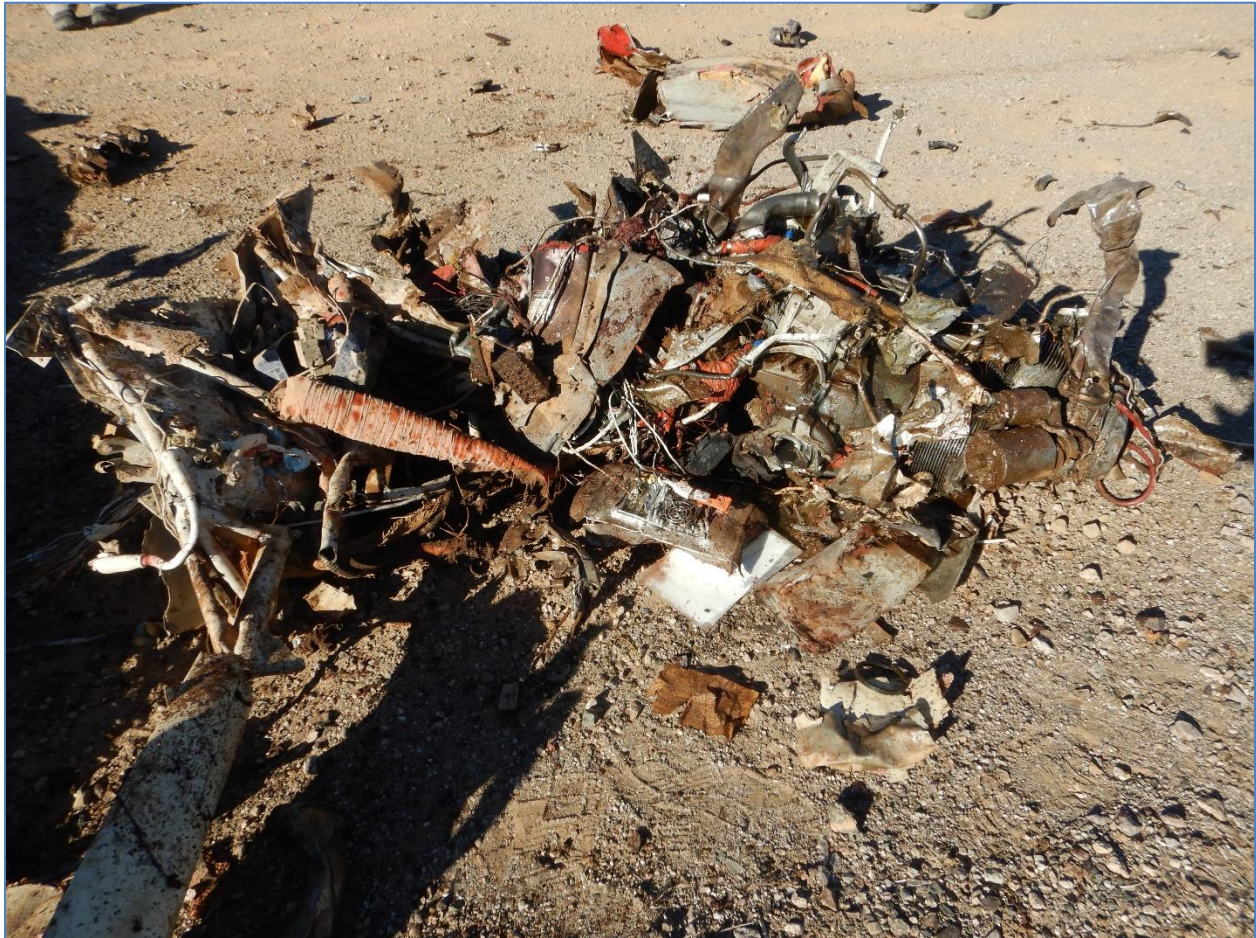
The Lycoming YIO-360-M1B engine and instrument panel were crushed and distorted and remained attached by various wiring. The propeller governor, alternator and several other components separated from the engine. The lower oil sump section separated revealing its internal surface. A cylinder head separated from its cylinder bore. A valve from the separated cylinder head was found near the main wreckage. The cockpit engine controls (throttle, mixture and propeller) remained attached.

Figure 5-Accident site, right side view of the engine, firewall and engine mounting structure.
