# National Transportation Safety Board

WPR22FA100

## STRUCTURES

Group Chair's Factual Report

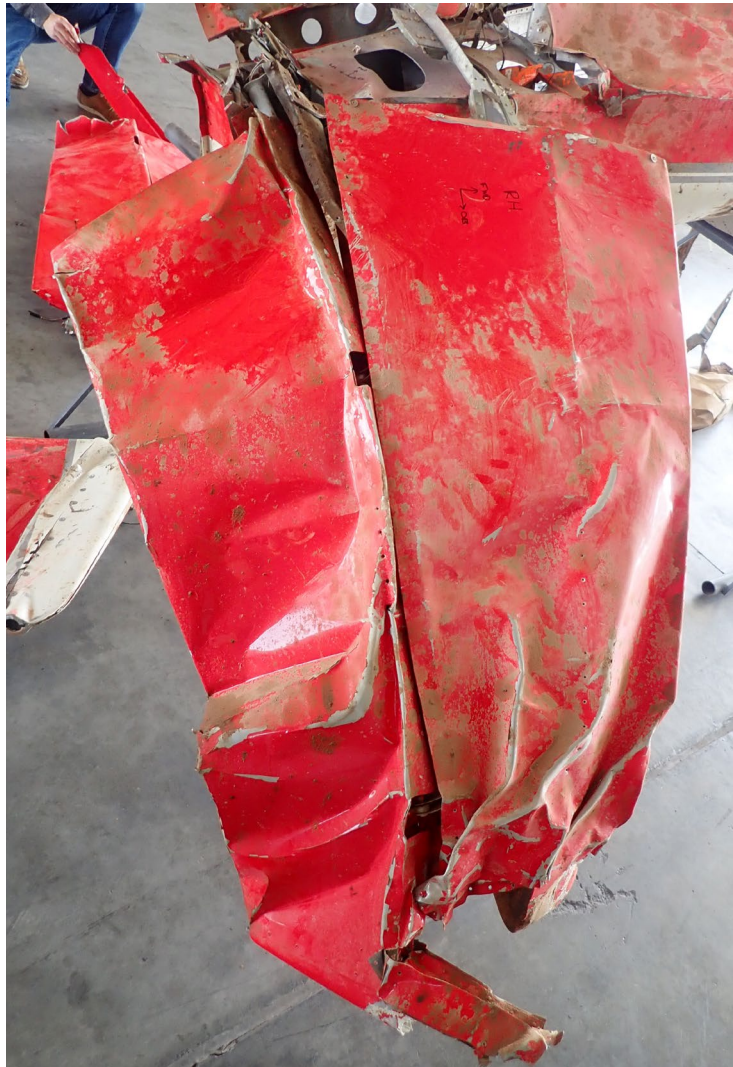
**Figure 2.** Right horizontal stabilizer and elevator (NTSB photo).

The right horizontal stabilizer and elevator remained partially attached to the empennage and were deformed and curled downward about 45° along the length (Figure 2). The horizontal stabilizer front spar was fractured at the right outboard end of the center reinforcement angles. The right horizontal stabilizer remained attached to the empennage by the rear spar. The right elevator remained attached by both of its hinges

and the center bellcrank. There was impact damage to the outboard leading edge of the right horizontal stabilizer, and the right elevator counterweight was separated and recovered at main wreckage site.

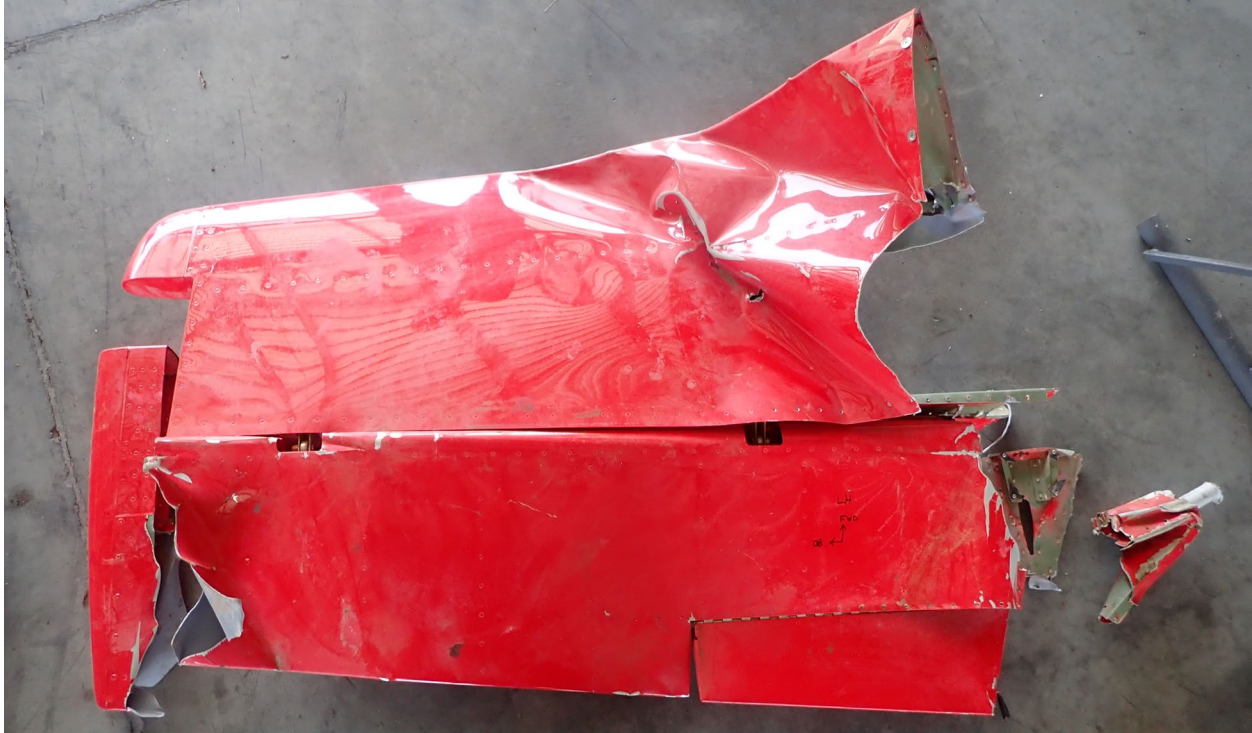
**Figure 3.** Left horizontal stabilizer and elevator (NTSB photo).

The left horizontal stabilizer and attached elevator separated prior to ground impact (Figure 3). The inboard 20 inches of the left horizontal stabilizer was deformed upwards. The left elevator remained attached at both hinges. The elevator trim tab remained attached. The trim tab control arm remained attached to the tab, but the arm was bent and had broken away from the linear actuator at the forward rod end. A small portion of the left elevator lower skin, about 6 inches by 8 inches, where the trim motor attached was separated. The trim motor assembly was separated from its mounting point with portions of the plastic mounting tabs still attached. The left elevator inboard root rib was separated with a 5-inch section of the elevator torque tube attached. The left elevator tip and counterweight assembly separated as a complete unit.

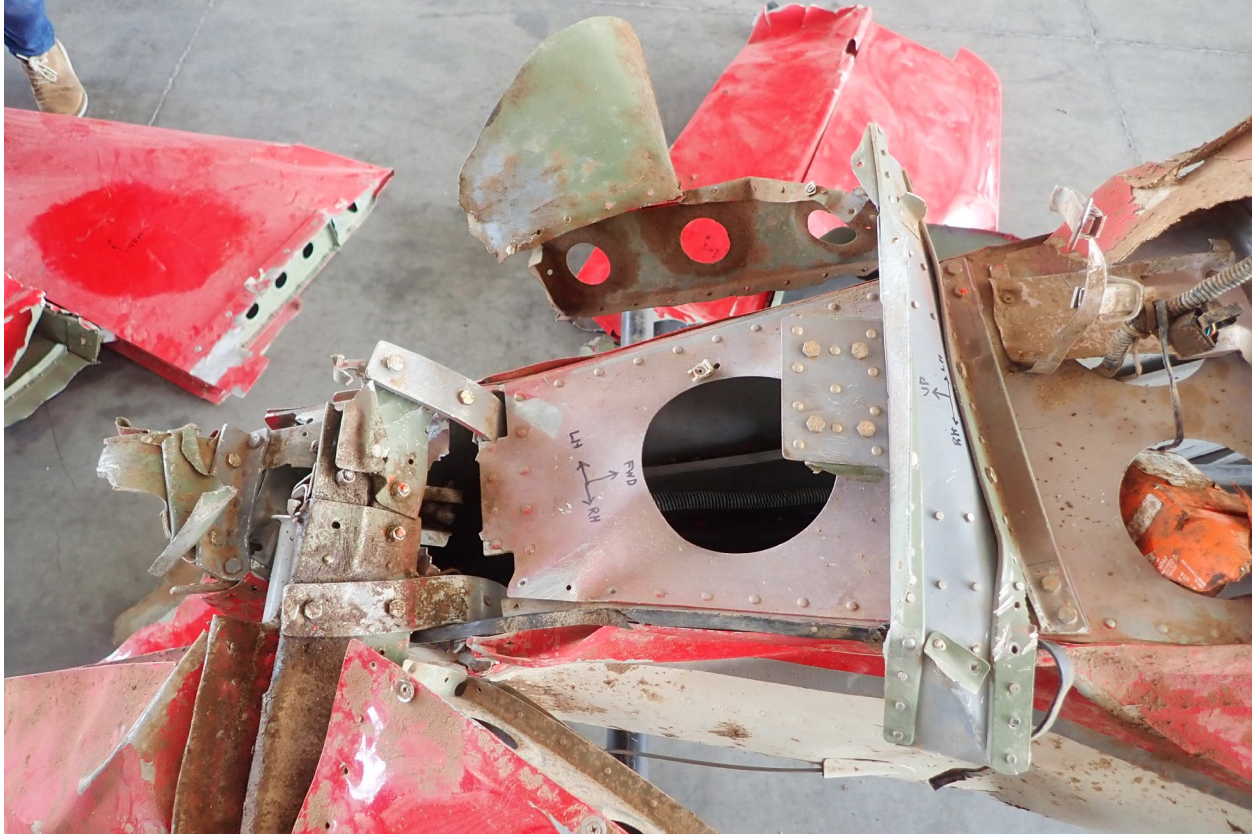
**Figure 4.** Horizontal and vertical stabilizer attach points, looking down (NTSB photo).

The horizontal stabilizer front spar center section, about 17 inches long, remained attached to the shelf and fuselage bulkhead by four bolts through the lower reinforcement angle and was rotated aft about the lower spar cap (Figure 4). There was slight forward deformation to the left side of the upper and lower front spar reinforcement angles and pronounced aft and downward deformation to the right side of the upper and lower front spar reinforcement angles. The left horizontal stabilizer inboard main rib remained partially attached to the front spar with a piece of upper skin attached. The horizontal stabilizer c-channel front spar was fractured on both the left and right sides at the ends of the reinforcement angles. The vertical stabilizer forward attach point remained attached to the horizontal stabilizer front spar center section. The vertical stabilizer c-channel forward spar was fractured at the upper end of the attach fitting and the spar web was bent aft about 90°. Van's Aircraft Service Bulletin SB 14-01-31 (horizontal stabilizer forward spar doubler) had been complied with.

The four horizontal stabilizer rear spar attach bolts were all intact and installed through the vertical fuselage flanges. Both vertical fuselage flanges were deformed aft. The upper and lower rear spar reinforcement bars were still connected to the right vertical fuselage flange and were fractured about 2.5 inches left of centerline through the left attach point holes. The upper reinforcement bar had no obvious deformation on either side of the fracture point. The lower reinforcement bar was buckled and deformed on both sides of the fracture consistent with left horizontal stabilizer separation in a downward and leading edge down direction. The left elevator torque tube was fractured from the elevator horn and the right elevator torque tube remained attached. The rod end remained connected to the lower end of the elevator horn and was free to move. The rod end was fractured in the threaded area. The vertical stabilizer rear spar attach points were intact with the left and right attach bolts installed. The vertical stabilizer rear spar and doubler were fractured above the attach points and the remaining portions were bent aft above the attach points. The lower rudder hinge rod end remained attached to the brackets and was free to move. The rod end was fractured in the threaded area and exhibited downward deformation. The right rudder stop was deformed upwards, and the left rudder stop was intact. There was no evidence of repeated impact on the rudder stops.

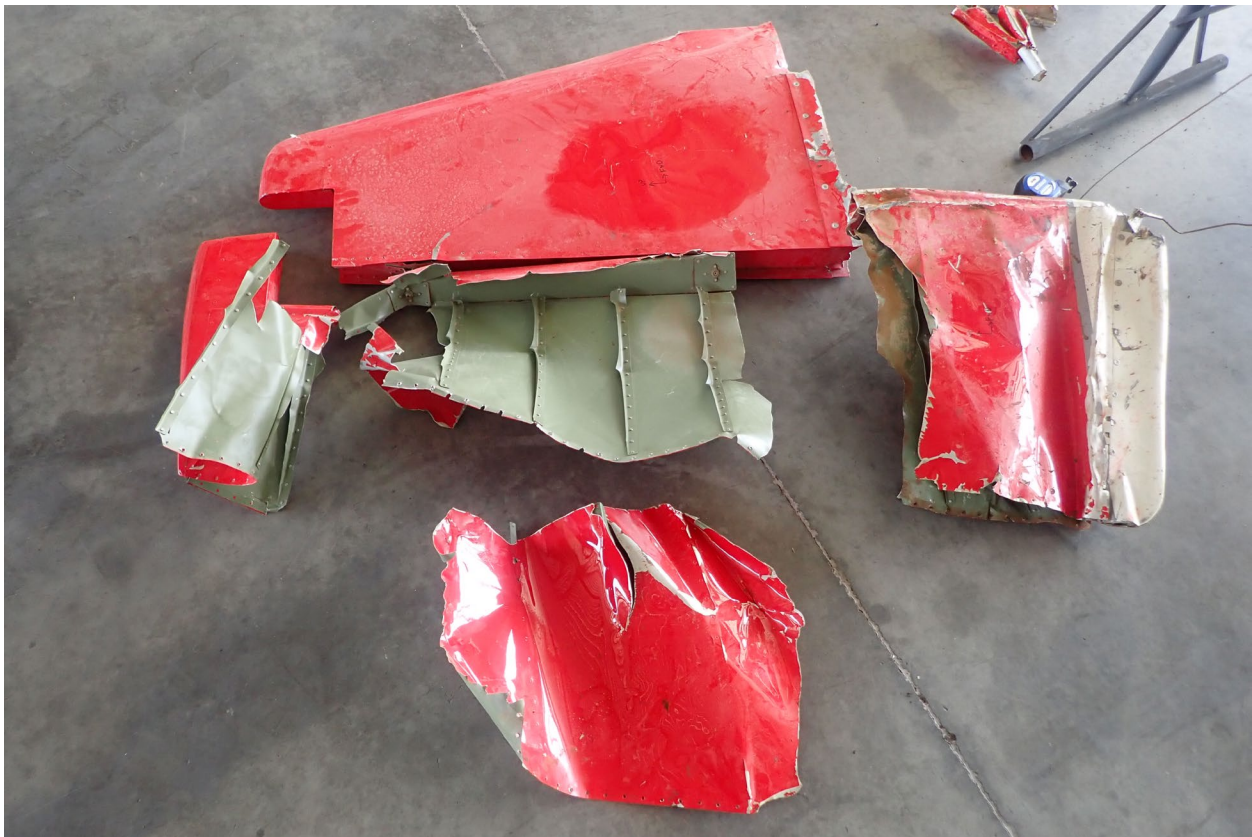
**Figure 5.** Vertical stabilizer and rudder (NTSB photo).

The vertical stabilizer separated mostly intact prior to ground impact (Figure 5). The front and rear spars were fractured at the lower end of the stabilizer. A portion of

the rudder between the center and upper hinges remained attached. The portion included the leading edge and the left skin with four stiffeners attached. All the stiffeners exhibited buckling damage. The complimentary right rudder skin section, including three stiffeners, was separated. The entire rudder trailing edge was splayed open, and all the trailing edge rivets were pulled through the skin. The rudder trailing edge strip was separated and not recovered. There was no evidence of adhesive or sealant on the rudder skins at the trailing edge. The rudder tip and counterweight assembly separated prior to ground impact. The left rudder skin below the counterweight included the upper stiffener and the right rudder skin below the counterweight included the upper two stiffeners. There was a saw-tooth fracture of the right rudder skin below the counterweight. The lower portion of the rudder remained connected to the empennage by the rudder cables but was separated for the exam. The lower rudder from the center hinge to the lower end was mostly intact but damaged. The trailing edge was splayed open, and the bottom tip cap was installed.

There was no evidence of corrosion on the structure examined. All the fracture surfaces examined had a dull, grainy appearance consistent with overstress separation.

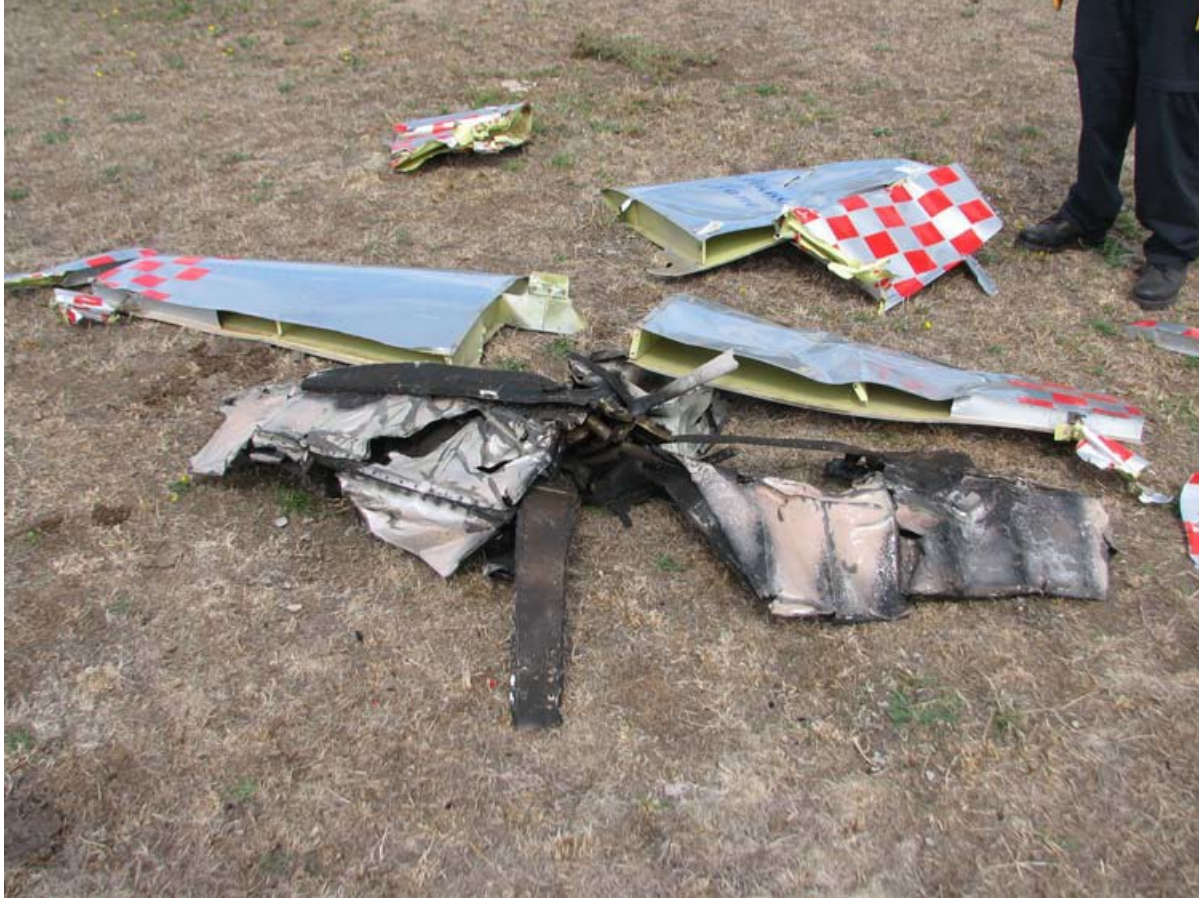
**Figure 6.** RV-4, VH-ZGH, empennage components layout (ATSB photo).

On February 23, 2007, an experimental amateur built Vans RV-4 airplane, VH-ZGH, experienced an inflight breakup while descending in a spiral dive after performing aerobatics near Clyde North, Victoria, Australia. The Australian Transport Safety Bureau (ATSB), investigated the accident (200701033) and published the [final report](#). The investigation concluded that the airplane was overweight and outside the CG limits for the flight and the pilot likely lost control during an aerobatic maneuver resulting in an unrecoverable spin. The airplane structure failed as a result of exceeding design limits. The left and right sides of the horizontal stabilizer, vertical stabilizer, rudder, and elevator counterweights separated from the airplane during the accident sequence and were recovered up to 380 feet from the main wreckage (Figure 6). The main wreckage was partially consumed by a post-crash fire. The vertical stabilizer was mostly intact with the upper half of the rudder attached and the lower half of the rudder separated. The rudder had a formed trailing edge versus a fastened one. The left and right horizontal stabilizers separated mostly intact leaving the center section of the front spar and most of the rear spar attached to the fuselage. Most of the left and right elevators remained attached to the stabilizer rear spar that remained attached to the fuselage. The rear spar and elevators were deformed down and aft significantly. The left and right elevator counterweights were separated and recovered adjacent to the burned main wreckage.

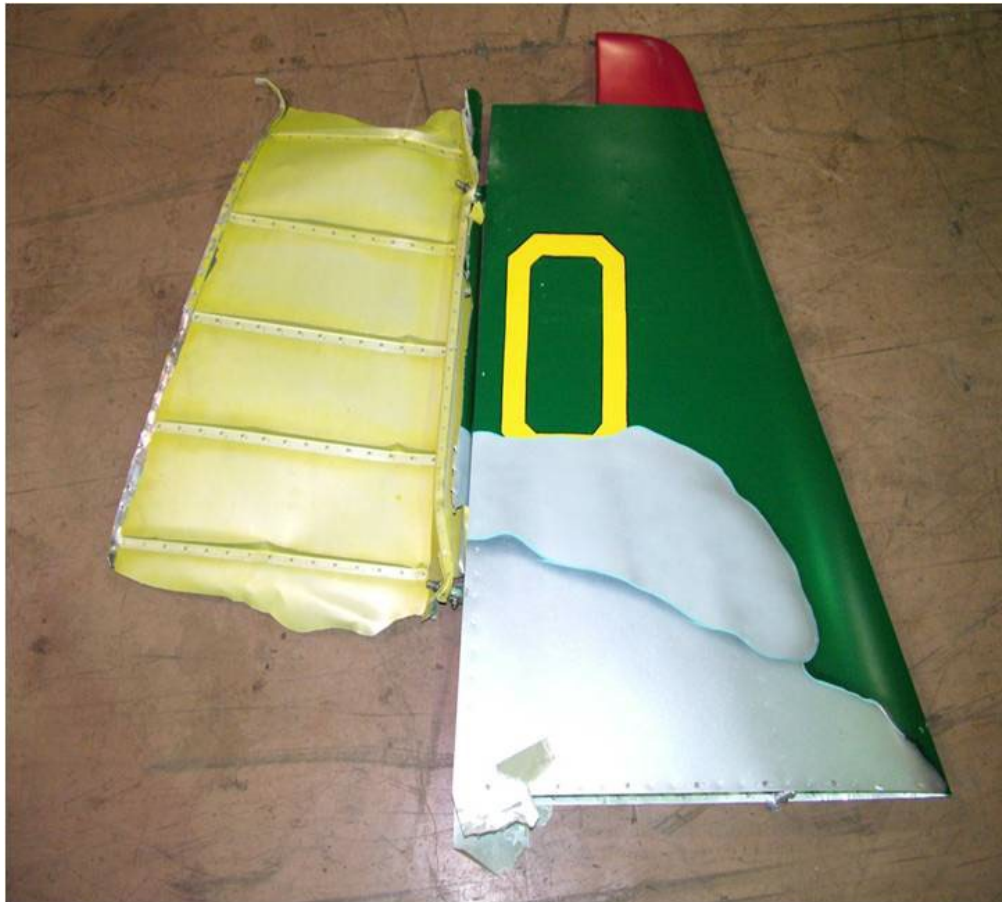
**Figure 7.** RV-7, G-GNDY, separated vertical stabilizer and rudder (TSB photo).

On January 23, 2010, an experimental amateur built Vans RV-7A airplane, C-GNDY, experienced an inflight breakup while flying in formation with another airplane and filming aerobatic maneuvers near Wolfe Lake, Ontario, Canada. The Transportation Safety Board of Canada (TSB) investigated the accident (A10O0018) and published the [final report](#). The investigation concluded that the airplane speed reached 234 KIAS during the maneuvering sequence and encountered either flutter or overstress of some rudder components causing the vertical stabilizer and parts of the rudder to separate from the airplane. The vertical stabilizer and upper half of the rudder separated during the accident and were recovered about 0.6 nm from the main wreckage. The vertical stabilizer was mostly intact with the left half of the upper rudder installed (Figure 7). Two pieces of the upper right rudder skin and the trailing edge strip were recovered in the debris field. The lower half of the rudder remained attached to the airplane and the trailing edge was splayed open. There was no

evidence of sealant on the rudder trailing edge skins. The rudder counterweight was not recovered.

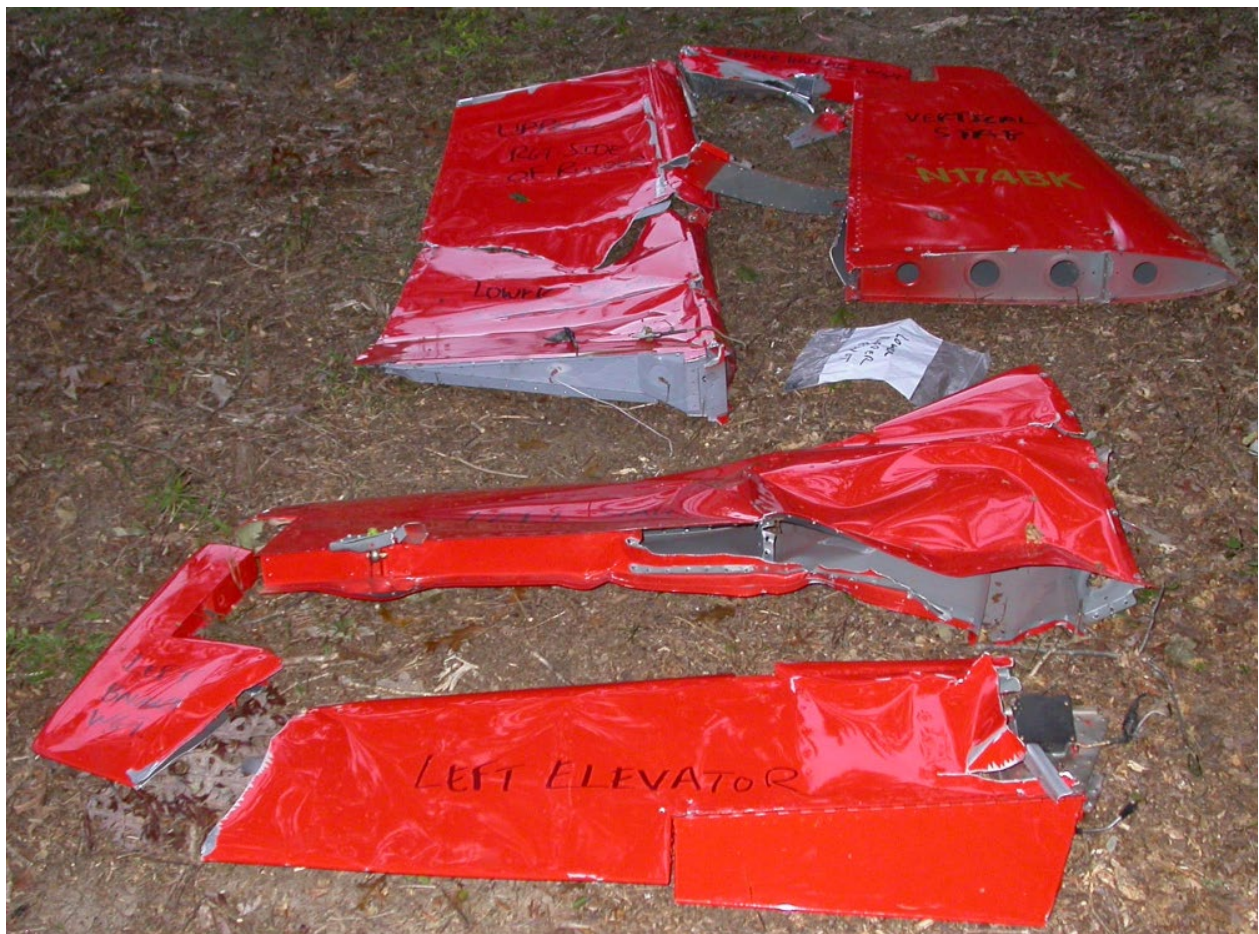
**Figure 8.** RV-7A, N174BK, separated empennage components (NTSB photo).

On September 20, 2013, an experimental amateur built Vans RV-7A airplane, N174BK, was destroyed during an inflight breakup and impact with terrain after a rapid loss of altitude and increase in airspeed near the Township of Hamilton, New Jersey. The NTSB investigated the accident (ERA13FA424) and determined that the

probable cause was the pilot's improper aerobatic maneuver that resulted in a loss of control, exceedance of the airplane's design limitations, and a subsequent inflight breakup of the airplane. The final report and public docket can be found [here](#) by entering the accident number. During the accident the left horizontal stabilizer, left elevator, vertical stabilizer, rudder, left wingtip, and canopy separated and were recovered up to 0.6 mile from the main wreckage. The vertical stabilizer separated mostly intact, and the rudder separated from the vertical stabilizer in three pieces (Figure 8). The rudder trailing edge remained fastened together. The left horizontal stabilizer separated mostly intact leaving the inboard half of the rear spar attached to the fuselage. The left elevator with the trim tab attached separated from the stabilizer and the outboard portion of the elevator with the balance weight separated. The structures study determined that the left horizontal stabilizer damage was consistent with down loading and the vertical stabilizer damage was consistent with loading to the left.

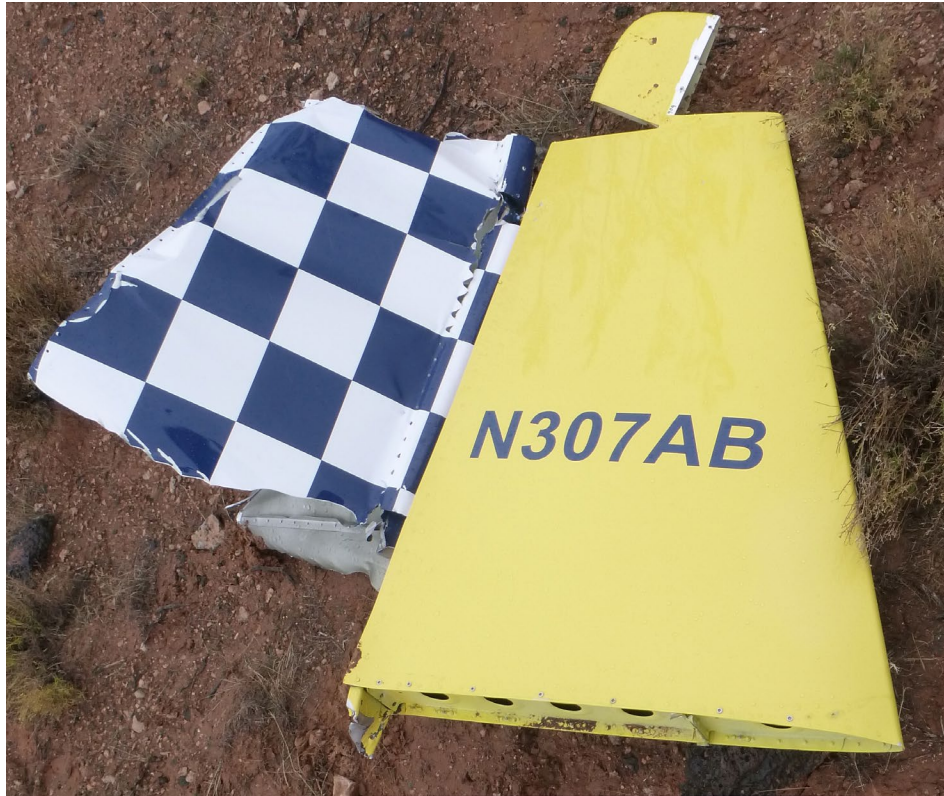
**Figure 9.** RV-7, N307AB, separated vertical stabilizer and partial rudder (NTSB photo).

On December 10, 2015, an experimental amateur built Vans RV-7 airplane, N307AB, experienced an inflight breakup and impacted terrain near Hurricane, Utah. The NTSB investigated the accident (WPR16FA036) and determined that the probable cause was the pilot’s aerobatic maneuver leading to airspeeds above the never exceed speed of the airplane which resulted in rudder flutter and an in-flight breakup. The final report and public docket can be found [here](#) by entering the accident number. During the accident, the left and right horizontal stabilizers, left and right elevator counterweights, vertical stabilizer, half of the rudder, rudder counterweight, left wingtip, left outboard wing, and canopy separated and were recovered up to 1,400 feet from the main wreckage. The vertical stabilizer separated mostly intact with the upper half of rudder attached (Figure 9). The rudder counterweight was separated from the top of the rudder and the trailing edge of the rudder was splayed open. The lower half of the rudder remained attached to the fuselage with the trailing edge splayed open. There was evidence of sealant between the rudder skins and trailing edge strip. The left and right horizontal stabilizers separated mostly intact leaving the center section of the front spar and most of the rear spar attached to the fuselage. Deformation on the horizontal stabilizers was consistent with separation in a downward direction. Most of the left and right elevators remained attached to the stabilizer rear spar that remained attached to the fuselage. The elevators and rear spar were deformed down and aft significantly. The outboard half of the left wing separated from the airplane with signatures consistent with downward separation. The outboard half of the right wing remained attached but had downward deformation.

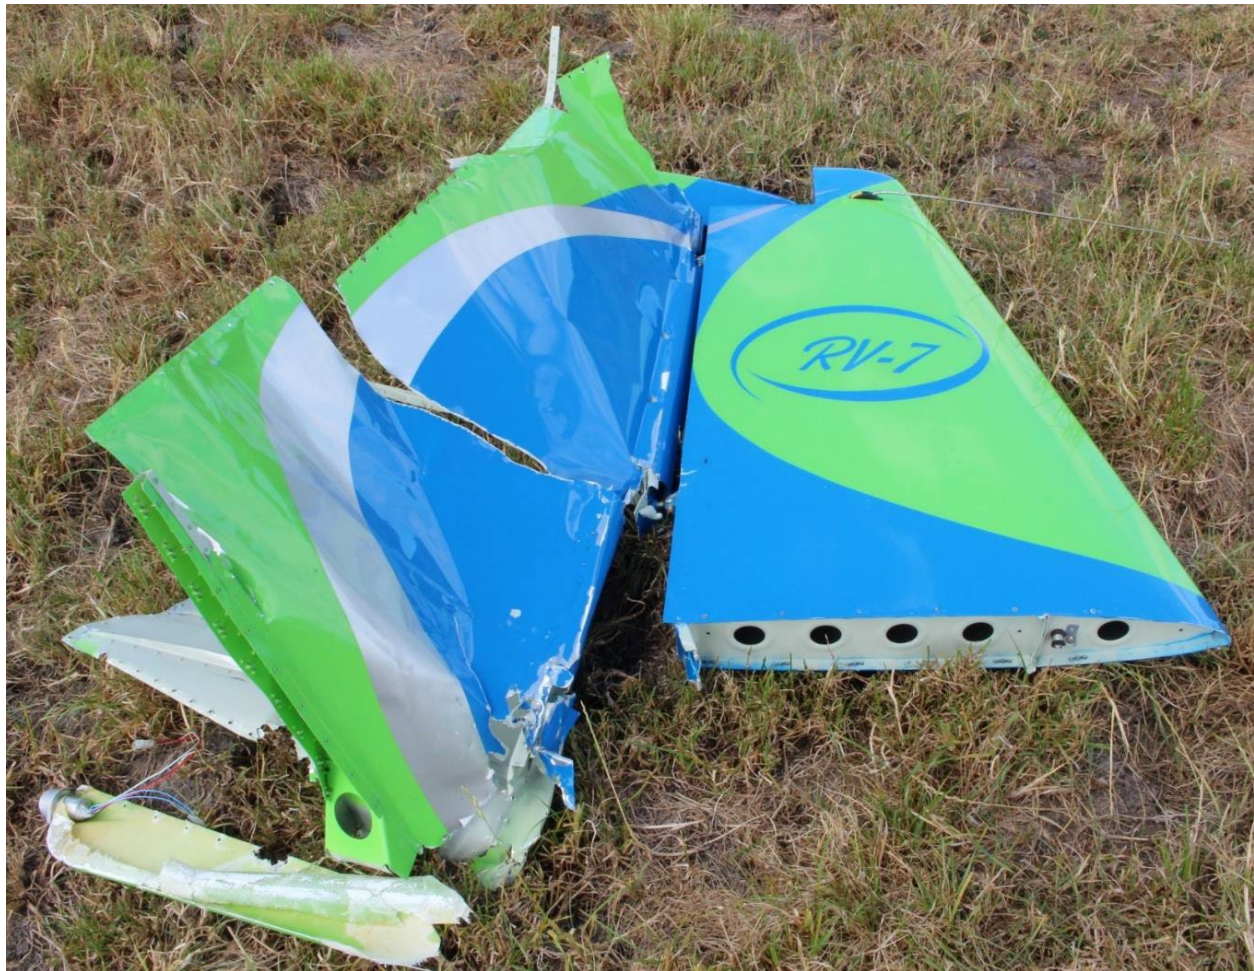
**Figure 10.** RV-7, ZK-DVS, separated vertical stabilizer and rudder (NZ CAA photo).

On January 1, 2018, an experimental amateur built Vans RV-7 airplane, ZK-DVS, experienced an inflight breakup after entering a highspeed descent from an unusual attitude near Te Kopuru, Northland, New Zealand. The Civil Aviation Authority of New Zealand investigated the accident (17-8080) and published the [final report](#). The investigation concluded that the pilot entered a high speed descent from an unusual attitude and was unable to recover the airplane which led to a rudder flutter event when the airplane exceeded the design limitation airspeed. During the accident sequence the vertical stabilizer, portions of the rudder, left wingtip, right wing, and left elevator counterweight separated from the airplane and were recovered up to 2,000 feet from the main wreckage. The vertical stabilizer was mostly

intact with the upper half of the rudder attached (Figure 10). Some lower rudder structure and the rudder counterweight were separated and found in the debris field while a portion of the lower rudder remained attached to the fuselage. The rudder trailing edge was splayed open and there was no evidence of sealant on the trailing edge skins or strip. The left and right sides of the horizontal stabilizer with attached elevators remained attached to the fuselage but were deformed down and aft. The right wing was reported to have failed downward in negative overload.

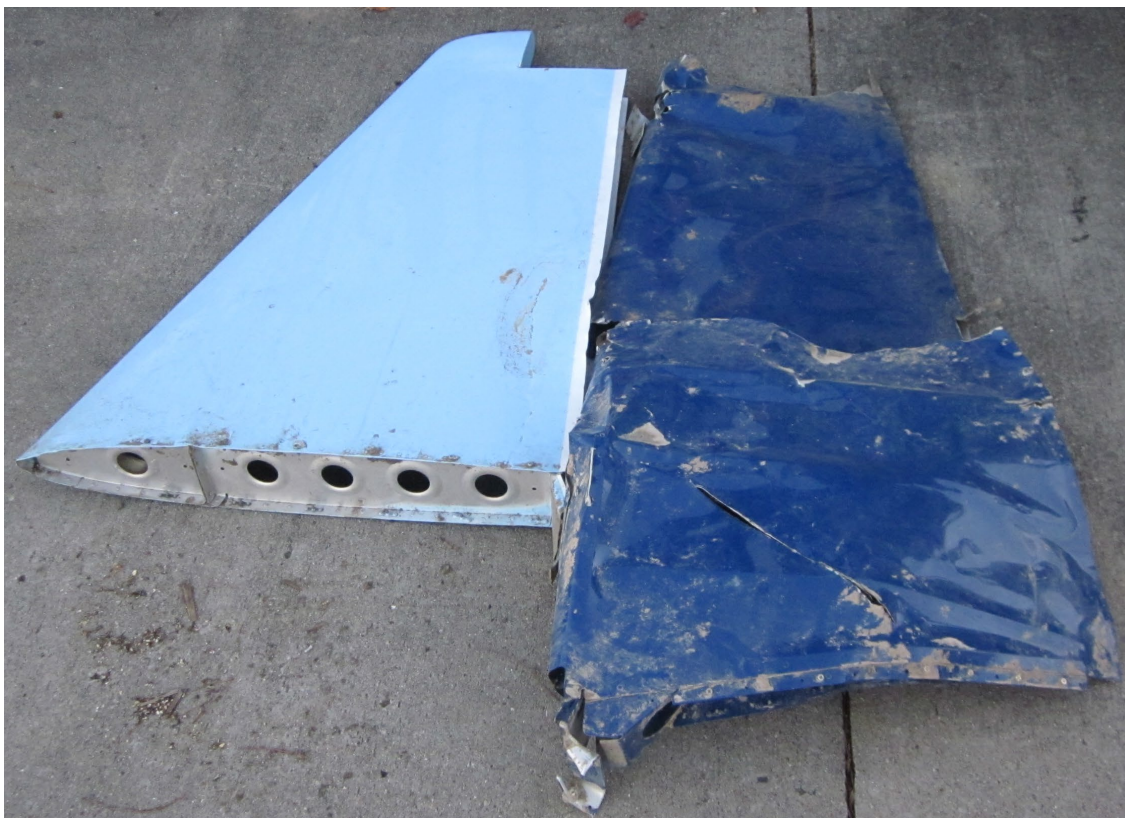
**Figure 11.** RV-9, N807LK, separated vertical stabilizer and rudder (NTSB photo).

On July 22, 2016, an experimental amateur built Vans RV-9A airplane, N807LK, experienced an inflight breakup and impacted terrain near Springfield, Ohio. The NTSB investigated the accident (CEN16LA281) and determined that the probable cause was the pilot's decision to fly into known thunderstorms, which resulted in an inflight breakup. The final report and public docket can be found [here](#) by entering the accident number. During the accident the vertical stabilizer, rudder, and left elevator counterweight separated and were recovered up to 0.63 nm from the main wreckage. The vertical stabilizer separated mostly intact, and the rudder fractured near the center hinge point and separated (Figure 11). The upper and center rudder hinges were pulled from the stabilizer rear spar. The rudder counterweight was separated from the top of the rudder and the trailing edge of the rudder remained fastened together. The left and right horizontal stabilizers and elevators remained attached to the fuselage with little deformation or damage.

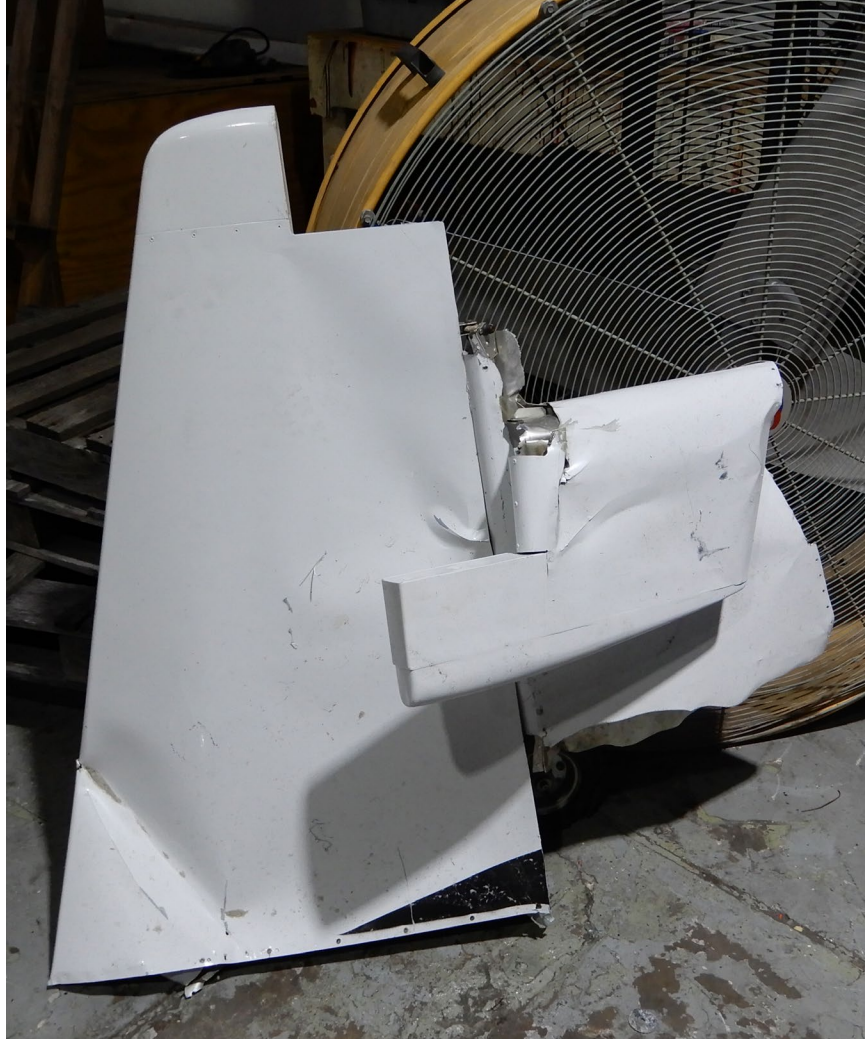
**Figure 12.** RV-9A, N4889R, separated vertical stabilizer and rudder (NTSB photo).

On September 13, 2020, an experimental amateur built Vans RV-9A airplane, N4889R, experienced an inflight breakup and impacted the water near Steinhatchee, Florida. The NTSB investigated the accident (ERA20LA315) and determined that the probable cause was the failure of the air traffic controller to provide hazardous weather information to the pilot, resulting in the flight's encounter with strong updraft conditions, an inflight loss of airplane control, and an in-flight breakup. Contributing was the pilot's decision to initiate a flight into an area under the influence of a tropical storm, with forecast rain showers and thunderstorms, which increased the potential for an encounter with significant convective weather. The final report and public docket can be found [here](#) by entering the accident number. During the accident the vertical stabilizer, rudder, left and right sides of the horizontal stabilizer, right elevator, left and right elevator counterweights and both wings were separated and recovered up to 1,300 feet from the main wreckage. The vertical stabilizer separated mostly intact with the upper half of the rudder attached (Figure 12). The upper 16 inches of the rudder above the upper hinge including the counterweight was folded over to the left upon itself. The rudder was fractured below the center hinge and the lower portion was not recovered. The rudder trailing edge was partially splayed open, and it could not be determined if there was sealant applied. The separated left side of the horizontal stabilizer was mostly intact with most of the left elevator attached. The left elevator counterweight and more than half of the left elevator upper skin were separated and not recovered. The separated right side of the horizontal stabilizer was partially intact. The right elevator separated from the right horizontal stabilizer but remained attached to the stabilizer rear spar that was pulled from the stabilizer. The right elevator counterweight was separated and not recovered.

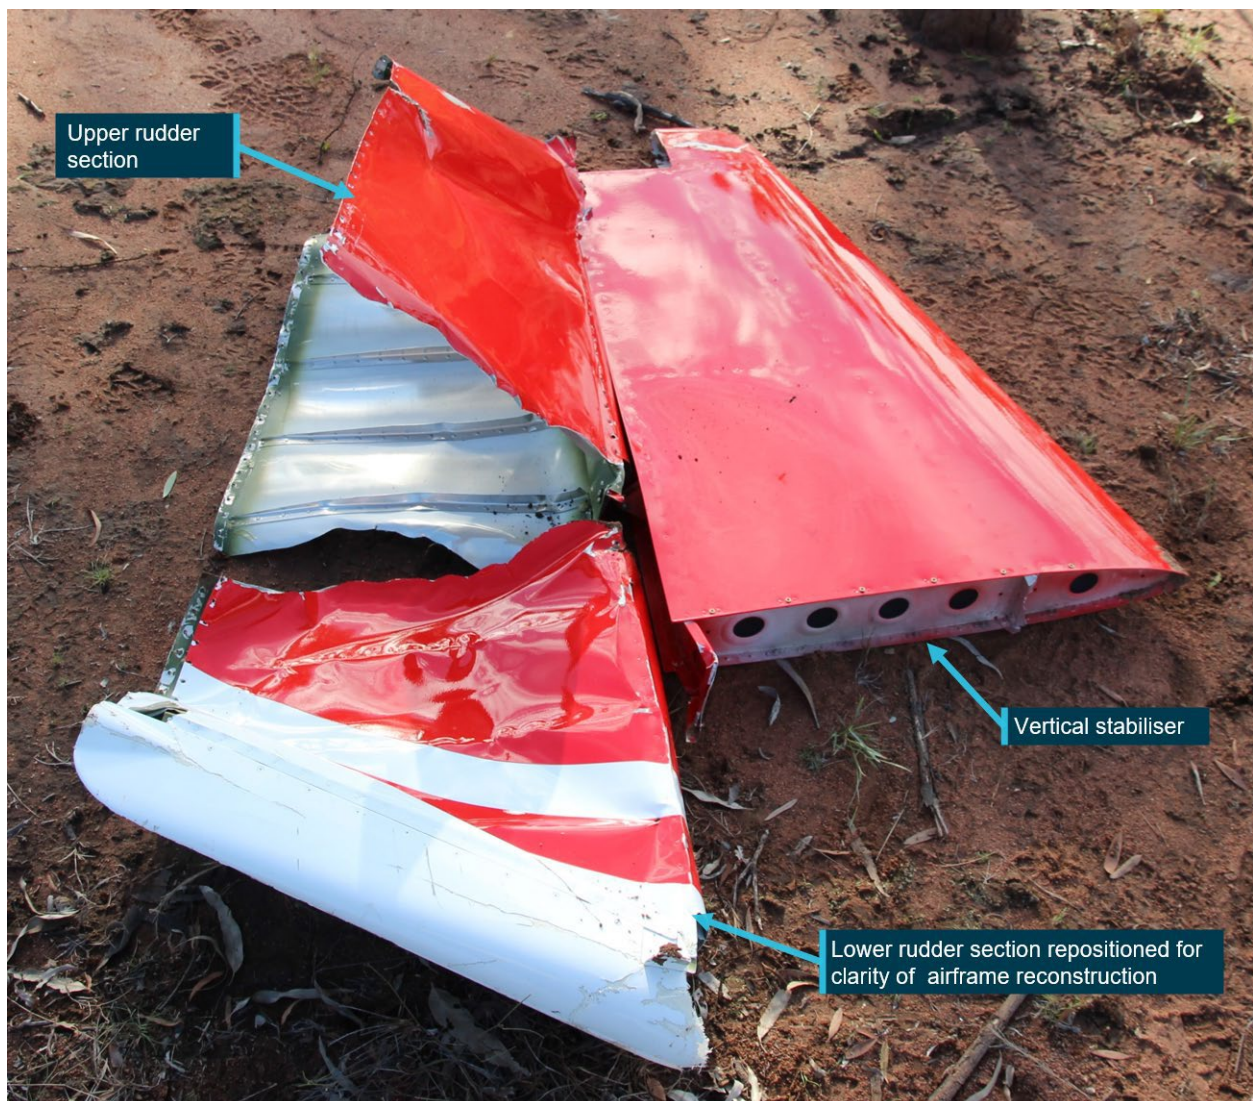
**Figure 13.** RV-7A, VH-WXI, separated vertical stabilizer and rudder (ATSB photo).

On April 23, 2021, an experimental amateur built Vans RV-7A airplane, VH-WXI, experienced an inflight breakup after the pilot became spatially disoriented after encountering adverse weather near Charters Towers, Queensland, Australia. The ATSB, investigated the accident (AO-2021-017) and published the [final report](#). The investigation concluded that the pilot became spatially disoriented and lost control of the airplane. "The aircraft's speed exceeded  $V_{NE}$  (never exceed speed or maximum airframe speed), leading to rudder flutter, airframe structural failures, and subsequent in-flight breakup." The left and right sides of the horizontal stabilizer, vertical stabilizer, rudder, and elevator counterweights separated from the airplane during the accident sequence and were recovered up to 4,900 feet from the main

wreckage. The vertical stabilizer was mostly intact with the upper half of the rudder attached (Figure 13). The lower half of the rudder was separated just below the center hinge point and recovered in the debris field. The rudder counterweight was separated and not recovered. The trailing edge of the rudder was splayed open and there was no evidence of sealant applied to the trailing edge skins. The rudder trailing edge strip was separated and not recovered. The left side of the horizontal stabilizer separated mostly intact with upward buckling. The right side of the horizontal stabilizer separated leaving the right side of the rear spar attached to the fuselage. Most of the left and right elevators remained attached to the fuselage and were deformed aft and down significantly. The left and right elevator counterweights were separated.

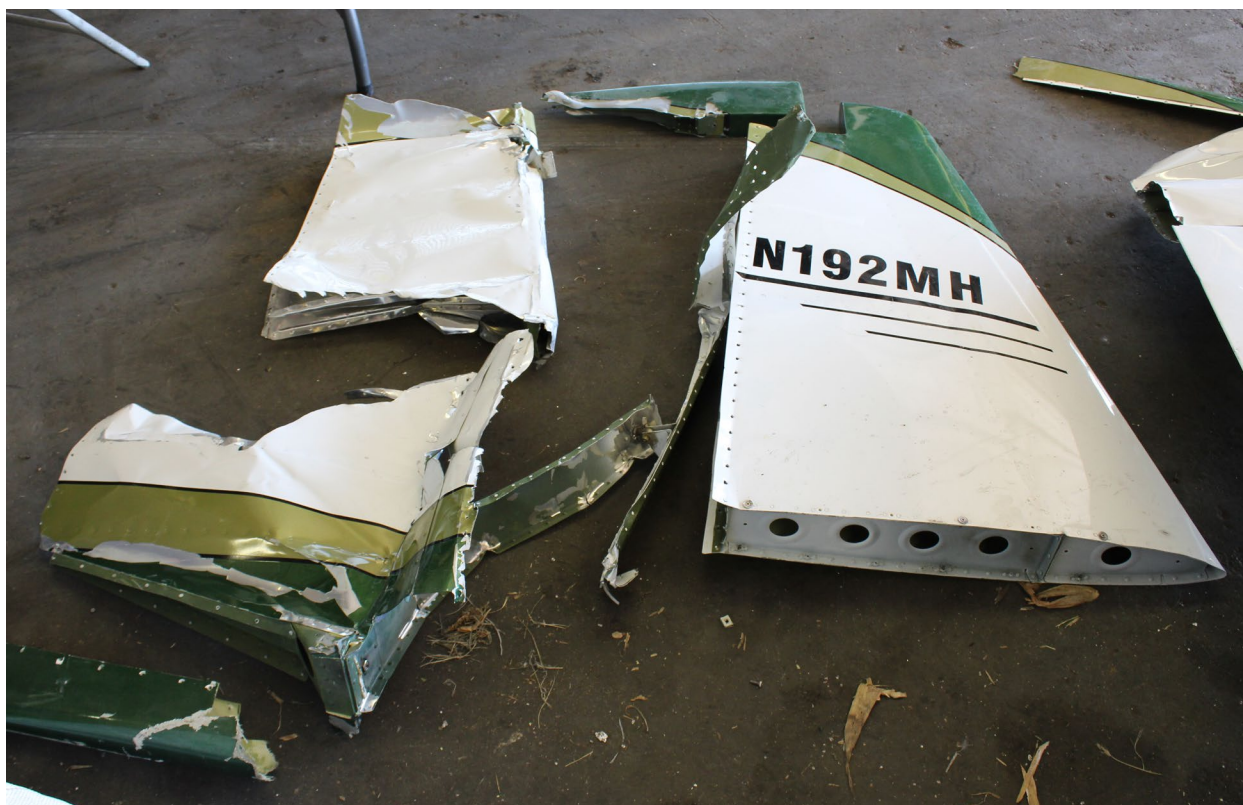
**Figure 14.** RV-9A, N192MH separated vertical stabilizer and rudder (NTSB photo).

On July 25, 2020, an experimental amateur built Vans RV-9A airplane, N192MH, experienced an in-flight breakup and impacted terrain near Tryon, Nebraska. The NTSB investigated the accident (WPR22FA266) and determined the probable cause was the non-instrument rated pilot's decision to continue flight towards deteriorating weather conditions and subsequent failure to remain in visual instrument meteorological conditions, which resulted in a loss of control, exceedance of the airspeed design limitations, and in-flight breakup of the airplane due to rudder flutter. The final report and public docket can be found [here](#) by entering the accident number. Radar and ATC information showed the pilot reported they were at 12,300 ft and "still in the soup". Radar information then showed the airplane was descending and the airspeed exceeded  $V_{NE}$  by about 70-80 kts depending on the actual wind conditions before the data ended. During the accident the vertical stabilizer, rudder, left and right sides of the horizontal stabilizer, right elevator, left and right elevator counterweights, the left outboard wing, and both wingtips separated and were recovered up to 1 mi from the main wreckage. The vertical stabilizer separated mostly intact with the rear spar pulled out and separated (Figure 14). The vertical stabilizer rear spar was twisted along its length, had diagonal buckling damage, and remained attached to the lower rudder section through the center hinge. The upper half of the rudder was separated with the upper hinge pulled from the stabilizer rear spar. The rudder counterweight was separated. A piece of the left center rudder skin was recovered, and a piece of the right center rudder skin was not recovered. The rudder trailing edge was splayed open and there was evidence of sealant applied. The left side of the horizontal stabilizer was mostly intact with most of the left elevator attached and they remained attached to the aft fuselage that had separated from the airplane. The right side of the horizontal stabilizer was separated and partially intact and had a portion of the right elevator between the center and outboard hinges attached. The inboard portion of the right elevator was recovered in the debris field. The outboard left wing, left aileron, and a portion of the left flap separated and had signatures consistent with downward separation. The right wing remained attached to the fuselage but had downward deformation. Both wingtips were separated and fractured into multiple pieces.

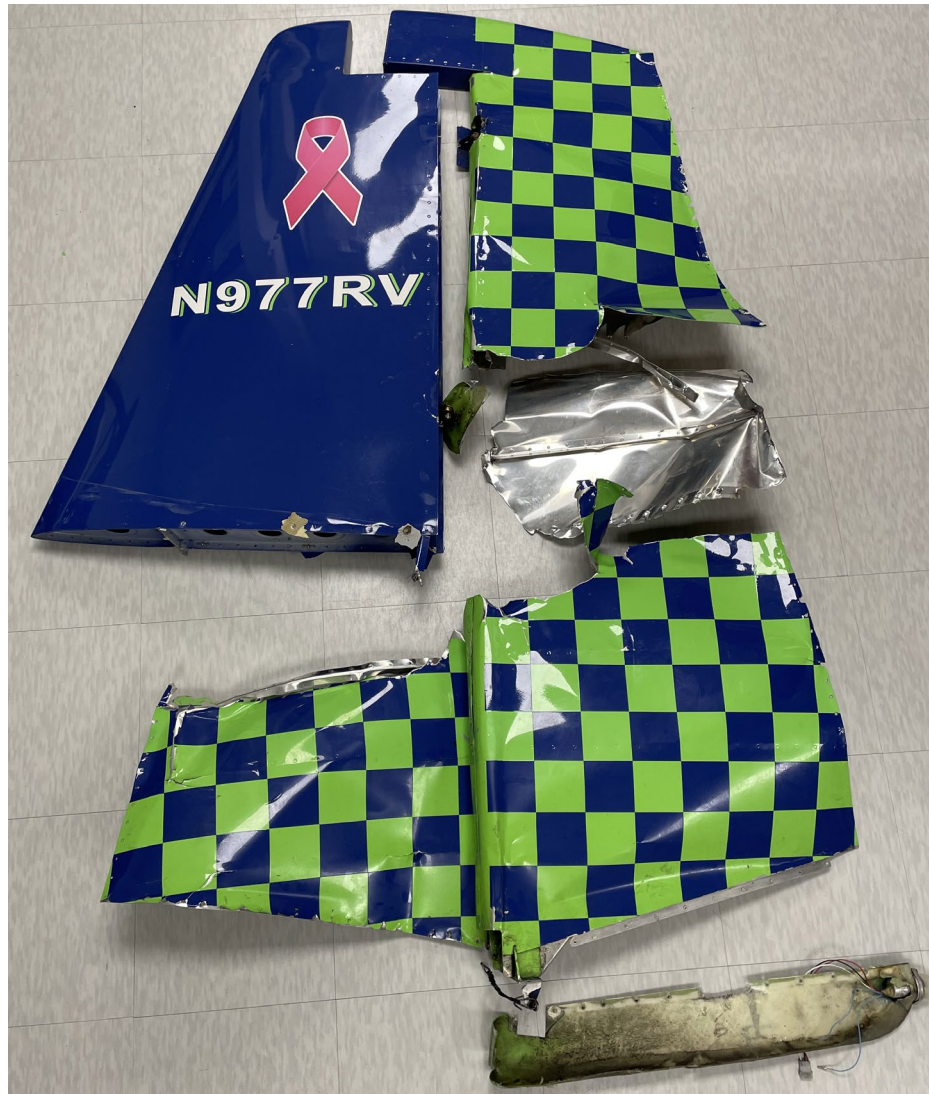
**Figure 15.** RV-7, N977RV, separated vertical stabilizer and rudder (NTSB photo).

On June 2, 2023, an experimental amateur built Vans RV-7 airplane, N977RV, experienced an inflight breakup and impacted terrain near Gibbon, Nebraska. The NTSB is investigating the accident (CEN23FA220). The preliminary report can be found [here](#) by entering the accident number. Preliminary ATC information revealed the pilot had requested a lower altitude due to encountering ice. After beginning the descent, the pilot was advised by ATC of “extreme precipitation” in the area and about 1 minute later ATC approved a lower altitude. No further communication was received from the pilot. During the accident the vertical stabilizer, rudder, and pieces of the horizontal stabilizer fairings separated before ground impact and were recovered up to 130 feet from the main wreckage. The vertical stabilizer separated mostly intact (Figure 15). The center rudder hinge was intact on the vertical stabilizer

with a section of the rudder spar attached. The upper half of the rudder was separated with the upper hinge pulled from the stabilizer spar. The rudder counterweight remained attached. A piece of the right center rudder skin was separated and recovered. The lower half of the rudder was separated and recovered. The rudder trailing edge was splayed open and there was evidence of sealant applied. The rudder trailing edge strip was separated and not recovered. The horizontal stabilizer and both elevators remained attached to the fuselage and had ground impact damage.

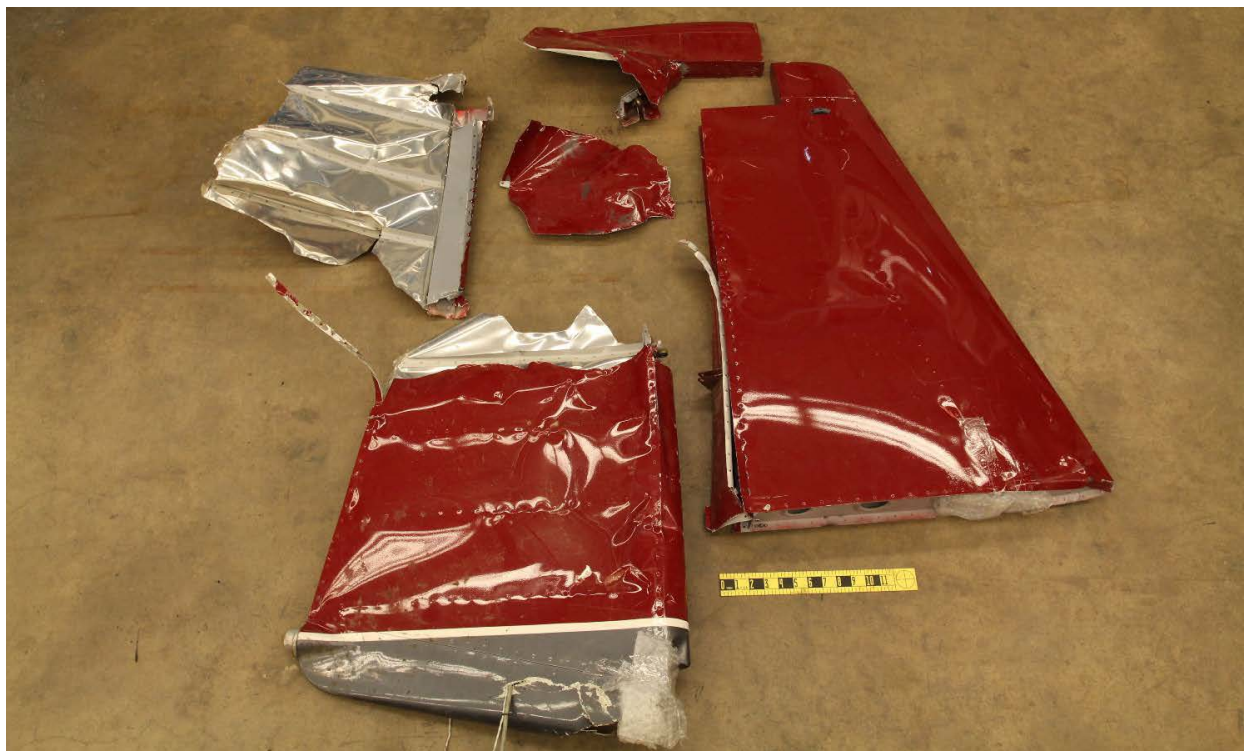
**Figure 16.** RV-7, N731RV, separated vertical stabilizer and rudder (NTSB photo).

On July 27, 2017, an experimental amateur built Vans RV-7 airplane, N731RV, experienced an inflight breakup and impacted terrain near Arlington, Arizona. The NTSB investigated the accident (WPR17FA134) and determined that the probable cause was the inflight overstress separation of the vertical stabilizer and rudder during flight which resulted in the pilot's inability to maintain airplane control. Contributing to the accident was an inflight collision with a bird. The final report and public docket can be found [here](#) by entering the accident number. During the accident the vertical stabilizer, rudder, and most of the canopy plexiglass were separated and recovered about 1 mi from the main wreckage. The vertical stabilizer separated mostly intact with a section of the rear spar pulled out and separated (Figure 16). The lower end of the separated section of vertical stabilizer rear spar had twisting deformation. The upper portion of the rudder with the counterweight was separated and included a section of the rudder spar with the upper hinge point. The hinge rod end bearing was intact, and the hinge brackets were pulled from the vertical stabilizer. The center portion of the rudder was separated and fractured into two pieces. A section of the right center rudder skin was not recovered. The lower half of the rudder below the center hinge was separated mostly intact. The center hinge rod end bearing remained attached to the rudder and the hinge brackets remained attached to the vertical stabilizer spar. The hinge bolt was fractured and not recovered. The rudder trailing edge was splayed open and there was evidence of sealant applied. The horizontal stabilizer and elevators remained attached to the fuselage and exhibited ground impact damage. The right wing remained attached to the fuselage, and the outboard portion had downward deformation.
