Fabian Salazar  
Air Safety Investigator  
Western Pacific Region

**Subject:** WPR22FA151 / Record of Conversation

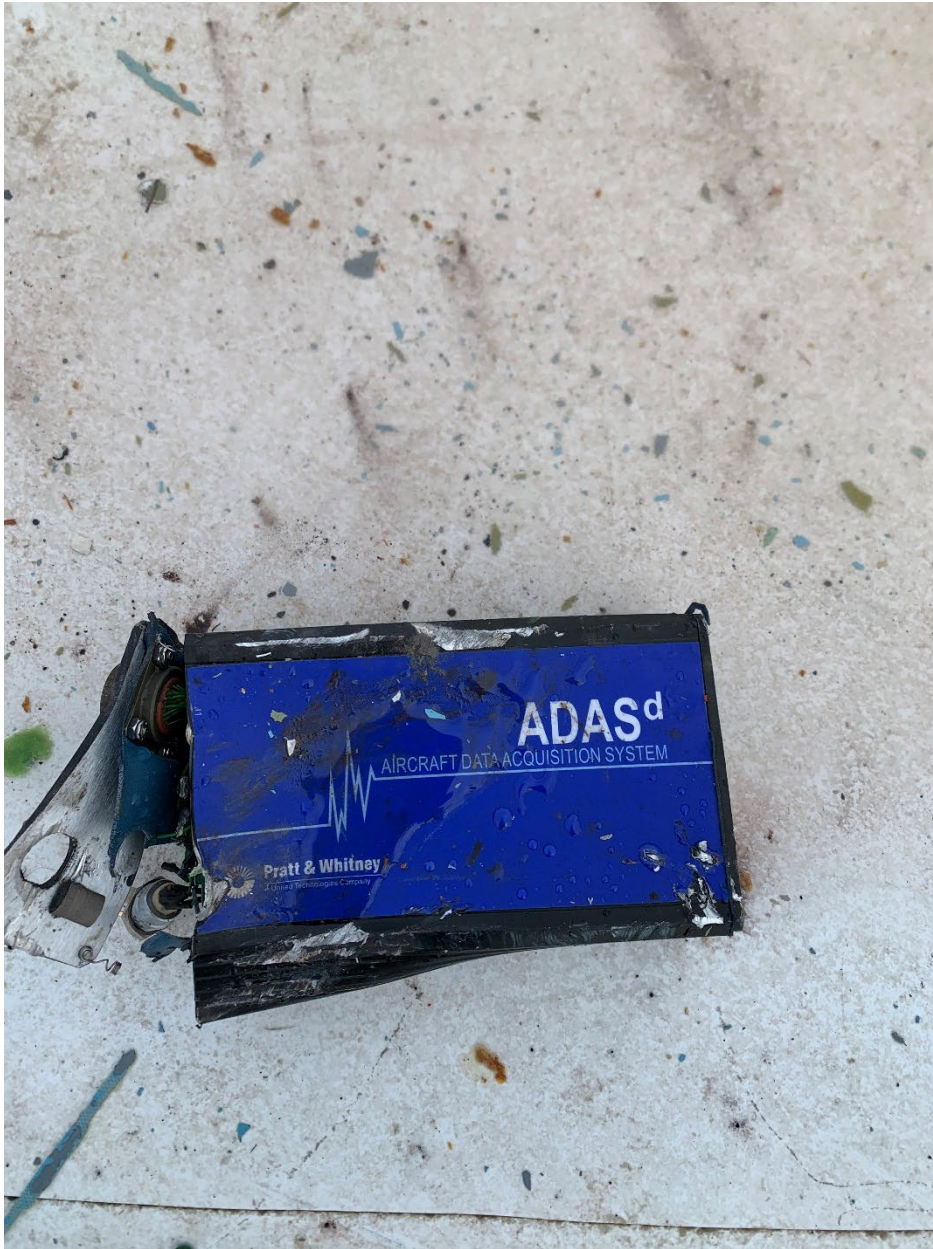
On April 19, 2023, about 1000 MDT, the IIC met with Mr. Duma and Mr. Ederer to discuss the engine Aircraft Data Acquisition System (ADAS), Figure 1 and 2, data download and the engine examination conducted by Mr. Ederer.

Figure 1. ADAS box recovered from the accident.

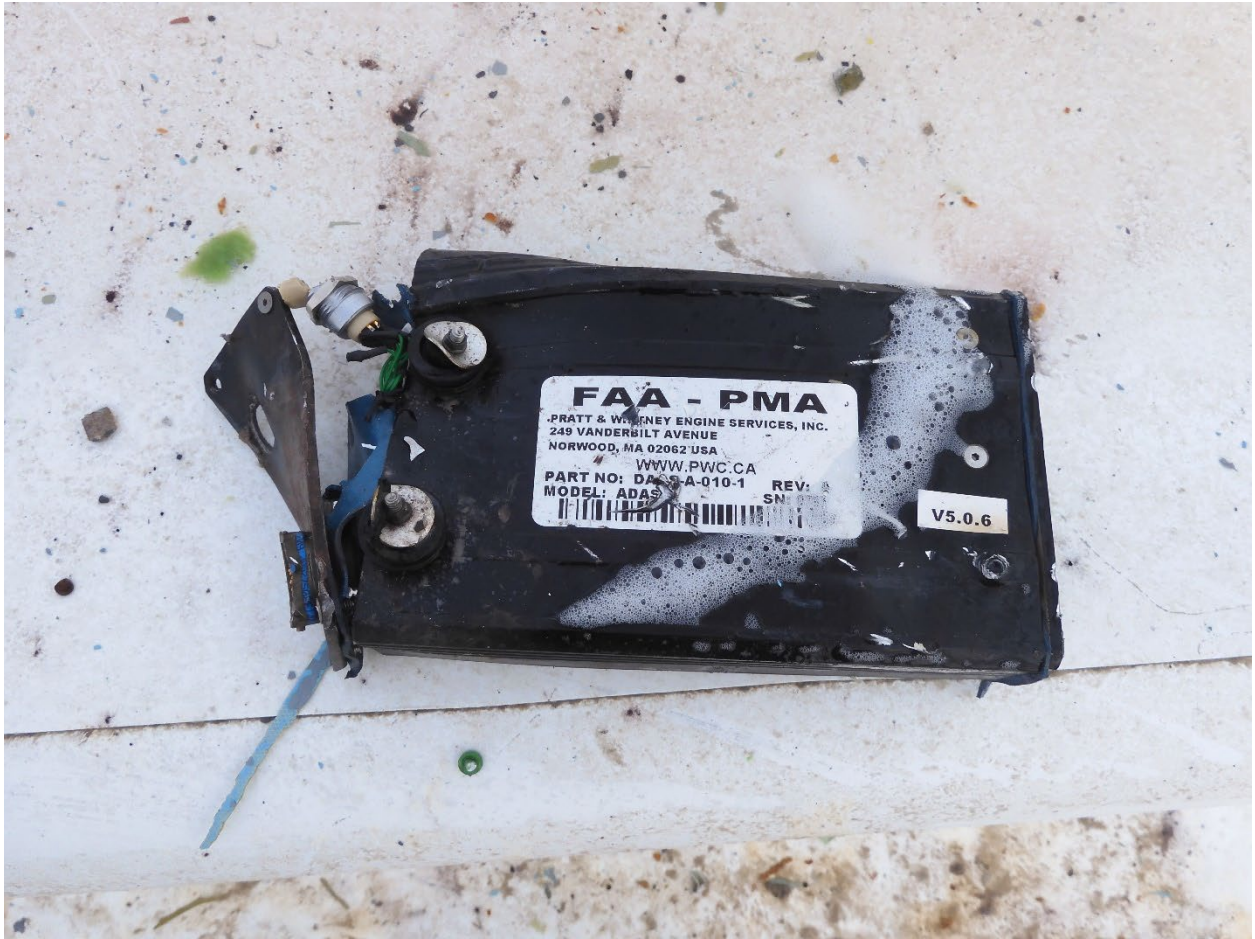
Figure 2. Back of ADAS box.
