# National Transportation Safety Board

WPR22FA151

## AIRCRAFT PERFORMANCE STUDY

Location: Heyburn, Idaho  
Date: April 13, 2022  
Time: 08:32 Mountain Daylight Time (MDT)  
14:32 Coordinated Universal Time (UTC)  
Airplane: Cessna 208B, registration N928JP

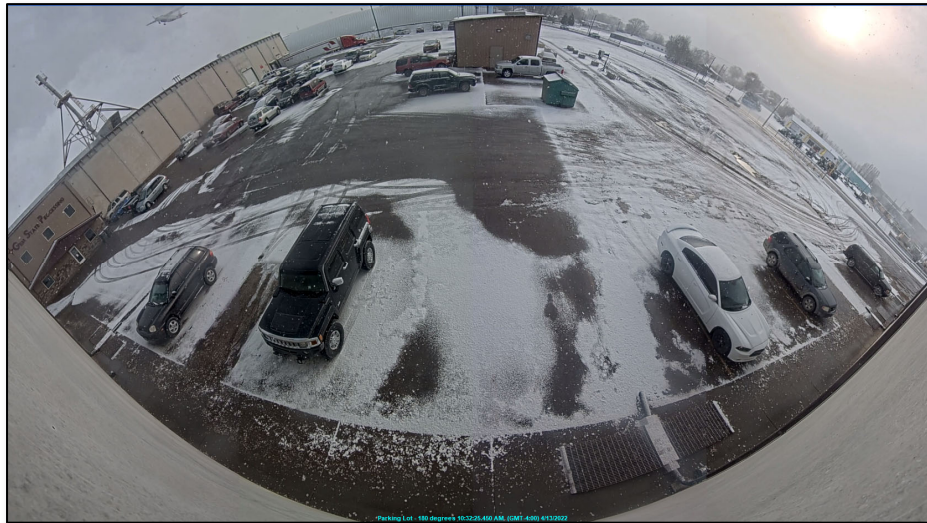
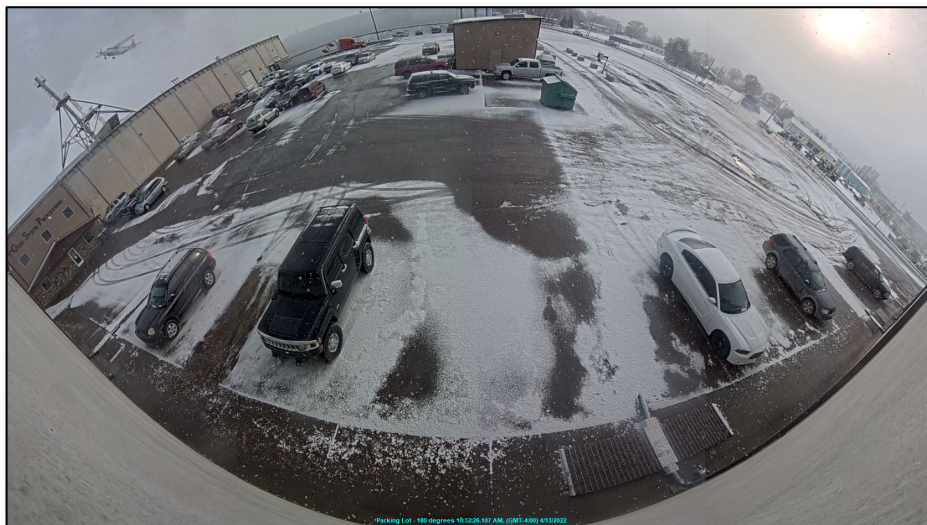
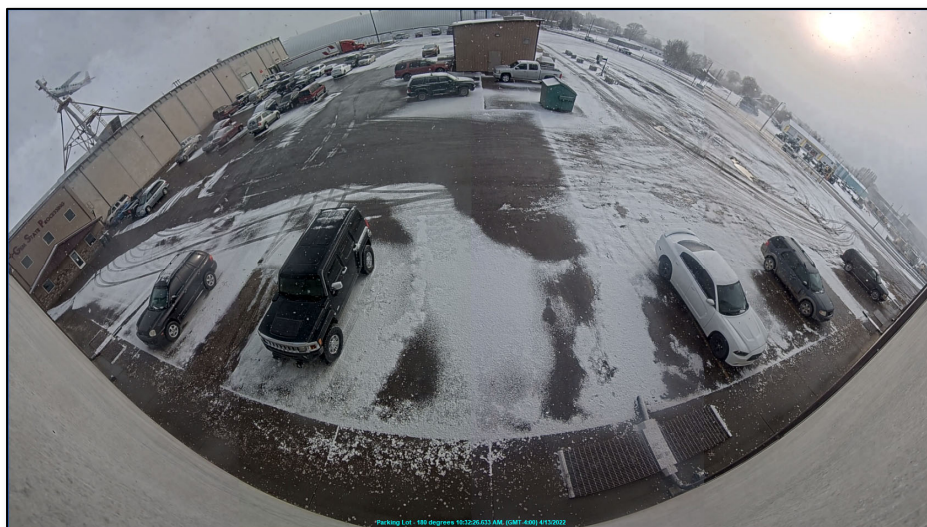
Video footage recovered from a security camera located on a processing plant revealed a view of the rooftop of the processing plant, along with an exhaust stack supported by steel framework on the roof. Snow was observed falling. About 08:32:25, the airplane came into view in a wings-level, nose-high descent. The airplane struck the exhaust stack at 08:32:26.6 and fell to the rooftop.

**Figure 6.** Surveillance video frames showing N928JP approaching and impacting the agglomerator exhaust stack.

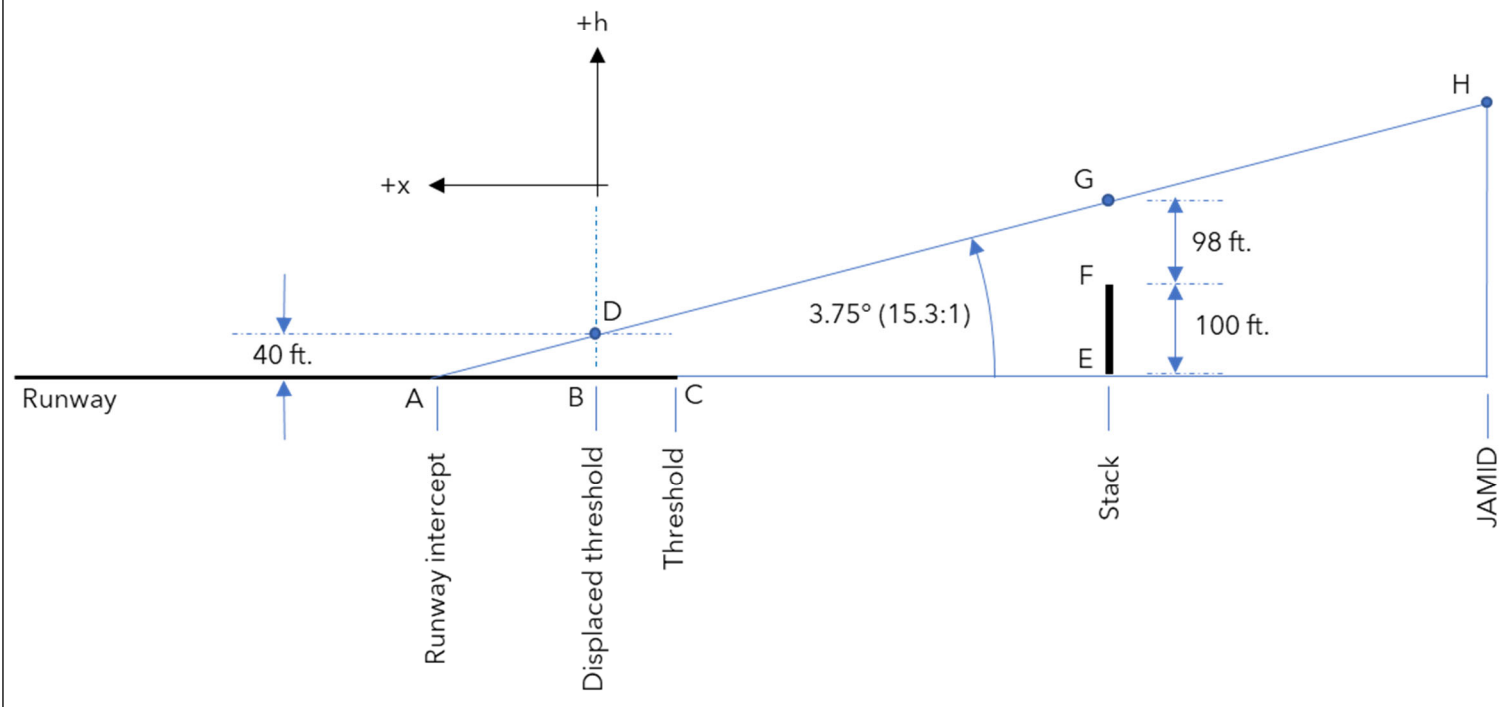
The elevation of the processing plant and the height of six of the plant's exhaust stacks ("drum" stacks) above the ground were measured during a survey requested by the NTSB. The latitude and longitude of the exhaust stack impacted by N928JP (the "agglomerator stack") was determined from satellite imagery of the plant in *Google Earth*. An "aeronautical study" of the potato plant exhaust stacks conducted by the FAA in 2016 indicates that the drum stacks and the agglomerator stacks are the same height, and the elevations and heights noted in the FAA study are consistent (within 2 ft.) with the results of the survey requested by the NTSB.

**Figure 7.** Profile view of runway and agglomerator exhaust stack geometry. x coordinates are from KBYI runway 20 displaced threshold.

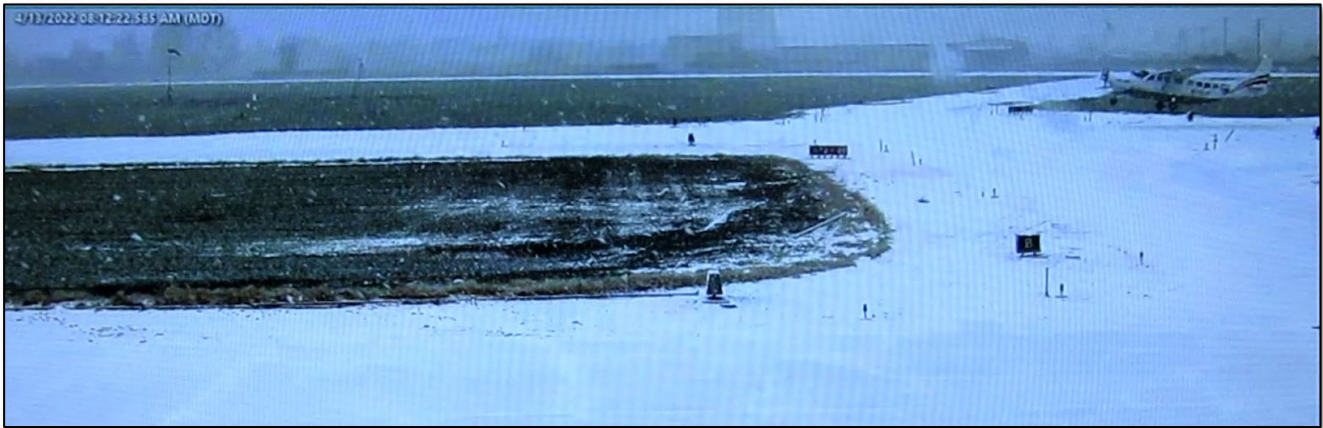
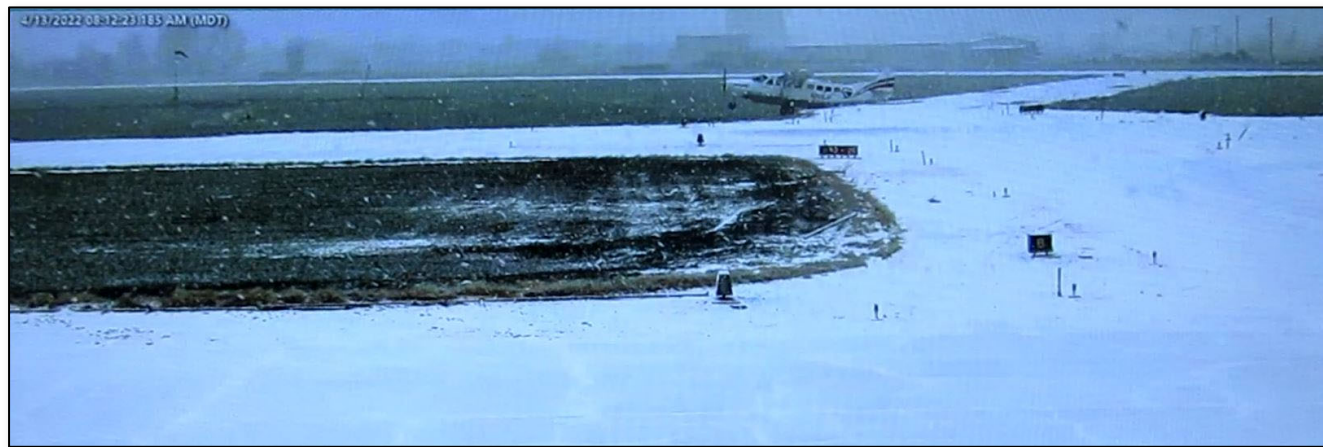
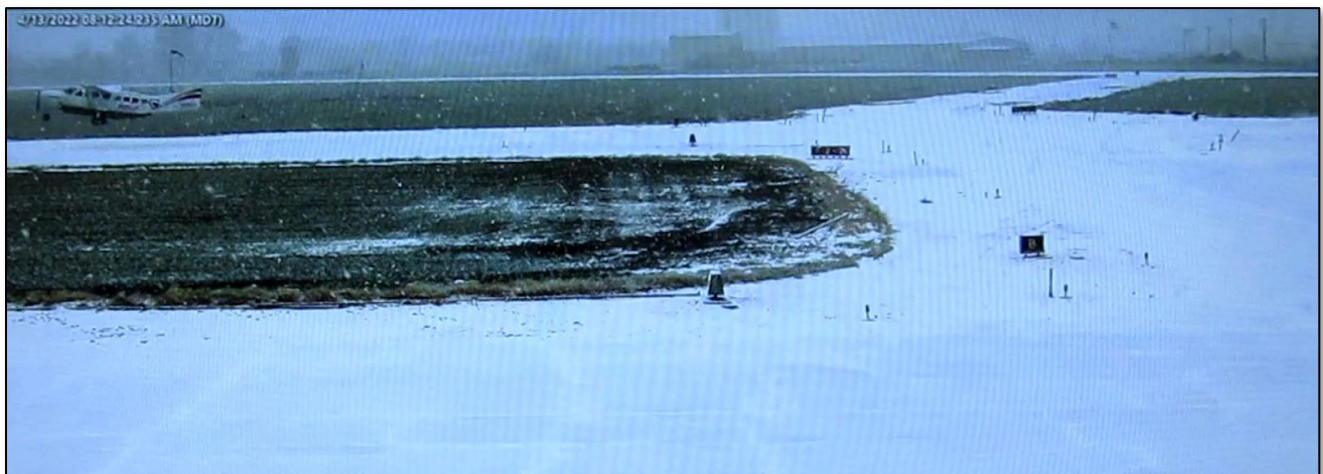
- The estimated trajectory for N928JP's first approach indicates that the airspeed over the displaced threshold was about 120 KCAS, too fast for an attempted landing. Given this high speed, it is possible that the pilot never intended to land following the first approach, but instead only meant to "[circle] over the airport to check the winds and runway condition" as suggested in the Gem Air FMD document. However, the pilot did not communicate such an intention to ATC; an opportune time to have done so would have been at 08:07:27, after ATC transmitted IFR flight plan cancellation instructions. Instead, the pilot asked ATC for the Twin Falls Tower phone number, which suggests that she was anticipating cancelling her flight plan on the ground.

**Figure 9.** Surveillance video frames showing N928JP flying over KBYI runway 20.

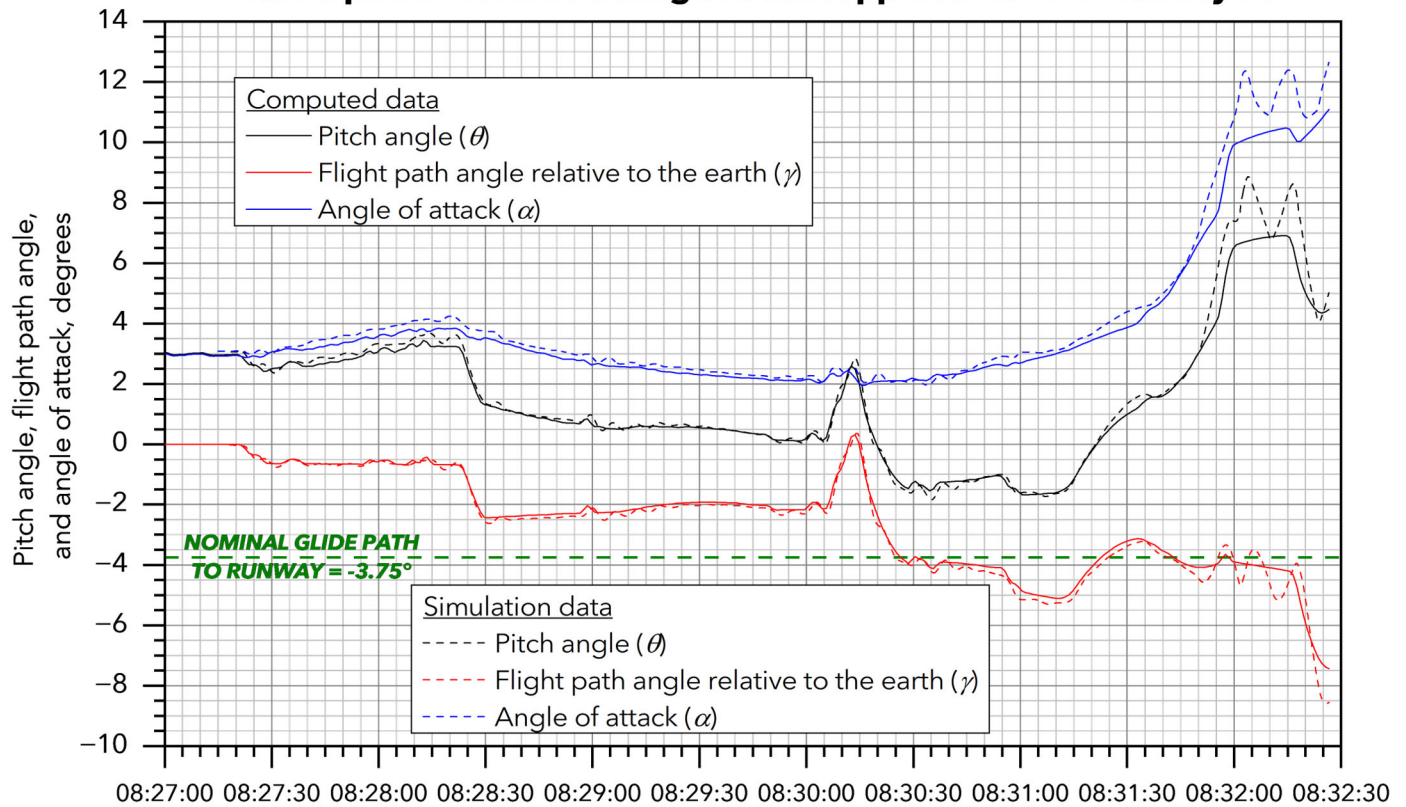
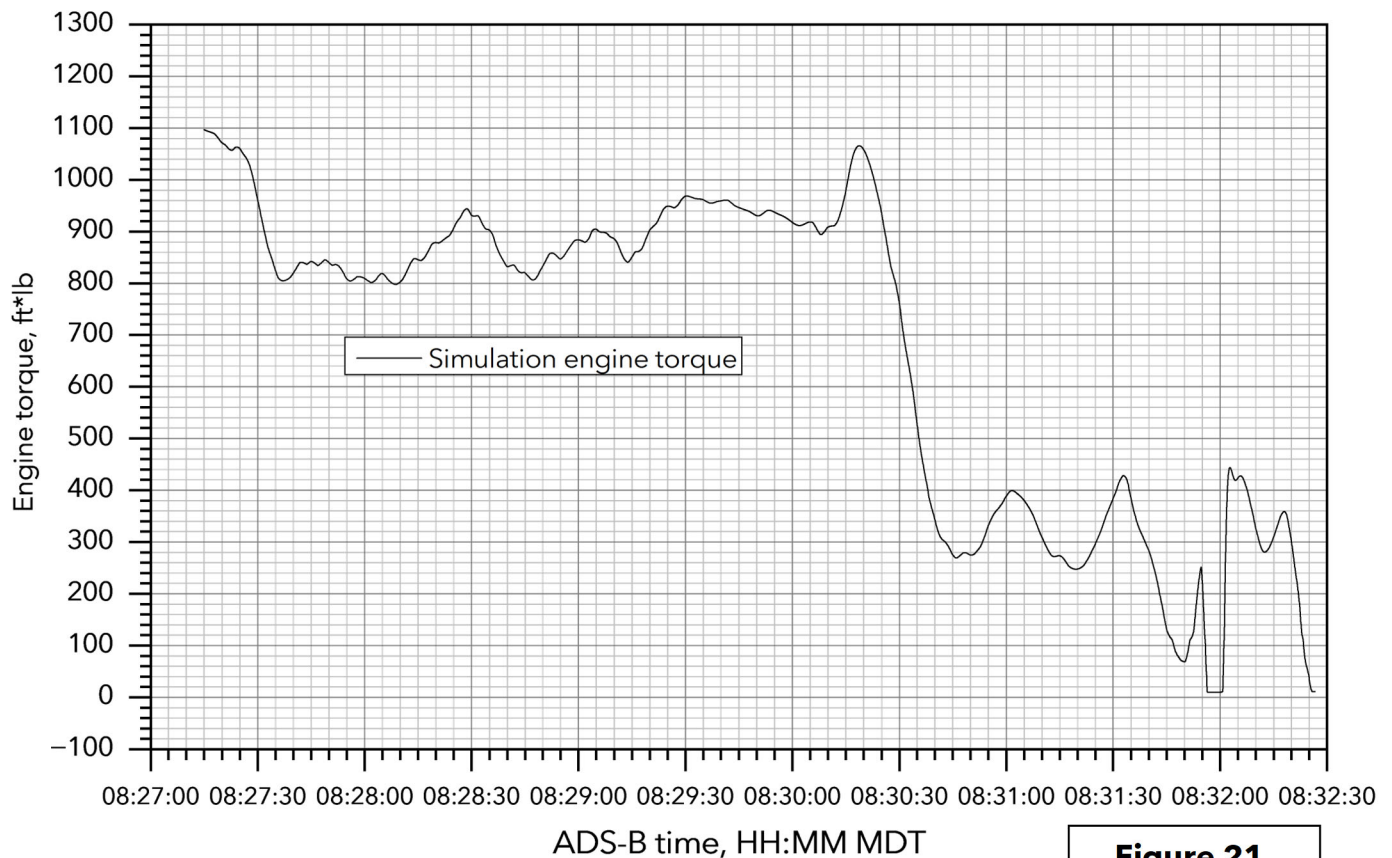
Figure 21.

As noted above, the reduction in pitch angle from about  $7^\circ$  to  $4.5^\circ$  at 08:32:15 (0.7 nm from the displaced threshold) shown in Figures 21 & 22, resulting in a steepening flight path angle, might reflect the pilot's response to a possible activation of the stall warning horn as the  $C_L$  increased into the range in which the horn could be activated (see Figure 25).

## Pitch & power vs. time during accident approach to KBYI runway 20

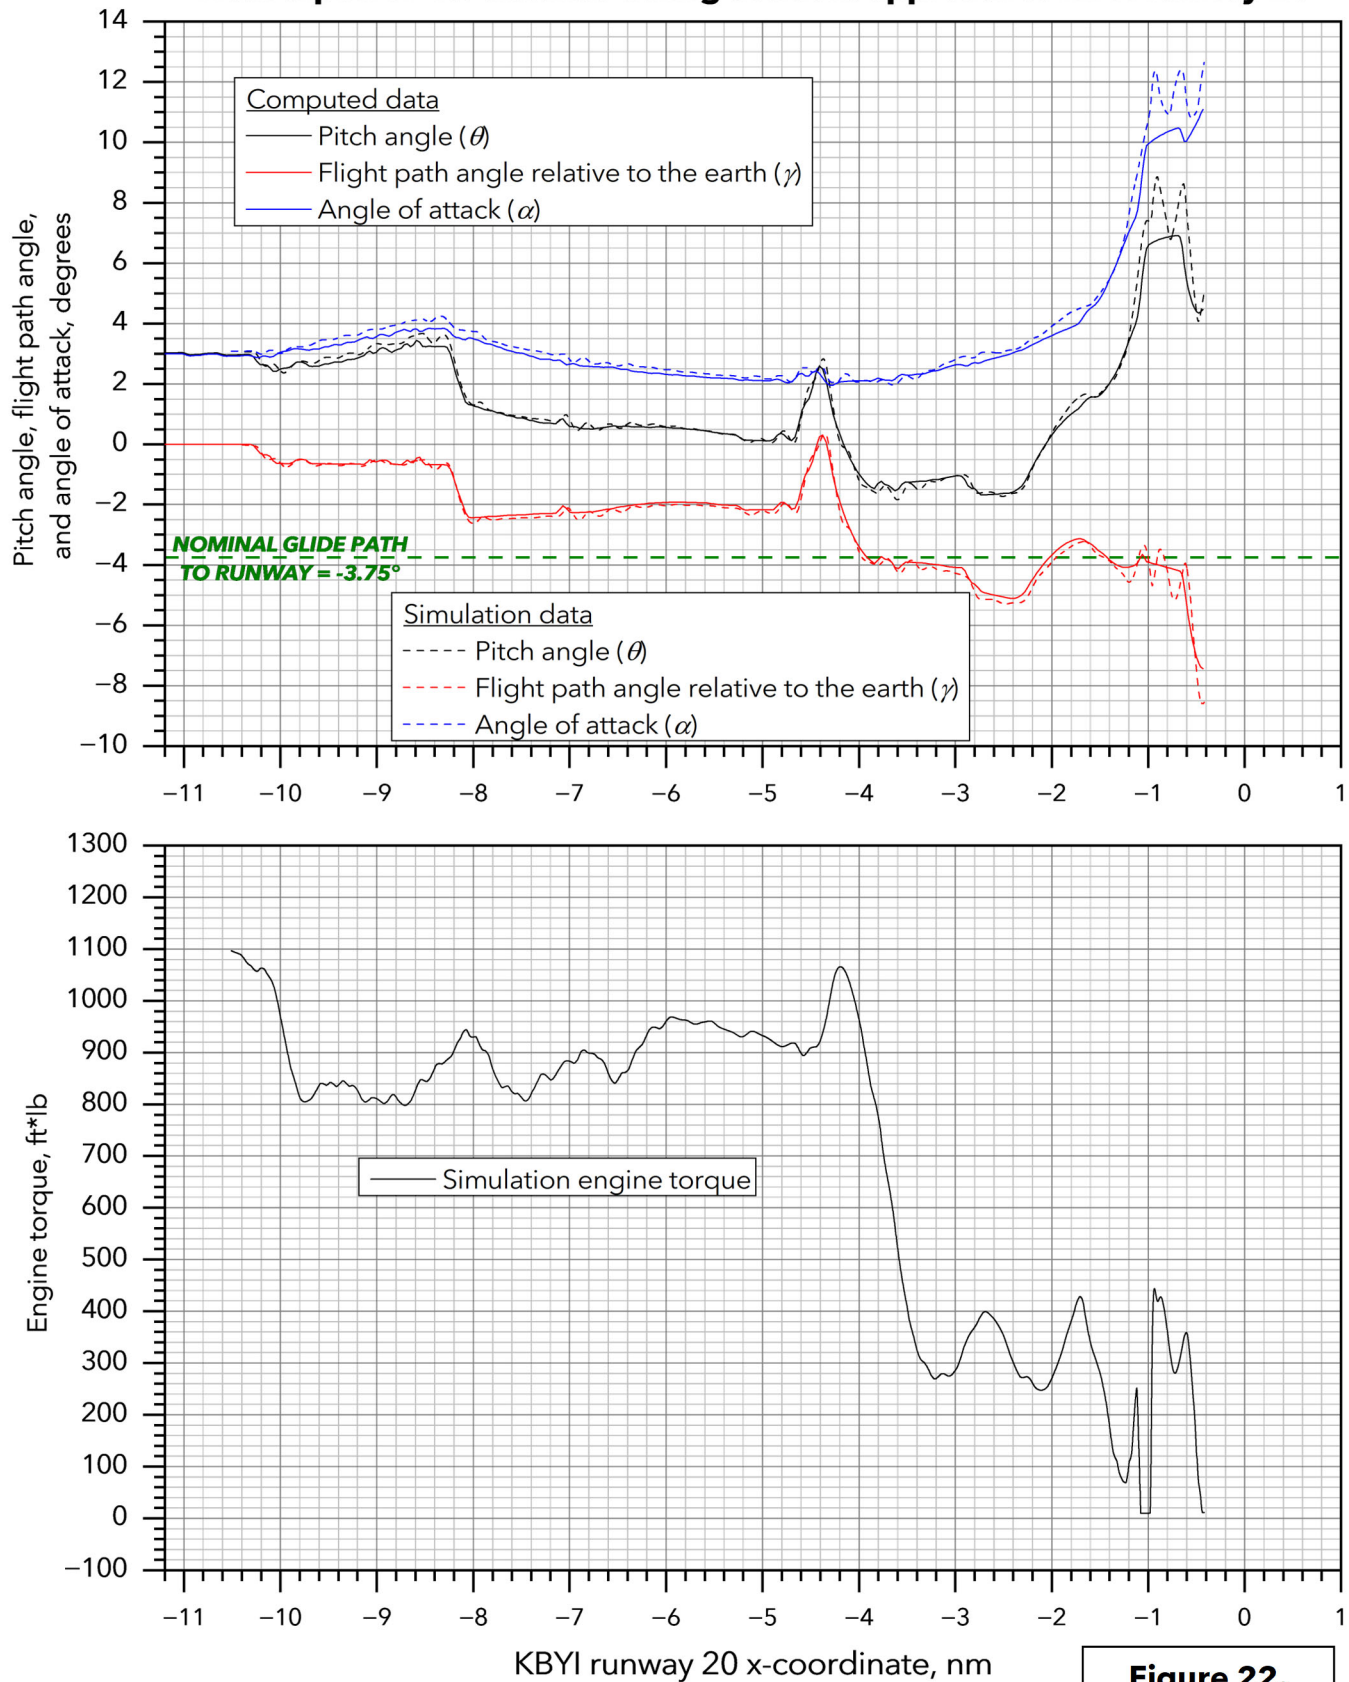
**Figure 22.**

## Pitch & power vs. distance during accident approach to KBYI runway 20

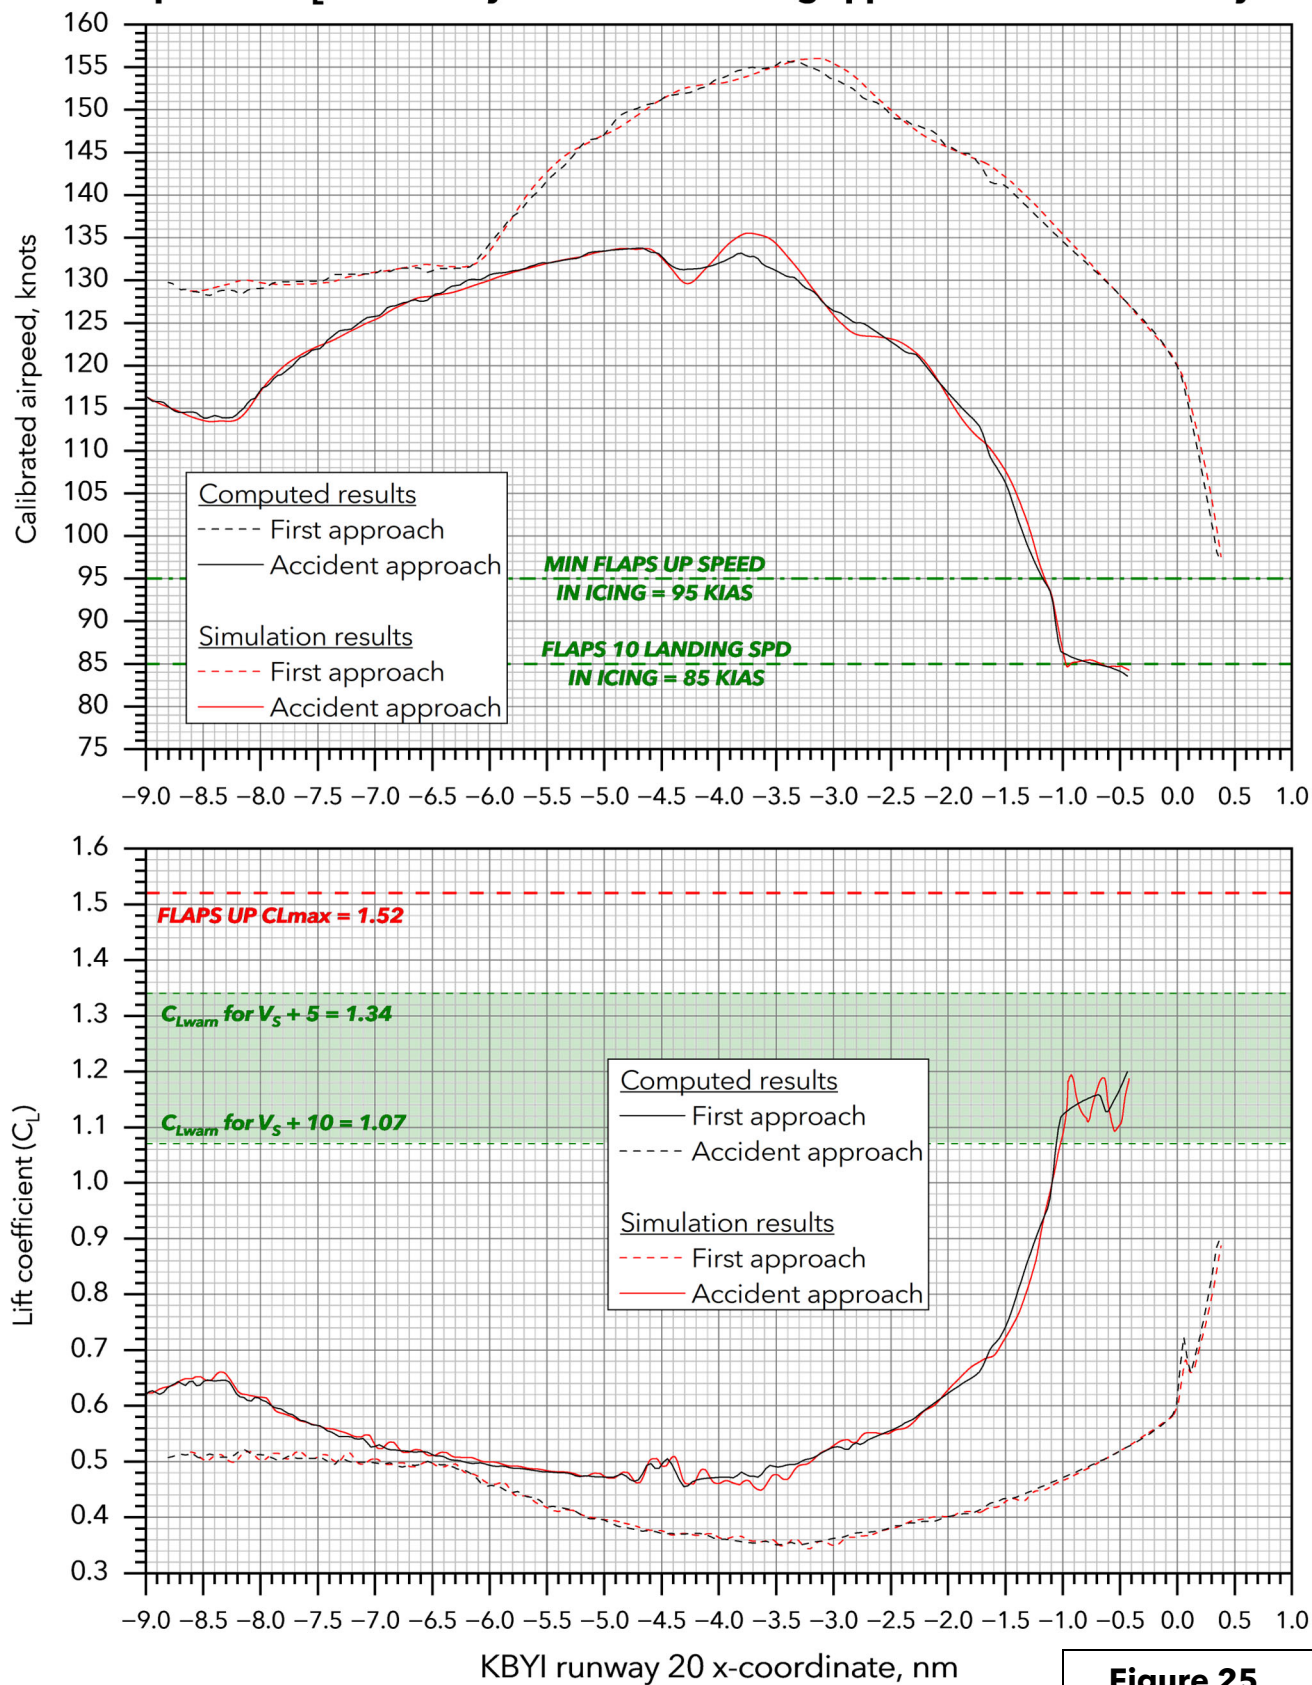
**Figure 25.**

## Speeds & $C_L$ vs. runway x coordinate during approaches to KBYI runway 20

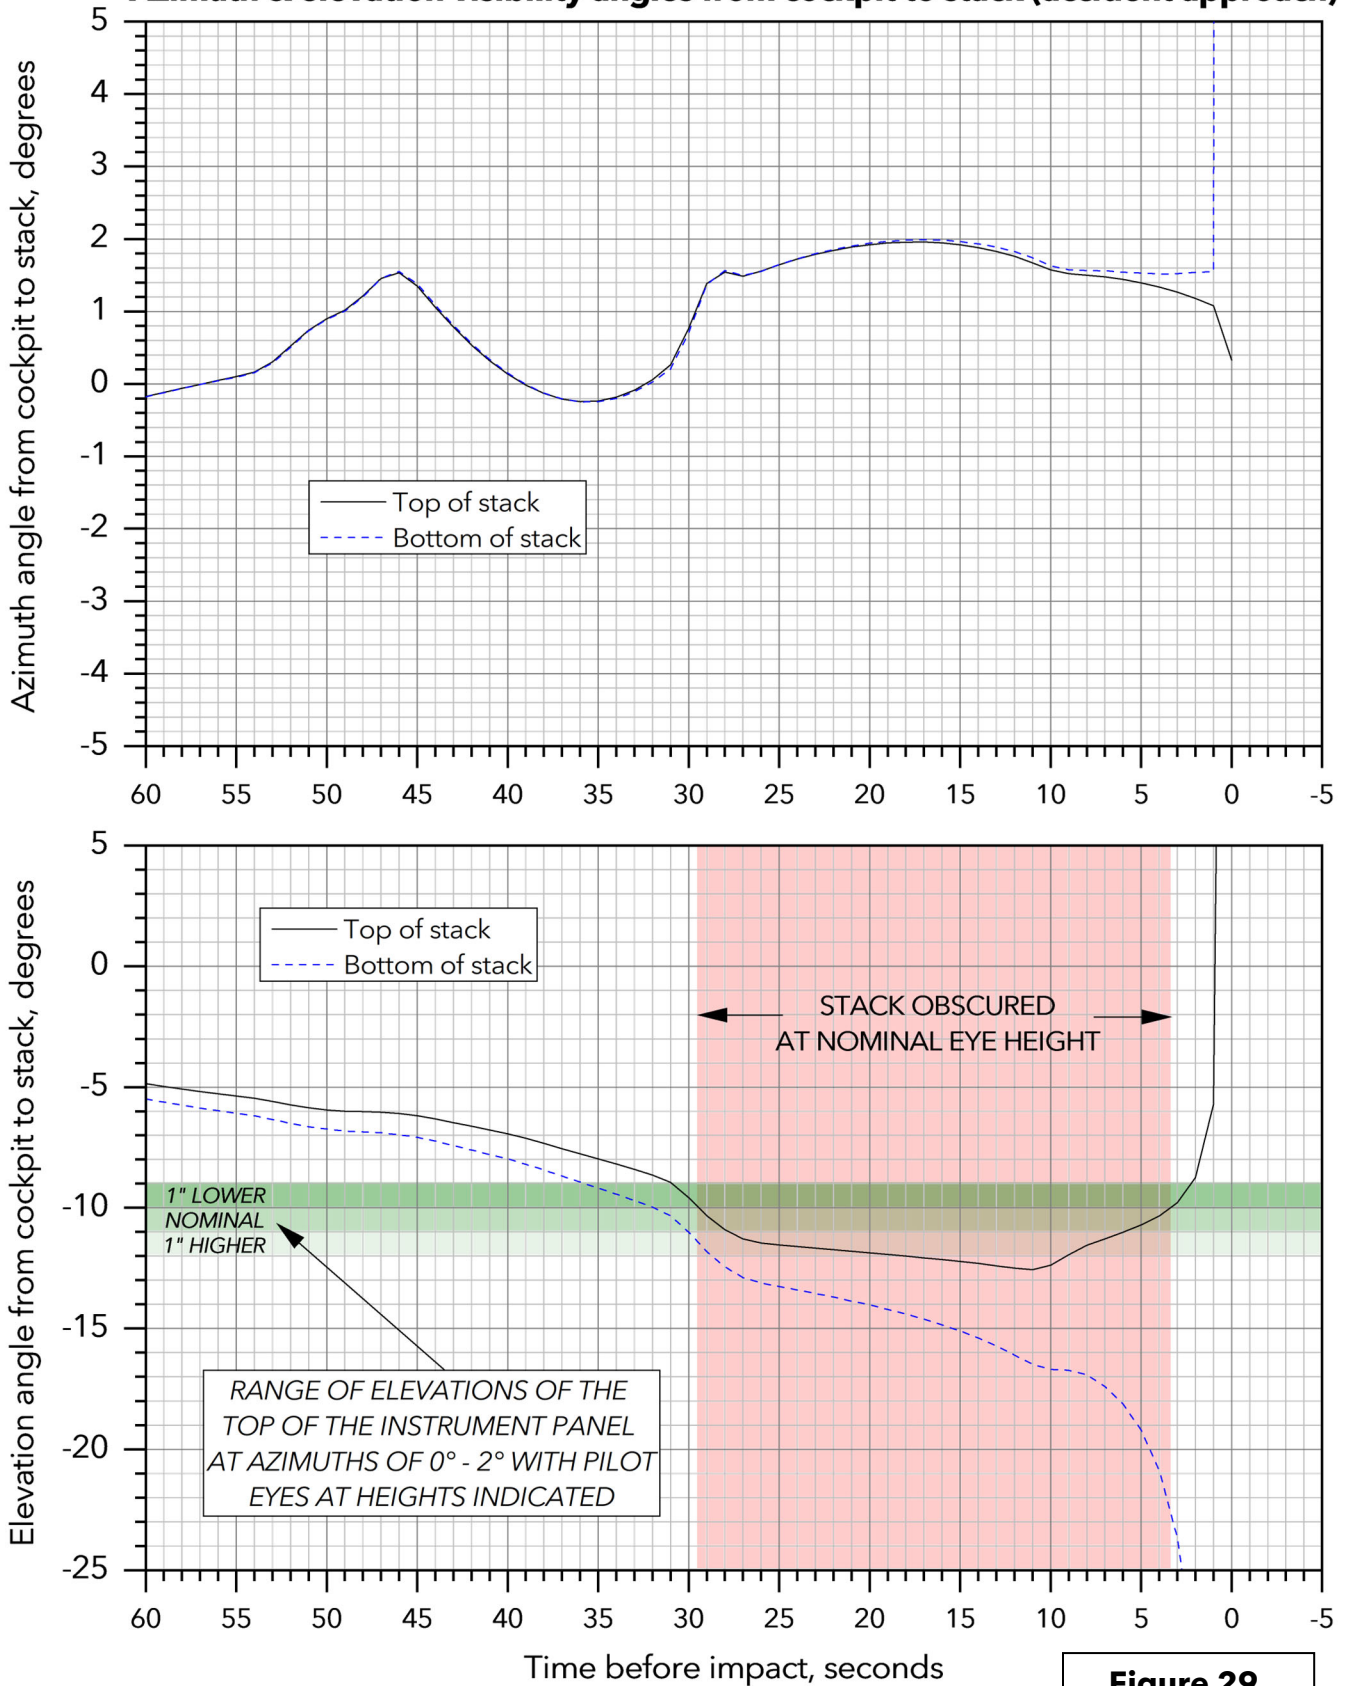
**Figure 29.**

As noted above, variations in the height of the pilot's eyes will affect the elevation angles of the top of the cowl and instrument panel. The green bands labeled '1" lower' and '1" higher' in Figure 29 show this effect; raising or lowering the pilot's eyes shifts the elevation angle of the top of the panel by about  $1^\circ$ , which in turn affects the times at which the exhaust stack is obscured by the cowl and / or instrument panel.

Figures 29 & 30 indicate that between 60 and 30 seconds before impact, the exhaust stack would not have been obscured by the airplane structure, but might have been too small (or too distant in limited atmospheric visibility) to be noticed. Between 30 and 3.3 seconds before impact, the stack might have been totally obscured by the cockpit structure, even though the runway likely remained visible. When the top of the stack became unobscured about 3 seconds before impact, it was likely too late for the pilot to recognize the hazard and take action to avoid the collision.

## Azimuth & elevation visibility angles from cockpit to stack (accident approach)
