# National Transportation Safety Board

WPR22FA151

## AIRCRAFT PERFORMANCE STUDY

Location: Heyburn, Idaho  
Date: April 13, 2022  
Time: 08:32 Mountain Daylight Time (MDT)  
14:32 Coordinated Universal Time (UTC)  
Airplane: Cessna 208B, registration N928JP

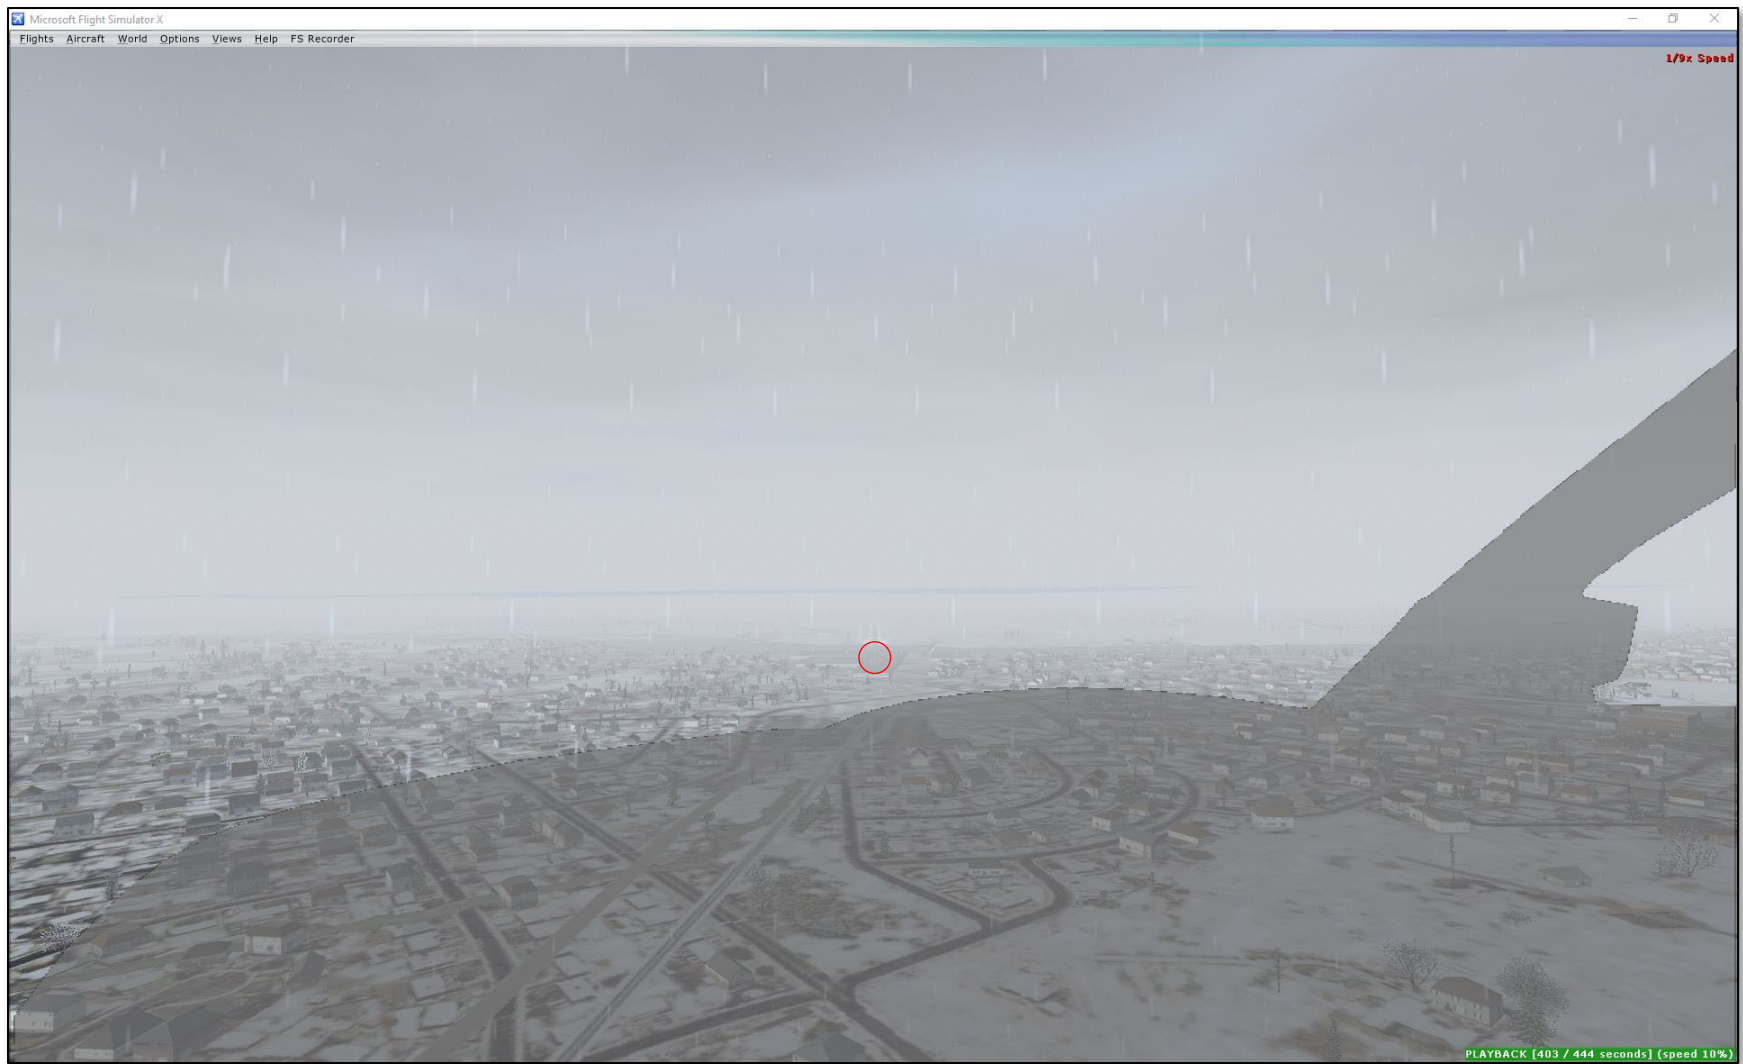
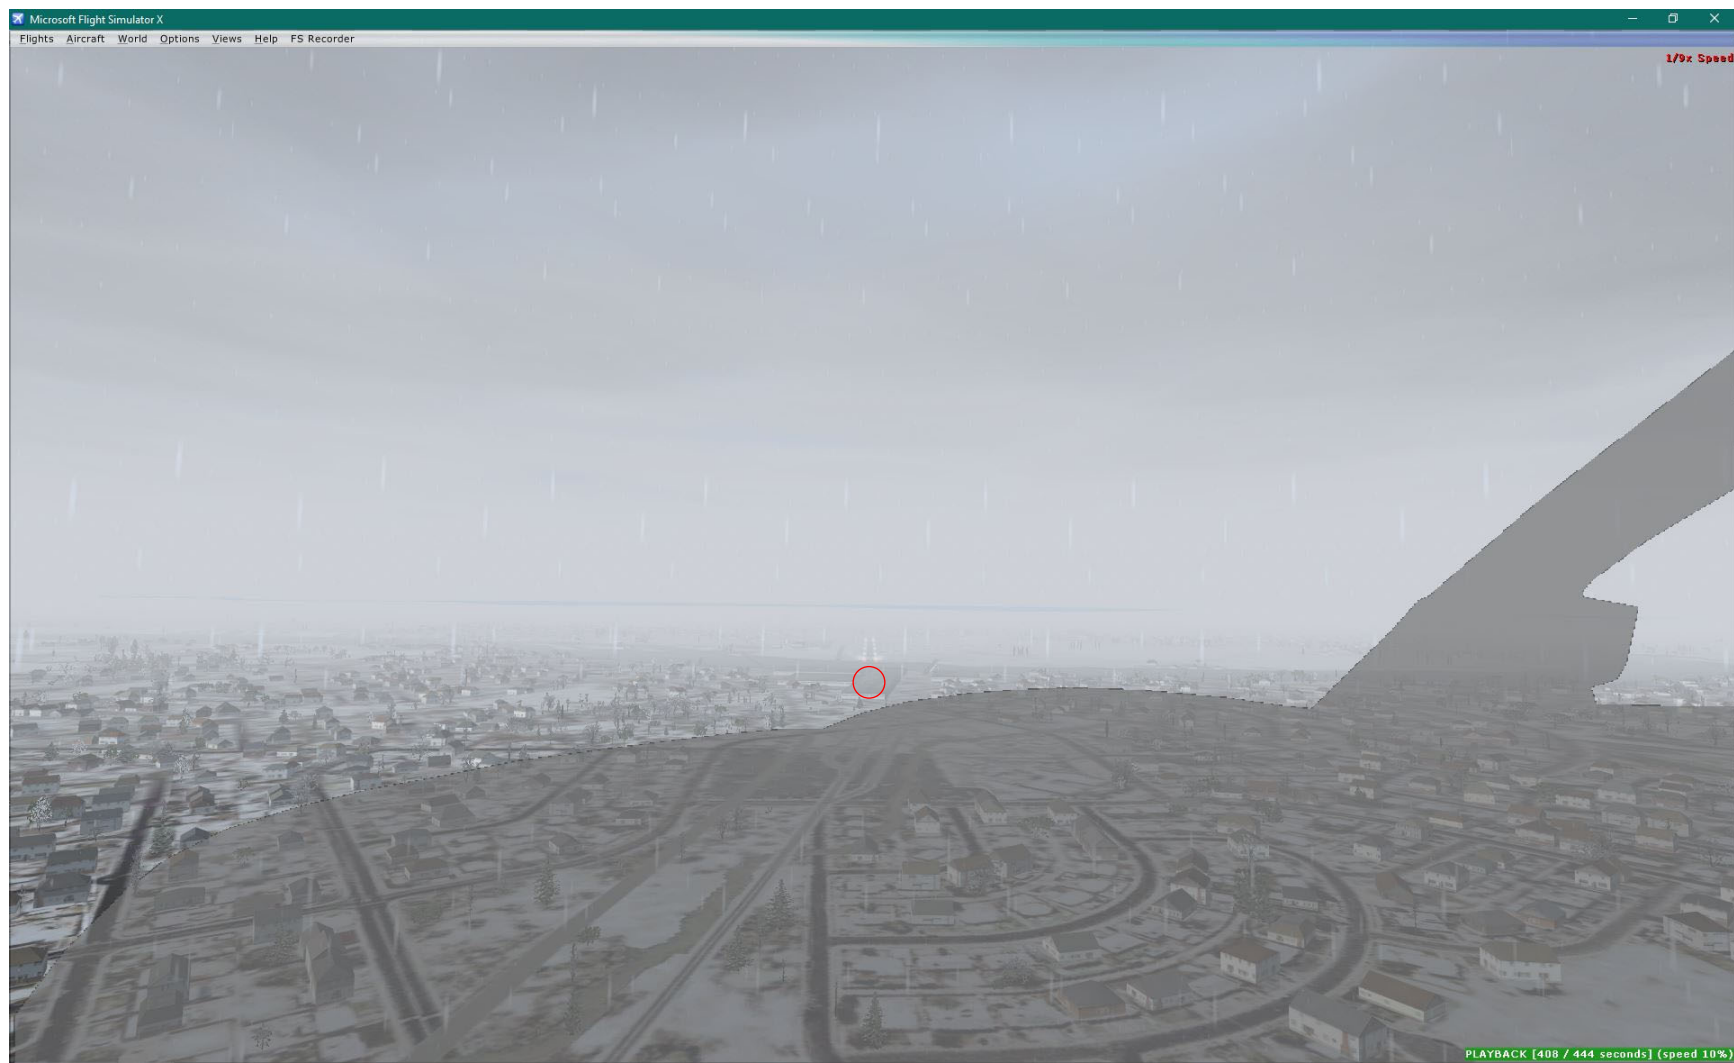
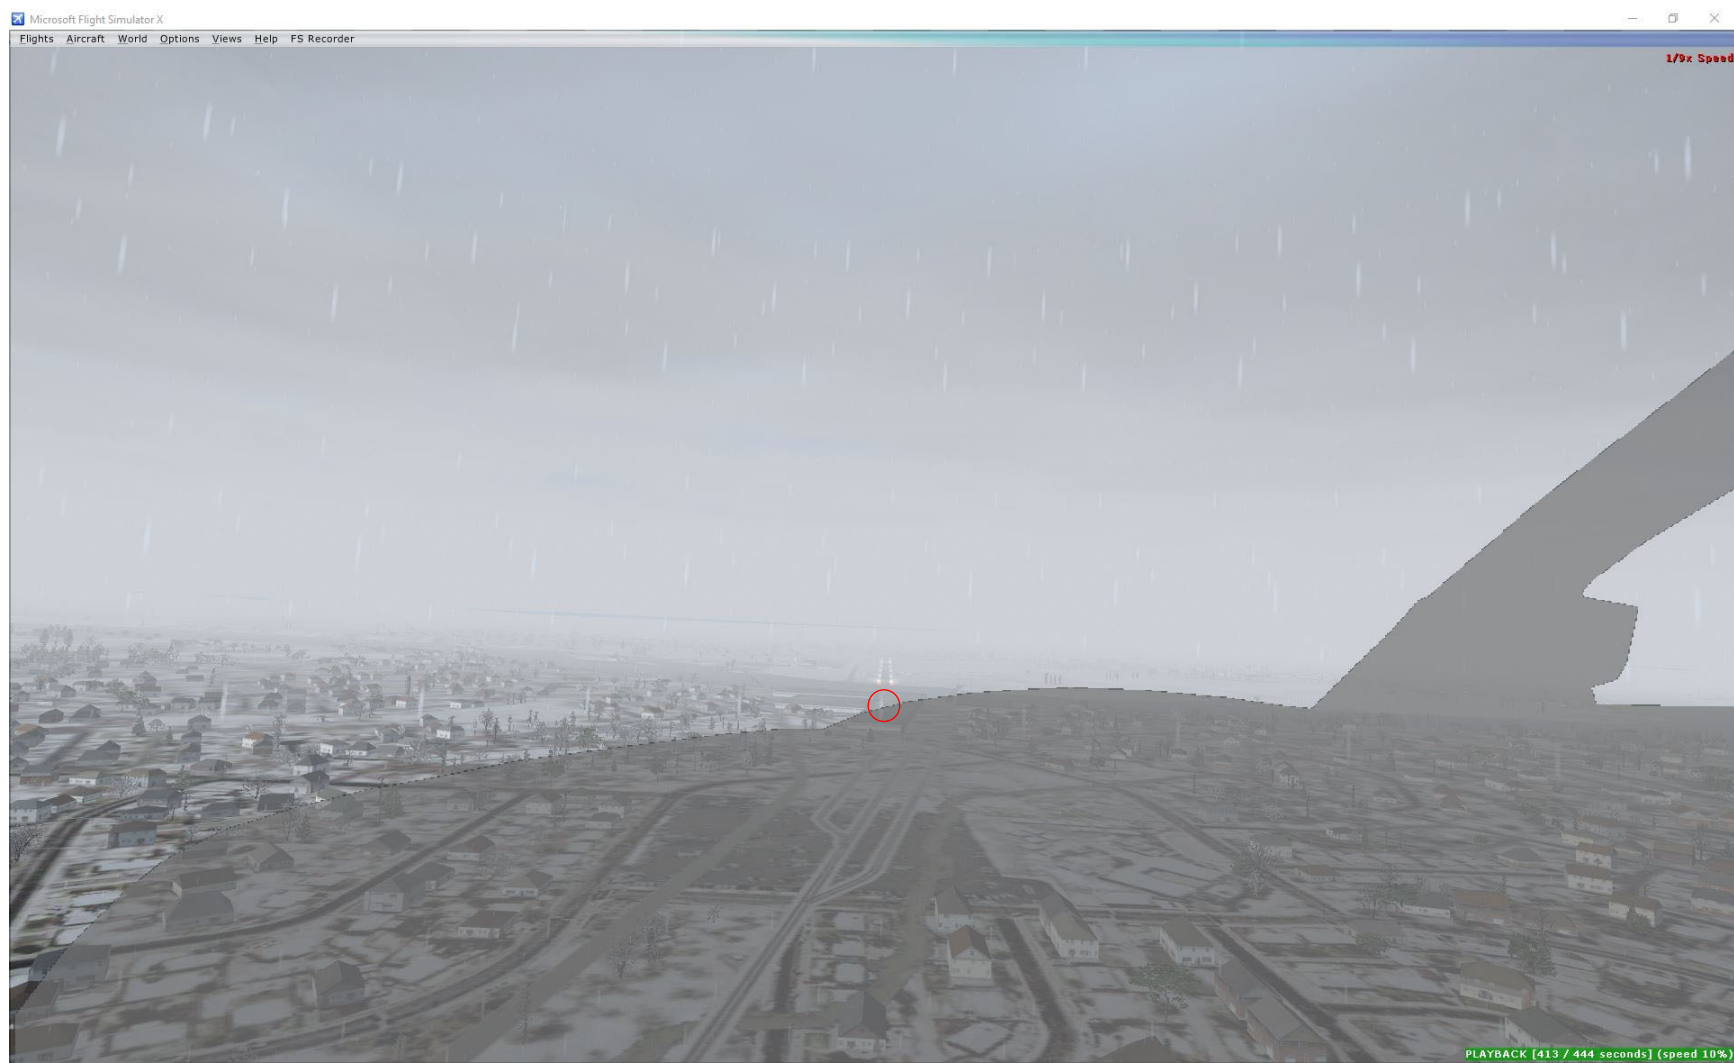
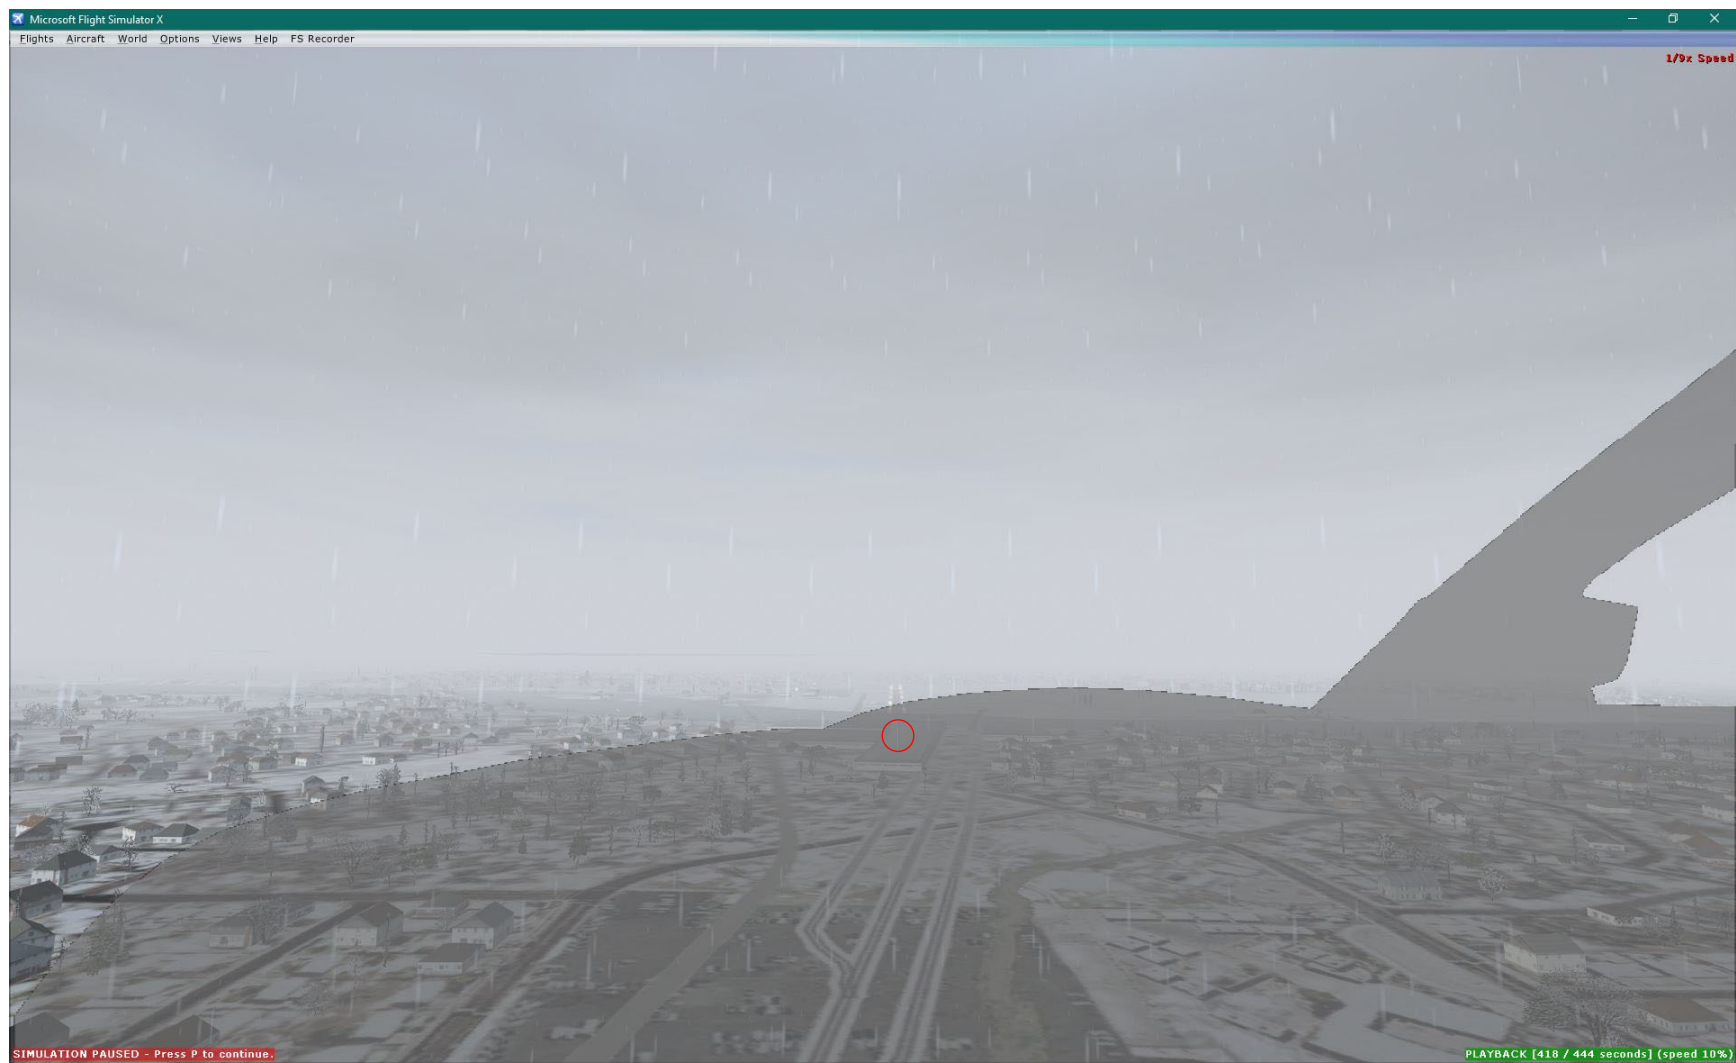
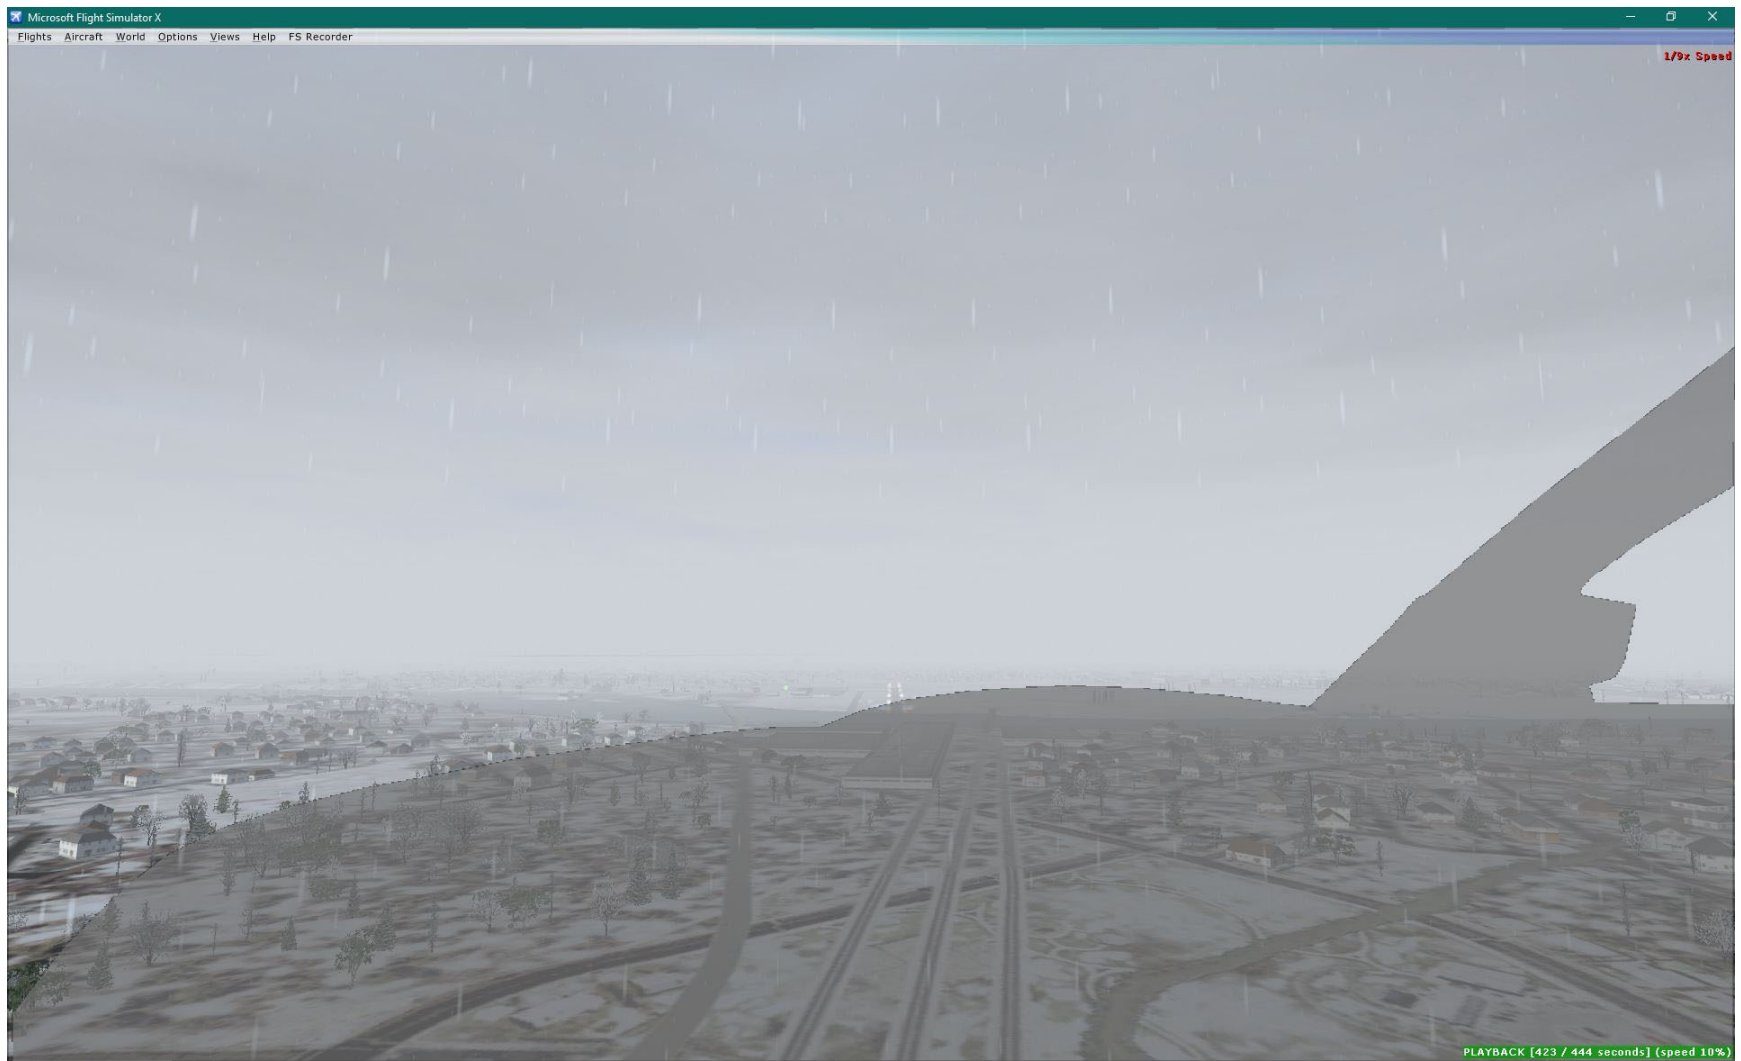
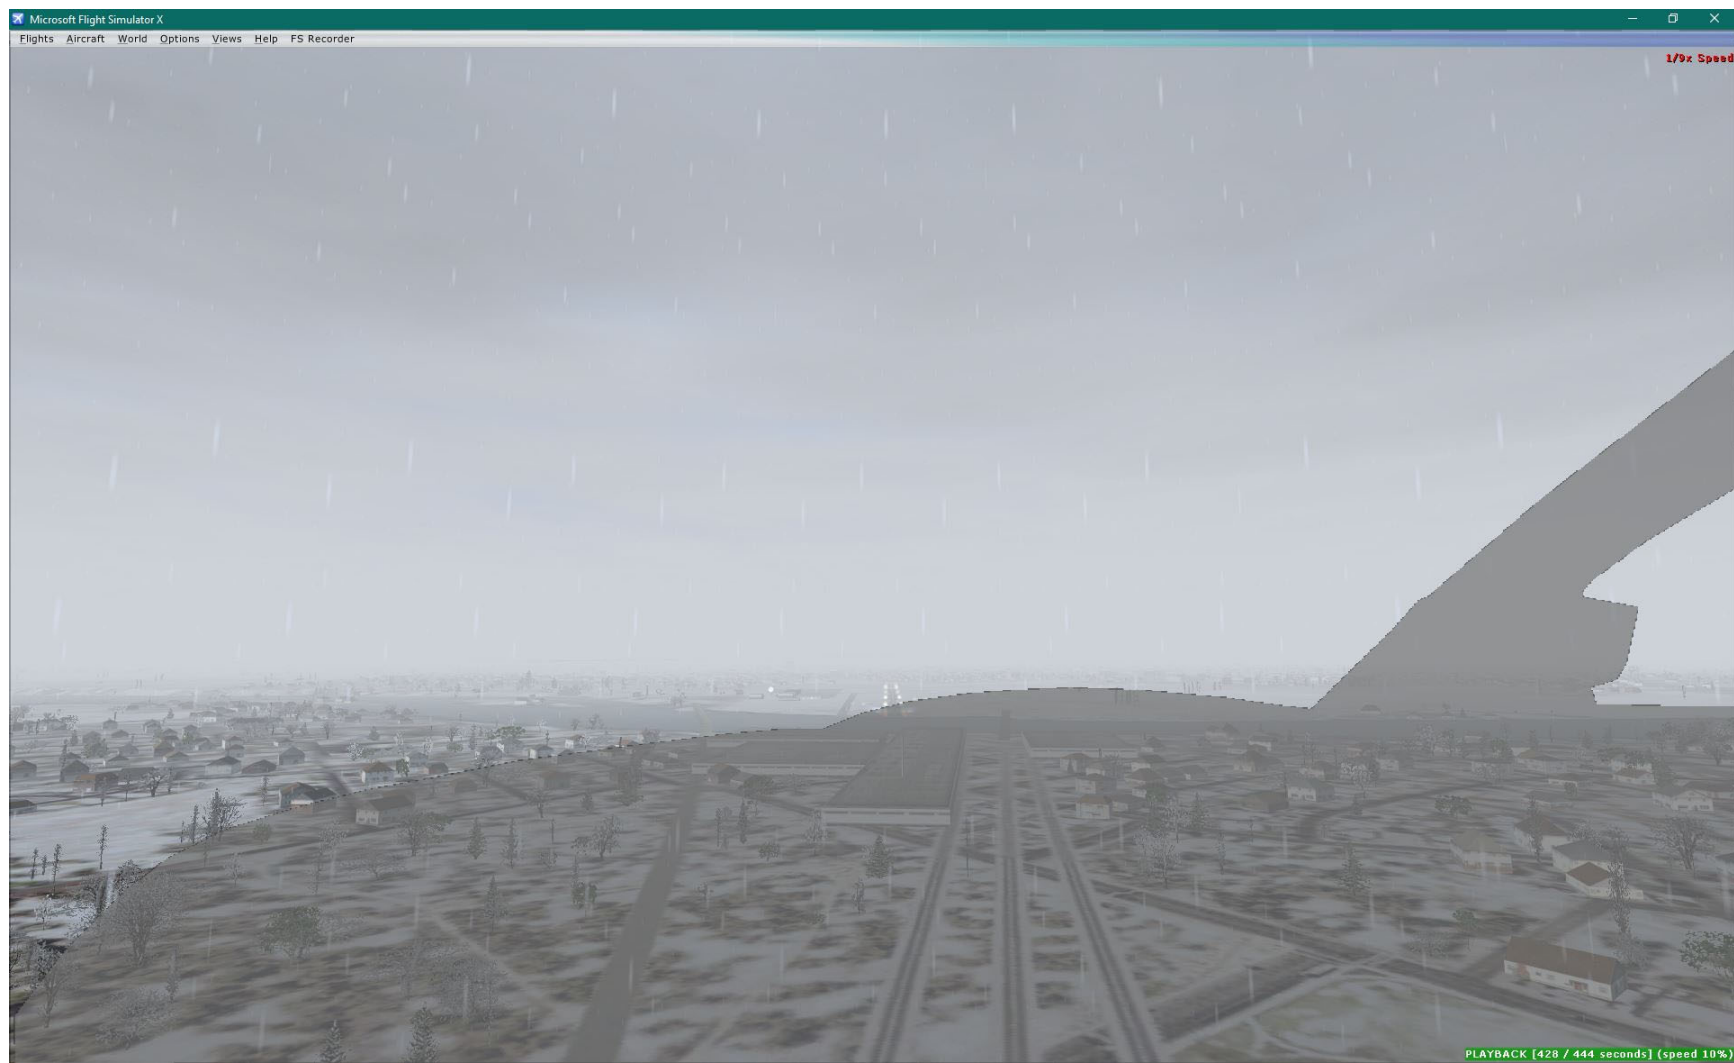
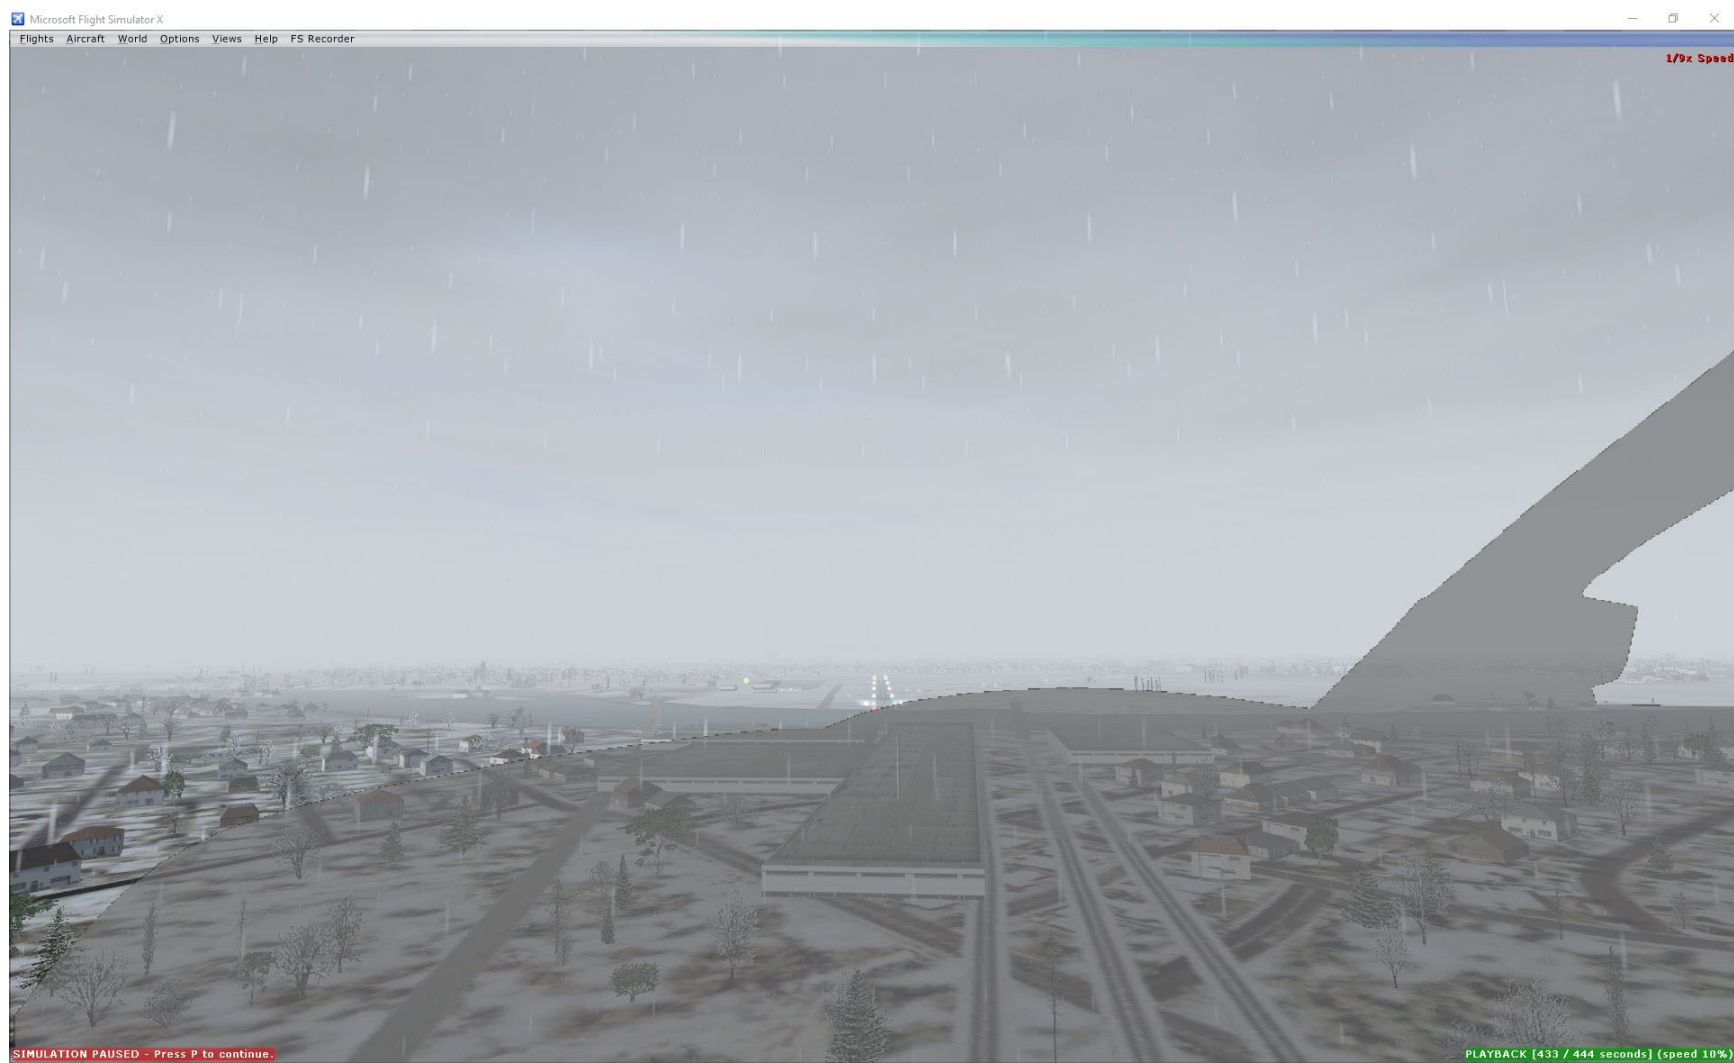
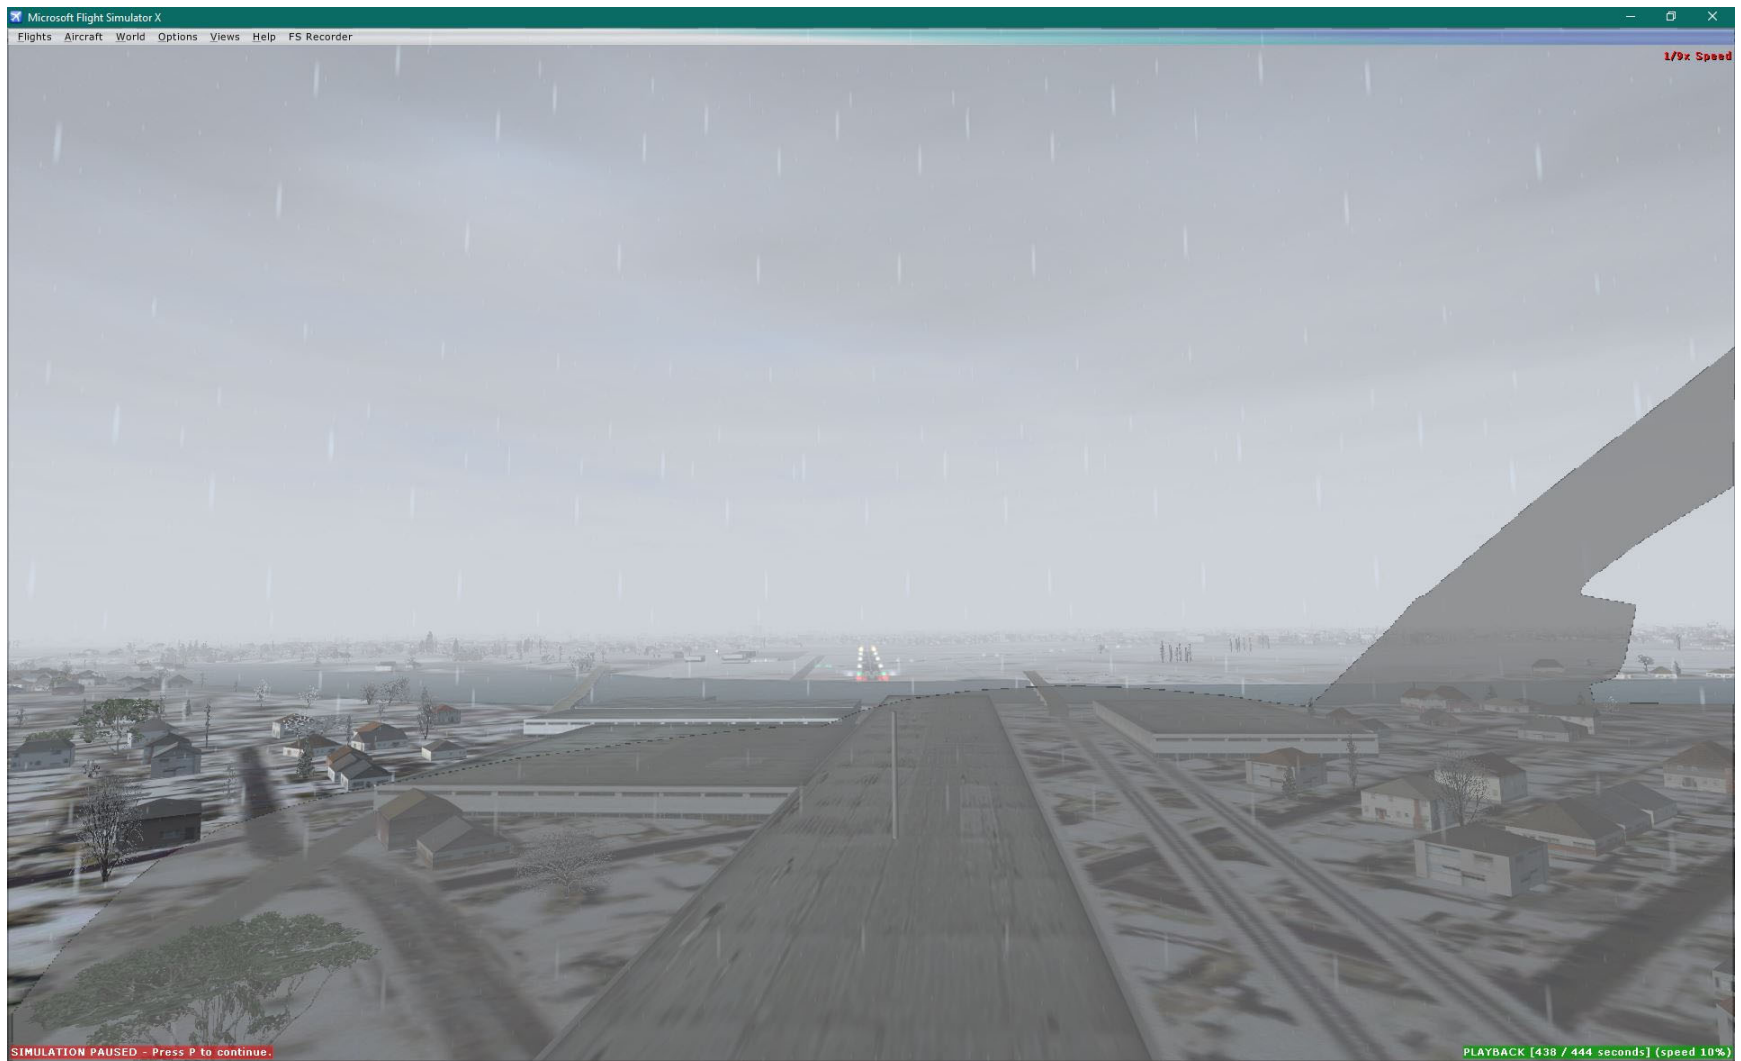
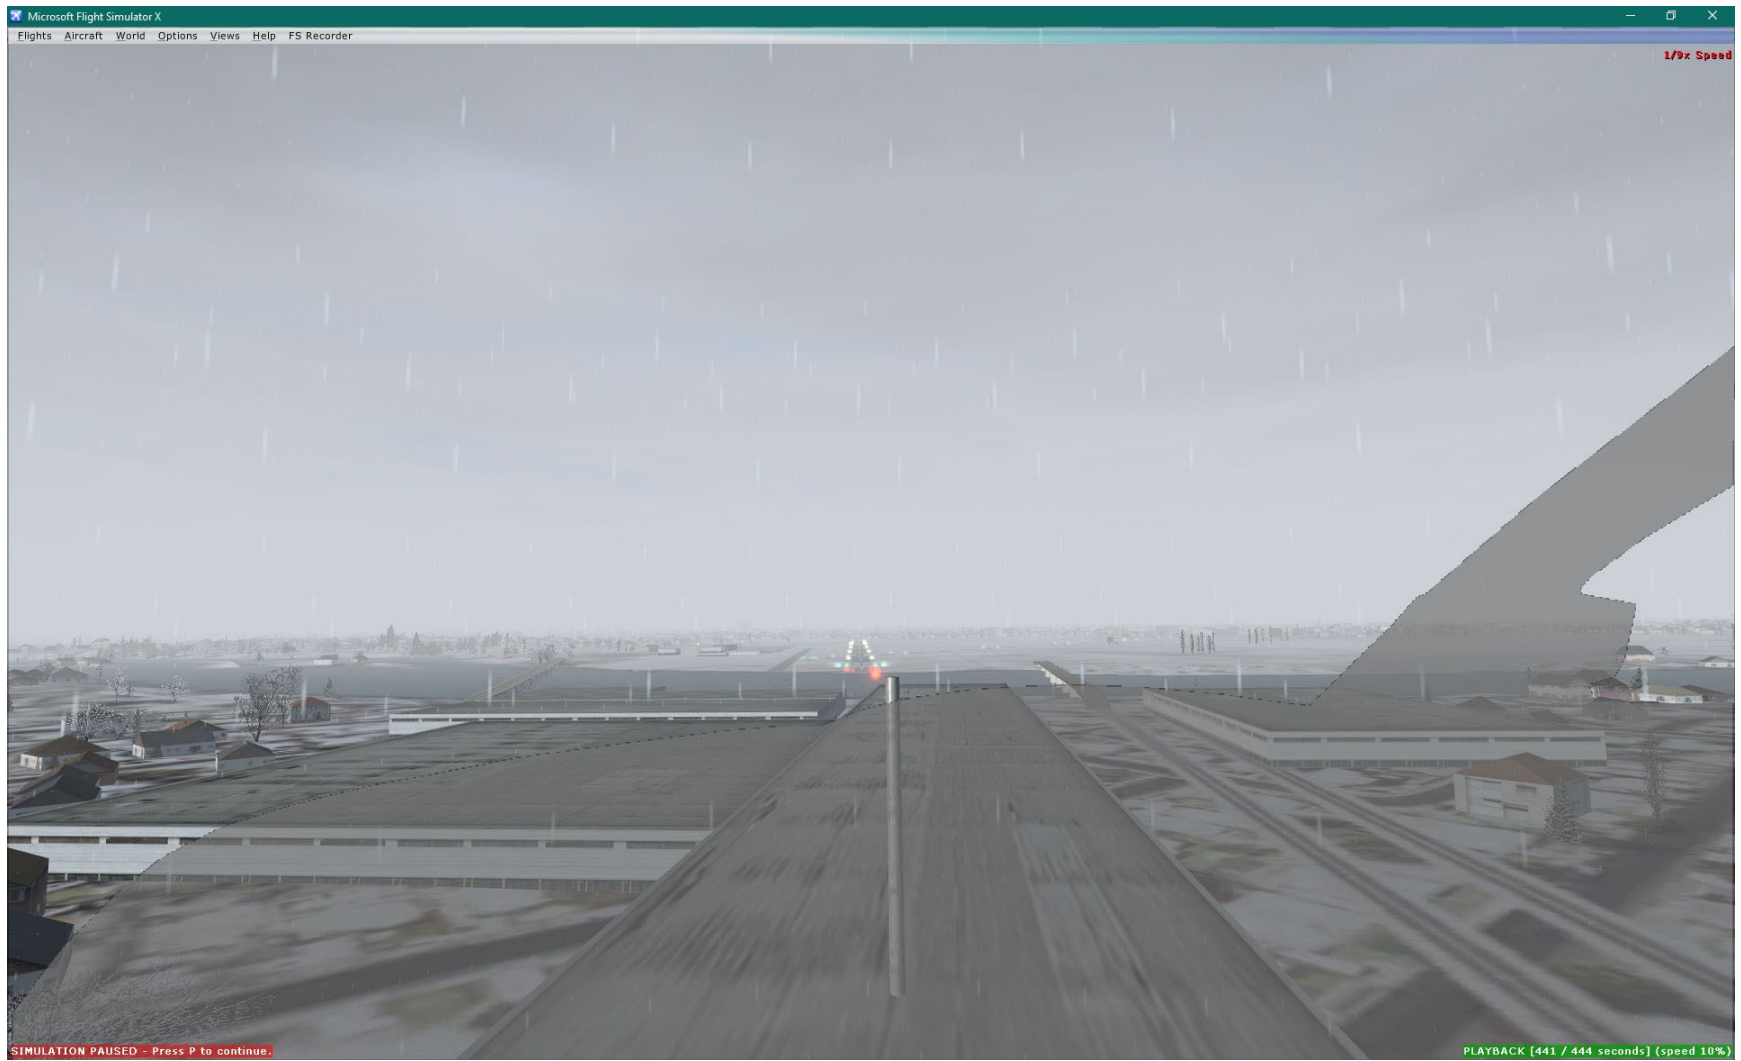
Figures 29 & 30 indicate that between 60 and 30 seconds before impact, the exhaust stack would not have been obscured by the airplane structure, but might have been too small (or too distant in limited atmospheric visibility) to be noticed. Between 30 and 3.3 seconds before impact, the stack might have been totally obscured by the cockpit structure, even though the runway likely remained visible. When the top of the stack became unobscured about 3 seconds before impact, it was likely too late for the pilot to recognize the hazard and take action to avoid the collision.

- When the top of the exhaust stack became unobscured about 3 seconds before impact, it was likely too late for the pilot to recognize the hazard and take action to avoid the collision.
