**Beechcraft**

## Air Safety Investigations Aircraft Incident/Accident Technical Report

| Aircraft Incident/<br>Accident Information | Year: 2013 | Make: Cessna | Model: 208B |
| Air Safety Investigator: Casey J. Love [REDACTED] | | Report #: ASI-22-AQ-T | Report date: 09-13-22 |

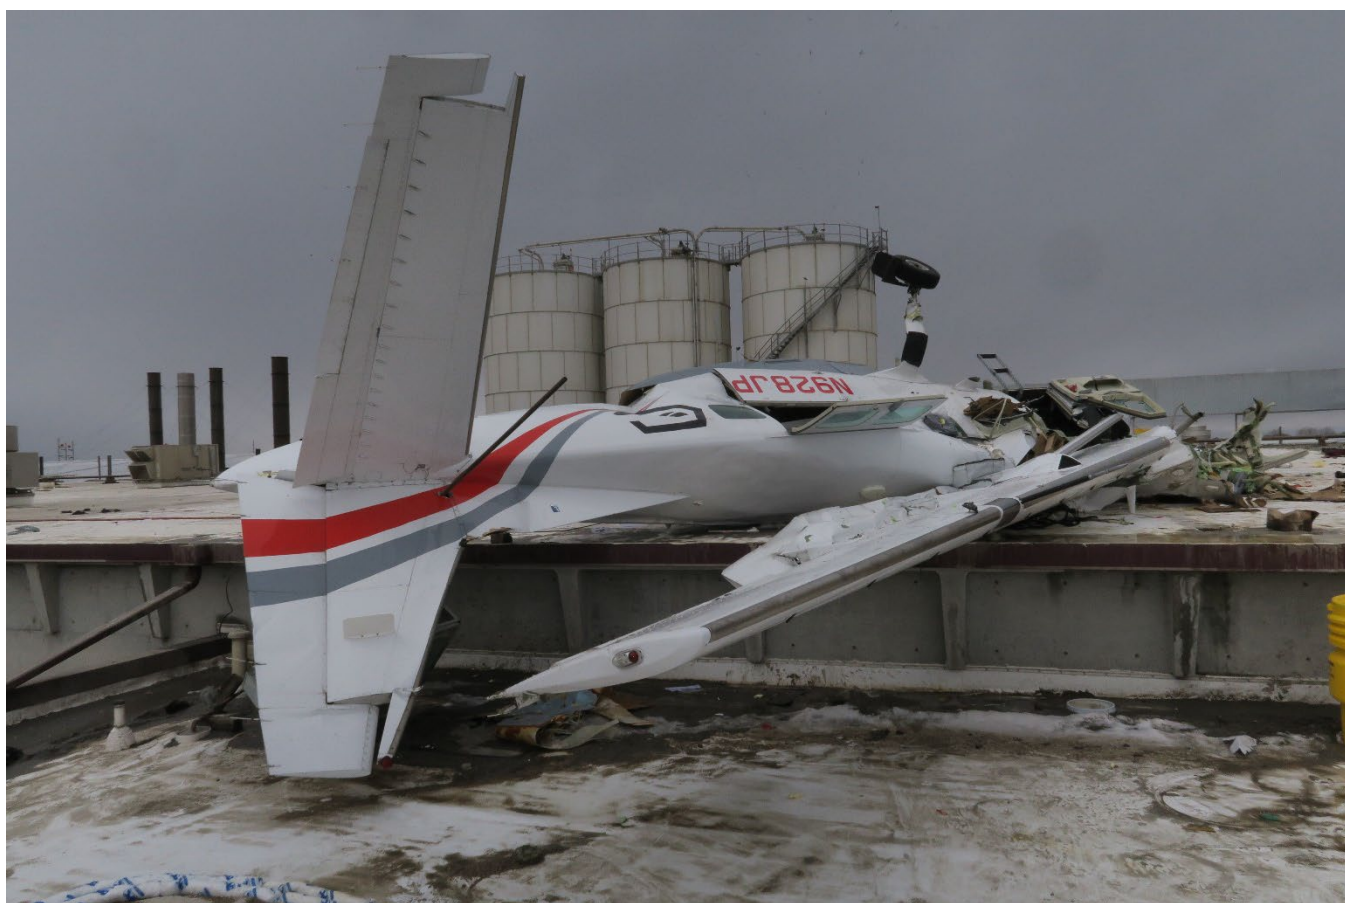
ASI-22-AQ-022 (Wreckage overview)

Upon impact with a smokestack, the left and right wings separated from the fuselage at the wing root attach fittings. The right wing separated from the fuselage and came to rest approximately 60' from the main wreckage. The left wing came to rest beside the fuselage. The flaps and ailerons remained attached to the wings. The empennage remained attached to the fuselage. The right horizontal stabilizer and elevator were bent downward approximately 70 degrees midspan. The right horizontal stabilizer, right elevator, vertical stabilizer, and rudder were virtually undamaged. The engine and mount were displaced aft into the firewall and remained partially attached to the airframe. The firewall was impacted by the engine and exhibited a concave shape conforming to the engine. The fuselage structure and belly skin were impact separated at the cockpit aft door posts but remained attached via cables and wires.

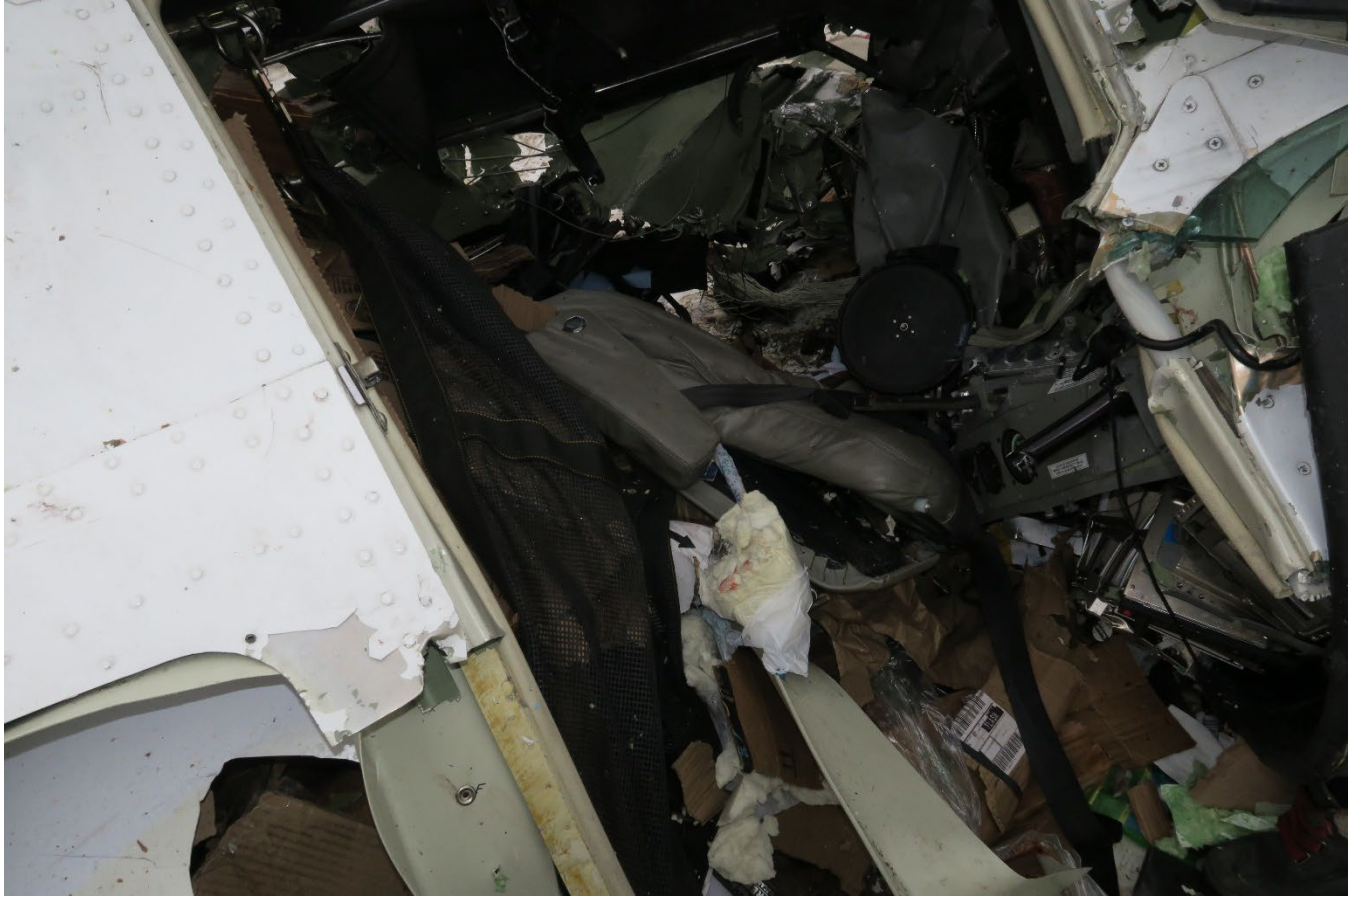
ASI-22-AQ-066 (Cockpit and Co-pilot Seat)

The pilot seat base was cut by first responders. The lap restraints were used. The cut portion of the seat restraints were not observed. Portions of the co-pilot seat restraints were found fragmented at the accident site. The aircraft was configured for cargo operations.

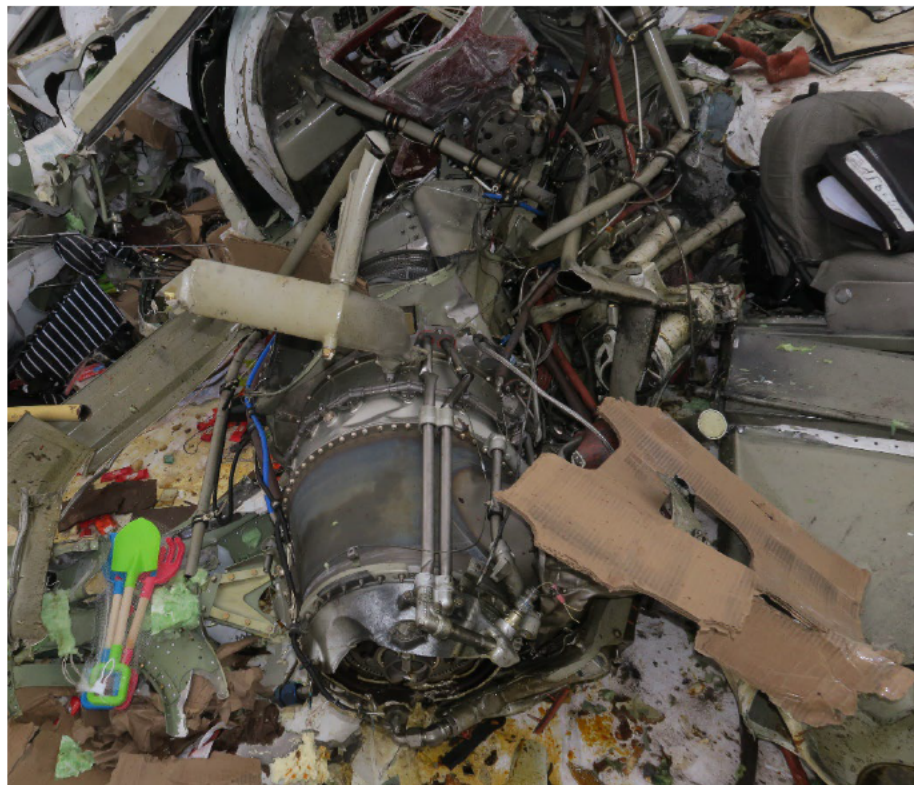
ASI-22-AQ-057 (Engine) (Cropped)

The inertial separator door, louvers, and linkage were impact separated from the aircraft. The throttle cable was attached to the fuel control. The propeller control cable was fracture separated from the propeller governor.

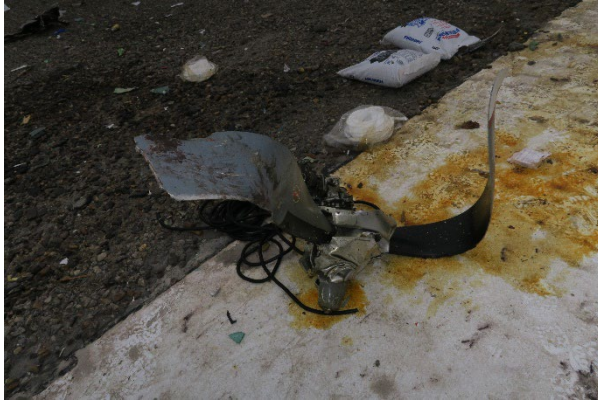
ASI-22-AQ-082 (Propeller)

The propeller remained attached to the drive shaft. The end of the drive shaft, propeller governor, and a section of the reduction gear box (RGB) separated from the RGB. Blade A impact separated from the hub. The outboard one third of the blade fracture separated. An approximately two-inch deep by 4-inch-long gouge existed on the leading edge, inboard of the fracture separation. Blade B and C remained attached to the hub. The tip of blade B impact fracture separated and was found on scene. Blade B also exhibited S bending and impact signatures on the camber side of the blade and was bent aft mid-span. Blade C did not exhibit leading edge damage but was bent aft 90 degrees mid-span.
