# National Transportation Safety Board

WPR22FA151

## AIRPORTS

Specialist's Factual Report

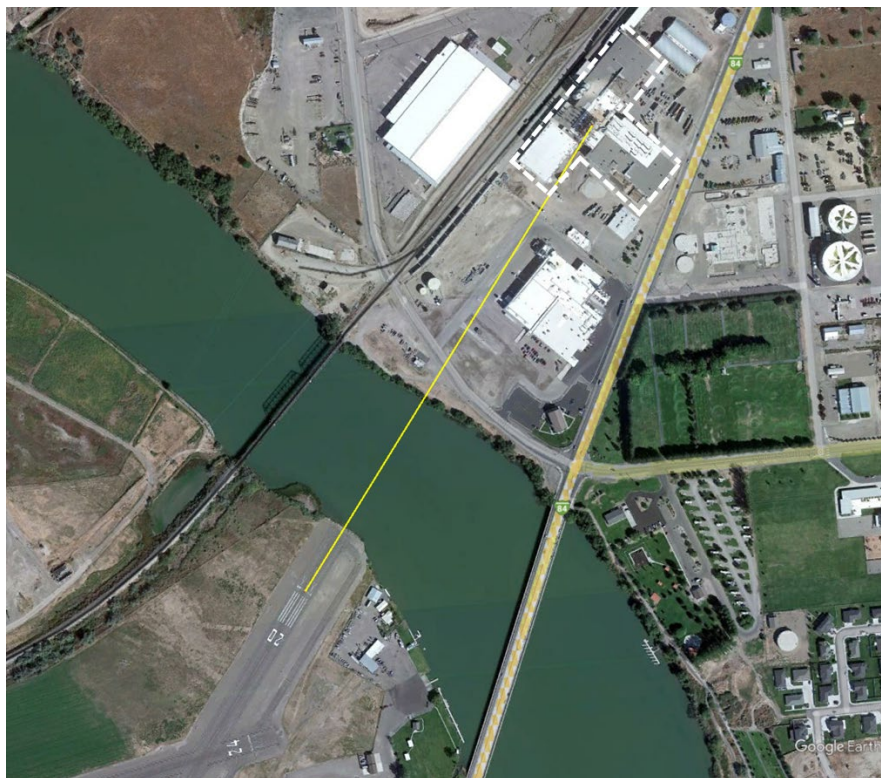
**Figure 2.** Zoomed in Google Earth image showing the extended centerline of the runway 20 approach with the Gem State processing plant outlined in white.

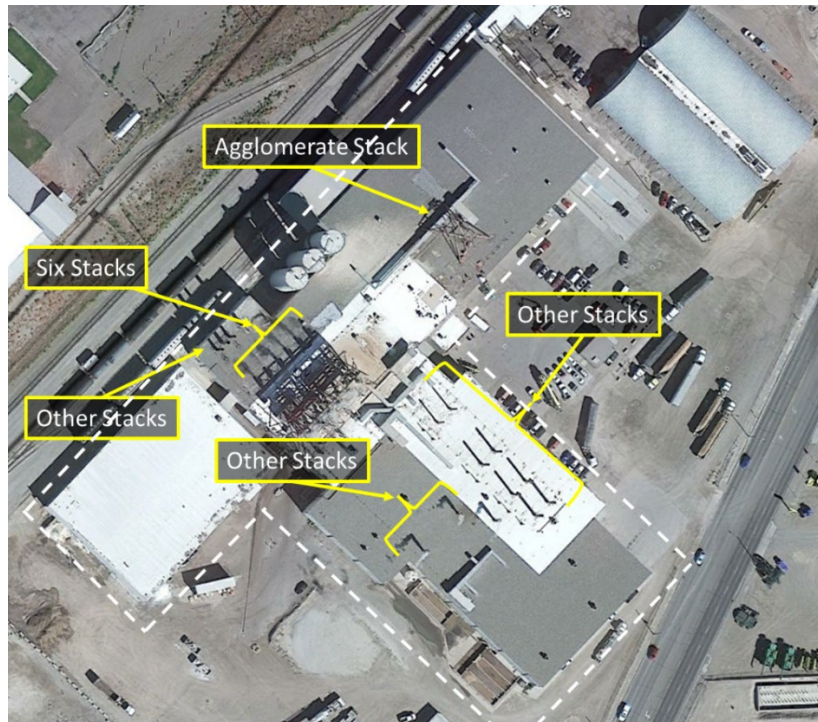
**Figure 3.** Google Earth image of the Gem State processing plant, showing the multiple vent stacks located on the roofs.

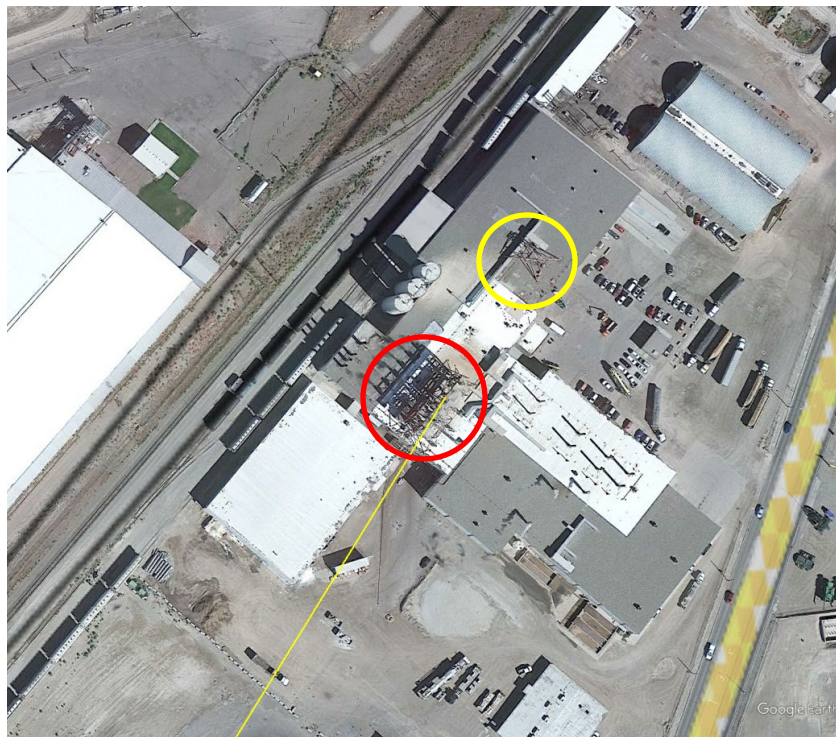
**Figure 4.** Zoomed in Google Earth image of the Gem State processing plant showing the extended centerline of the runway 20 approach. The group of six vent stacks is circled in red while the agglomerate stack is circled in yellow. All seven were measured to be 100 feet AGL.

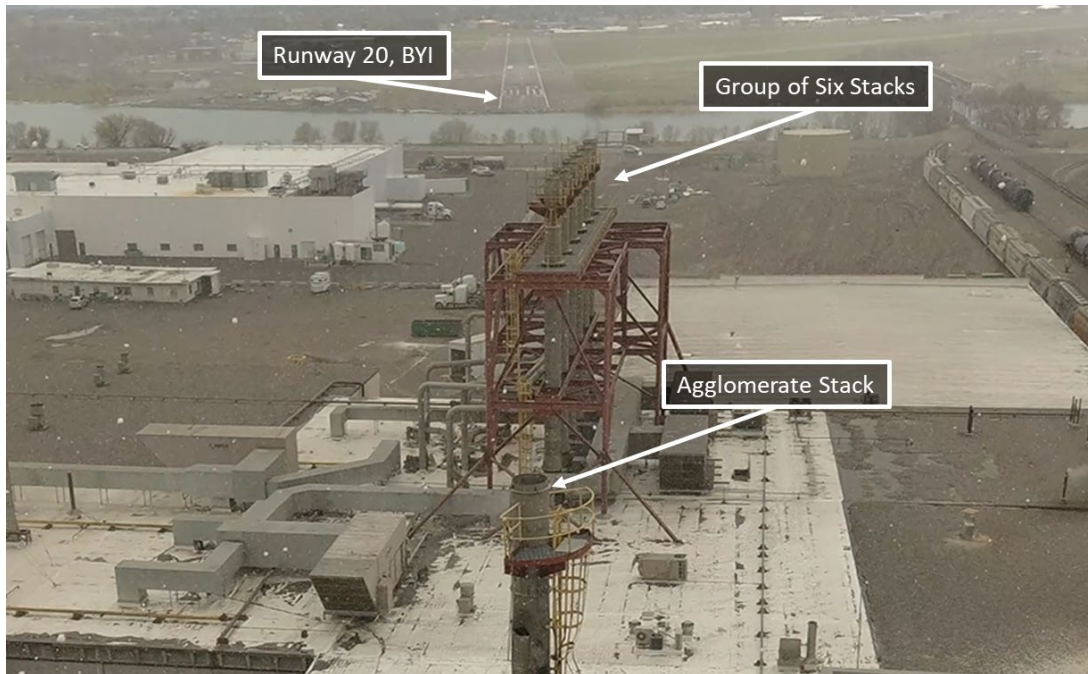
**Figure 5.** Aerial view of the agglomerate stack and the group of six stacks. Runway 20 is in the background.

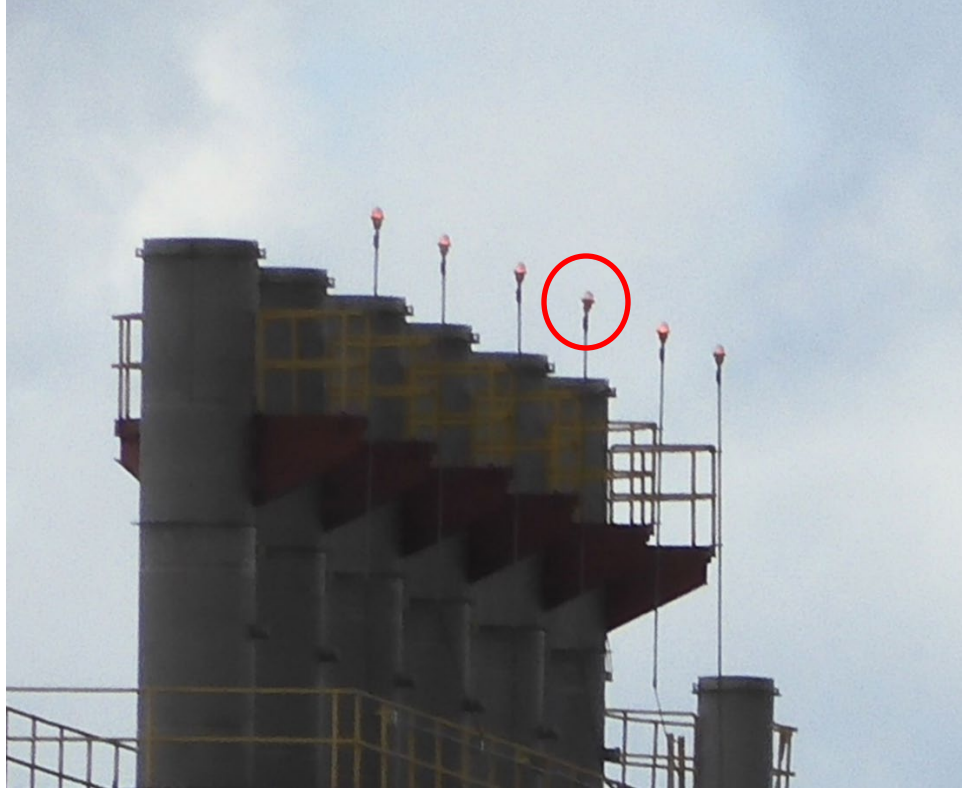
Finally, the NTSB asked for clarification whether the stacks in question were required to be both marked and lighted in accordance with FAA Advisory Circular 70/7460-1. The FAA confirmed that "as a condition of the No Hazard Determination, dated February 2, 2017, the stacks were required to be painted with white and aviation orange paint, and lit with red obstruction lights, per FAA Advisory Circular 70/7460-1." The NTSB noted during the investigation that neither the agglomerate stack (that the airplane struck) nor the six drum dryer stacks were painted with white and orange aviation paint. A June 3, 2016 email from Gem State to the FAA indicated that "we currently have red warning lights on silos #1 & #3 (outside ones) and plan on adding red warning lights to our other stacks." A photo taken on the day of the accident revealed that five of the six aircraft warning lights on the group of six drum dryer stacks were illuminated, as shown in figure 6.

**Figure 6.** The group of six vent stacks with their aircraft warning lights. Five of the six lights were noted to be illuminated postaccident. The non-illuminated light is circled.

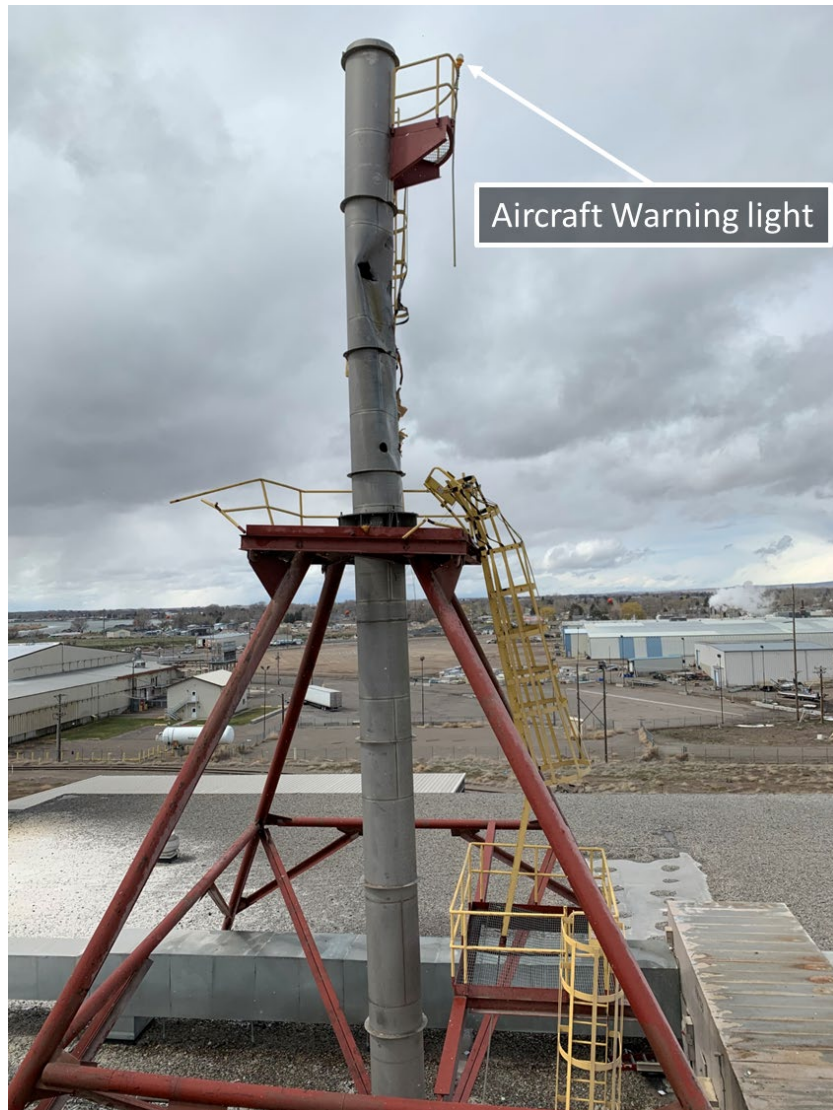
The agglomerate stack was also equipped with an aircraft warning light as shown in figure 7; however, the light was reported stolen to the Heyburn Police Department after the stack was removed from the rooftop and placed on the ground. It was not available for subsequent NTSB examination.

**Figure 7.** Postaccident photo of the agglomerate stack that the airplane struck.
