# National Transportation Safety Board

WPR22FA151

## **AIRFRAME AND ENGINE EXAMINATION REPORT**

Airplane: N928JP / Cessna 208B

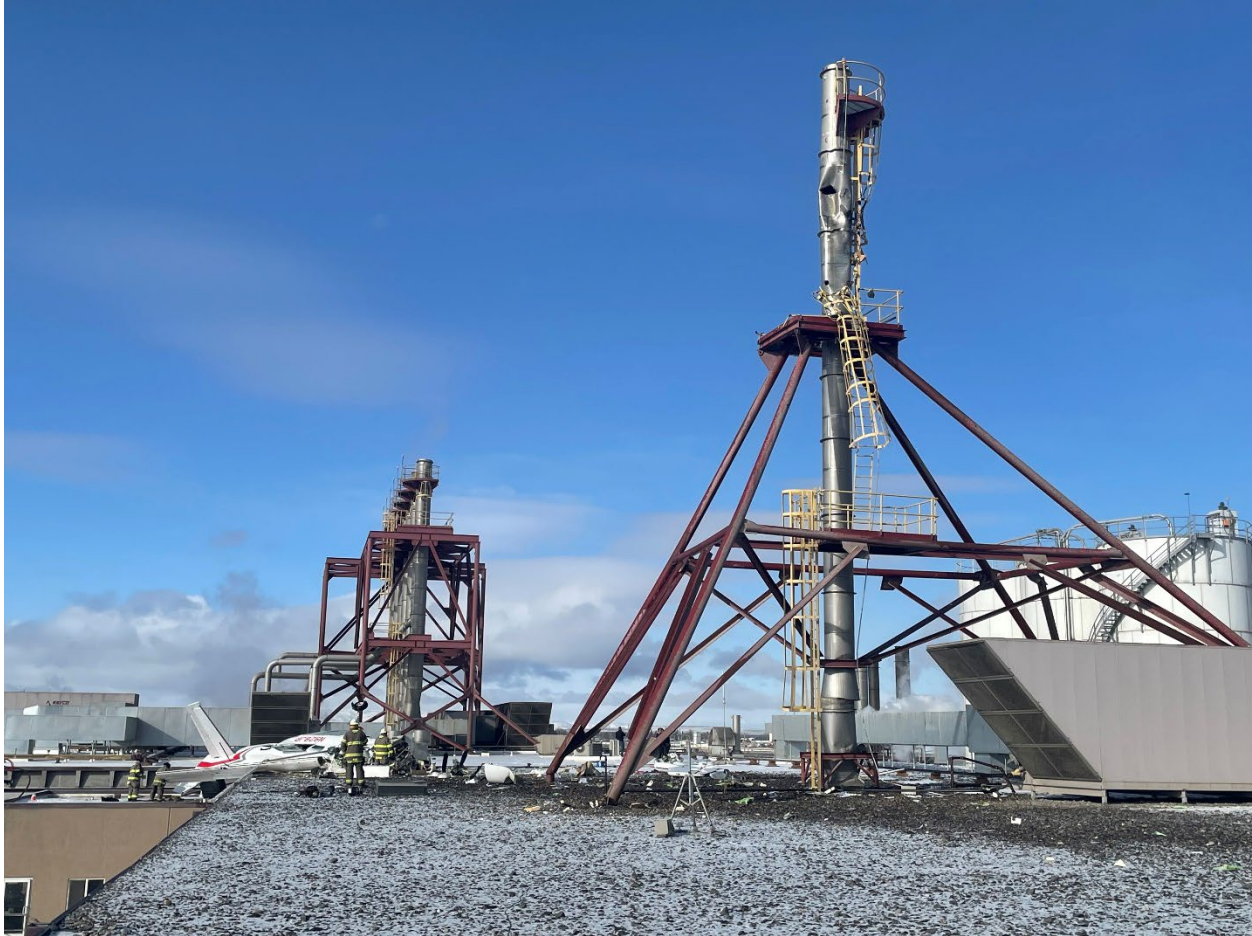
The airplane came to rest on the roof of a processing plant. Lat Long coordinates: 42.551386 - 113.759731. The roof supported a single smokestack about 100 ft above ground elevation. About 220 ft west of that smokestack was a set of 6 smokestacks about the same height. The single smokestack exhibited damage in the form of gouges, dents, missing and displaced yellow safety railings, and displaced electrical conduit, and wires. The beacon was installed but the conduit line was fractured and separated.

Figure 1. View of the roof top showing the agglomerate vent stack in the foreground, a row-of-six stacks in the background, and N928JP. Photo Courtesy of the Heyburn Police Department.

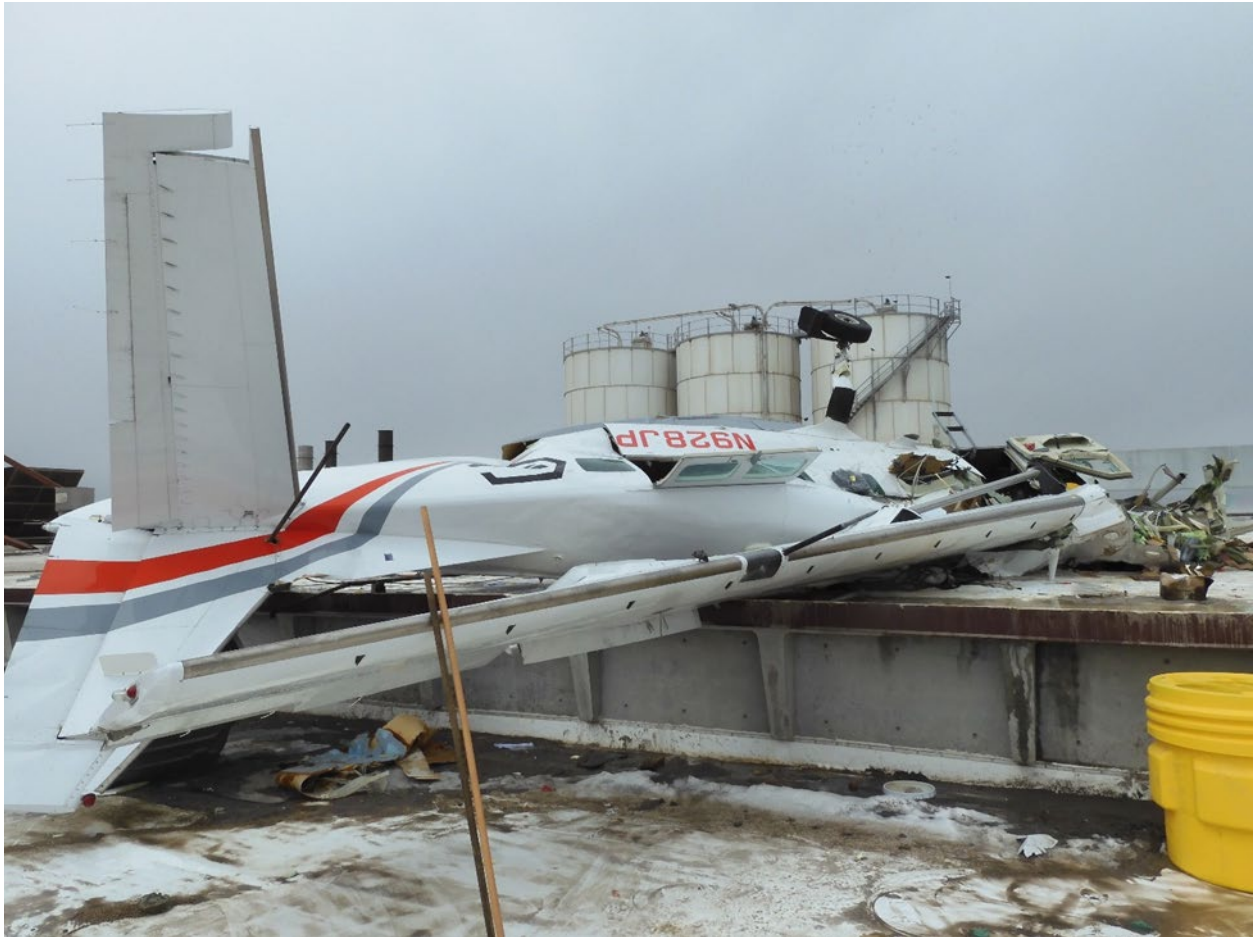
The right-side of the aft fuselage, from the cargo door aft to the empennage, exhibited substantial damage with dents and bending of the sheet metal throughout. The left-side of the aft fuselage exhibited substantial damage with deformation of the structure and denting and wrinkling of the sheet metal.

**Figure 2. Topside of N928JP.**

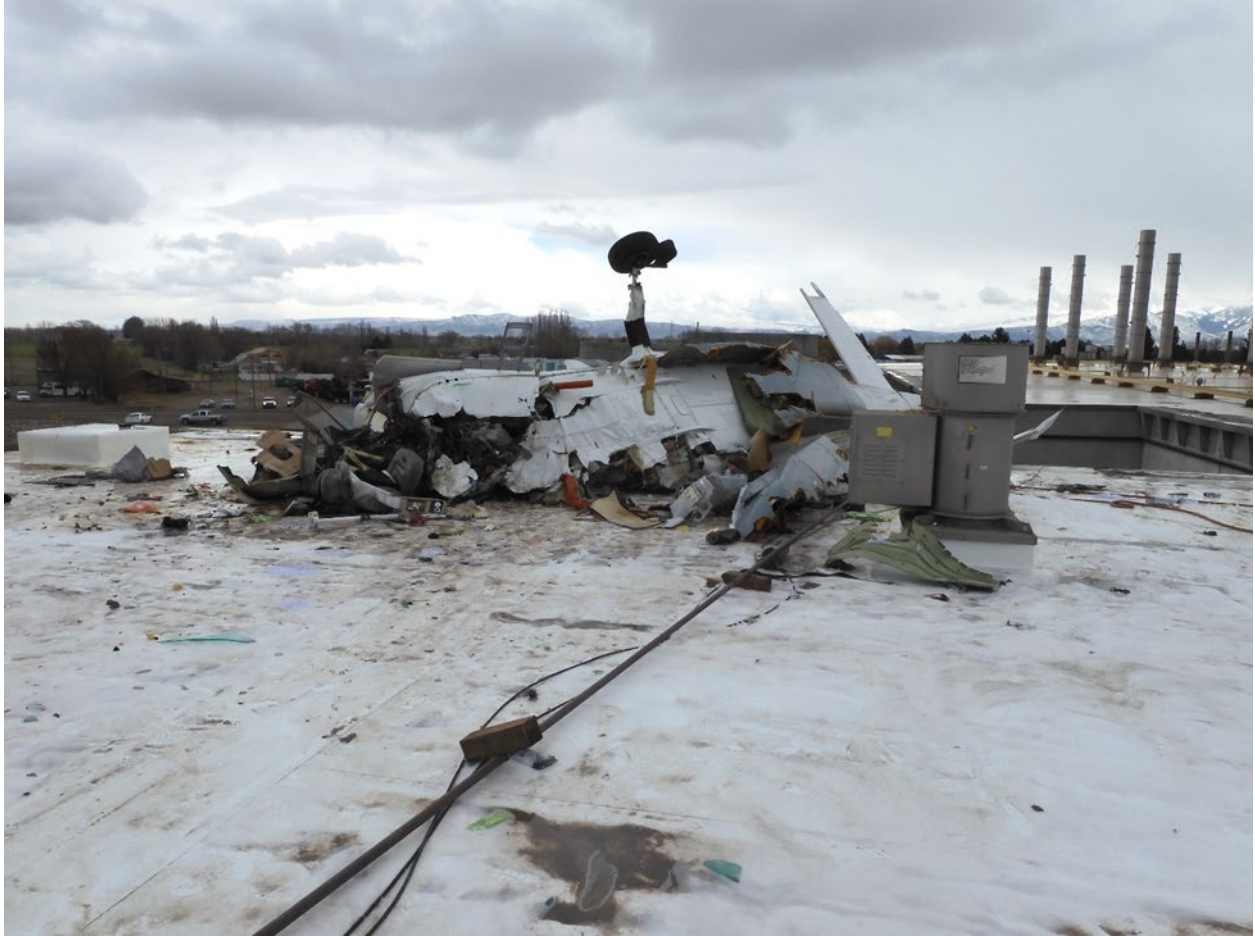
**Figure 3. Underside of N928JP.**

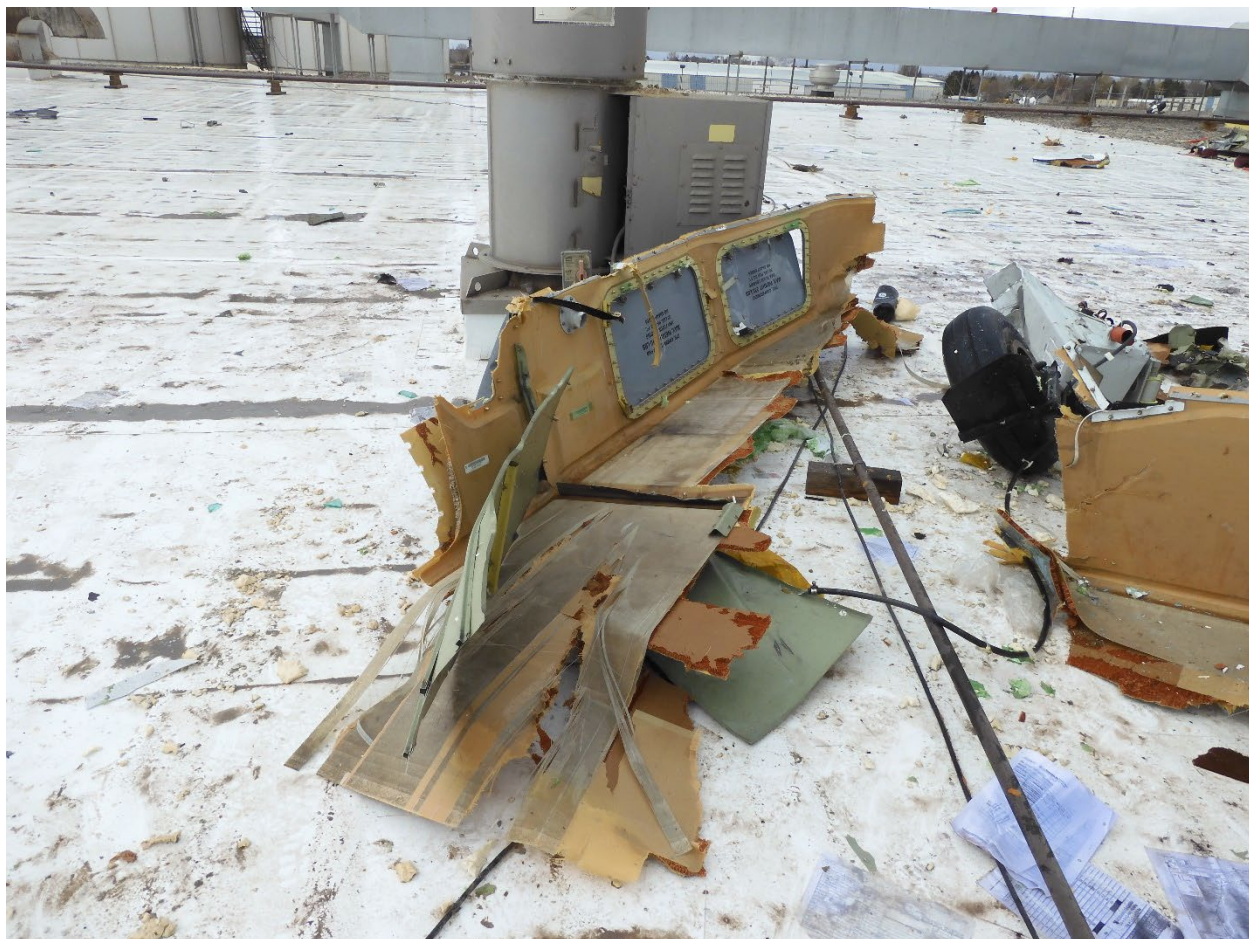
The airplane was equipped with a composite material belly pod. The belly pod had partially separated from the underside of the fuselage. The right side exhibited substantial fracturing and separation. A TKS de-icing system was located near the belly pod components. The TKS tank was breached, and no fluid was observed in the vicinity of the tank. The two pumps were secured to their respective mounts.

**Figure 4. Underside cargo pod.**

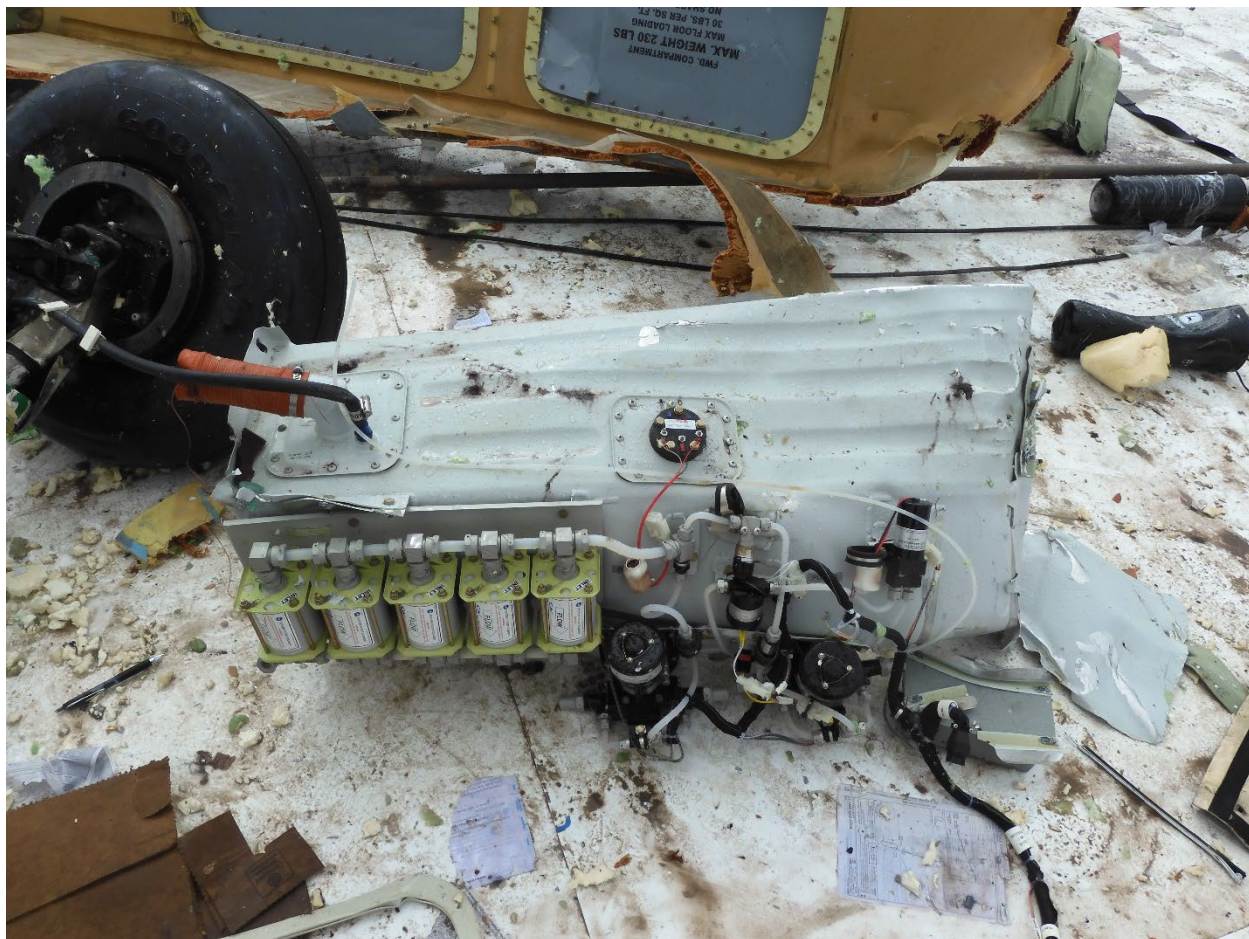
**Figure 5. TKS tank.**

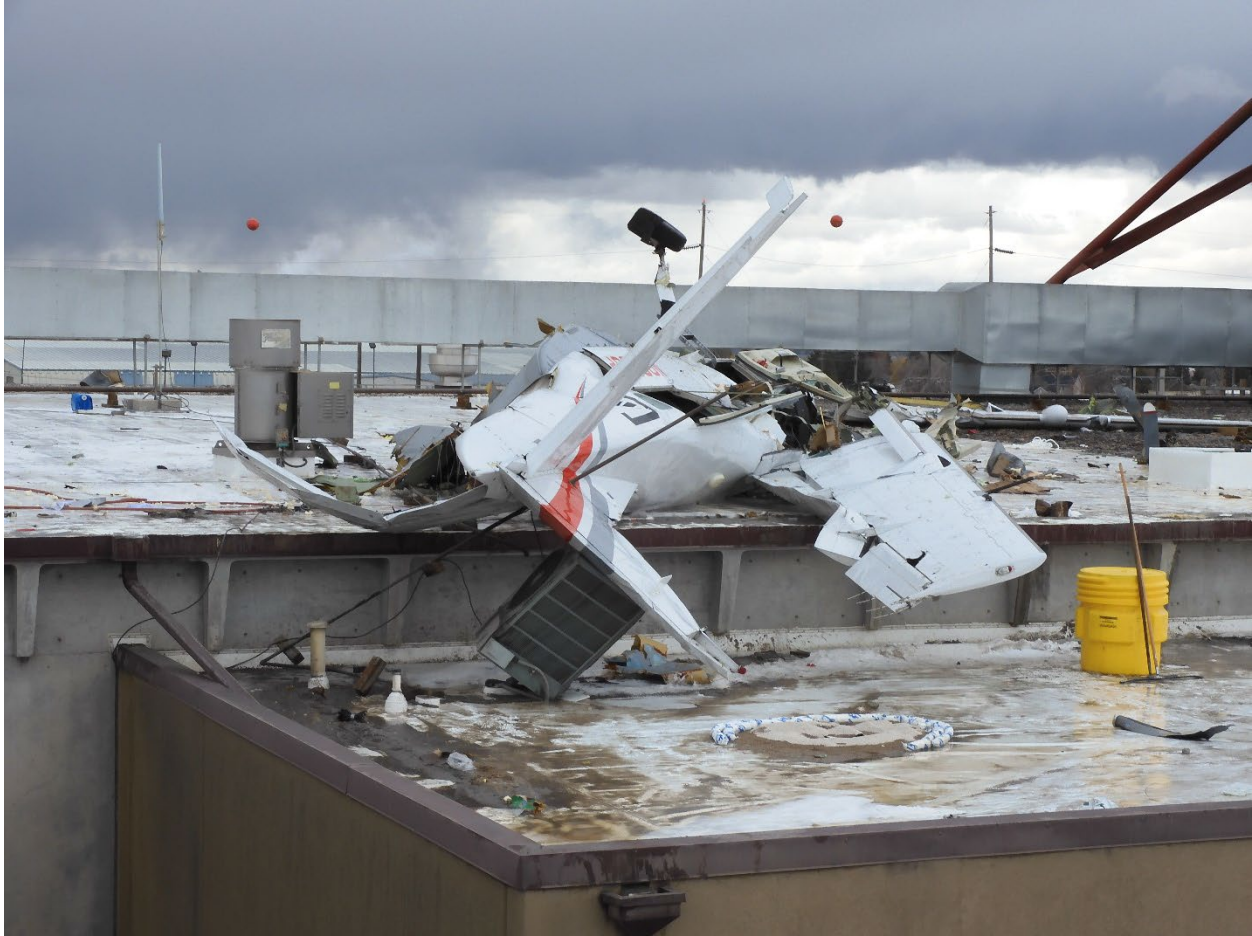
The left side of the vertical stabilizer exhibited minor damage with wrinkling of the sheet metal near the forward dorsal section. No evidence of ice accumulation was observed on the empennage. A steel gas pipe punctured through the base of the vertical stabilizer from the right-side to the left side. The left-side of the rudder exhibited substantial damage with wrinkles and bends to the sheet metal. The left-side horizontal stabilizer remained attached to the fuselage and exhibited minor damage. The left-side elevator remained attached to the horizontal stabilizer and exhibited minor damage. The left-side elevator trim remained attached to the elevator and exhibited minor damage.

The right-side horizontal elevator remained attached to the fuselage and was bent downward in a continuous arc. The right-side elevator remained attached to the horizontal stabilizer and exhibited the same downward bend. The right-side elevator trim remained attached to the elevator and had the same downward bend.

**Figure 7. Rear view.**

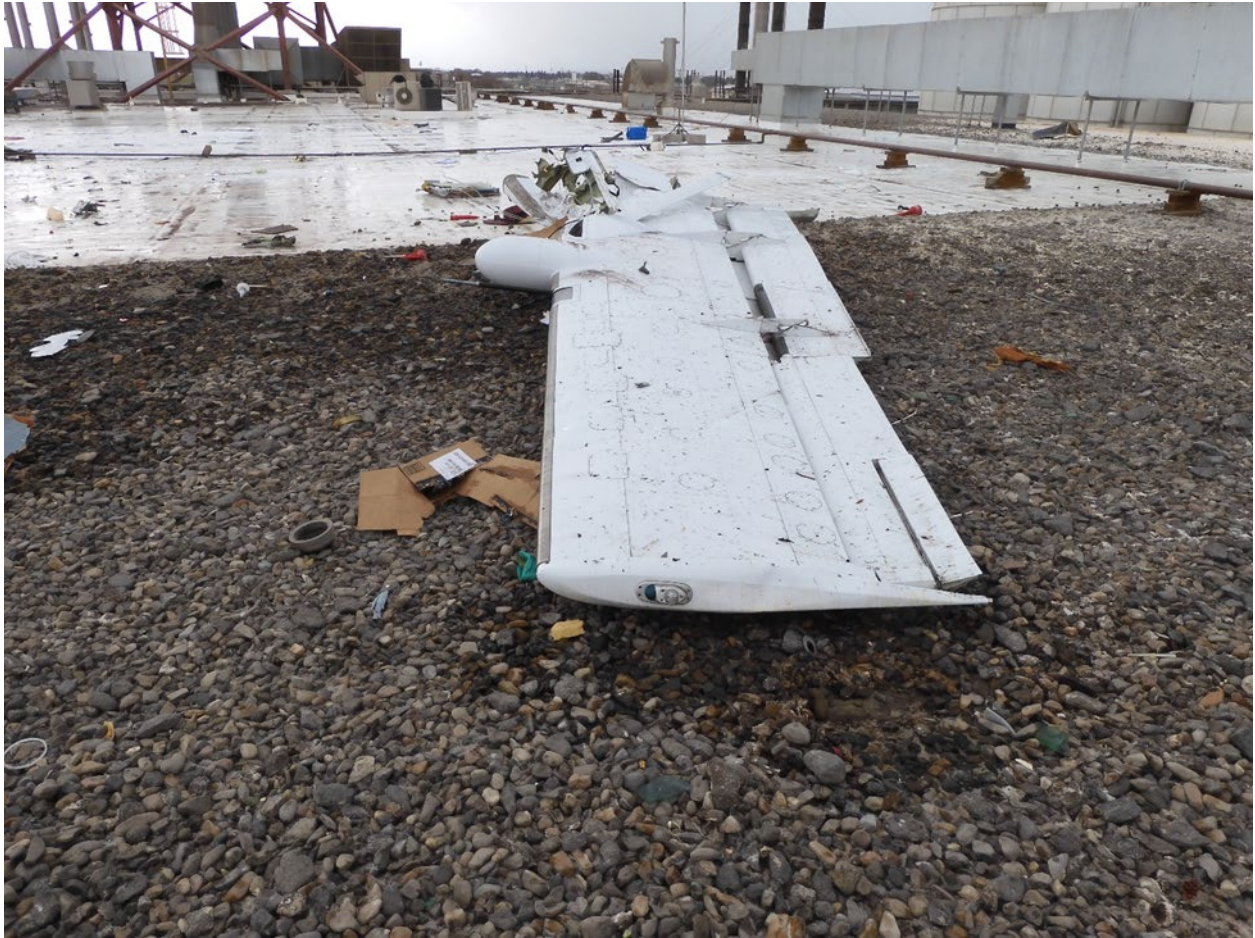
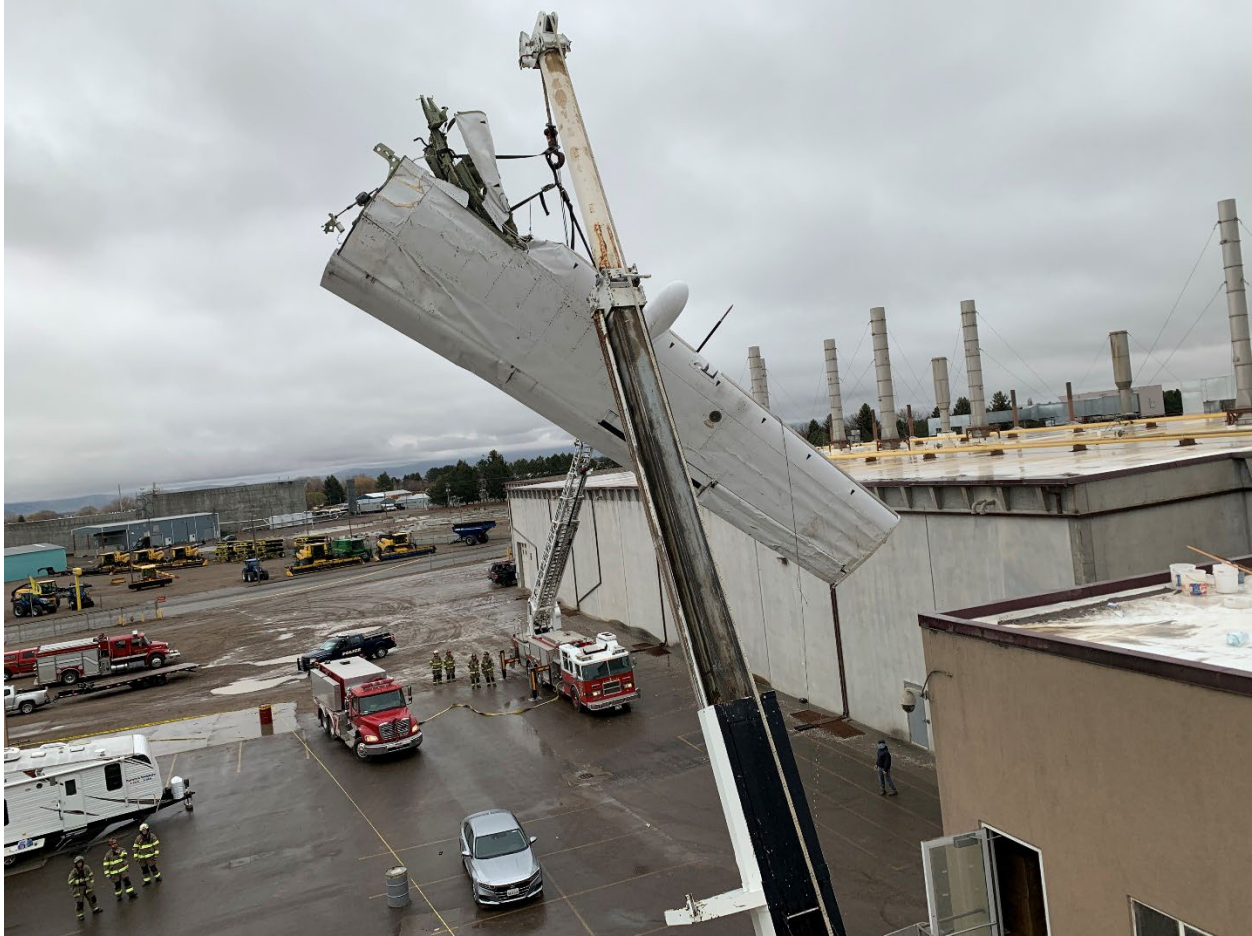
The right wing separated from the fuselage at the root and retained its shape and integrity. The wing was found near the fuselage, underside-up. There was debris on the wing, but overall, it appeared clean without evidence of ice or TKS fluid. The leading edge exhibited minor damage except for the last 4 feet nearest the root. A large circumferential dent extended inward (aft) through the wing spar. Yellow paint transfer was observed in this area. The flap remained attached to the wing and moved freely through its limits. The electric flap actuator remained attached at the bellcrank and had about 6.5 inches of threads exposed. The right aileron remained attached to the wing at its mounts, The aileron trim remained attached at the aileron. The aileron control cables remained attached to the aileron and extended to the wing root. Both control cables exhibited broom straw appearance at the separations. The weather radome remained attached to the right wing and exhibited minor damage. A very thin layer of ice was observed on the radome but was not significant or noteworthy. The right-wing pitot-static probe remained attached to the right wing and exhibited minor damage. The right-wing strut remained attached at the wing mount, but fracture separated at the fuselage. The leading edge separated from the

wing strut and was found in the wreckage. The wing tip remained attached along with the position light. The leading edge remained intact except for the root area. The landing light remained intact and exhibited minor damage. The right-wing finger filter was clean and clear of debris.

**Figure 9. Right wing underside view.**

**Figure 10. Right wing topside view.**

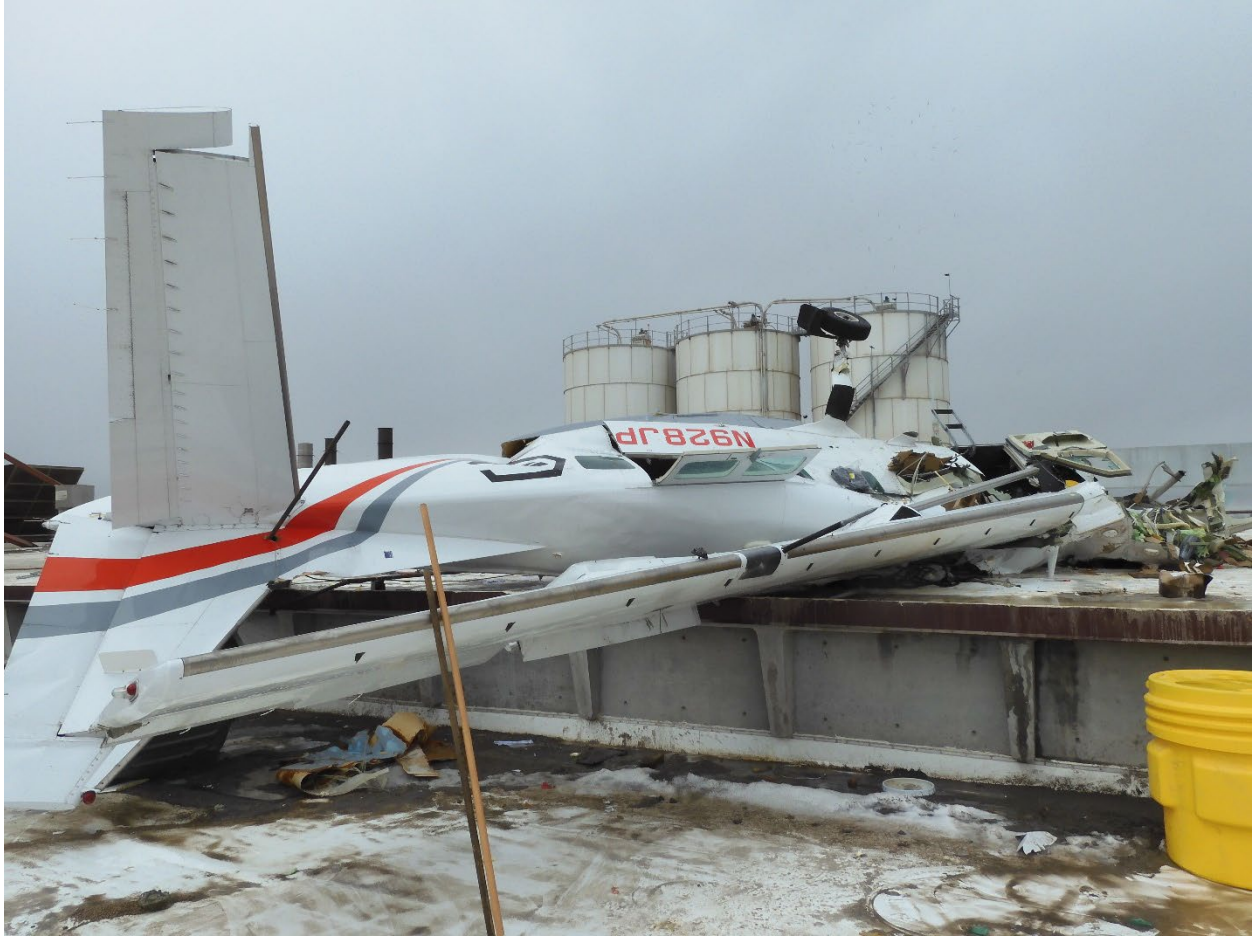
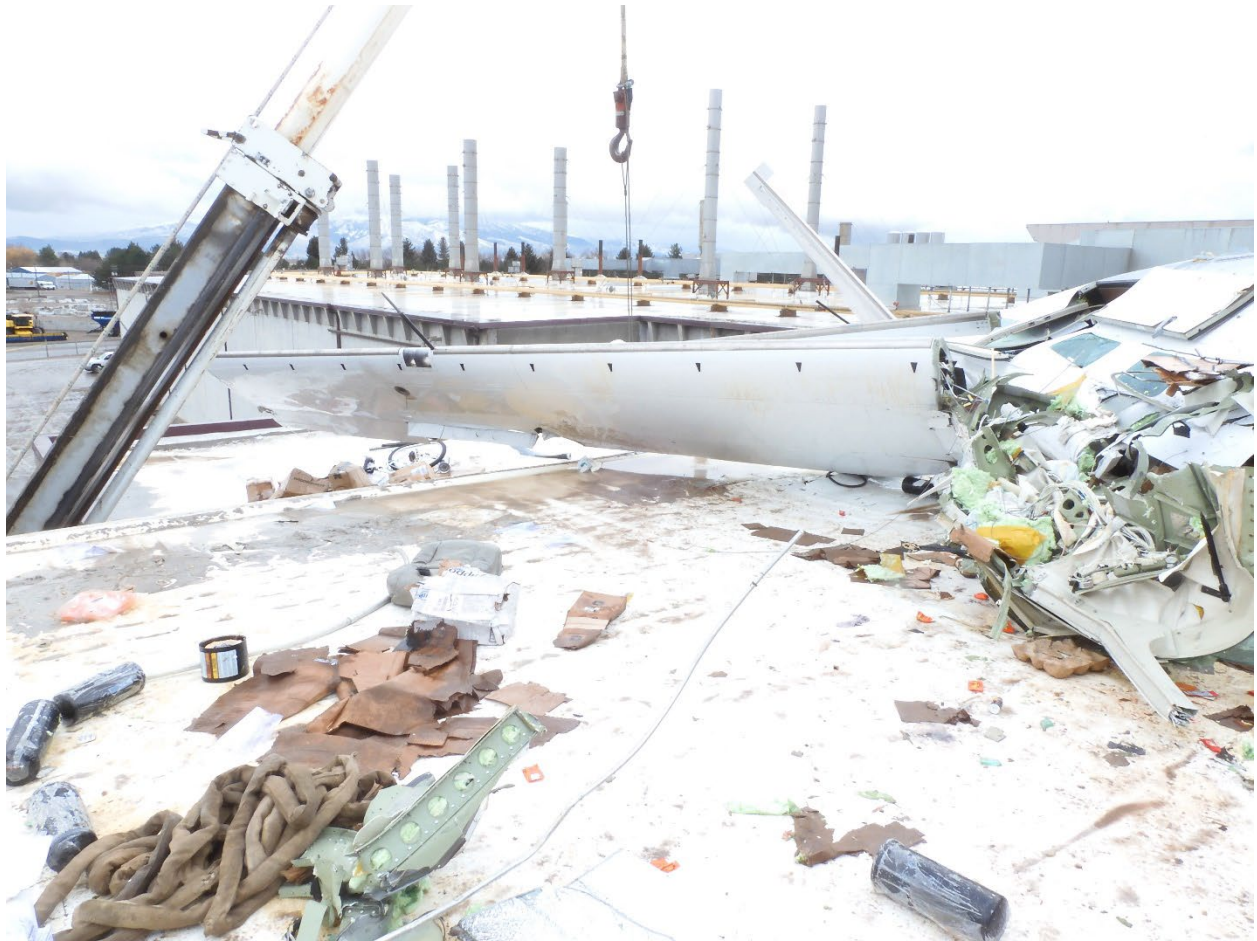
The left wing was partially attached to the fuselage by wires and control cables. Some cuts appeared to be made by first responders. A section of the upper cabin roof top remained attached to the left wing at the root. The left flap remained attached to the wing and exhibited substantial bending to about 90° near the outboard-most hinge. The left aileron remained attached to the wing and was deflected upwards. The left elevator trim remained attached to the elevator and exhibited a trailing edge down position. The wing tip remained attached to the wing along with the anti-collision light and the position light. The left-wing strut remained attached to the wing but separated from the fuselage. The leading edge of the left wing remained intact with minor damage. The left pitot-static probe remained attached to the wing and exhibited minor damage. The stall tab remained attached to the left wing and exhibited no damage. The wing appeared clean and not dirty or oily, with no trace of ice or TKS.

**Figure 11. Left-wing leading-edge view.**

**Figure 12. Left wing topside view.**

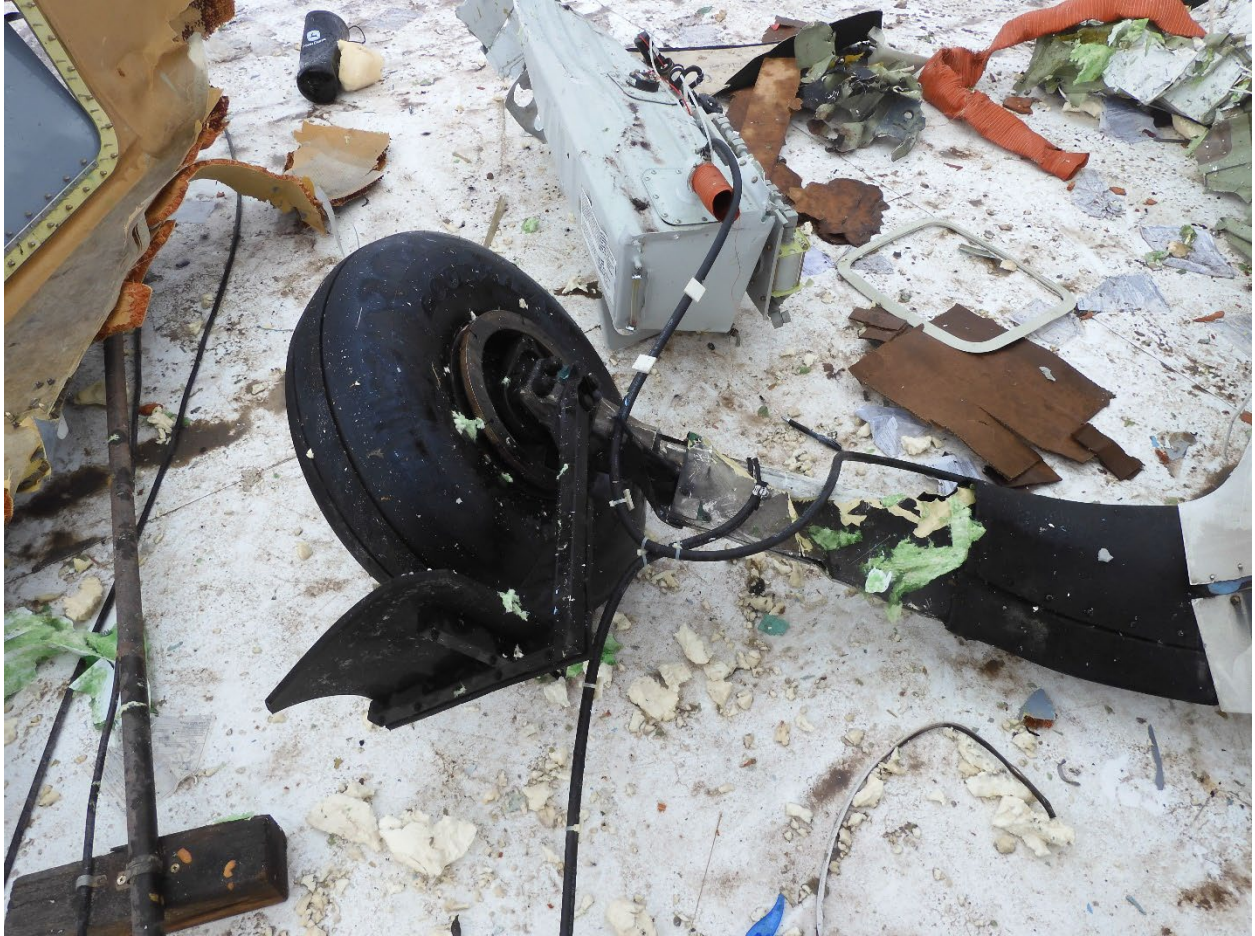
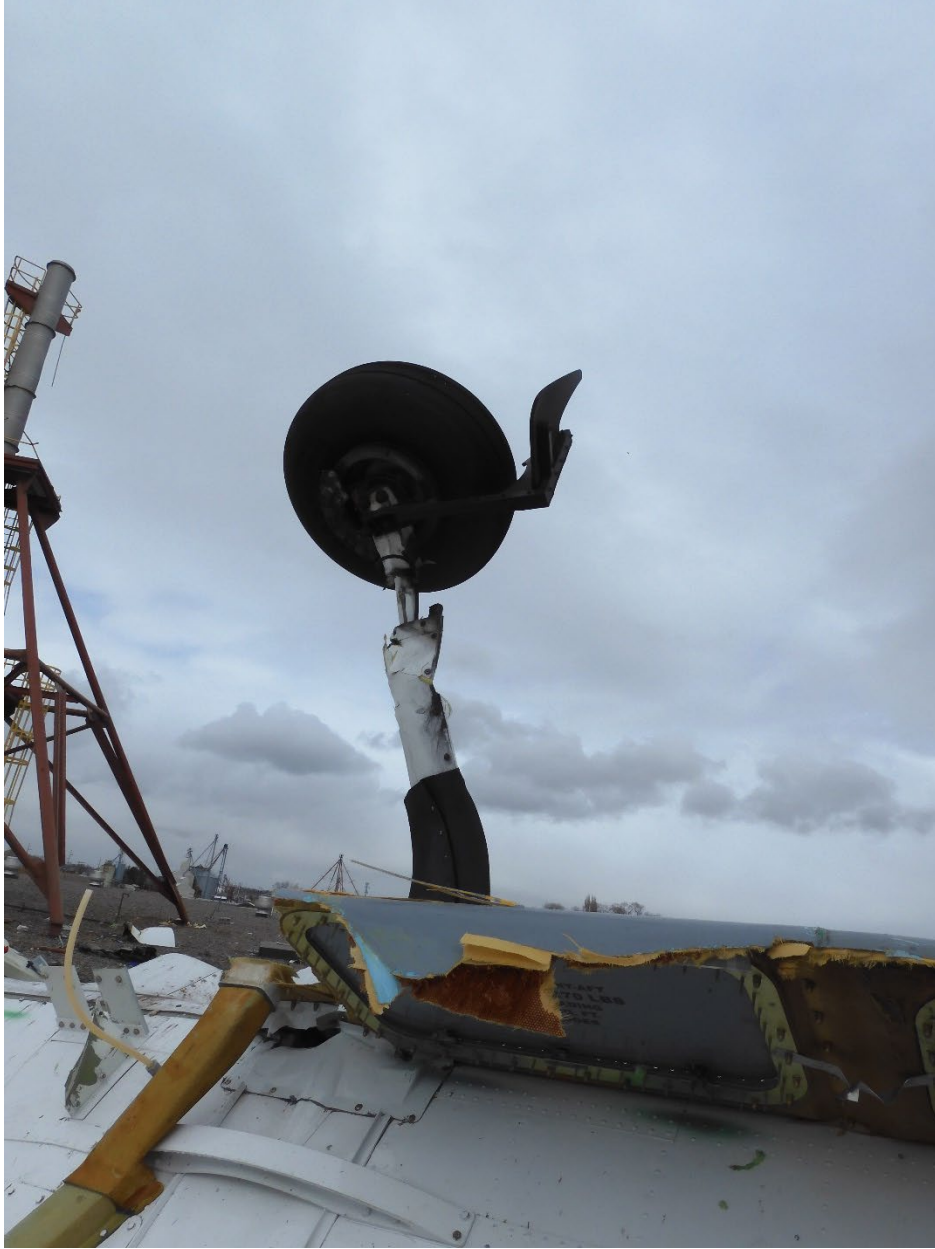
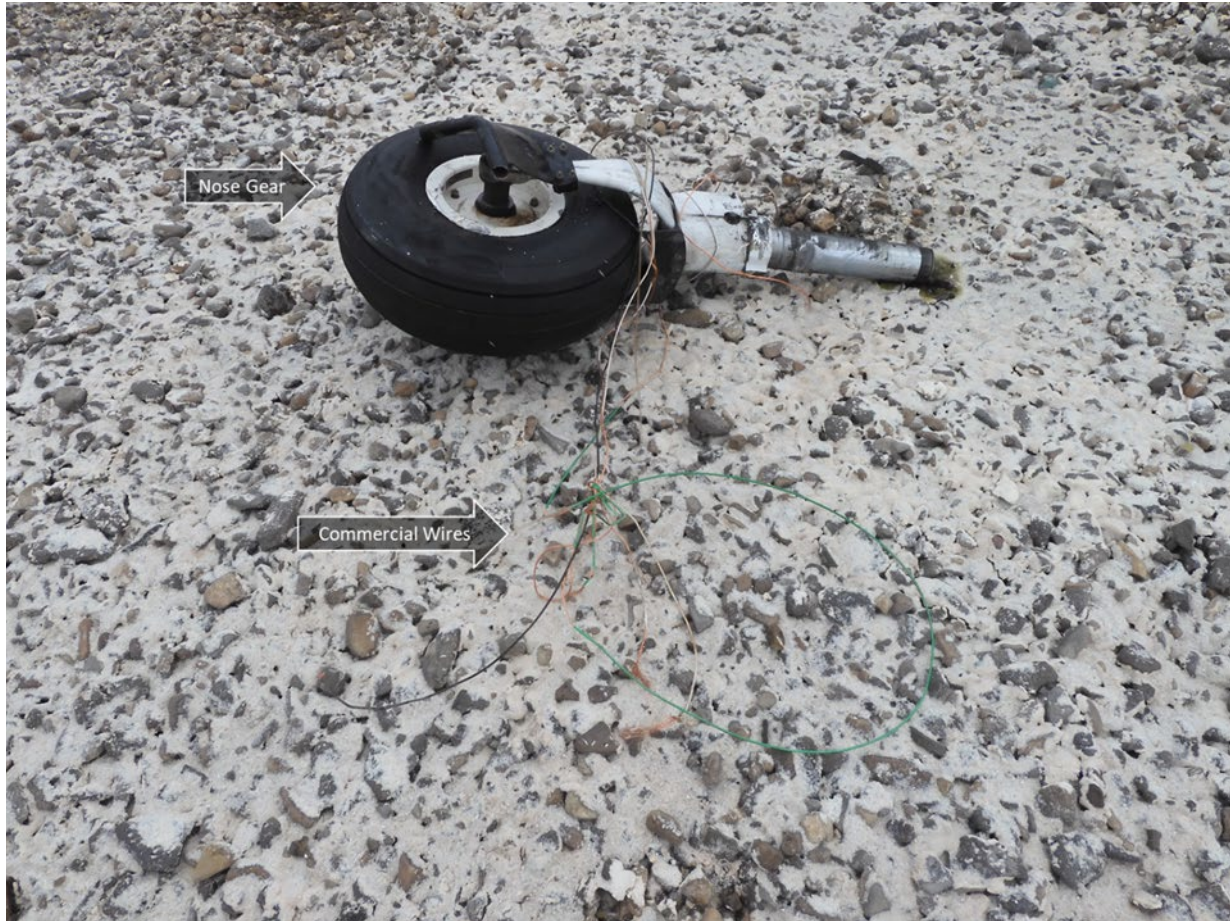
The left and right main landing gear remained attached to the fuselage. The left wheel remained attached at the spindle, but the left brake caliper separated from the wheel assembly. The right-wheel assembly remained attached to the wheel spindle and exhibited minor damage. The nose gear separated from the upper strut section. Commercial grade white, black, and green electrical wiring was found wrapped around the nose wheel. Electrical conduit was found within the wreckage area and looked to have come from the vent stack beacon. The nose wheel spring separated from the fuselage and was in the wreckage.

**Figure 14. Right-side main landing gear.**

**Figure 15. Left-side main landing gear.**

**Figure 16. Nose gear.**

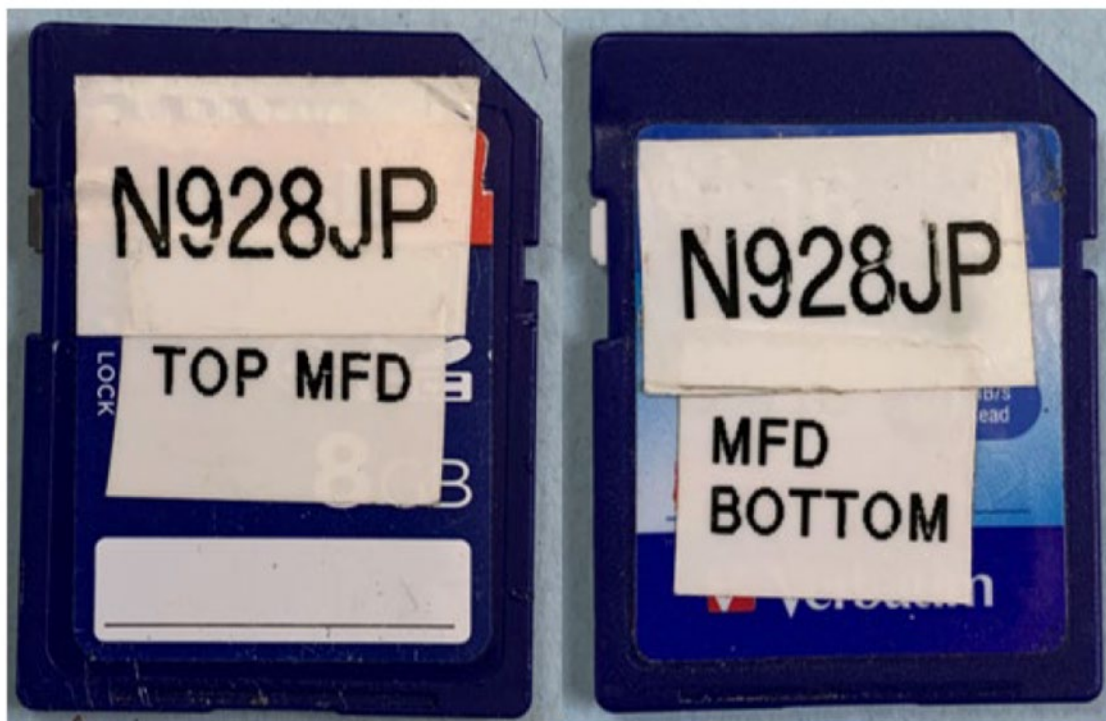
The cockpit was substantially damaged. The Garmin G1000 displays separated from the fuselage. One display fell to the ground elevation and the other remained on the roof. Two Garmin G1000 memory cards were found on the roof, resting in water. The standby altimeter, standby attitude indicator and standby airspeed indicators remained secured in the lower section of the instrument panel. The left-side control yoke was cut and removed by first responders. The left-seat was cut and removed by first responders.

**Figure 17. G1000 data cards.**

The Garmin G1000 memory cards were shipped to the NTSB Recorders Laboratory. Examination revealed that both cards were damaged and did not provide useful data for the investigation.

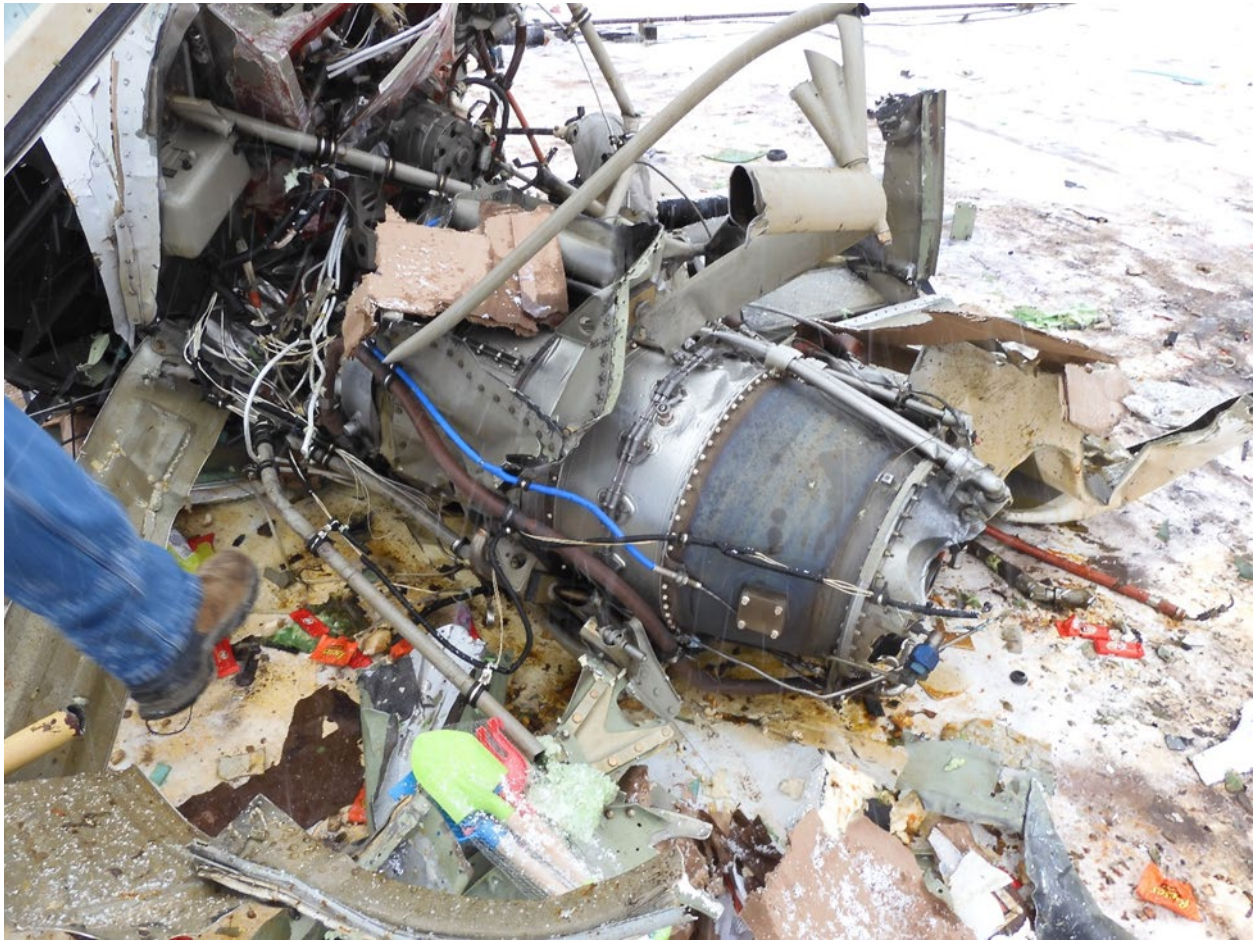
The engine was visually examined on site and revealed extensive impact damage. The engine cowlings separated from the fuselage. The exposed engine remained attached to the displaced and fractured engine mount. The forward section of the

engine separated from the engine and was found in fractured pieces in the wreckage. Smaller components of the engine were strewn on the roof.

Excerpts of the manufacturer's examination included. The compressor, compressor turbine, and power turbine exhibited no evidence of preimpact distress. Rotational signatures found on the first stage compressor rotor, compressor turbine, and power turbine were consistent with rotation at impact.

**Figure 18. Engine**

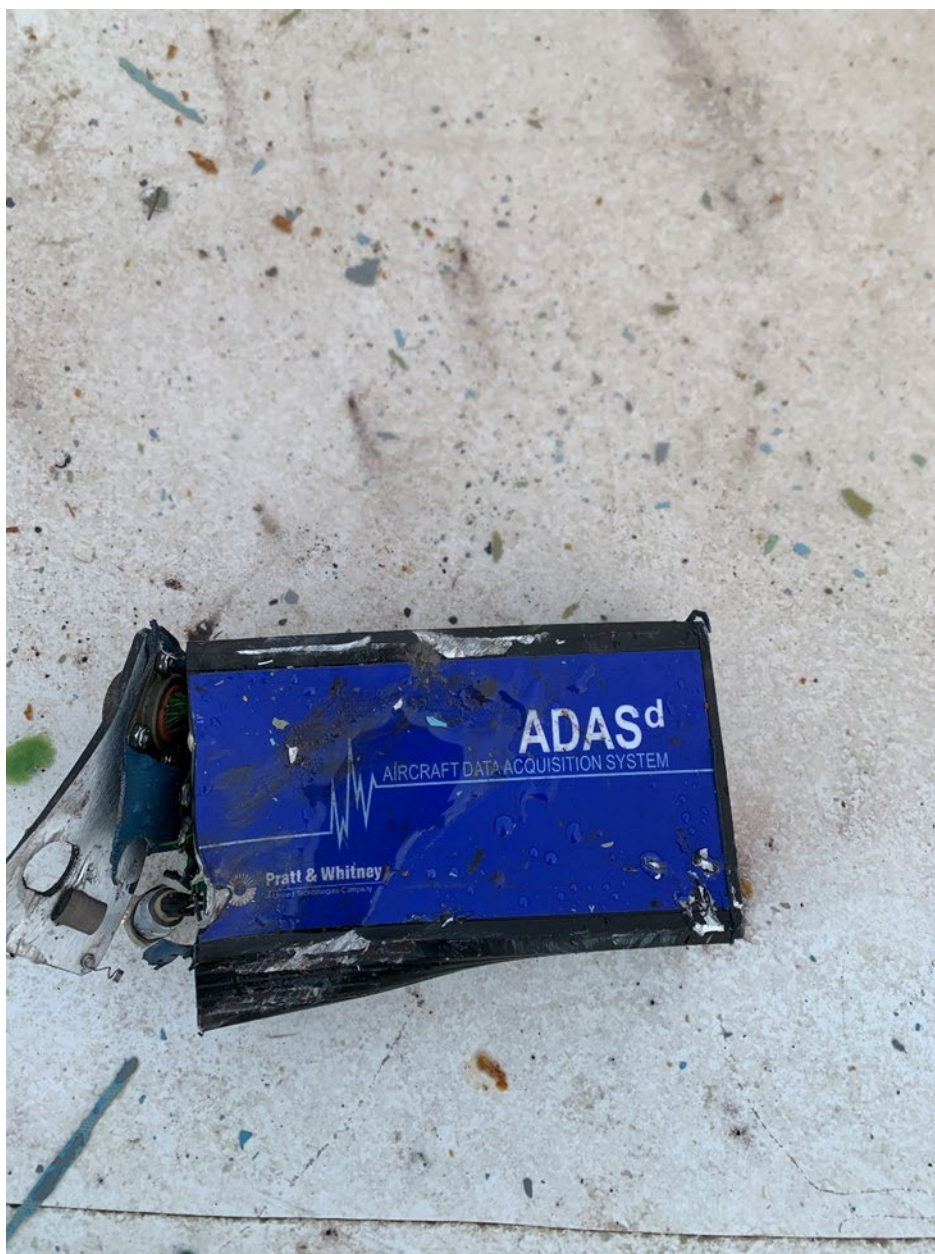
The Aircraft Data Acquisition System (ADAS) was recovered and examined by the NTSB recorders laboratory. Examination of the ADAS unit provided no usable data for the accident.

**Figure 19. Aircraft data acquisition system (ADAS).**

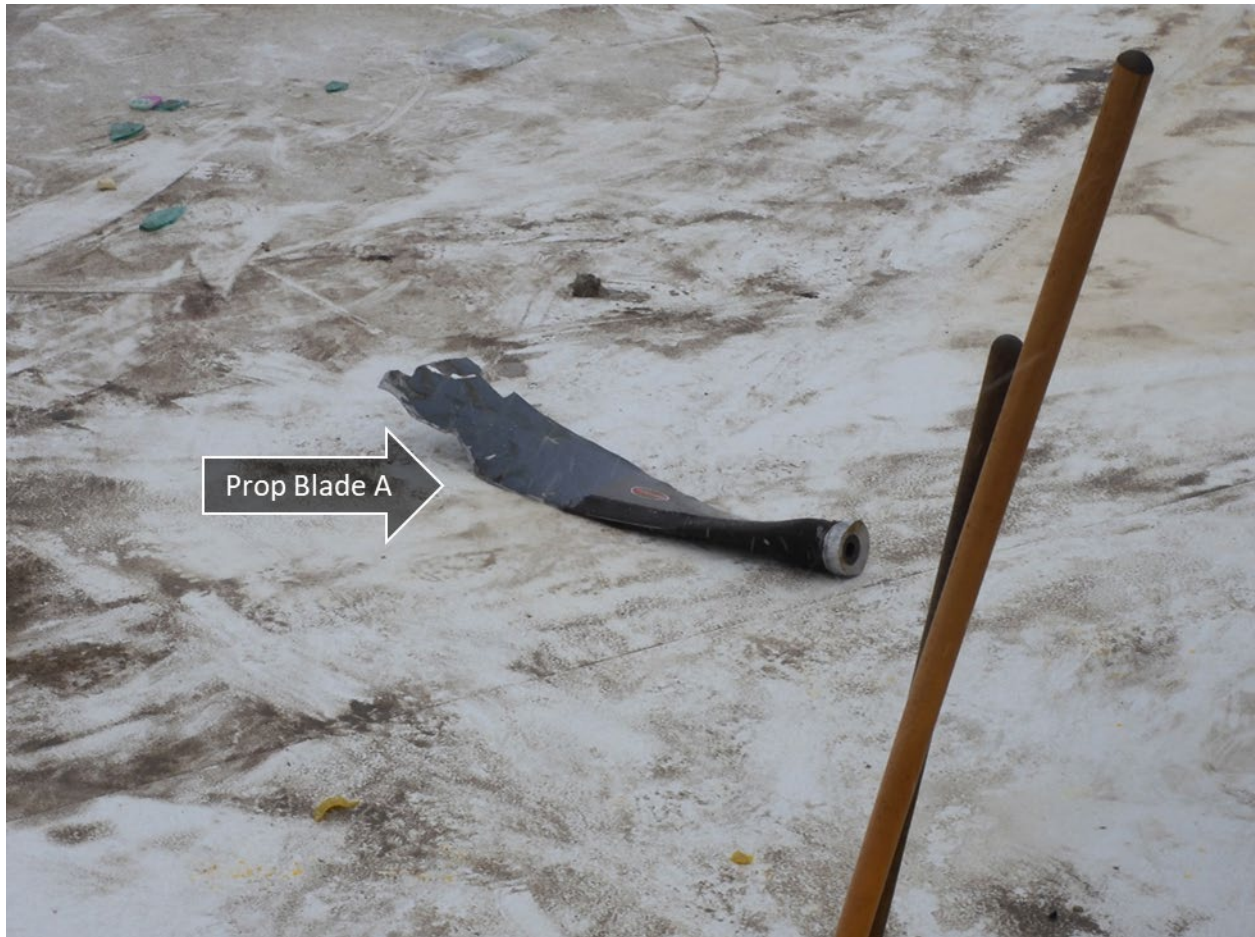
The propeller assembly separated from the engine. One of the propeller blades (prop blade A) separated from the hub. One blade (prop blade B) was identified by its tip remaining attached. Prop blade B remained attached to the hub and exhibited chord-wise bending to about 90°. The third blade (Prop C) remained attached to the hub and exhibited separation of material at the tip, along with S-bending. The prop

**Figure 20. Propeller blade A.**
