# National Transportation Safety Board

WPR22FA151

## **AIRFRAME AND ENGINE EXAMINATION REPORT**

Airplane: N928JP / Cessna 208B

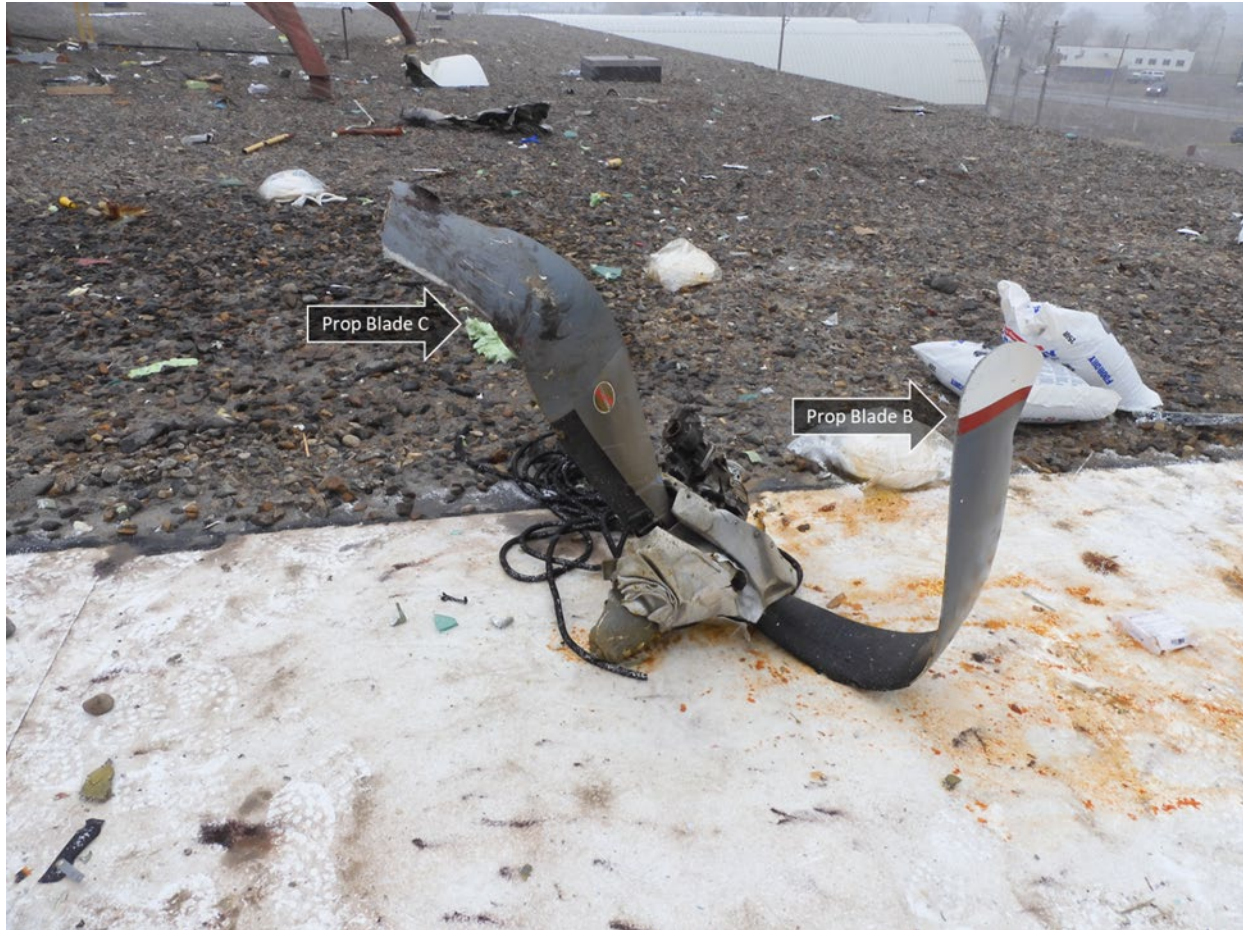
The propeller assembly separated from the engine. One of the propeller blades (prop blade A) separated from the hub. One blade (prop blade B) was identified by its tip remaining attached. Prop blade B remained attached to the hub and exhibited chord-wise bending to about 90°. The third blade (Prop C) remained attached to the hub and exhibited separation of material at the tip, along with S-bending. The prop

tip fell to the ground and was recovered. The oil dome was fractured, and oil was on the roof top where the prop came to rest. The spinner was crushed inward and remained secured to the hub.

**Figure 21. Propeller blade B and C, and propeller hub with spinner.**
