## **NATIONAL TRANSPORTATION SAFETY BOARD**

# **AIRFRAME AND ENGINE EXAMINATION**

**WPR22FA169**

Location: Kalispell, Montana  
Date: April 30, 2022  
Aircraft: Bearhawk LSA, N1908A  
NTSB IIC: Elliott Simpson

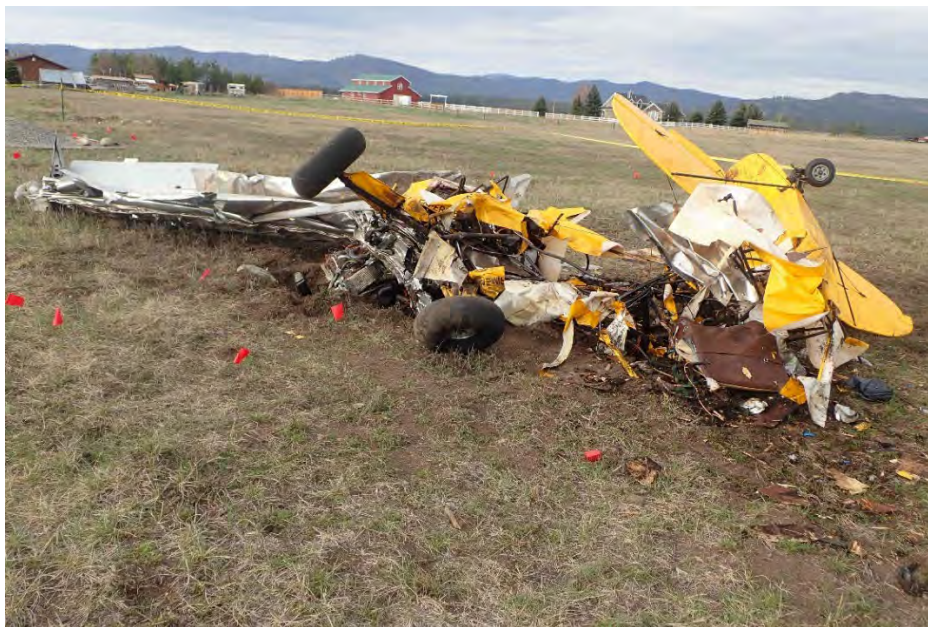
Figure 1 – Airplane at the accident site

The airframe sustained extensive crush damage and fragmentation through to the leading edge of the vertical stabilizer (figure 1). The engine remained partially attached to its mount and had been compressed aft such that fragmented remnants of the firewall had formed around the rear of the engine.

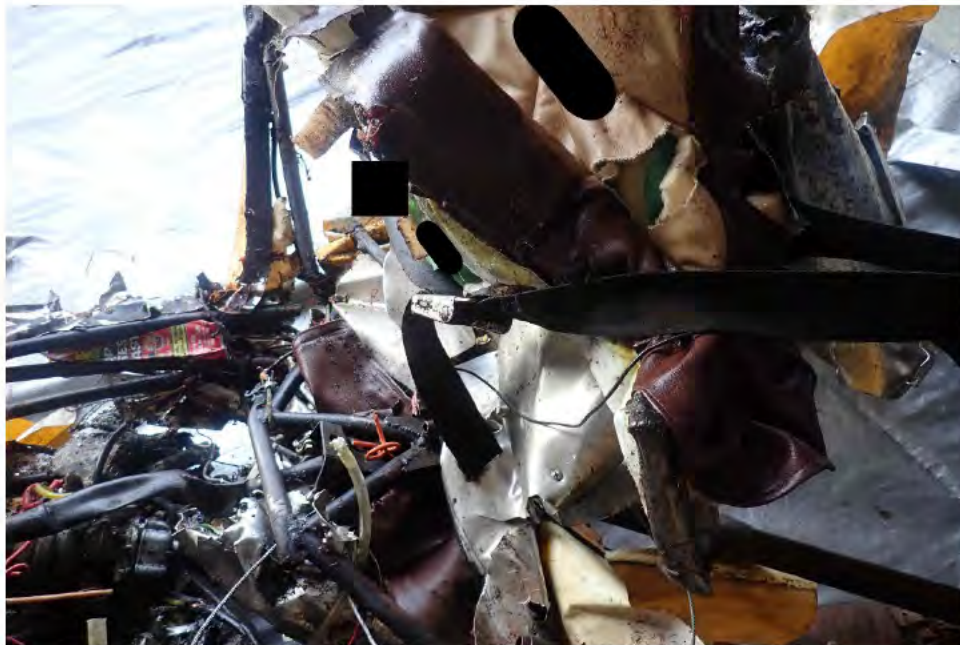
Figure 2 – Front seat and belt

The steel members of the cabin were deformed and fragmented. Crushed remnants of the forward seat remained attached to the right attach fittings. The airplane appeared to be equipped with lap belts only; the front belt was still latched and remained attached to its anchor fittings at the seat base (figure 2). (The belt was cut by first responders). The rear seat had detached from the airframe, with its six mounting bolts still intact (figure 3). The rear seatbelt was found unlatched (Figure 4), with each end still attached to the airframe structure. The pull up tab of the buckle exhibited downward deformation (figure 5); the latch mechanism still worked when tested.

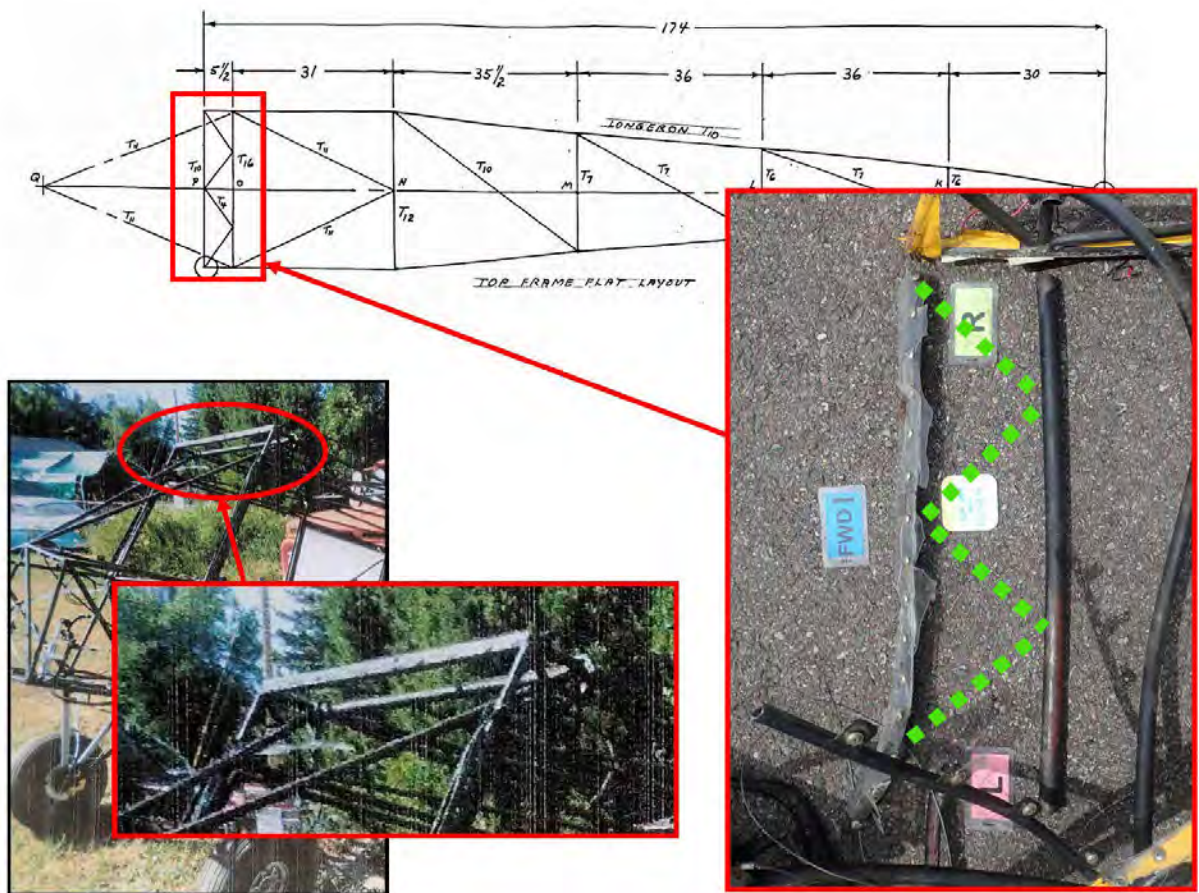
The construction plans call for diagonal bracing of the forward wing spar carry through area. Review of the build logs and airframe remnants revealed that this bracing had been omitted. There was nothing in the build logs that indicated this omission was intentional.

Review of the plans for the forward spar carry through assembly indicated that there should have been four diagonal braces between the main carry through tube and the forward carry through tube. Examination of the build logs and airframe revealed that they had not been installed (figure 6).

Figure 6 – Forward spar carry through section. Image from build logs (left), post-accident (right).  
Location of missing braces highlighted in green.

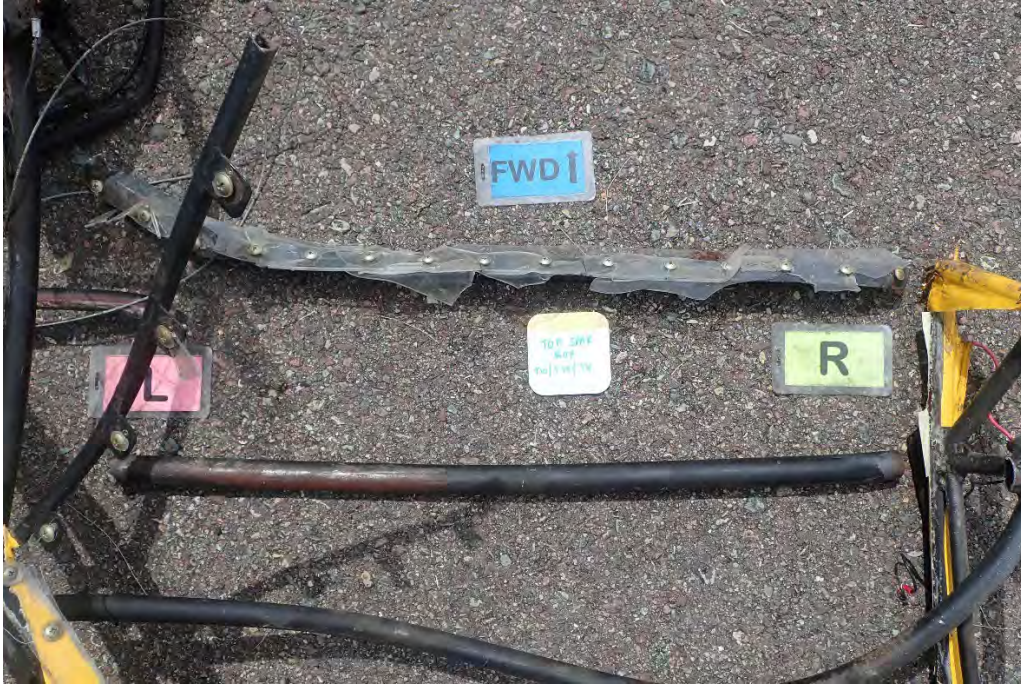
Figure 7 - Forward spar carry through section

The forward spar wing carry through tube, was 1 inch in diameter, with a material thickness of 0.060 inches, which met the plan specifications. The tube had separated at both ends from the main spar attach fitting cluster just inboard of both welds. The carry through tube exhibited a slight rearward buckle along its length (figure 7).

The forward carry through tube was 0.75 inch in diameter, which met the plan specifications, but was 0.05 inches thick rather than the 0.028 inch thickness called for in the plans. The tube exhibited a pronounced aft buckle with similar separations inboard of both weld clusters (figure 7).

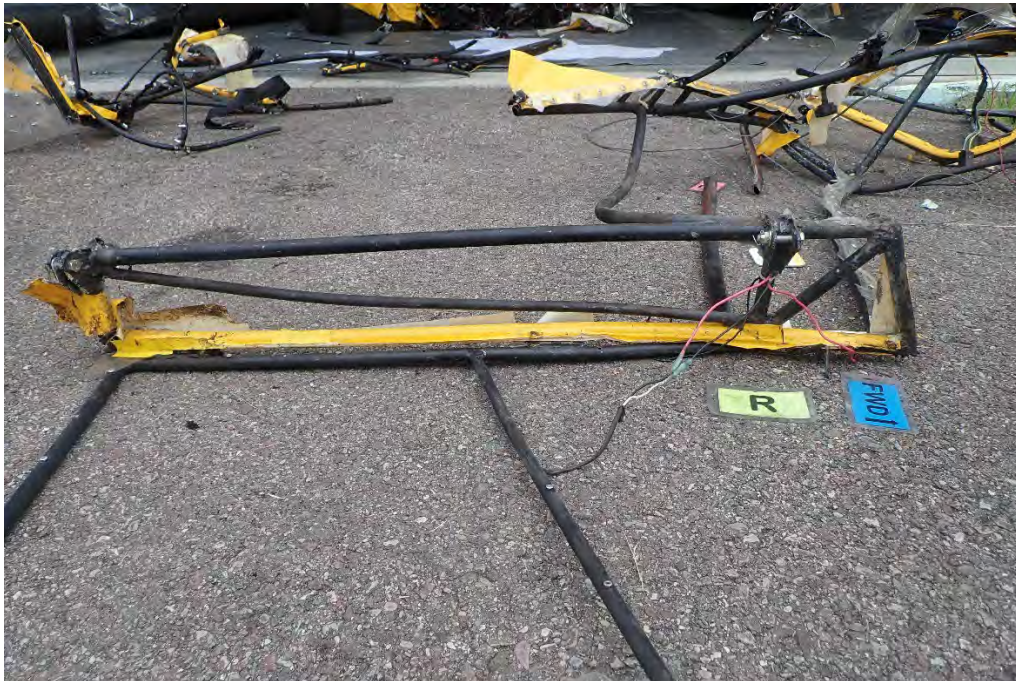
Figure 8 – Right wing root box assembly

The right wing root box assembly was mostly intact (figure 8). The forward spar attach point aft tang was straight, the forward tang had bent forward, but the bolt remained installed. The rear spar attach point assembly was intact, and the spar bolt was in place (figure 8).

The bolts for both the right forward and aft spar end cap were still in place at their respective fuselage fittings (figure 8). Close examination revealed two notches (figure 35) in the upper surface of the aft fitting, that matched the dimensions of a notch in the layup of the aft end cap tang (figure 36). Similarly, the forward fitting exhibited two scrape marks to its upper surface (figure 37), that matched the layup of the forward end cap tang.

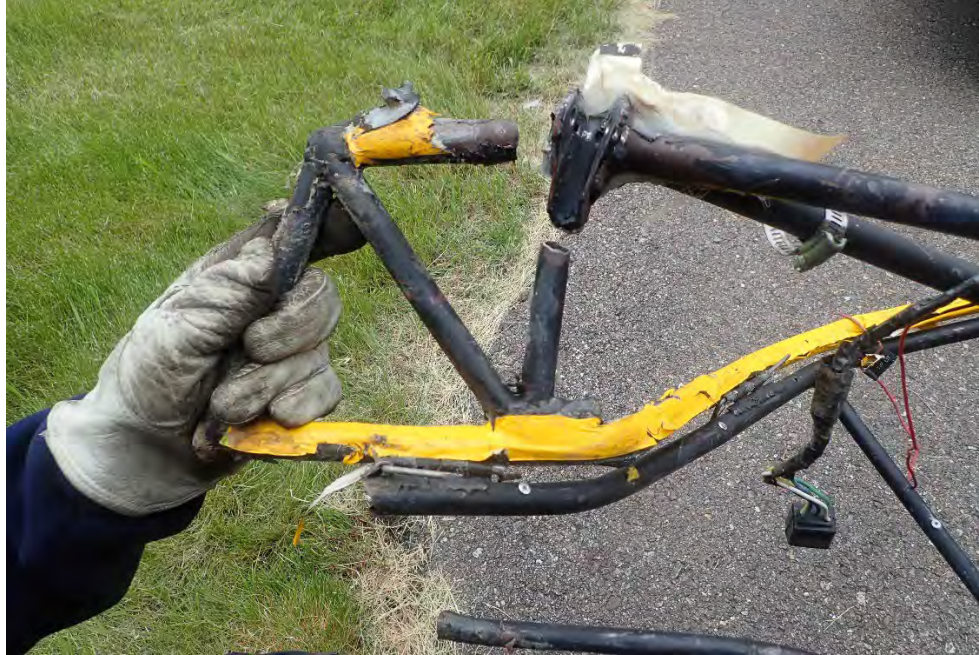
Figure 9 - Left wing root box assembly

On the left side of the wing root box assembly, the forward portion had partially detached, and had broken away from the wing root box assembly (figure 9- note bolt removed for clarity) at upper main spar cluster. The aft spar attach fitting remained attached to the assembly.

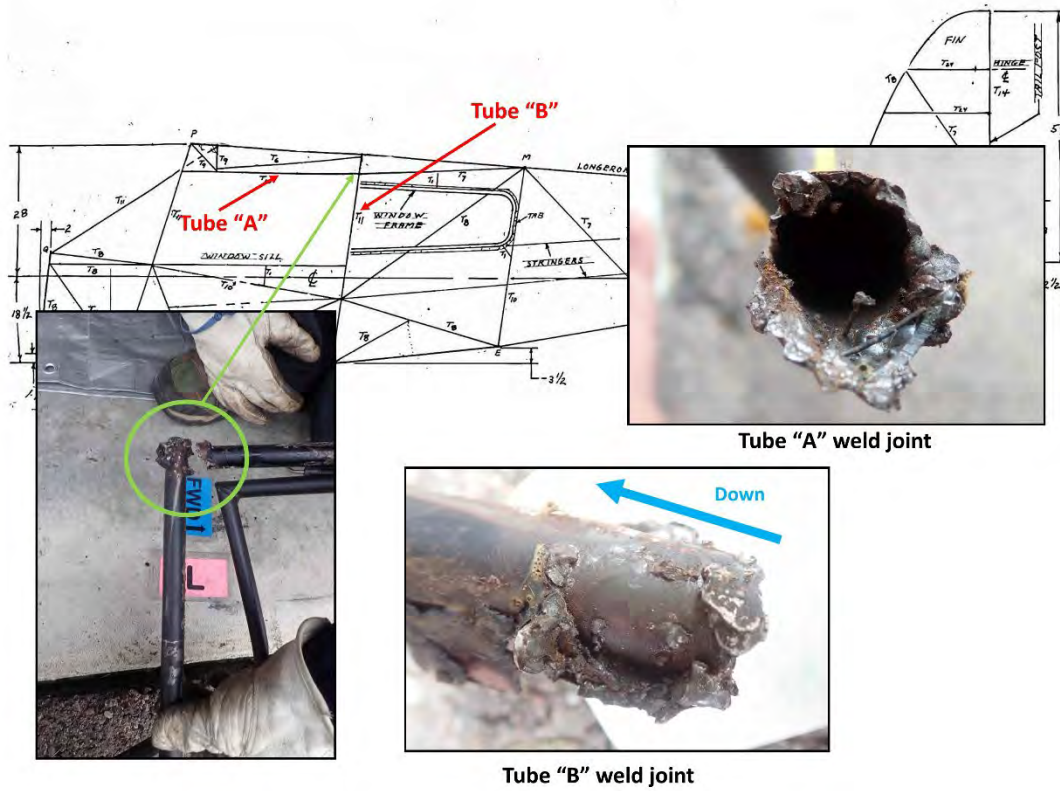
Figure 10 - Left fore-aft lower wing box longeron

The weld quality was generally poor with multiple areas of incomplete fusion, porosity, and burn-through. The left fore-aft lower wing box longeron exhibited an incomplete weld to the left aft vertical support with no penetration. However, the remaining airframe welds in all other locations appeared intact, with the separation failures appearing to have occurred in overload, just beyond the welds.

The left fore-aft lower wing box longeron exhibited a detached weld, at the interface with the left aft vertical support (figure 10). Examination of the weld indicated that there was almost no penetration into the vertical and horizontal members. Weld defects included porous weld fillets, and multiple remnants of welding wire.

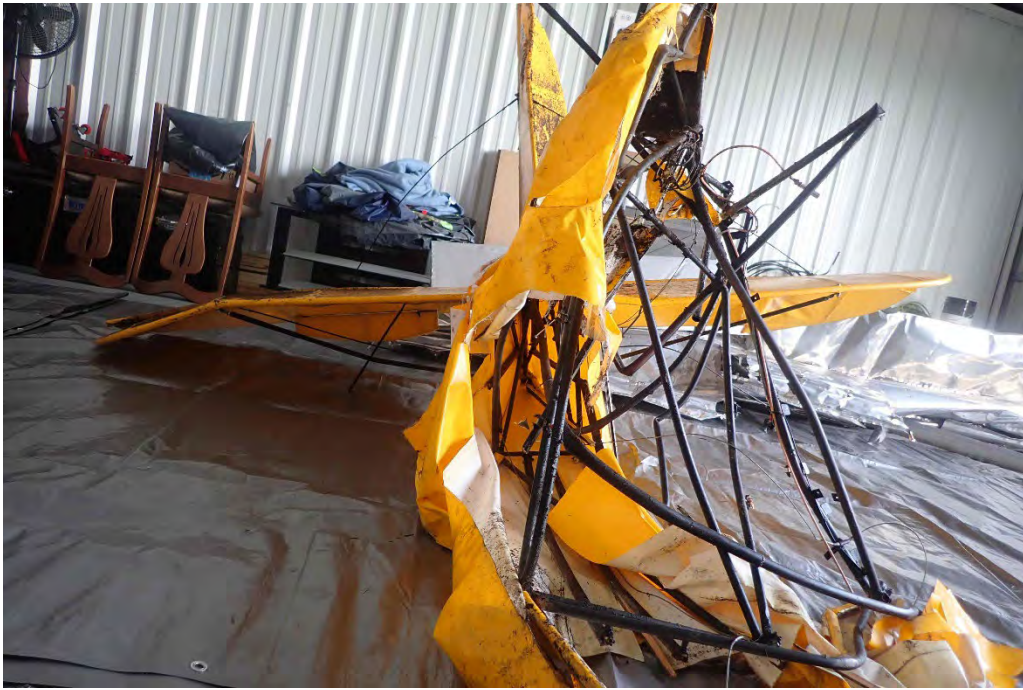
Figure 11 – Tail section

The tail section remained largely intact (figure 11). The vertical stabilizer remained attached at its base, and the rudder was still attached to its hinges, and moved freely. The rudder control cables were continuous from the control surface horn through to the foot pedals.

For the right horizontal stabilizer, the upper brace separated at outboard fitting, with similar granular surface feature at the separation point. Both lower braces remained attached, but the lower forward brace exhibited a 10 ° bend/buckle midspan. Outboard of the lower brace point, the right horizontal stabilizer and elevator had bent down about 20° (figure 11). This damage appeared to be consistent with ground impact (15).

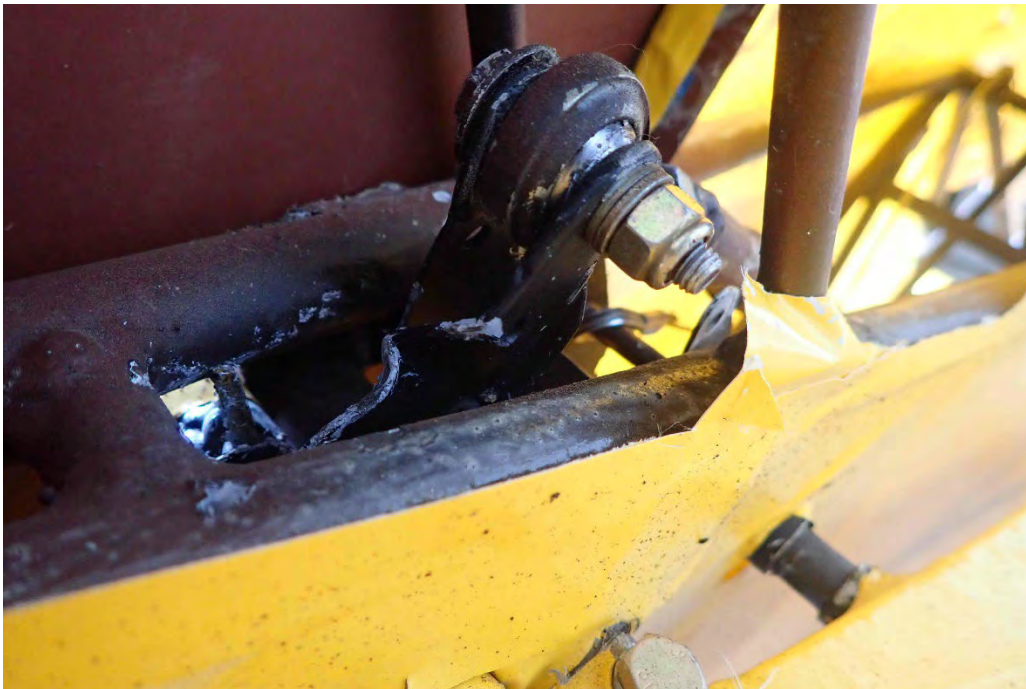
Figure 12 - Elevator bellcrank

The elevators remained attached to the horizontal stabilizer at their hinges and could be moved freely. The elevator push-pull tube remained attached to the right elevator bellcrank and was broken away from the left elevator bellcrank (figure 12). The push-pull tube was continuous to the intermediate bellcrank, which had detached from the lower airframe (figure 13). Forward of the bellcrank, the remaining section of the push-pull tube had separated and was located in the primary debris field. The other end of the tube had broken away from the aft control stick within the control column assembly (figure 14). All separated sections of the push-pull tube exhibited bending damage with granular surface features at the partings consistent with overload failure.

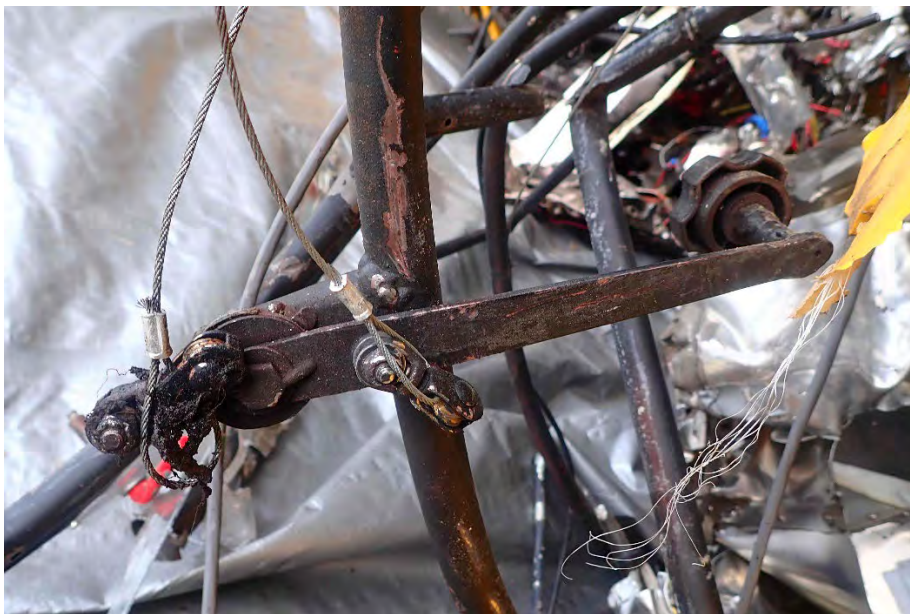
Figure 16 – Pitch trim cabin control

Pitch trim cable continuity was traced through to the control arm in the cabin. The control arm could be moved, and slight friction was felt, which appeared to be consistent with a friction lock system (figure 16). The trim tab actuator torque tube remained connected to each side, but the right trim tab push-pull tube had broken away at the fitting on the tab, with granular surface features noted at the separation surface.

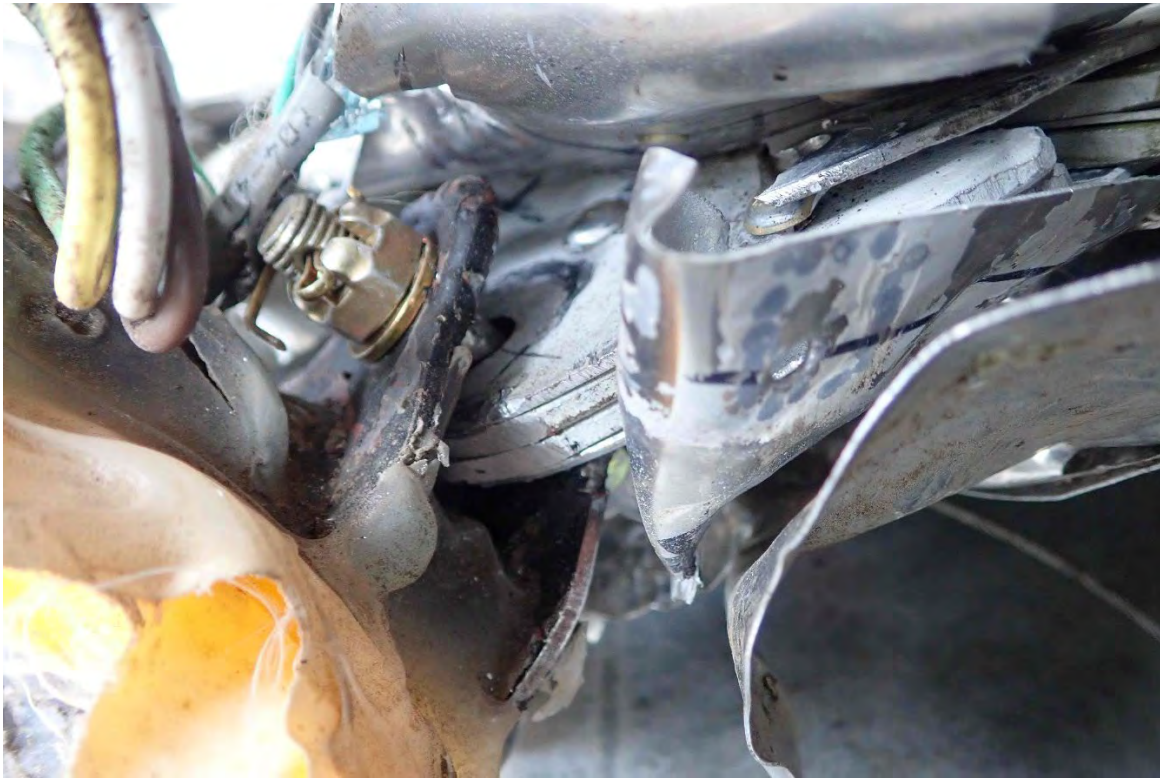
Figure 17 – Left wing forward spar end cap and fuselage fitting

The left wing remained partially attached to the airframe remnants by its forward spar end cap (figure 17). The rear end cap had pulled away from the airframe fitting (figure 18) but the fitting bolt remained in place (figure 19). The entire wing sustained rearward crush damage to the aft spar, with the aileron remaining attached (figure 20). The aileron control cable was continuous from the outboard bellcrank (figure 21) assembly through the strut and remained attached to the lower forward control stick

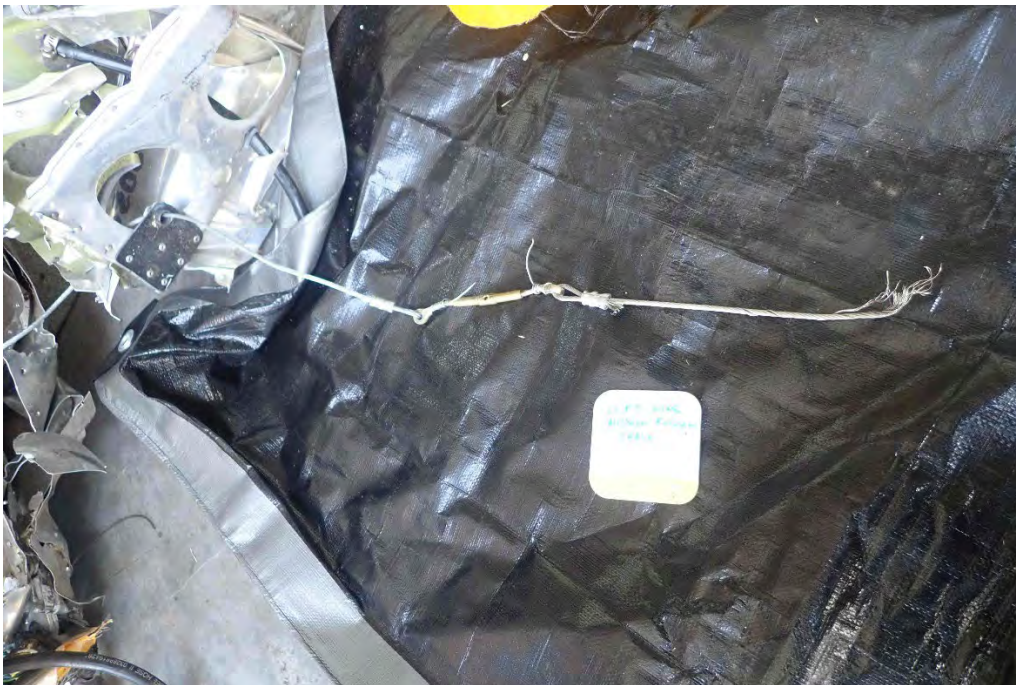
Figure 22 – Left wing aileron cable

assembly. The return cable was continuous from the outboard bellcrank through to the inboard section of the right wing, where it had disconnected with broom straw damage (figure 22).

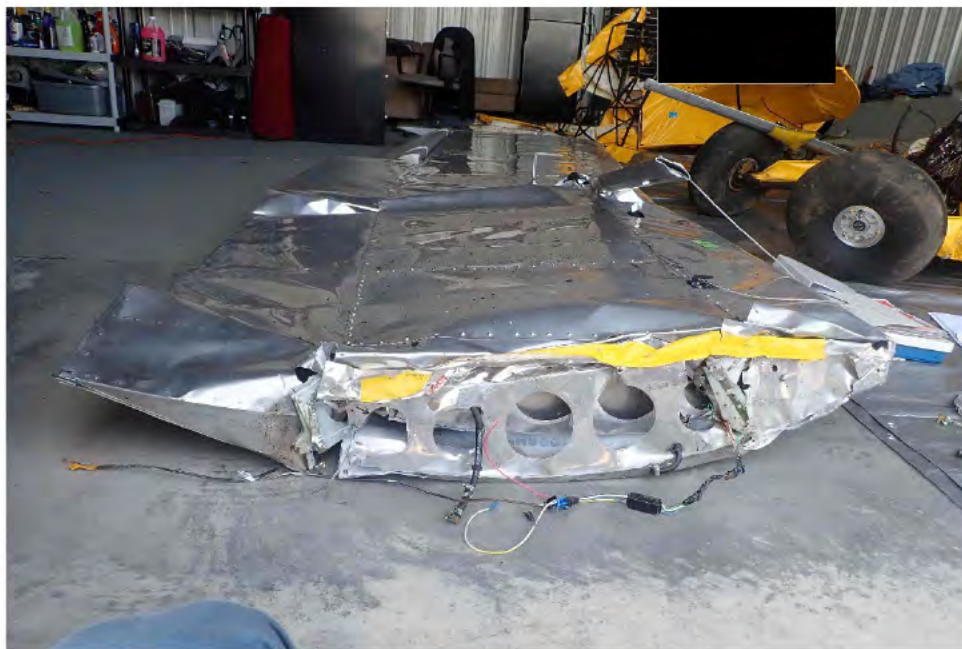
Figure 23 – Right wing root rib and end caps

The right wing had detached at both the forward and aft end caps (figure 23). The attach holes for the caps exhibited inboard and up “pull through”. Both caps were bent aft with their tips damaged consistent with ground/tarmac damage. The root rib sustained spanwise crush damage consistent with ground contact.

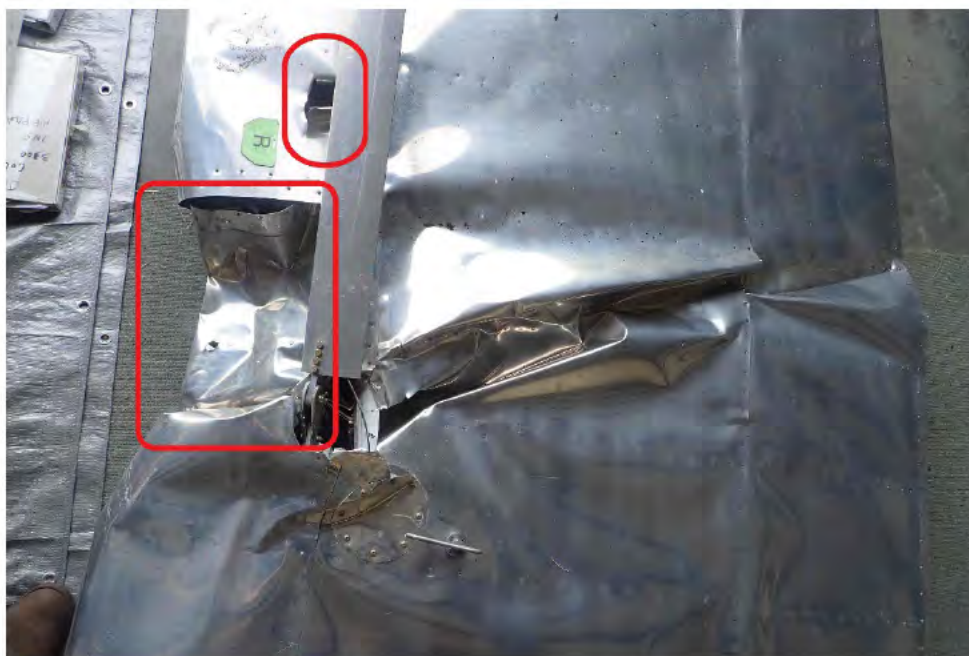
Figure 24 – Right wing outboard lift strut and wheel/step imprints

The strut had fractured near midspan. The upper section remained connected to the wing attach point (figure 24), and the lower section had detached from the lower fitting on the landing gear assembly. Concave buckling damage was noted on the upper (wing side) of the strut (figure 25), and on the outer side (lower section), material appeared to have torn out, and bent back against the strut structure (figure 26).

Similarly, a puncture to the underside wing skin surface, inboard of the strut mount, appeared to match the dimensions of the step, and exhibited scrape signatures to its surface that matched the anti-slip coating on the step (figure 24). A 20-inch-wide impact impression in the lower leading of the wing was present adjacent to the strut attach point, the dent matched the approximate diameter of the main landing gear tire (figure 24). There were also black transfer marks consistent with tire contact, and yellow paint transfer matching the tire hub cap (figure 31, 32).

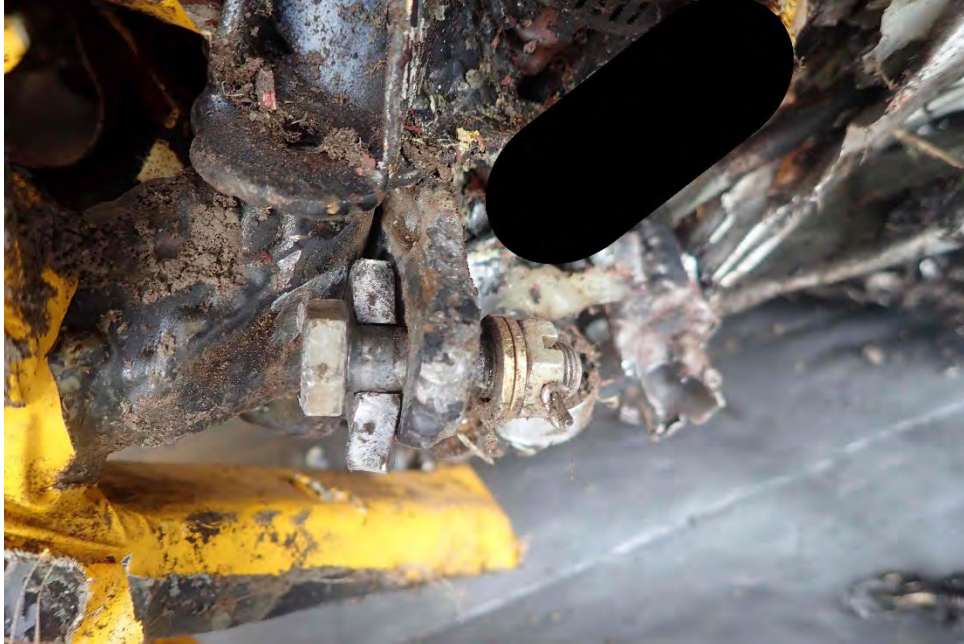
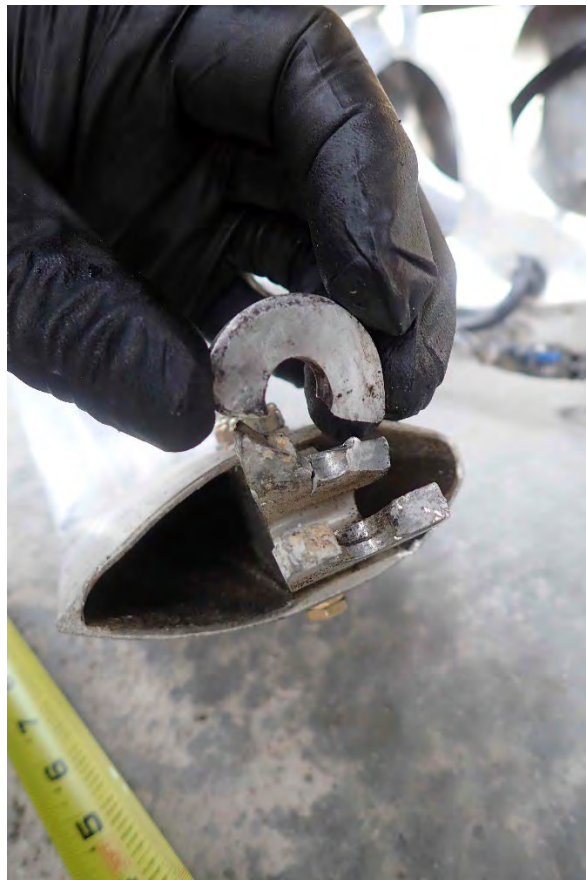
The strut bolt remained in place on the lower fuselage fitting along with the tip of one of the lower strut brackets (figure 27, 28). The clevises at the lower section of the strut exhibited downward deformation and failure. There was a one-inch-wide square shaped impact impression and bend centered about 9.5 inches above the lower attached point in the lower section of the strut (figure 24). The bend matched the dimensions and locations of the right landing gear step strut, when the strut was oriented down (figure 29, 30).

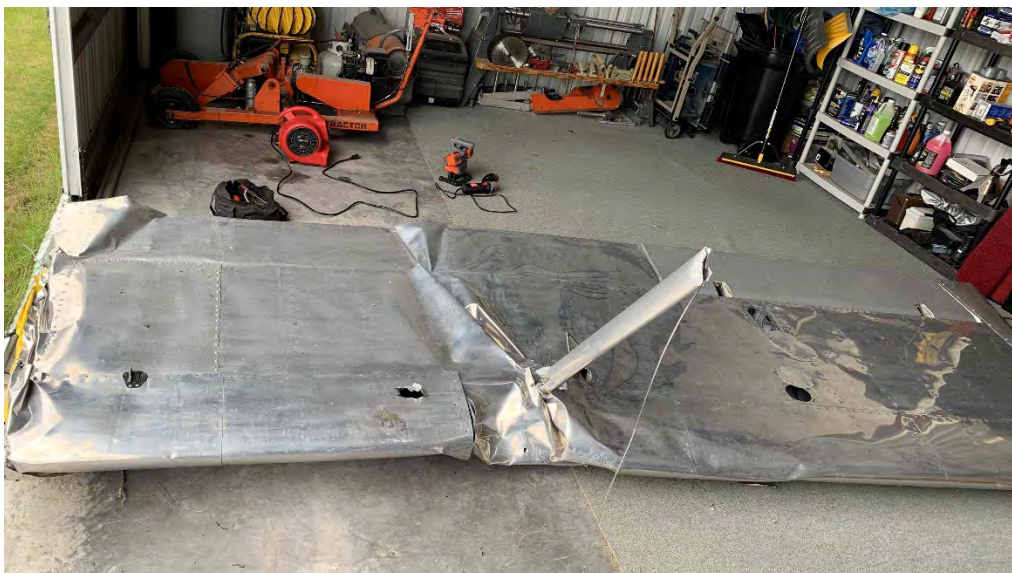
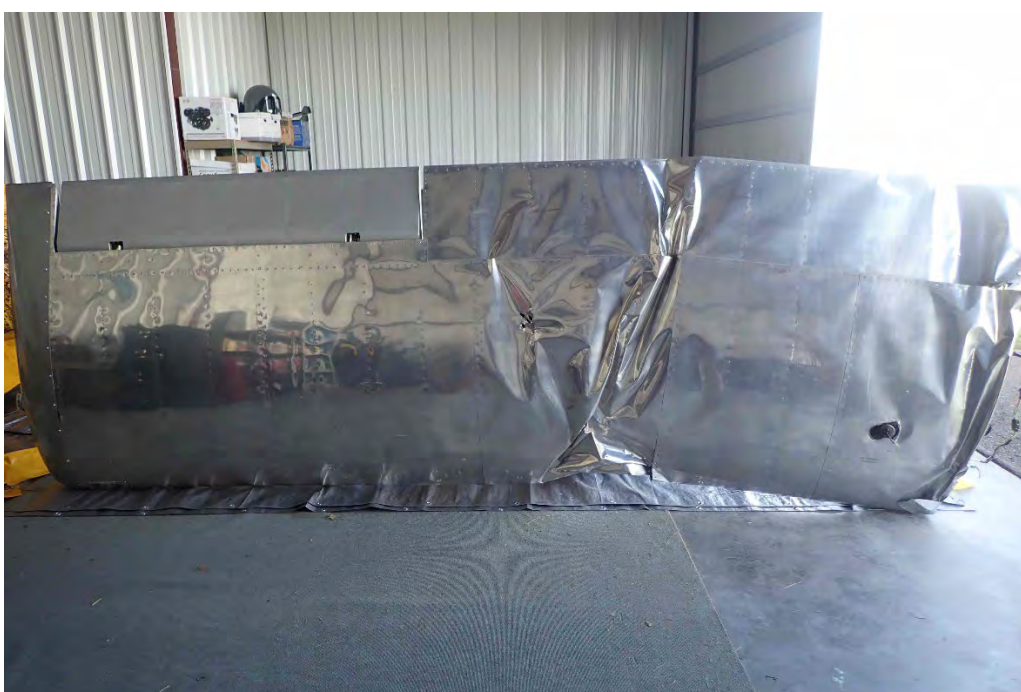
The wing was mostly straight along the lifting plane, but exhibited a forward bend at the tire indentation, with crumpling of the wing skin surfaces in the area (figure 33, 34). Examination of the main spar aft of the impact impression revealed that the spar caps had deformed into compete S-bends with some fracturing in the spanwise direction, reducing the wingspan by about 7 inches. The wing fuel tank was almost full at the time of the accident, and this spanwise crushing appeared to be consistent with ground impact.

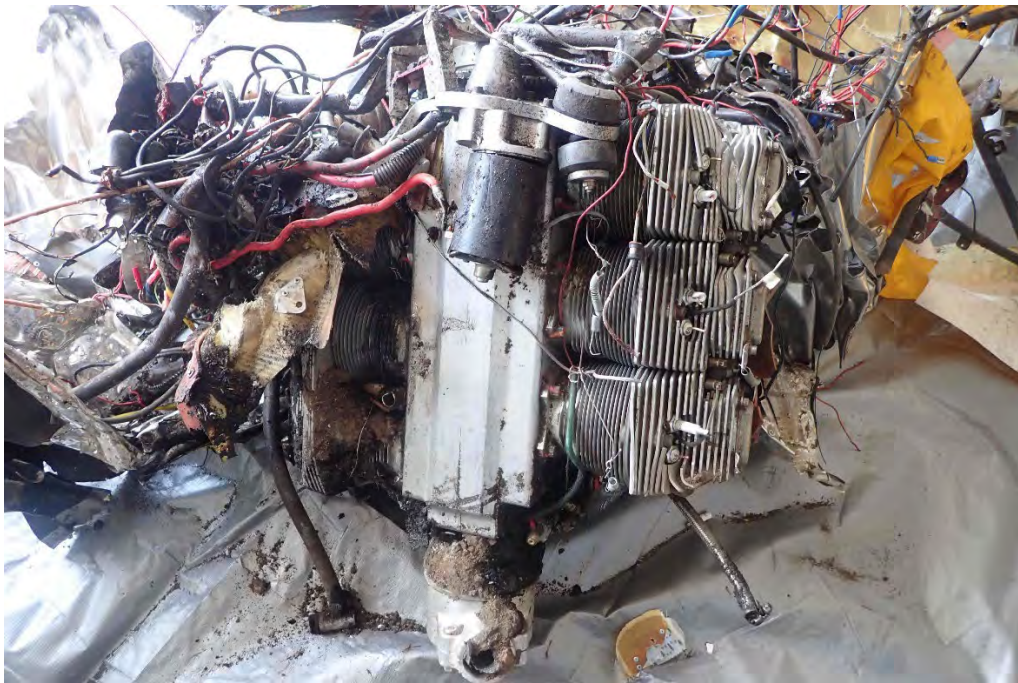
Figure 38 - Engine

The engine sustained significant impact damage, partially detaching the starter motor and alternator assembly, along with the ignition wires and all ancillary cables, and fuel lines (figure 38). The induction system was crushed, and the carburetor had detached but appeared largely undamaged. There was no evidence of catastrophic engine failure such as a crankcase breach, and all six cylinders remained attached to the crankcase. The gascolator had broken open, exposing the screen which was free of debris.
