**NATIONAL TRANSPORTATION SAFETY BOARD**  
Office of Aviation Safety

**Wreckage Examination Group Field Notes**

**A. ACCIDENT      WPR22FA172**

Location:      Sausalito, California  
Date:      May 6, 2022  
Time:      1210 PDT  
Operator:      Private  
Aircraft:      Vans RV-10 Experimental Airplane  
Registration:      N54MG

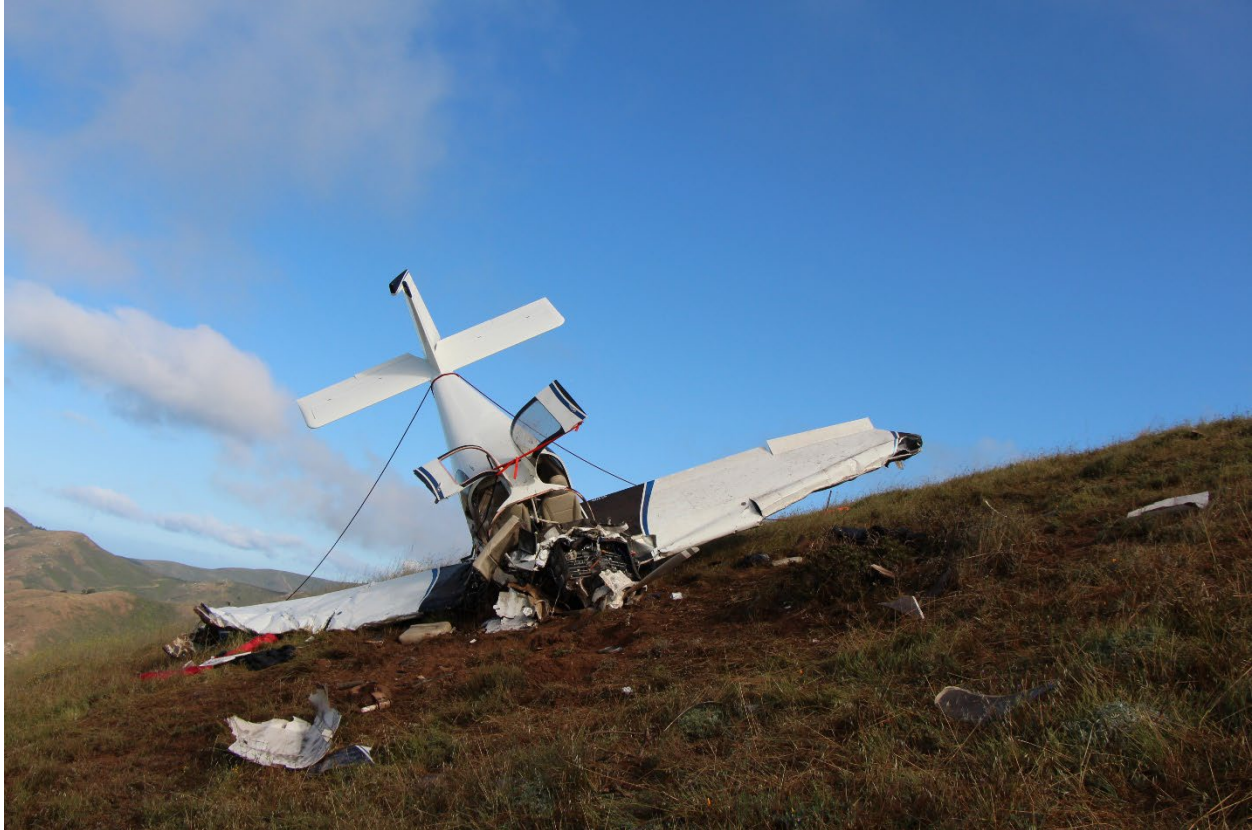
The airplane came to rest in an approximately 40° nose down attitude on a heading of about 111° magnetic, and was located on the southwest side of a hill in the Marin Headlands at a field elevation of about 800 ft msl. All four corners of the airplane were accounted for at the accident site. The first point of impact (FPI) was marked by a divot about 15 ft southwest of the main wreckage. A debris path comprised of engine cowlings, was traced from the FPI to the main wreckage on a magnetic heading of 340°.

*Photograph 1: Accident site from the southwest*

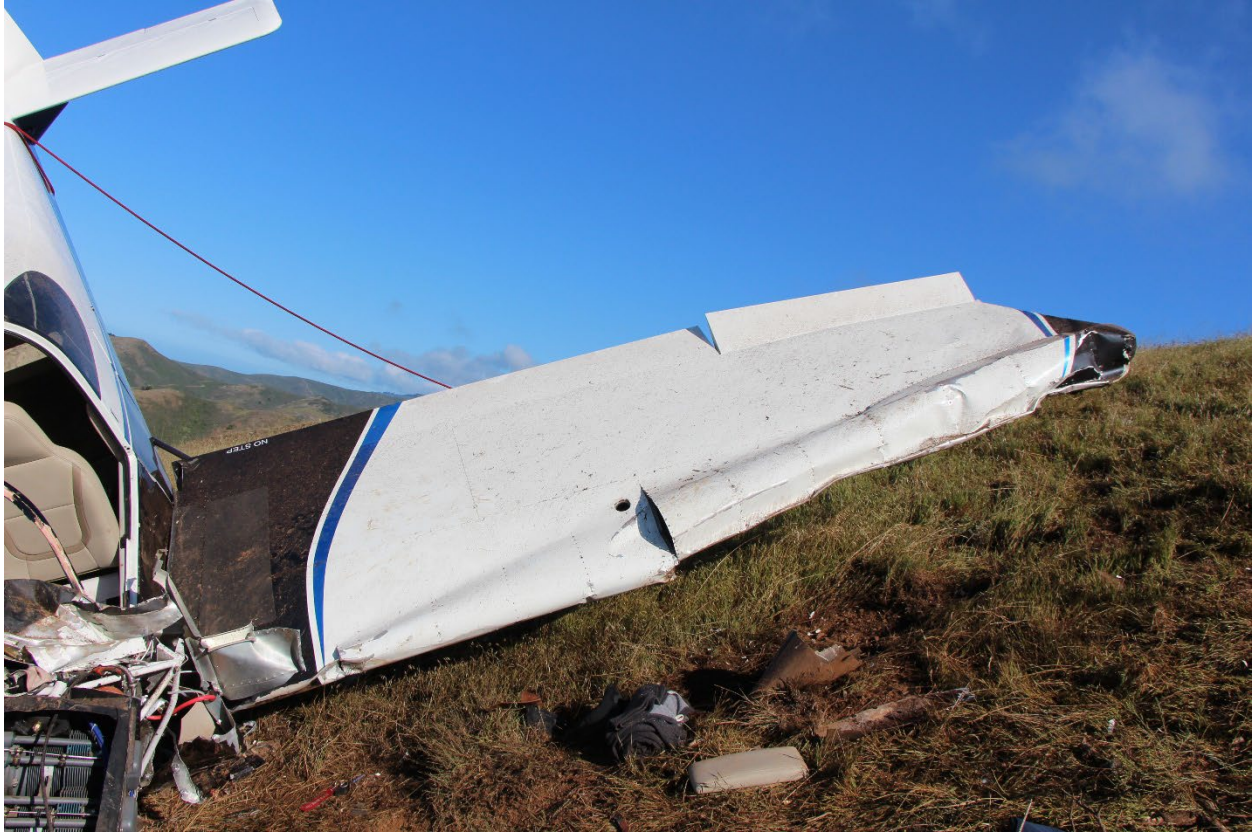
The left wing was attached to the fuselage and the aileron and flap were both attached to the wing at their hinge points. Leading edge crush damage was observed throughout the wing with hydraulic deformation along the inboard leading edge of the left wing fuel tank. The wing skin had separated at the left wingtip.

*Photograph 2: View of left wing at accident site*

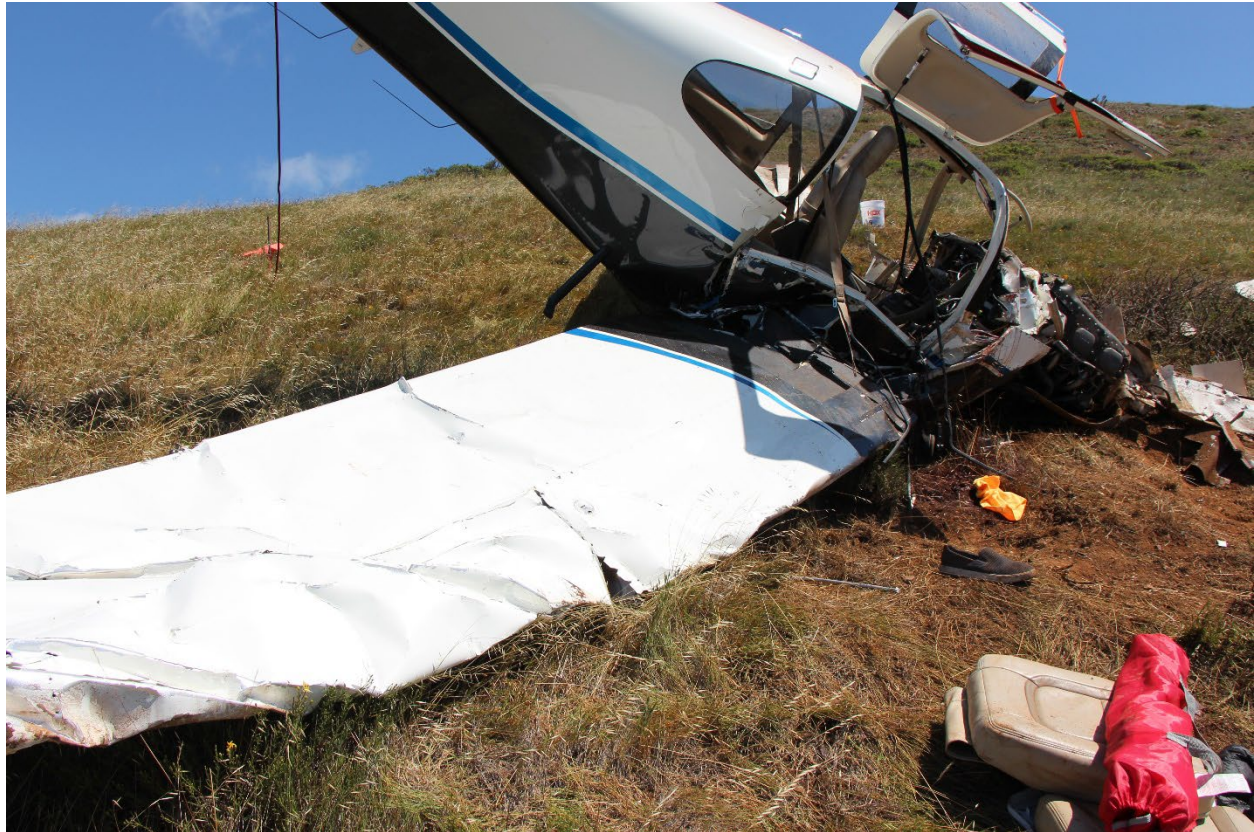
The right wing separated at the wing root and was displaced slightly aft of its normal position relative to the fuselage. The flap remained attached to the wing at all three of its hinge points. The left aileron had separated from the inboard push pull tube and outboard hinge and was located about 15 ft north of the main wreckage. Leading edge deformation and bending was observed from midspan to the outboard wing, which was bent upward. Compression wrinkles with some deformation was observed along the leading edge from the midspan right wing inboard to the wing root.

*Photograph 3: View of right wing at accident site*

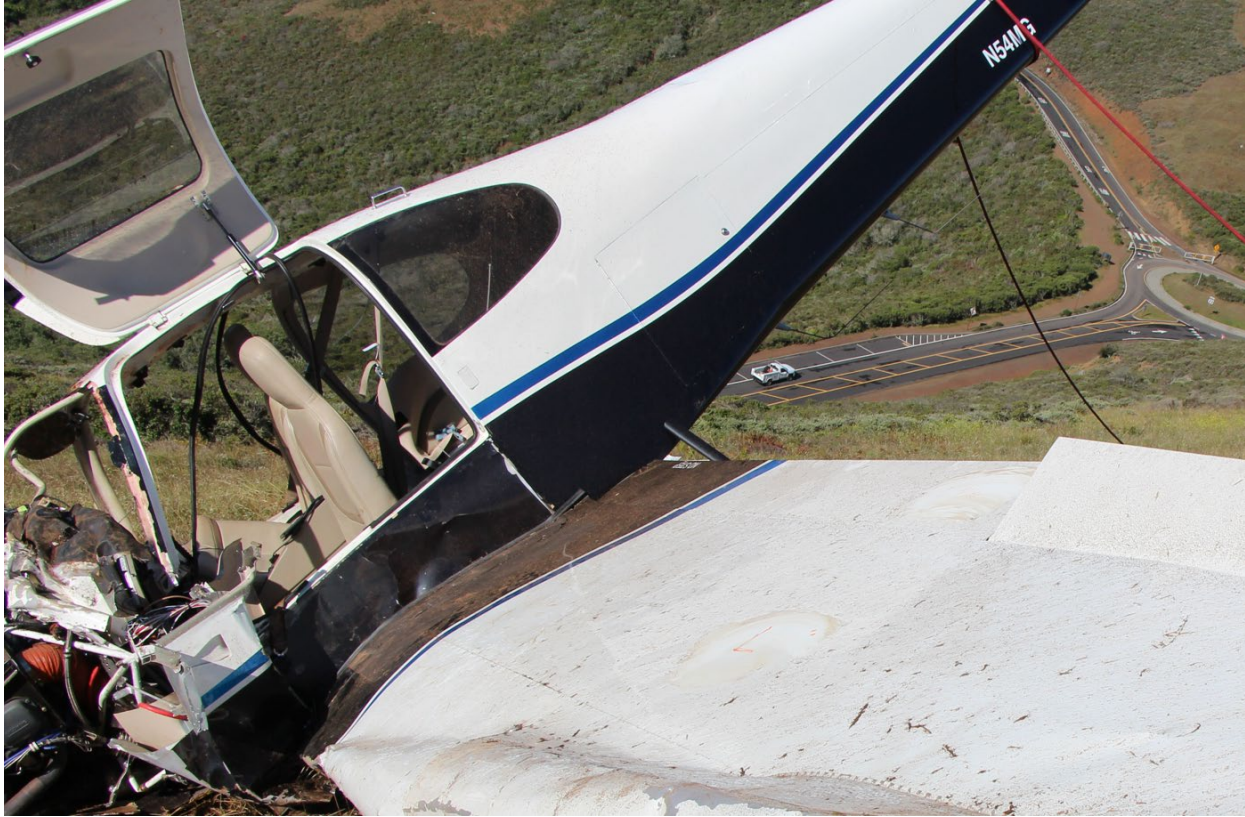
The fuselage was mostly intact. Compression wrinkles were observed at the top of the fuselage near the aft bulkhead. Both the windshield and right door plexiglass were broken and the fragments were collocated with the main wreckage. The left (pilot side) window post was separated near the lower fuselage. Both doors remained attached to the fuselage at their hinge points. The firewall was pushed forward into the engine compartment and the lower fuselage was crushed at the foot wells.

*Photograph 4: View of left side fuselage*

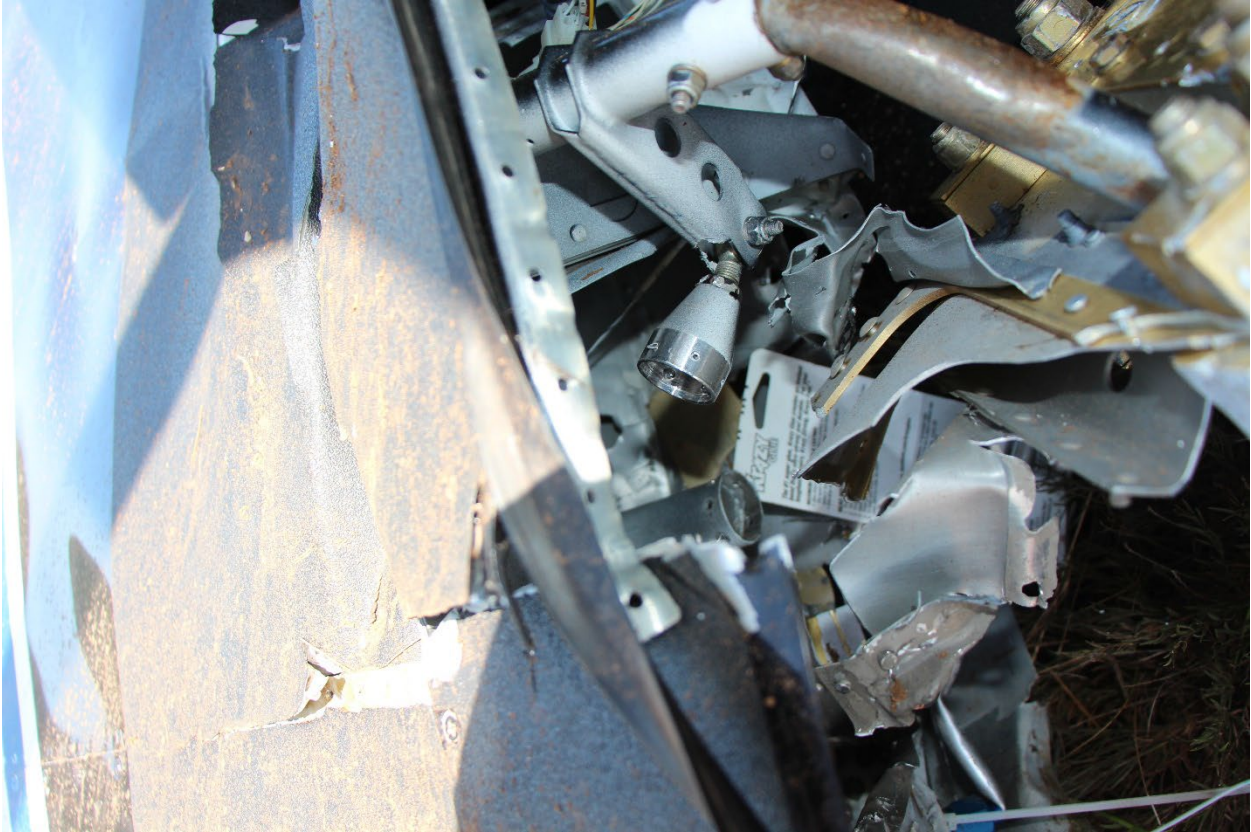
Flight control continuity was confirmed from the cockpit to the left aileron and traced from the cockpit to the right aileron push/pull tube through two separations at the wing root. The first separation was a fractured rod end at the aileron torque tube bellcrank. Additionally, each of the push tube rivets had sheared at the bell crank assembly. The electric flap system was not tested due to safety concerns.

*Photograph 5: Right wing torque tube at inboard wing*

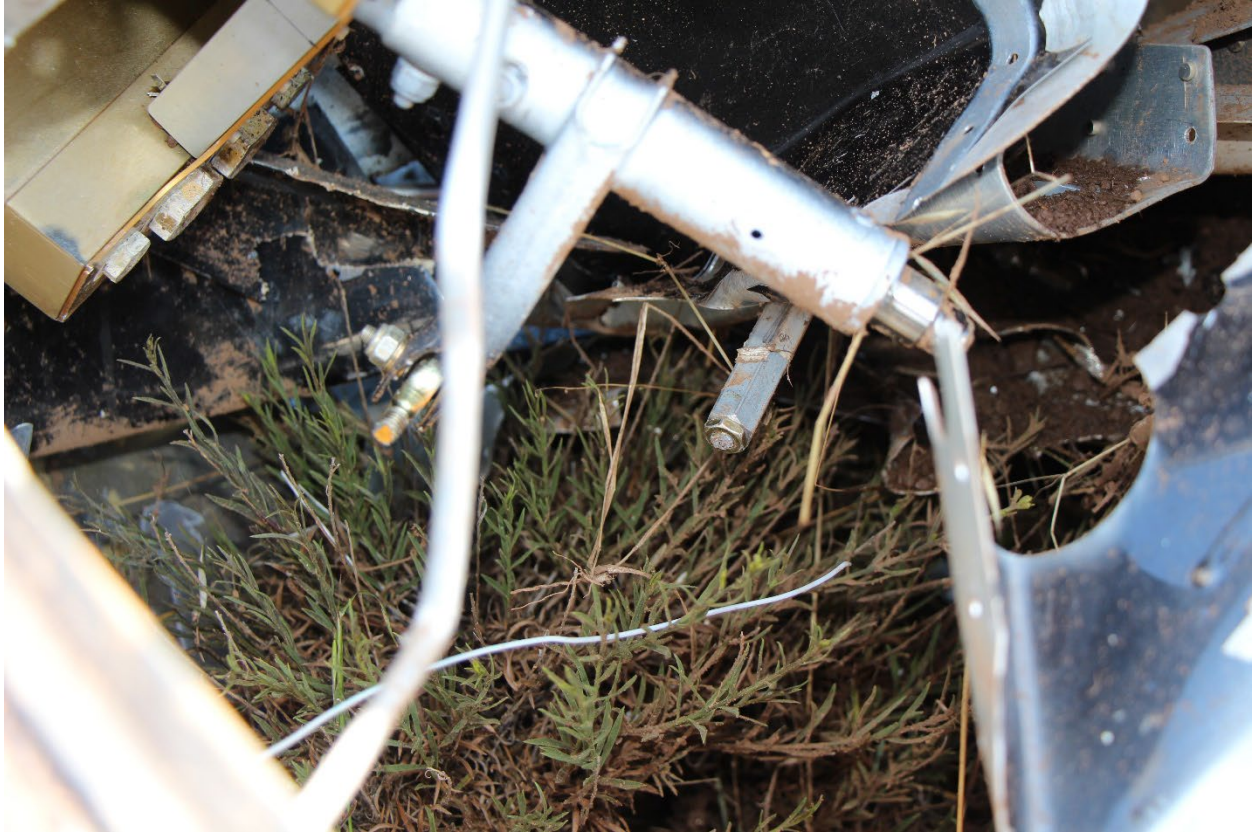
*Photograph 6: Fractured rod end and push tube, inboard right aileron*

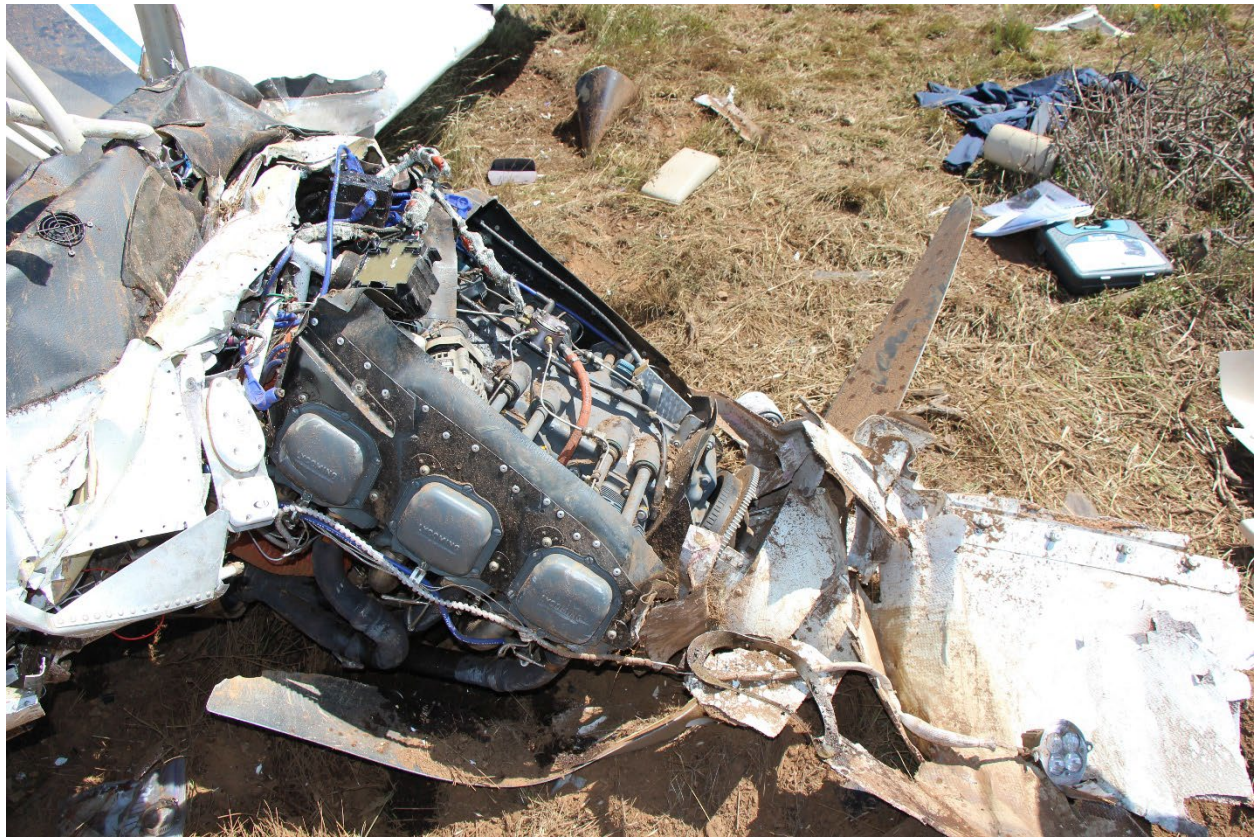
The airplane was equipped with a Lycoming Engines YIO-540-D4A5, a 250 hp, horizontally opposed, air cooled, reciprocating engine. The engine was attached to the firewall at the upper mounts and right lower mount. The left lower mount was fractured. The right and left electronic ignition cases were separated from the engine accessory case and some of the ignition harness leads had separated from the cases. The oil filter and alternator had also separated from the engine accessory case. Each of the 6 NGK top spark plugs were secured at their plug portals and their corresponding ignition harness leads were secure. The engine showed 4 quarts of oil in the oil sump, which could not be inspected as the bottom of the engine was flush with the ground and

The 2 bladed constant speed propeller remained attached to the engine at the crankshaft. One propeller blade was straight and did not exhibit any nicks, gouges or chordwise scratches. The other blade was bent about midspan with nicks and gouges near the blade tip and chordwise scratches at the blade face.

*Photograph 7: Right side engine and propeller*
