**NATIONAL TRANSPORTATION SAFETY BOARD**  
Office of Aviation Safety

**Wreckage Examination Group Field Notes**

**A. ACCIDENT      WPR22FA172**

Location:            Sausalito, California  
Date:                May 6, 2022  
Time:                1210 PDT  
Operator:           Private  
Aircraft:            Vans RV-10  
Registration:       N54MG

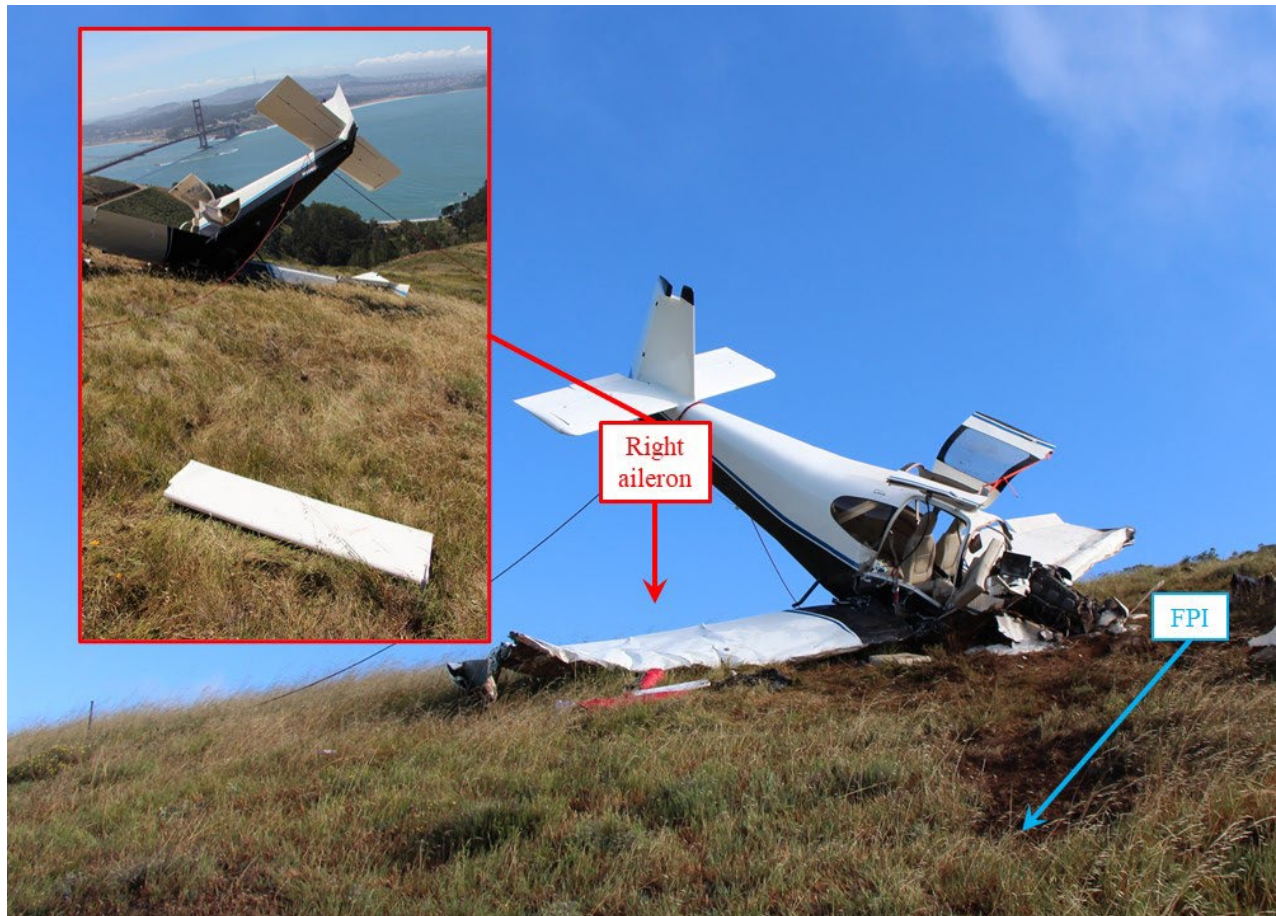
The airplane came to rest in a nose down attitude on an eastern heading. All major structural components of the airplane were accounted for at the accident site. The first point of impact (FPI) was marked by a depression about 15 ft southwest of the main wreckage. A debris path comprised of engine cowlings and plexiglass fragments, was traced from the FPI to the main wreckage.

Figure 2: View of accident site with first point of impact and right aileron

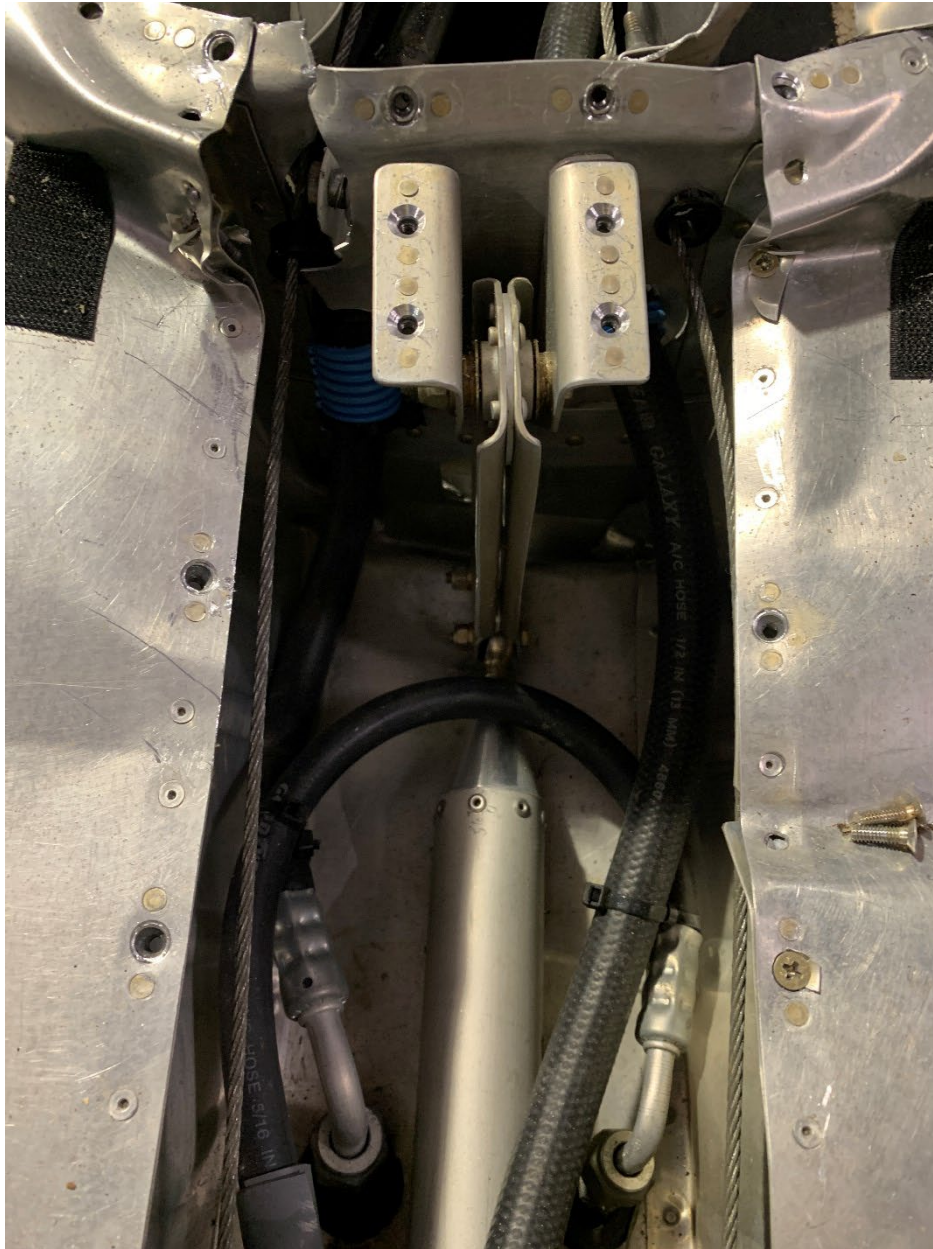
The elevator control sticks remained attached to the control column. Continuity was traced from the control assembly to the aft elevator pushrod (F-1091), which had been disconnected from the left and right elevator horns by recovery personnel. Full travel of the elevator control could not be achieved as the airframe skin below the elevator idler arm and forward elevator push rod was deformed. Both rudder pedals remained attached to their tubes, which had separated from their airframe mounting positions. The left and right rudder control cables were continuous from the rudder cable links at the right seat, left pedal and left seat, right pedal to the empennage. Both cables had been disconnected from the rudder horns by recovery personnel.

*Photograph 2: Elevator push rod and idler arm*

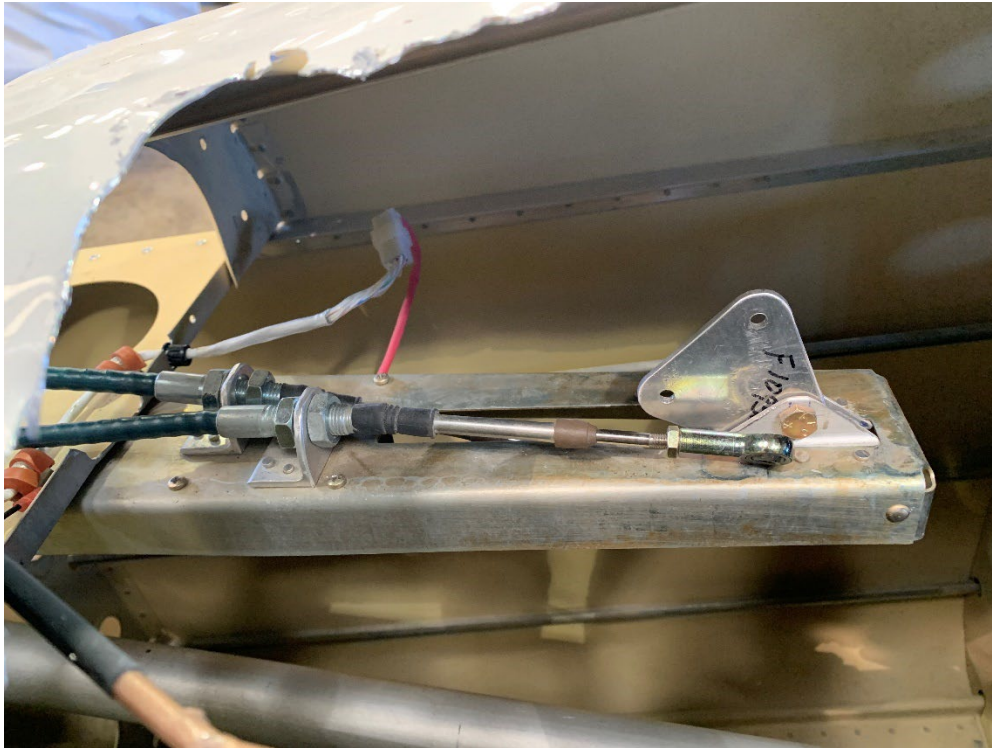
The elevator trim servo was attached to the trim mount bracket, located in the aft fuselage. The trim servo link subassembly was connected at the servo and the trim bellcrank. However, both trim cables were disconnected from the trim bellcrank by recovery personnel. The trim cables were also cut by recovery personnel. The left trim cable was continuous to the left elevator trim tab and the right trim cable had been disconnected from the right trim tab by recovery personnel. The trim servo actuated to its fully extended and retracted positions when tested with battery power.

*Photograph 3: Elevator trim servo assembly*

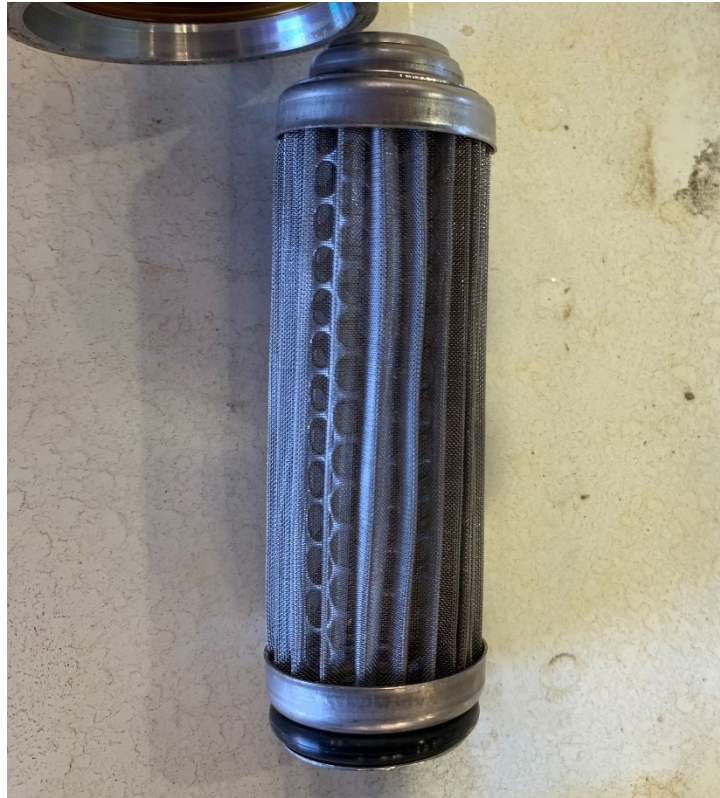
Continuity of the airframe fuel system was confirmed from the wings to the fuel pressure transducer forward of the engine firewall. The airframe fuel filter screen was free of contamination and the fuel pump functioned when tested with battery power.

*Photograph 4: Airframe fuel filter element*

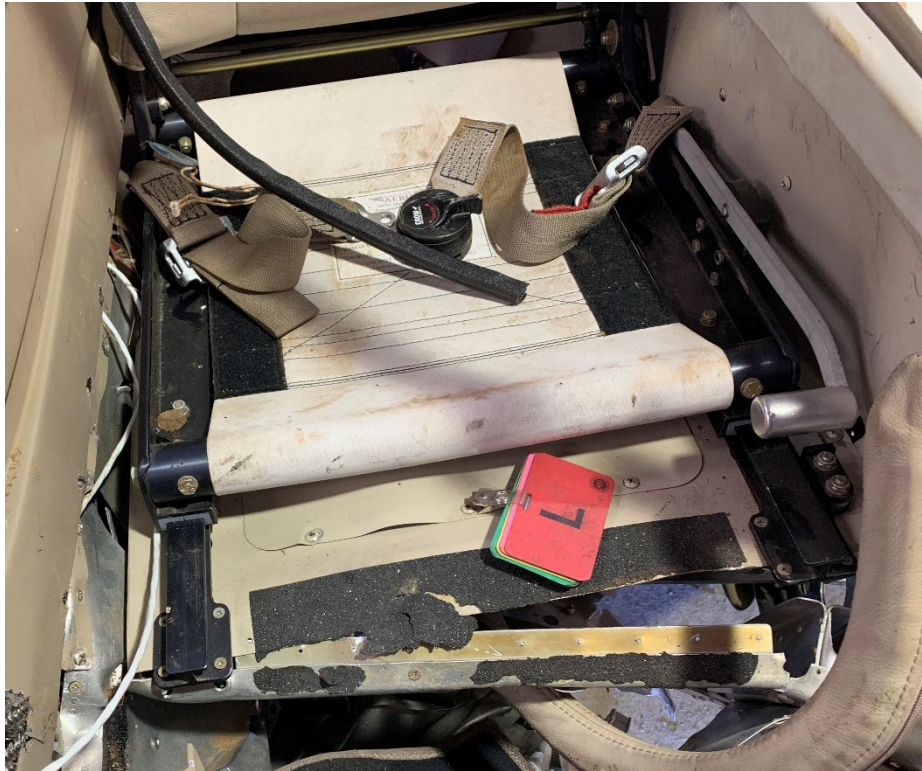
The seat remained attached to both the inboard and left seat rails, which were still attached to the airframe. The shoulder harness was attached to the cabin cover and the right and left lap belts were attached to the airframe at both anchors. The rotary buckle functioned normally when tested with each of the four points of the restraint system.

*Photograph 5: Left seat, seat rails*

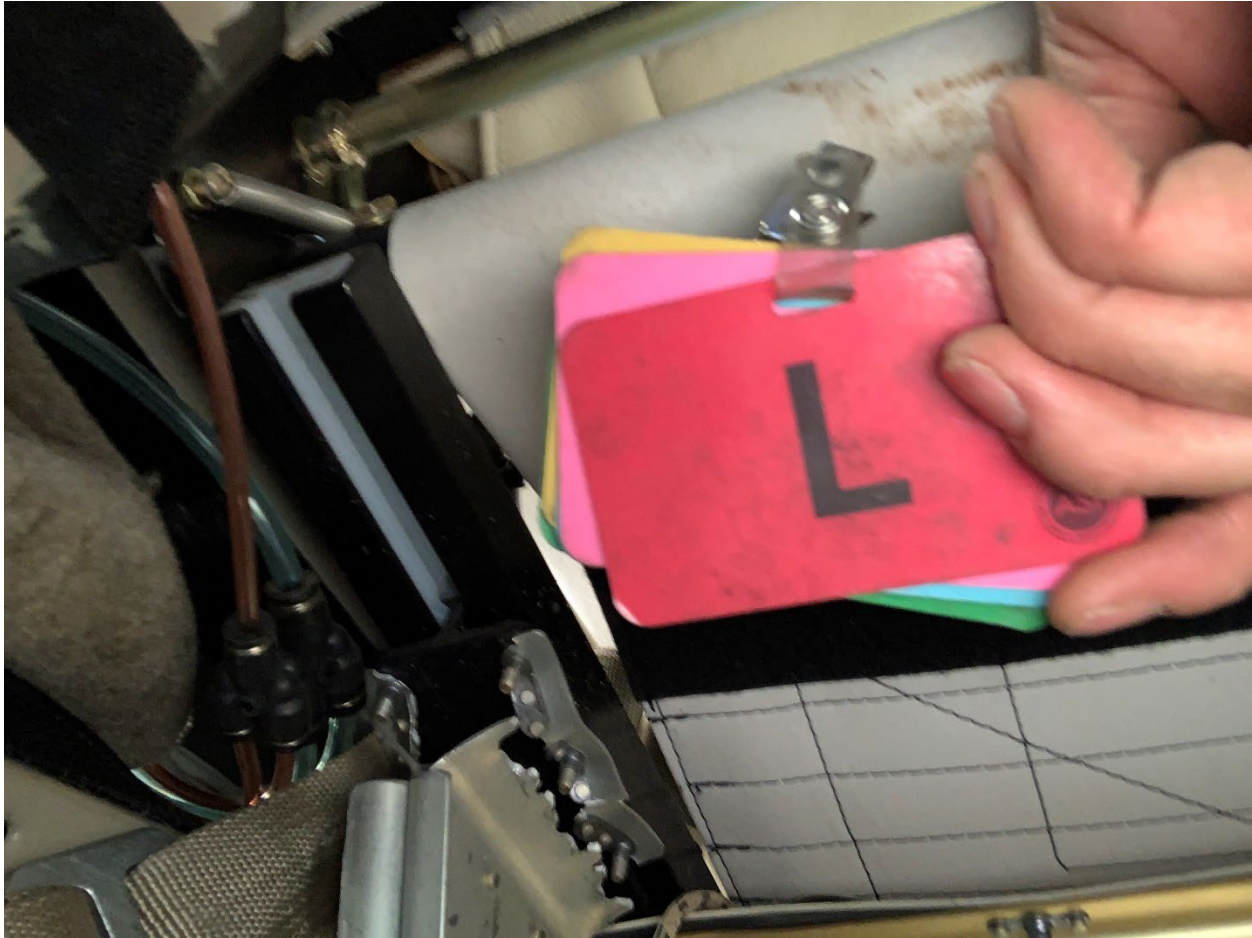
The seat remained attached to both the right and inboard rails. The right rail remained attached to the airframe and the inboard rail was partially separated from multiple rivets at the bracket. The shoulder harness was attached to the cabin cover and the right lap belt was attached to the airframe its anchor. The right lap belt anchor was also attached to the airframe, but right lap belt had been cut by recovery personnel. The rotary buckle functioned normally when tested with each of the four points of the restraint system.

*Photograph 6: Right seat, aft seat rail and fractured bracket*

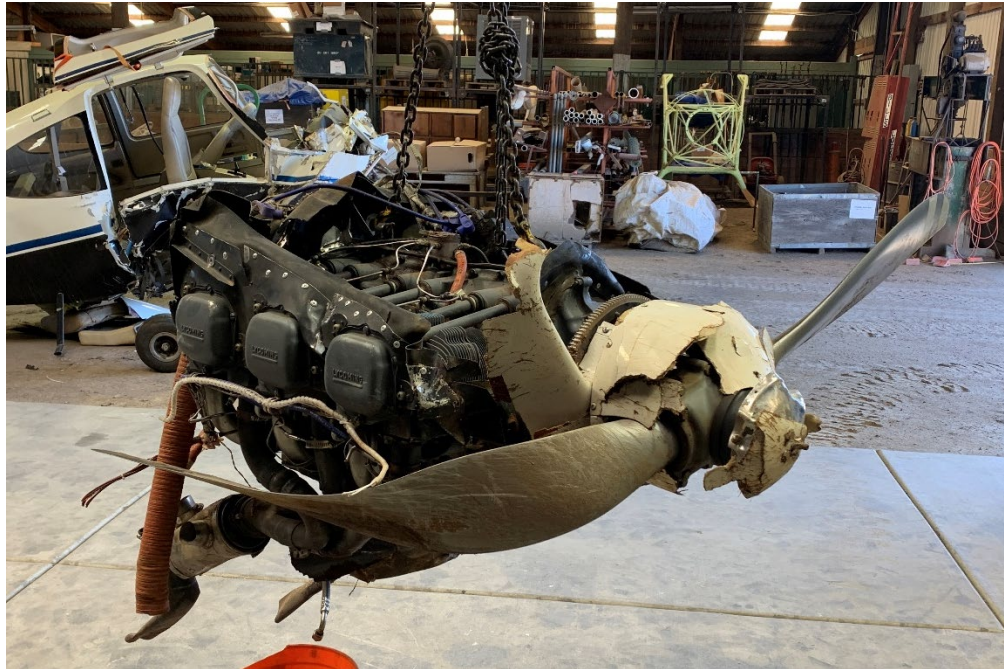
The airplane was equipped with a Lycoming Engines YIO-540-D4A5, a 250 hp, horizontally opposed, air cooled, fuel injection, normally aspirated, reciprocating engine. The engine sustained minimal damage with exception of the oil filter adapter, which had separated from the accessory case. Additionally, the no. 5 push rod was damaged from impact with the engine mount and exhaust system deformation was observed. Two of the three electric magnetos were separated from their mounts at the engine firewall.

*Photograph 7: Engine prior to examination*

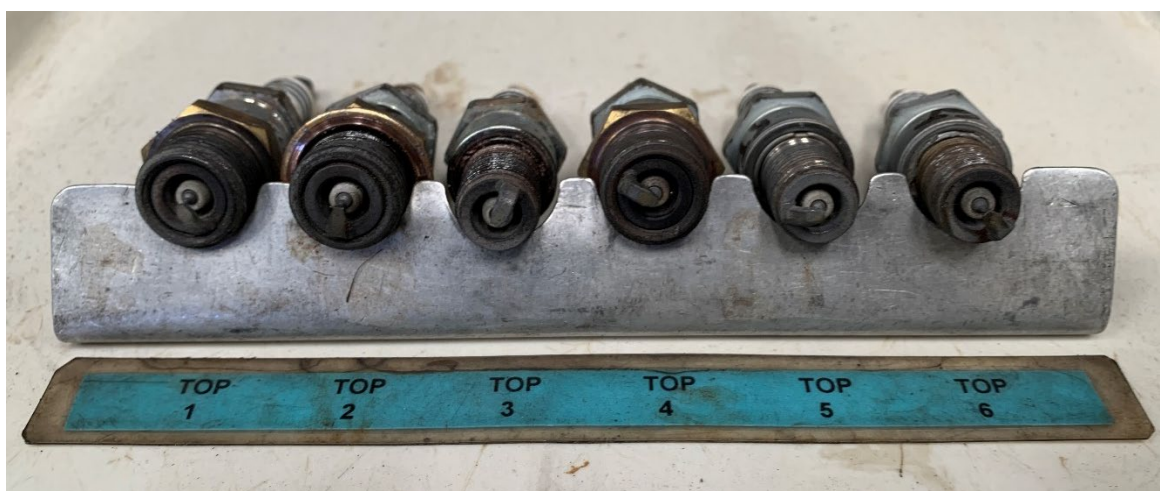
Ignition timing could not be established as the engine was equipped with an electronic ignition system. The ignition harness wires had varying degrees of impact damage, but were secure at each spark plug. The spark plugs were NGK BR8EIX fine wire plugs and all displayed coloration consistent with normal wear. The electrodes were undamaged.

*Photograph 8: Top spark plugs*
