# National Transportation Safety Board

WPR22FA173

## ACCIDENT SITE SUMMARY

Airplane: N801DT, Experimental amateur-built Comp Air 8 SS52

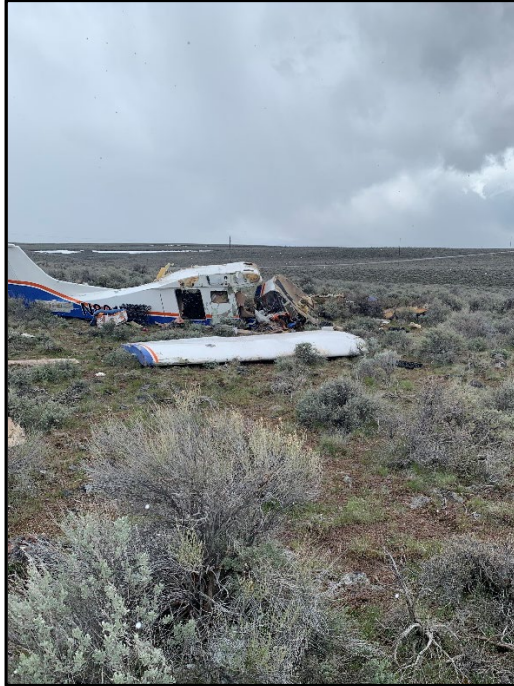
Photograph 1: Airplane wreckage as viewed from the right side.

The fuselage came to rest on a magnetic heading of about 269°. Both wings were separated. The left wing was significantly damaged and disbanded and the right wing was relatively intact with some outboard leading-edge damage sustained. The front portion of the fuselage, including the instrument panel sustained substantial impact damage. The engine was bent to the right about 90°. Flight control continuity was established to the rudder.

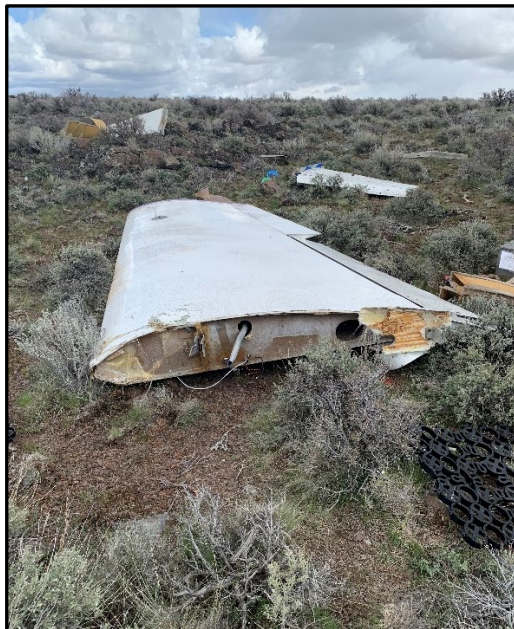
Photograph 2: Right wing as viewed from the wing root.
