# National Transportation Safety Board

WPR22FA173

## AIRFRAME AND ENGINE EXAMINATION

Airplane: N801DT, Experimental amateur-built Comp Air 8 SS52

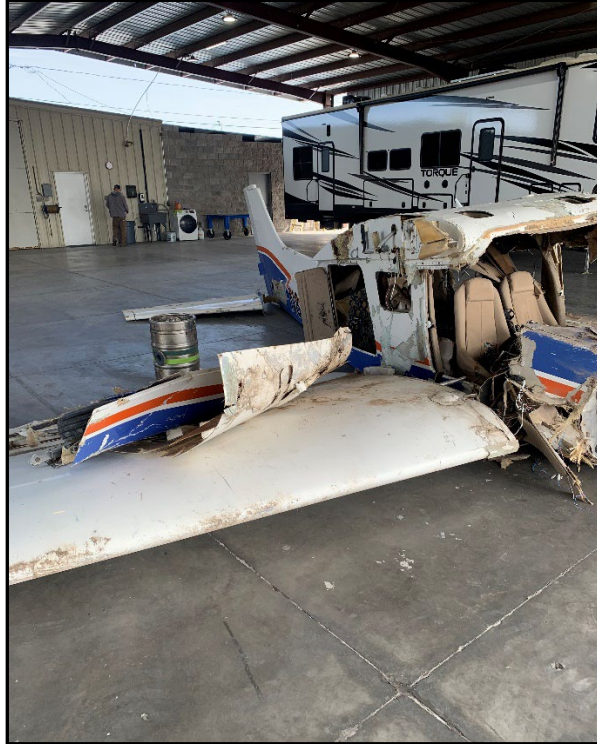
Photograph 1 - Airplane wreckage as viewed from the right side.

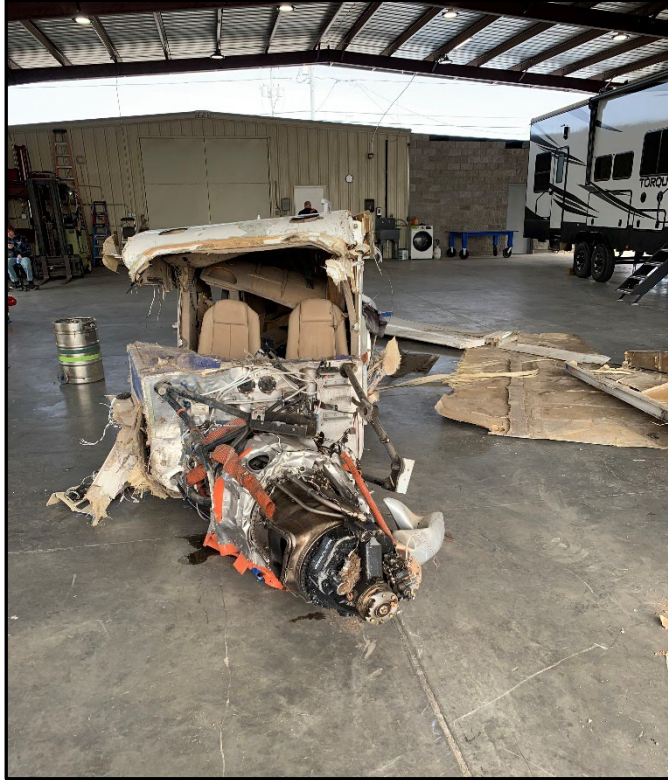
Photograph 2- Front view of the wreckage and engine.
