**NATIONAL TRANSPORTATION SAFETY BOARD**  
Office of Aviation Safety

**Wreckage Examination Report**

**A. ACCIDENT      WPR22FA184**

Location: Cape Girardeau, Missouri  
Date: May 22, 2022  
Time: 0803 CDT  
Operator: Private  
Aircraft: Experimental amateur-built Magni M24 Orion Plus  
Registration: N590DM

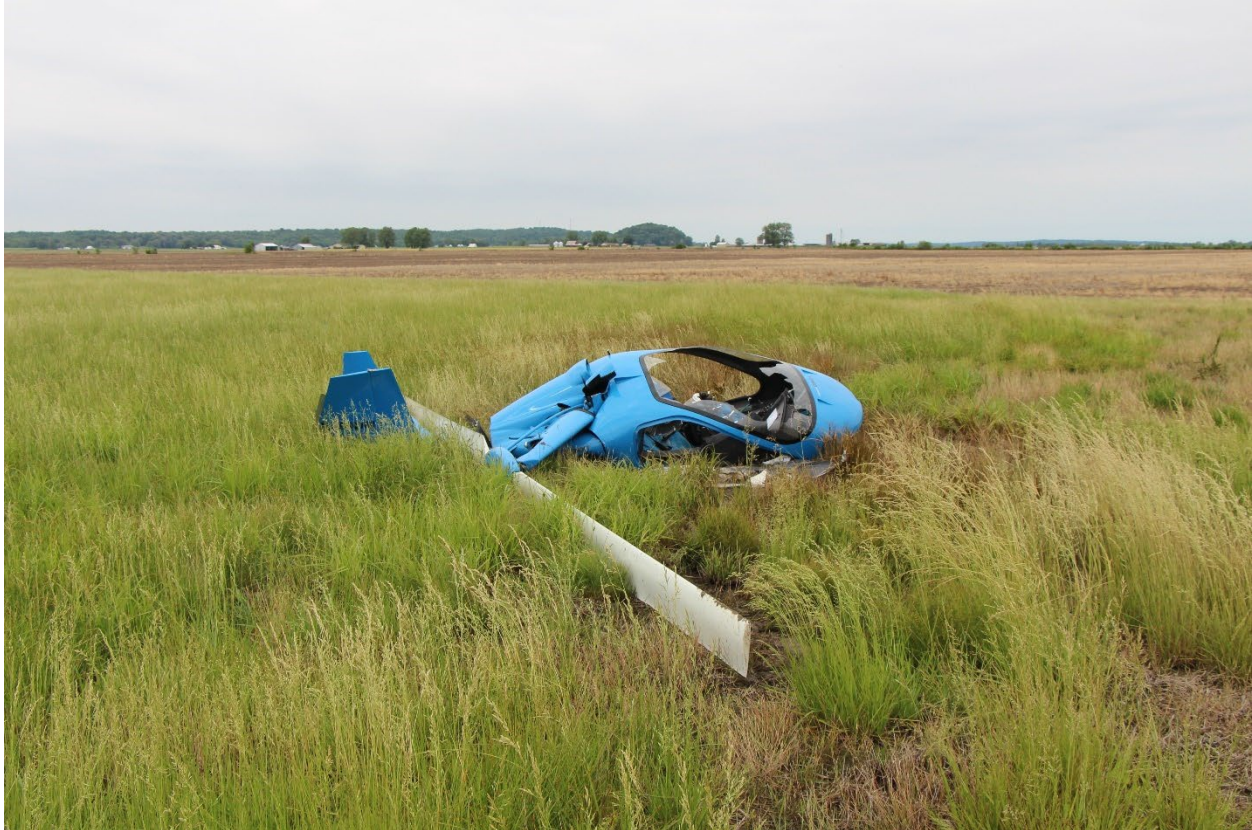
The gyroplane impacted a wetland about 1,000 ft west of the departure end of runway 10 at a field elevation of about 330 ft mean sea level. All major structures were accounted for at the accident site. The main wreckage, comprised of the fuselage, rotor, engine, and empennage, was oriented on a northwest heading. A section of the right horizontal stabilizer had separated from the main wreckage and was located 171 ft southwest of the main wreckage. The engine was partially submerged in mud and two propeller blades appeared above the surface; both separated about midspan. Both rotor blades were intact and attached at the rotor hub. The blades exhibited similar impact signatures about 3 ft from the outboard ends and black transfer markings about 3 ft from the hub of each blade. One blade displayed blue transfer markings on the bottom of the blade about 3 ft from the outboard end.

*Photograph 1: Accident site*

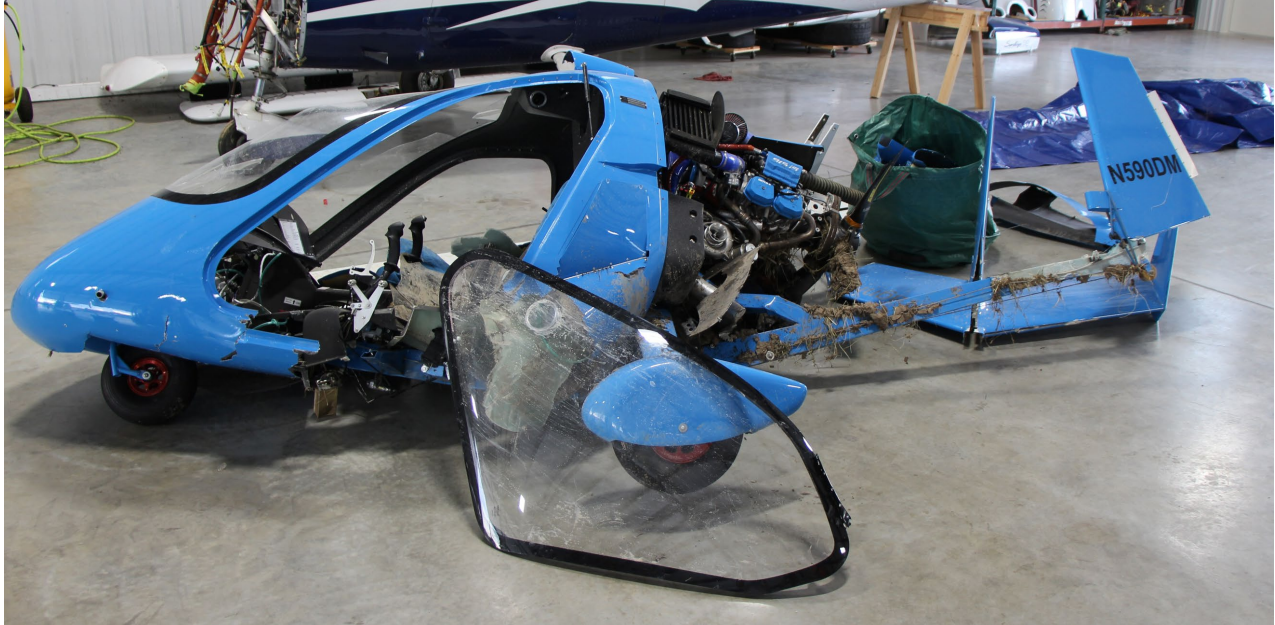
Photograph 2: Airplane prior to wreckage examination

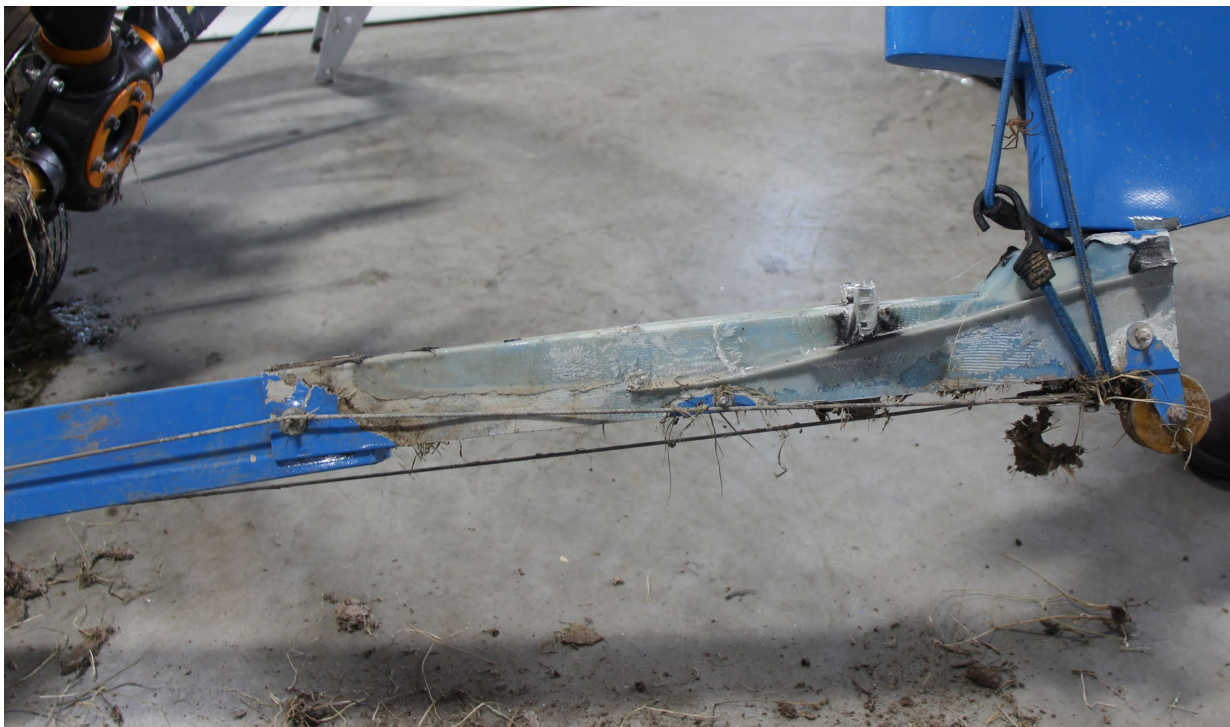
The rudder cables were continuous from the cockpit to the rudder pivot at the base of the vertical stabilizer. All the securing hardware was in place at the rudder pivot. Both the right and left cables were taught with the left cable hung above a bolt attached to the main structure. After the left rudder cable was released from the bolt using a pry bar both the right and left cables exhibited similar tension.

*Photograph 3: Left rudder cable hung on main structure bolt*

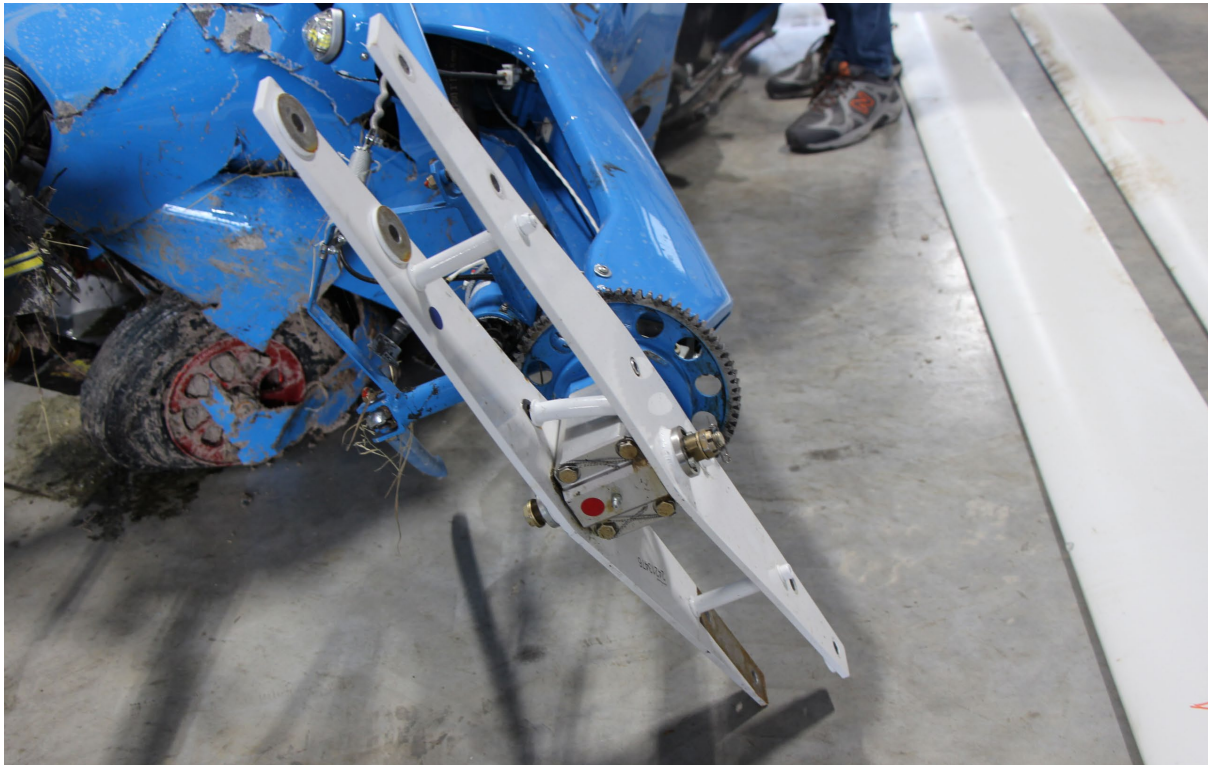
The rotor hub bar fairing was removed by recovery personnel during the recovery process, along with the rotor blades. The hub bar was intact and remained attached to the rotor head and notched gear. The blade 1 teetering stop displayed a partial bend and one of the securing bolts had separated at the hub bar. Smooth and continuous movement of the hub bar was achieved when the bar was rotated by hand. The hub block was removed, which exposed a set of lubricated bearings.

*Photograph 4: Hub bar and rotor hub*

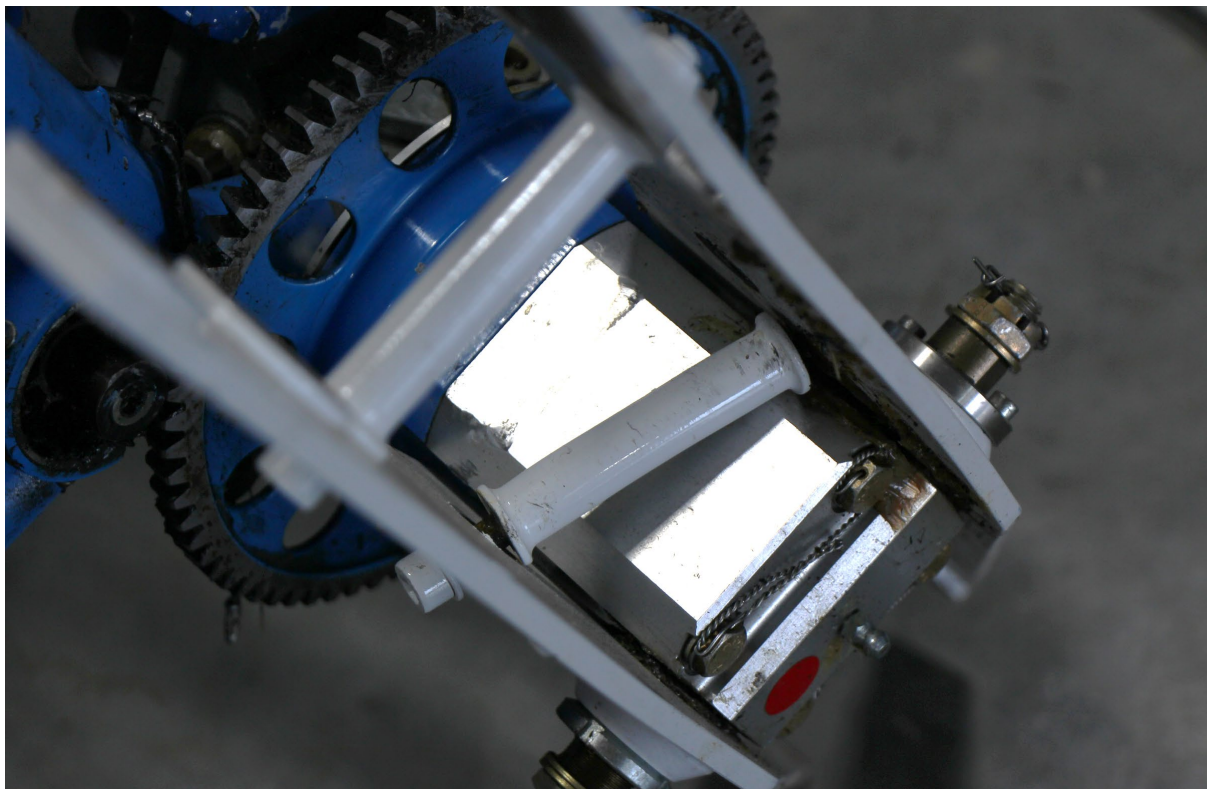
*Photograph 5: Blade 1 teetering stop at hub bar*

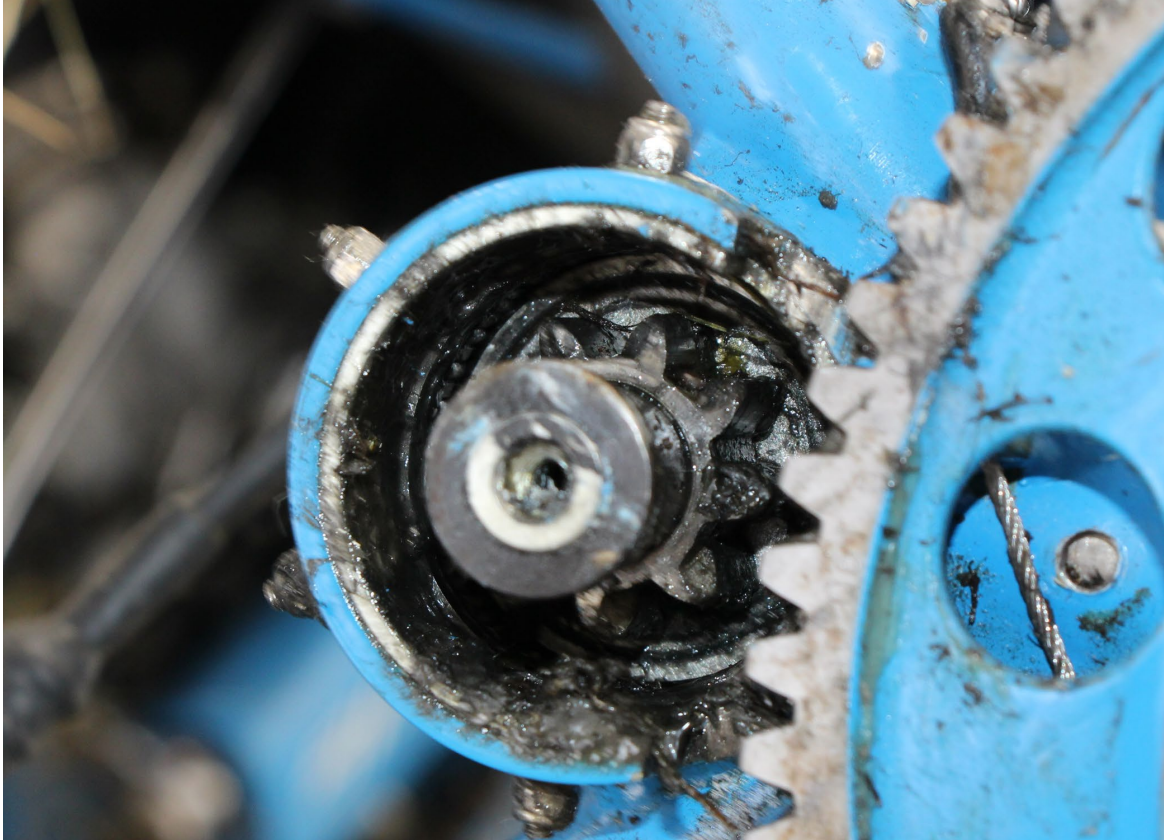
The prerotator shaft was continuous from the engine prerotation assembly to the Bendix block. The upper part of the Bendix block, a spur gear was unremarkable in appearance. The prerotator notched gear was bent and the rotor brake cable bracket below it had separated. The rotor brake cable exhibited a gouge mark and the housing was damaged at the bracket location.

*Photograph 6: Upper Bendix part*

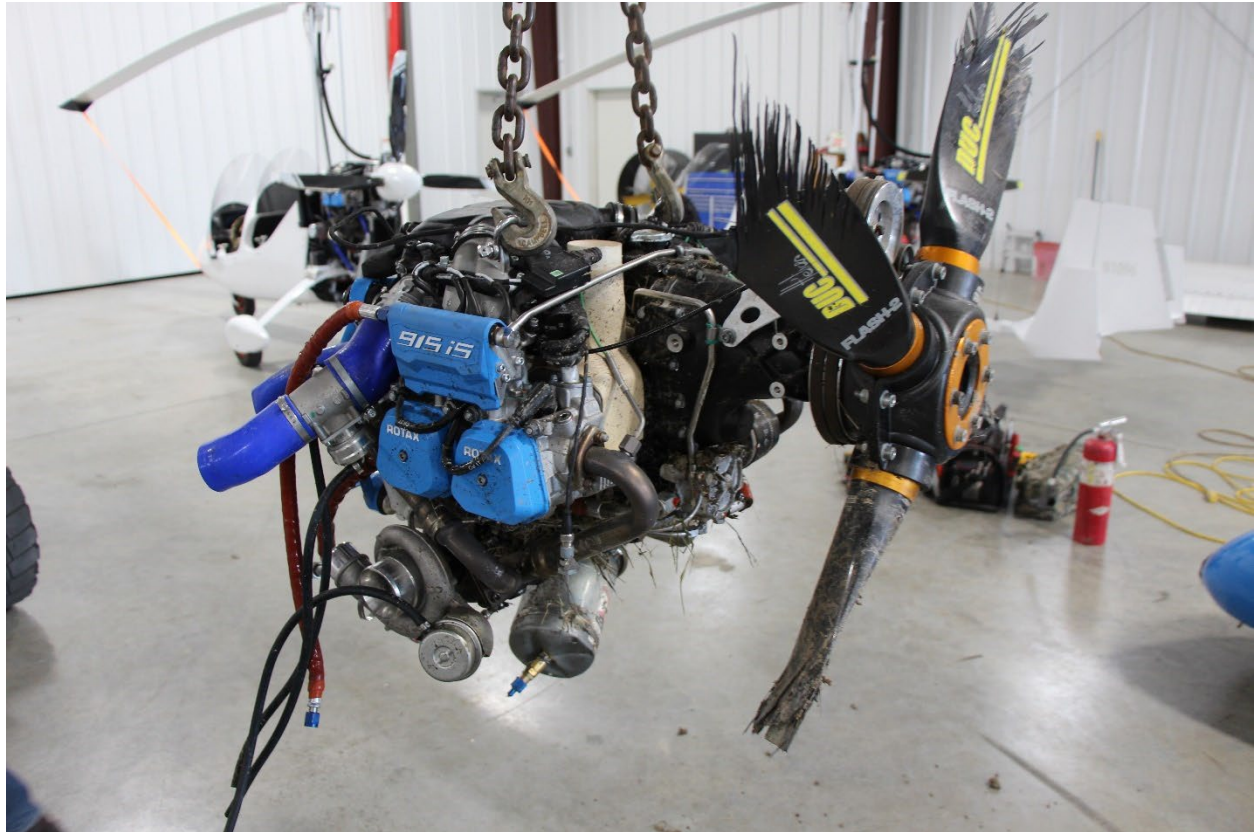
*Photograph 7: Engine prior to examination*

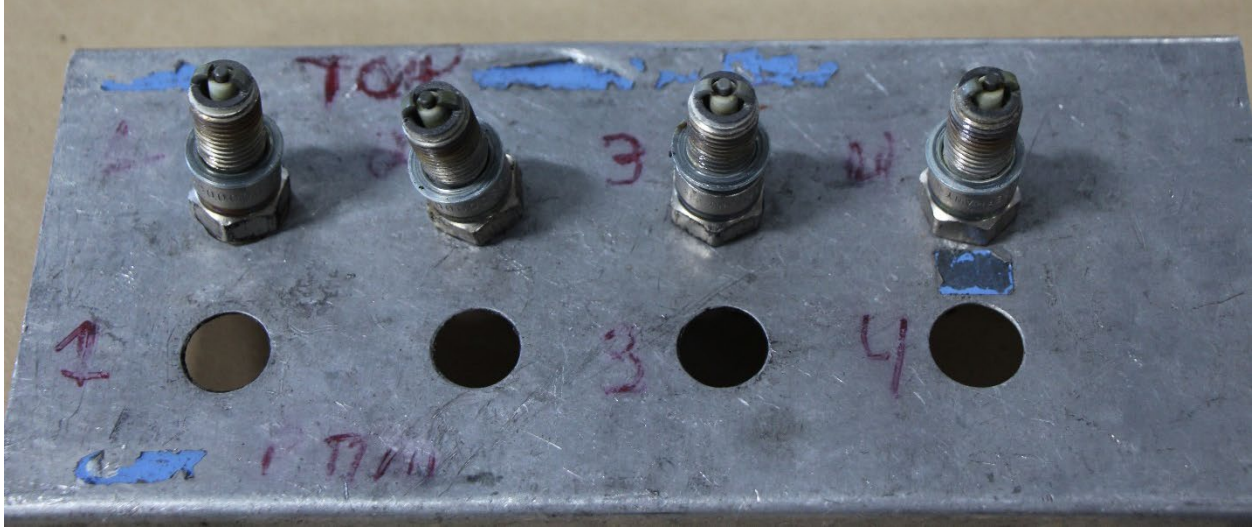
The ignition harness wires were secure at the top and bottom spark plugs. The spark plugs were Rotax BRP 29656 fine wire plugs and all displayed coloration consistent with normal wear. The electrodes were undamaged.

*Photograph 8: Top spark plugs*
