**NATIONAL TRANSPORTATION SAFETY BOARD**  
Office of Aviation Safety

**Onscene Examination Report**

**A. ACCIDENT      WPR22FA184**

Location: Cape Girardeau, Missouri  
Date: May 22, 2022  
Time: 0803 CDT  
Operator: Private  
Aircraft: Experimental amateur-built Magni M24 Orion Plus  
Registration: N590DM

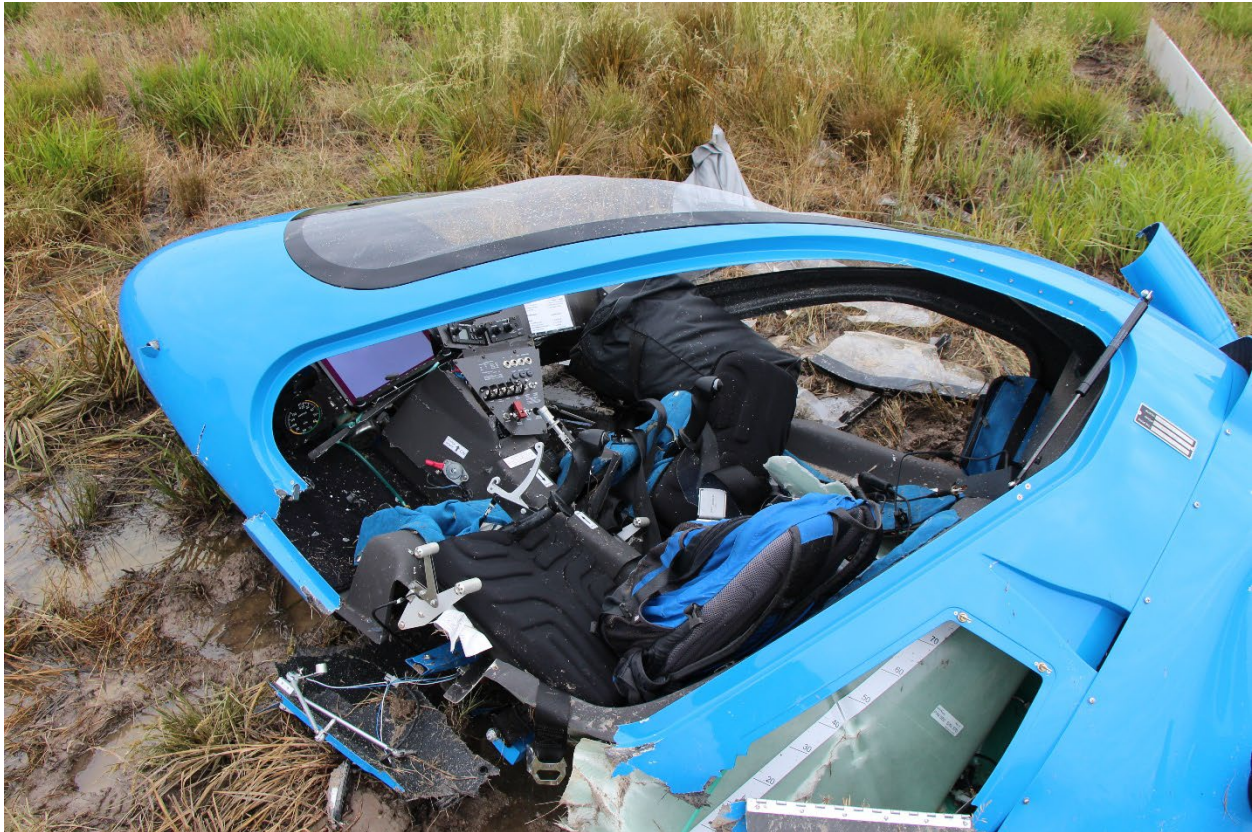
The gyroplane came to rest towards its right side in a slight nose up attitude. The right side of the engine was partially submerged in mud along with the keel beam. The tail section remained attached to the fuselage through its steel keel, which was canted to the left. The tail showed a similar roll orientation as the fuselage. The engine was attached to the firewall through both lower mounts and the upper right mount; the upper left mount was fractured. Both fuselage doors were separated at their hinges and the windshield was broken and fragmented. The fuel tank, located beneath the seat structure, was fractured. Both the left main landing gear and nose landing gear were intact; however the nose landing gear was bent to the left. The right main landing gear was not visible due to the gyroplane's orientation. The left side lower enclosure was fragmented below the cockpit, while the main structure was intact.

*Photograph 2: View of cockpit at accident site*

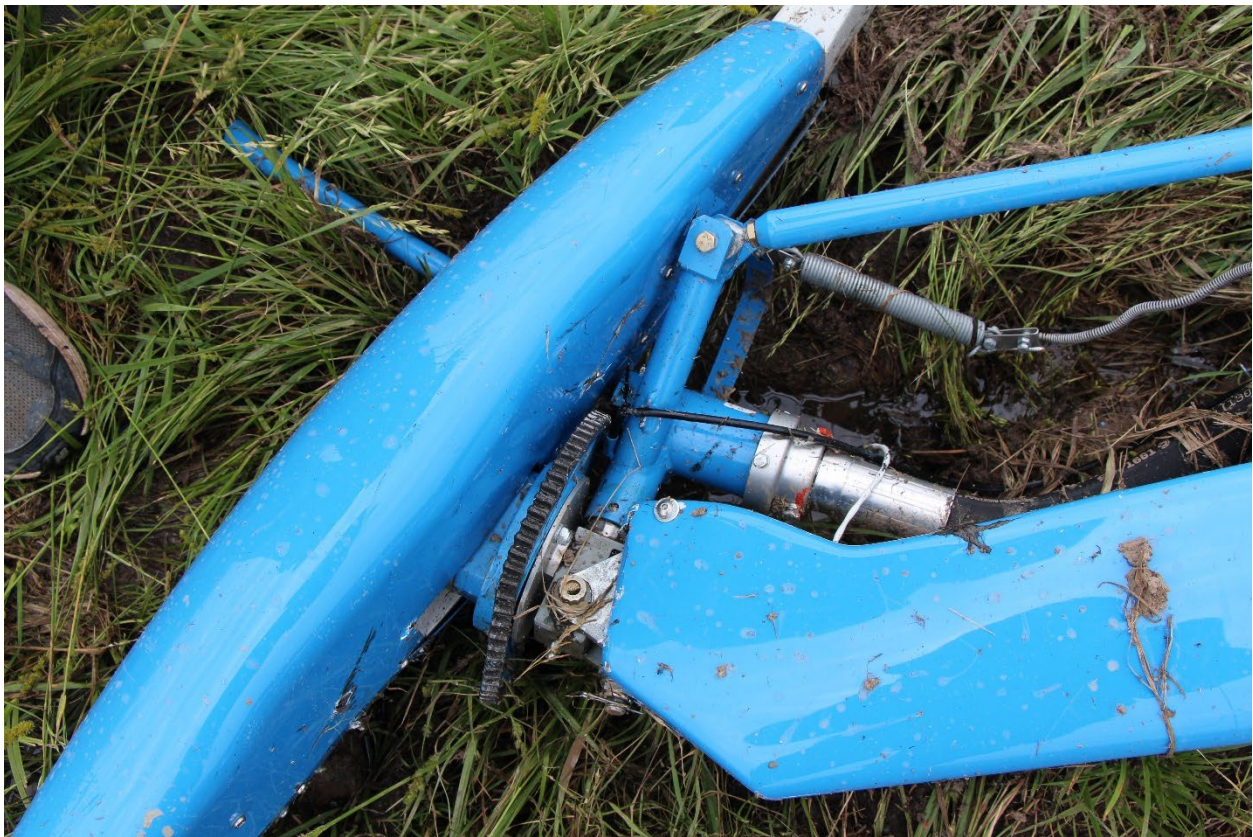
Both rotor blades remained attached to the rotor head. The prerotator notched gear was bent and impact marks were noted in the bottom of the rotor head cover.

*Photograph 3: Bent notched gear and rotor head housing*

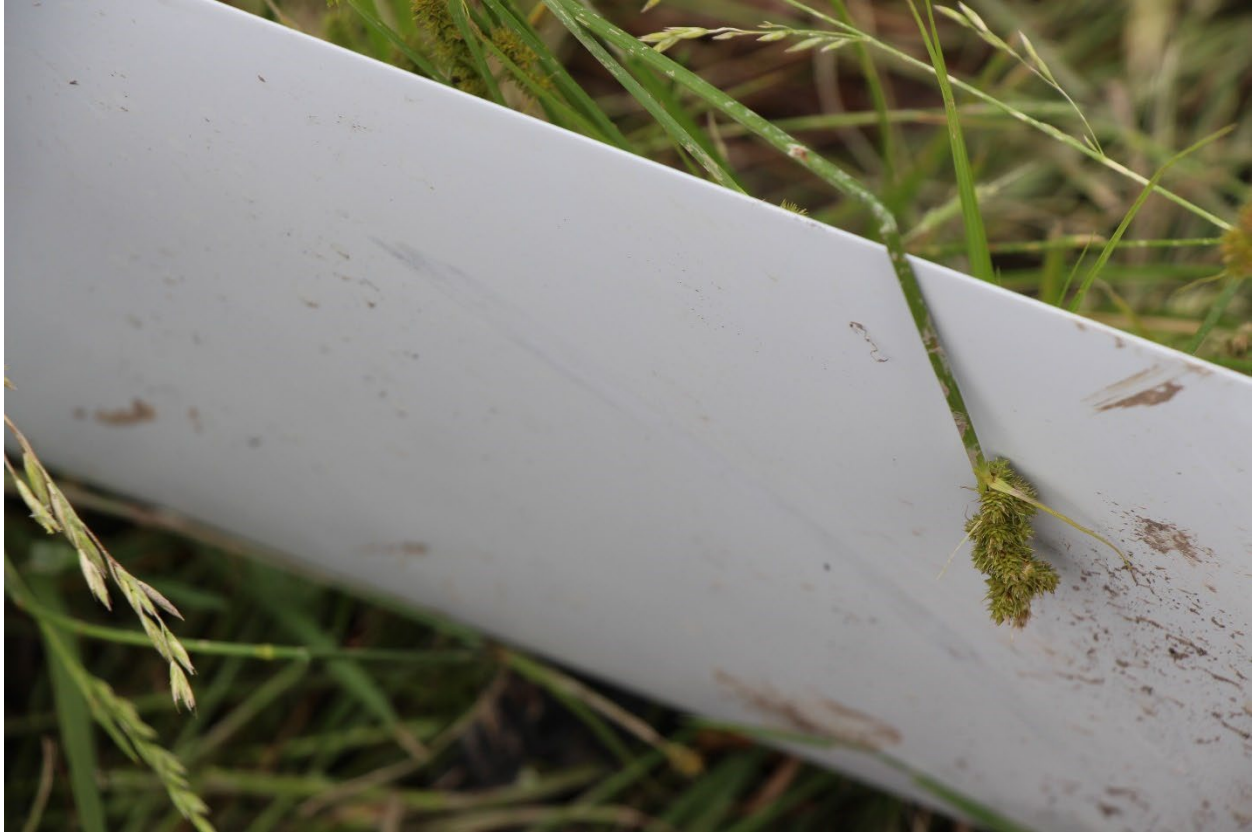
A four inch long split was observed outboard at the center trailing edge of the blade. An impact mark was observed at the bottom part of the blade about 3 ft from the outboard end. The remainder of the trailing edge of blade 2 was unremarkable. Black transfer marks were observed at the bottom of blade about 3 ft from the rotor head. Additionally impact marks were located at the leading edge of blade about 3 ft from the rotor head.

*Photograph 4: Black transfer marks on blade 2*

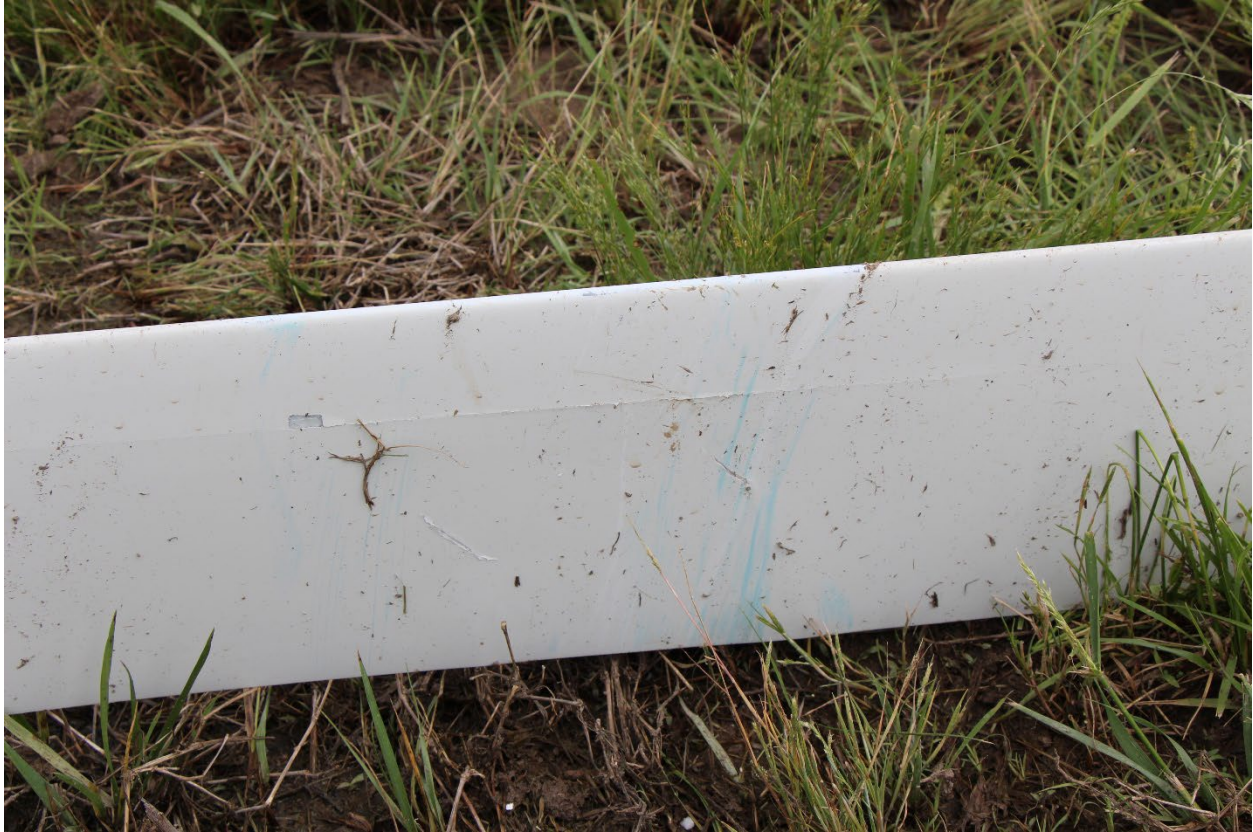
The blade displayed an impact mark at the leading edge about 3 ft from the rotor head with a corresponding impact signature at the trailing edge of the blade. Parallel striations were observed at the bottom of the blade also about 3 ft from the rotor head. The blade also displayed a slight bend about 3 ft from the outboard end near its trailing edge. Blue paint transfer marks were noted about 4 ft from the outboard end of the blade. The top skin of the blade was broken along the spar and cracks were noted on the top and bottom of the blade about 3 ft from the outboard end.

*Photograph 5: Blue transfer marks on blade 1*

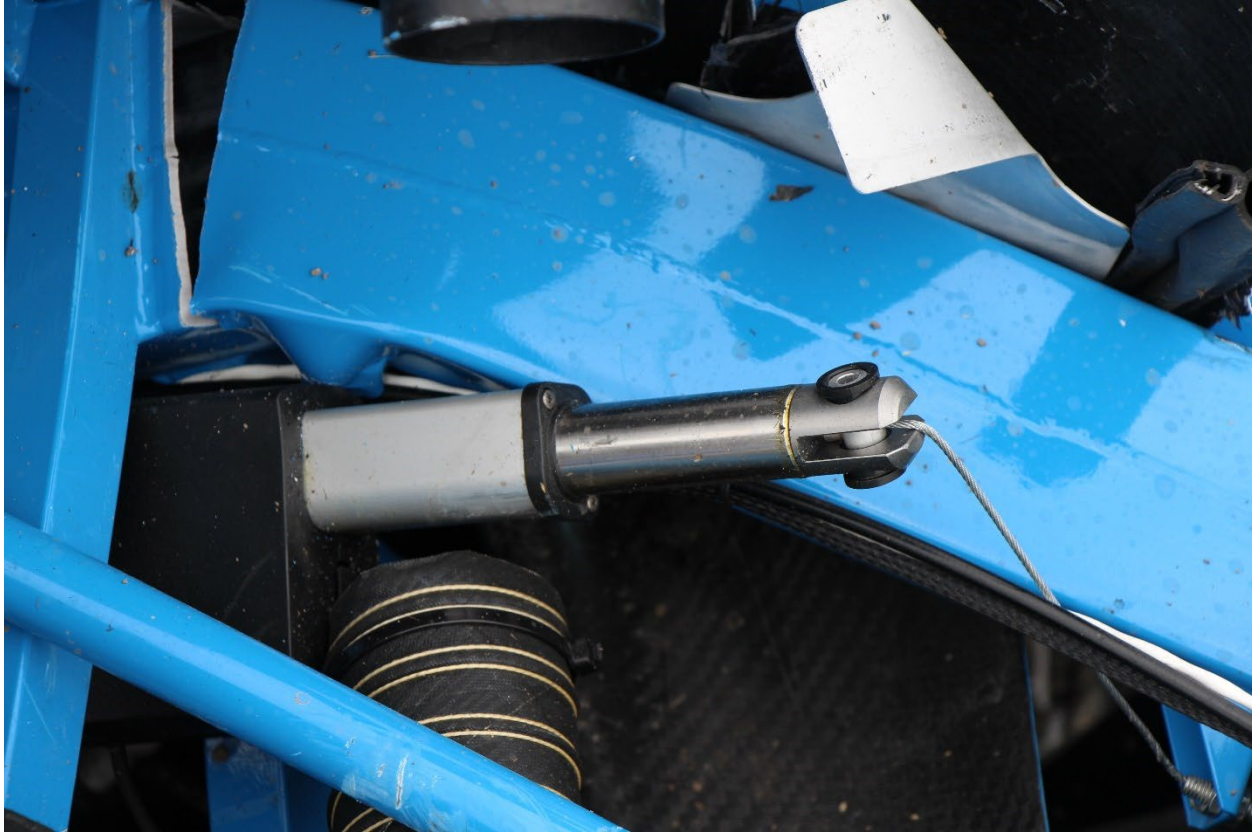
The electric trim actuator was extended 3.5 inches.

*Photograph 6: Electric trim actuator*

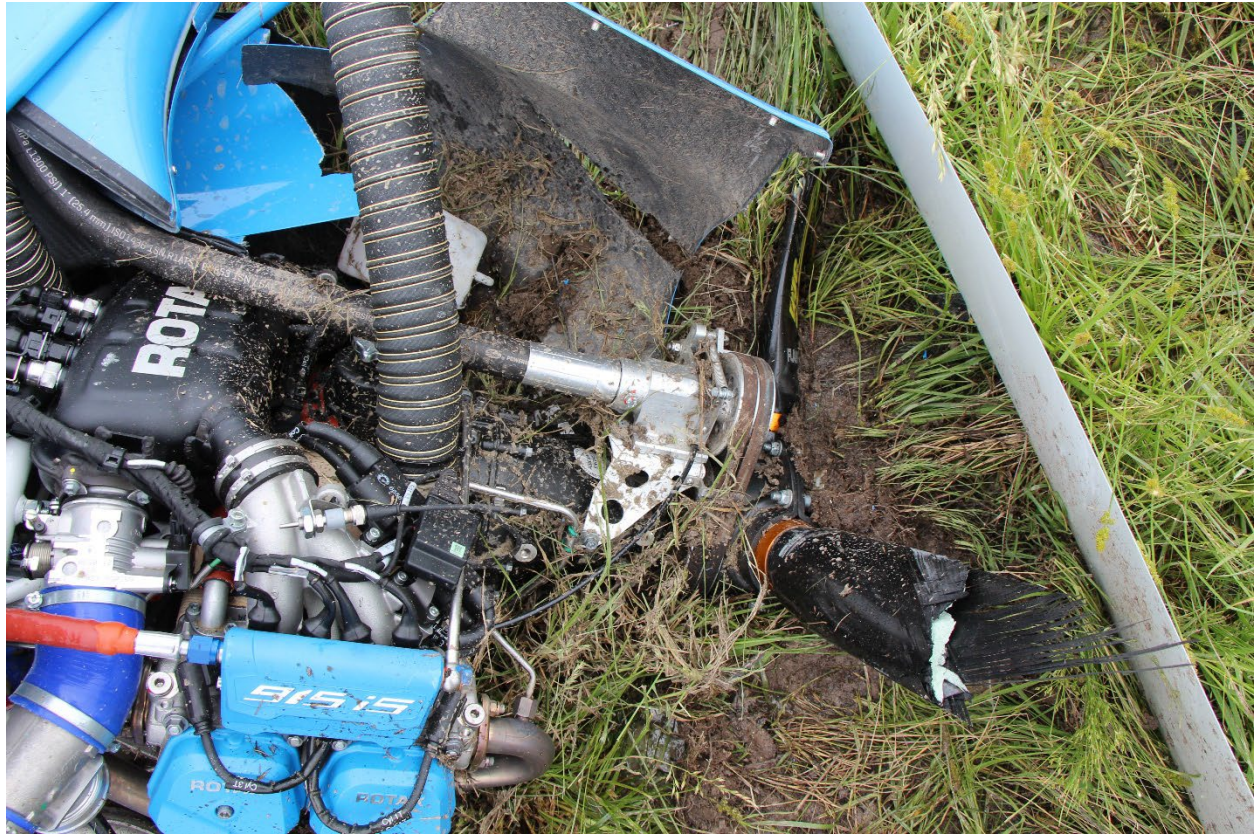
The gyrocopter was equipped with a 4 bladed pusher propeller; two of the propeller blades were submerged and the two visible blades were separated about midspan.

*Photograph 7: Visible propeller blades*
