# National Transportation Safety Board

WPR22FA188

## **MATERIALS LABORATORY**

Specialist's Factual Report 22-090

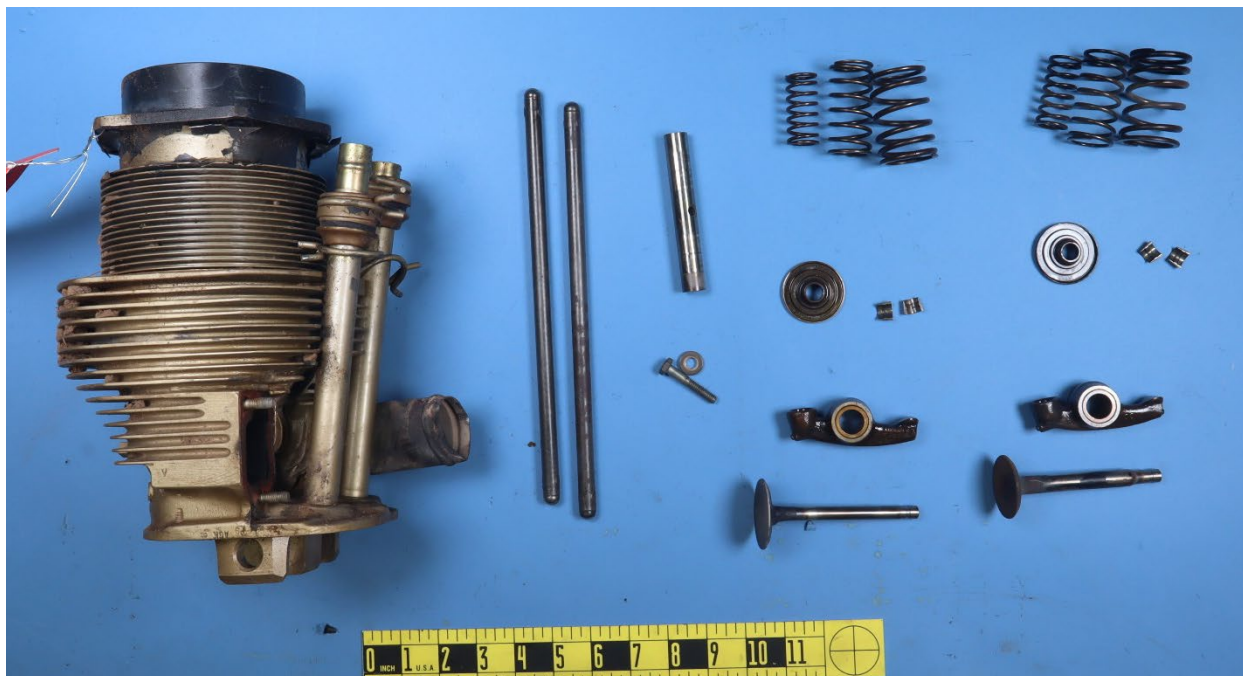
Figure 1 shows the components from the #4 cylinder position as received. Most of the components had been disassembled from the cylinder assembly, and the spark plugs had not been included in the shipment.

**Figure 1.** Components from the #4 engine position, as received.

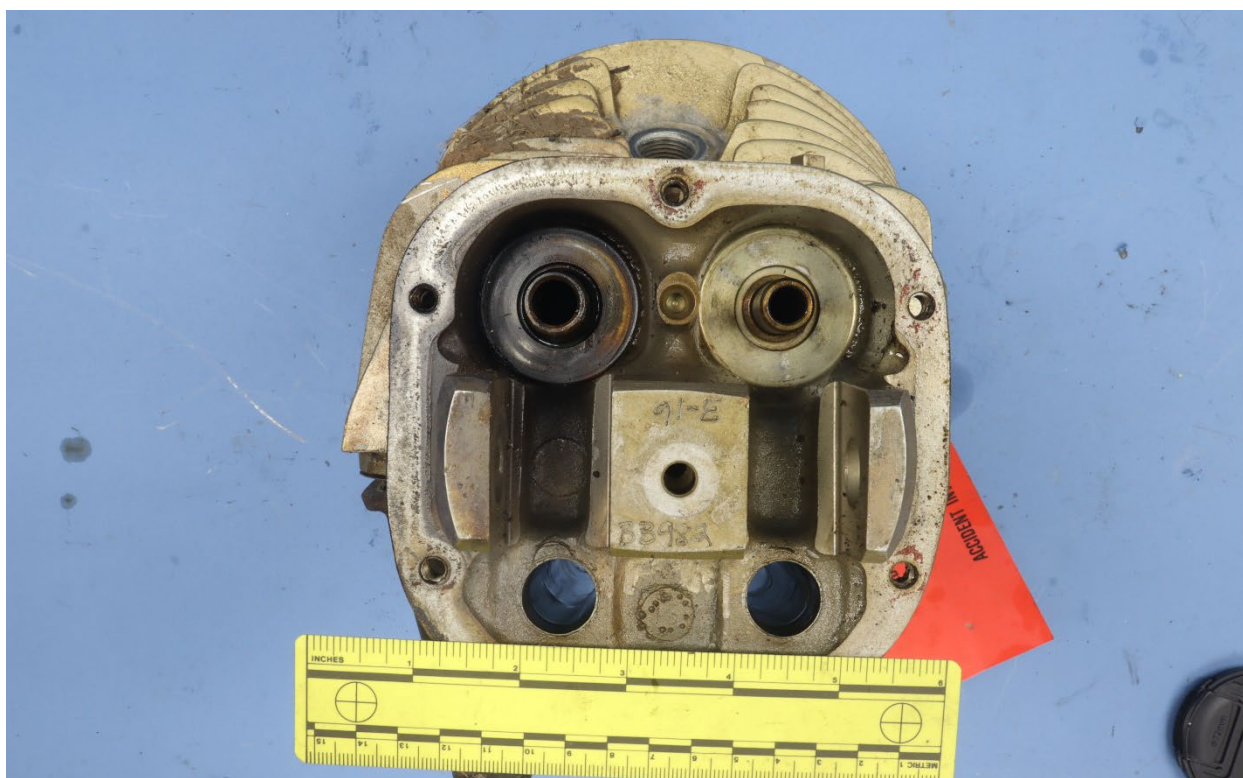
Views of the cylinder surfaces are shown in Figures 2 through 4. The oil cover had been removed, with the valves, springs and other components in this area removed. The side with the exhaust valve stem bore (left in Figure 2) exhibited darker coloring and deposits, consistent with exposure to the hotter exhaust gasses than the intake side.

**Figure 2.** Top view of the cylinder assembly, as received, partially disassembled prior to receipt.

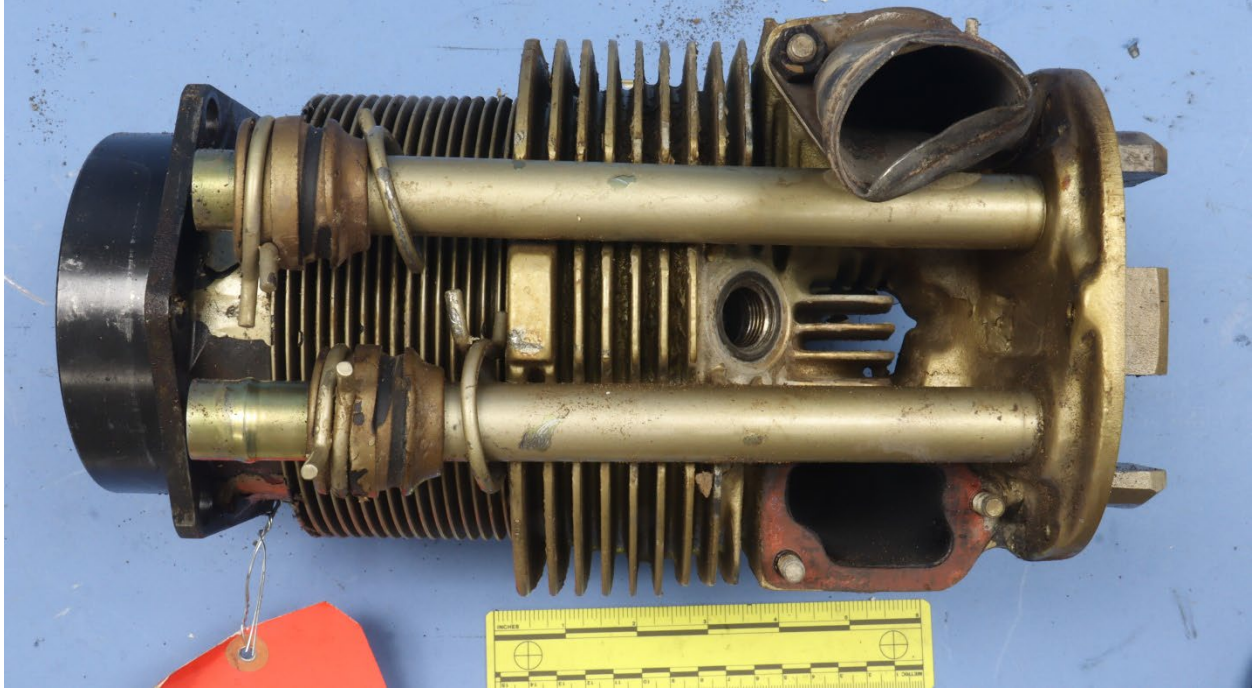
Figure 3 shows the pushrod side of the cylinder. The intake tube had been deformed inward, consistent with compressive forces such as crushing. The port connecting to the exhaust side (lower part of Figure 3) was not included. The opposite side

**Figure 3.** Side view of the #4 cylinder assembly, as received.

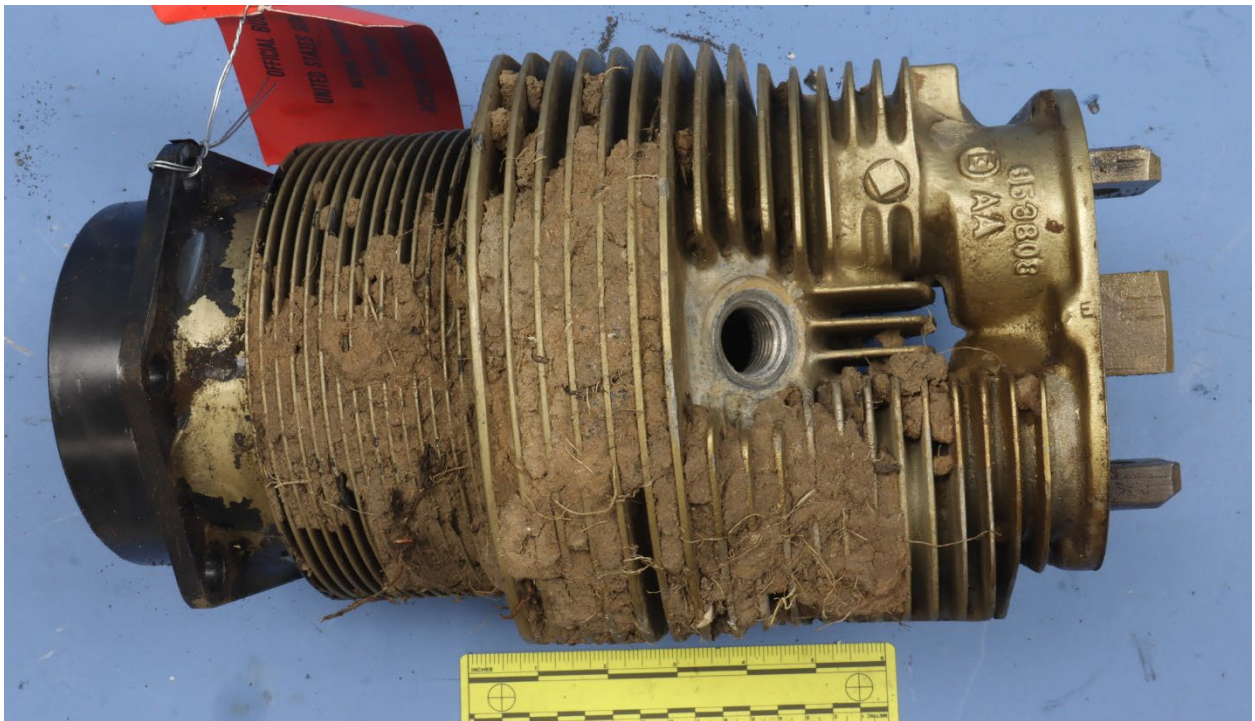
revealed soil compacted into the gaps between the cooling fins (Figure 4). There was no other noted damage on this side of the cylinder.

**Figure 4.** Opposite side view from **Figure 3** of the #4 cylinder assembly, showing caked soil between multiple cooling fins.

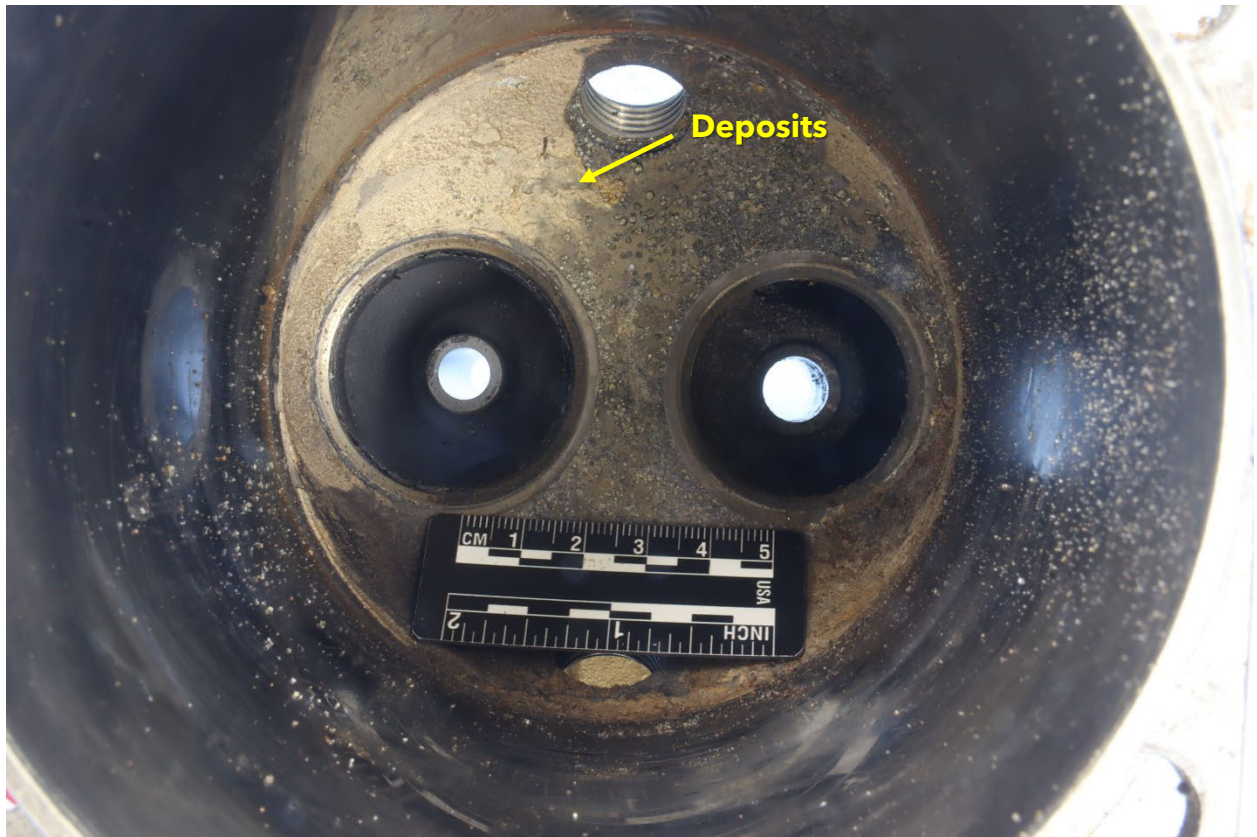
Figure 5 shows the interior of the cylinder, lit with a diffuse flash to reveal the interior features. On the left of the figure, the intake side displayed flattened, dull deposits, exhibiting a light yellowish-brown color. While these deposits were present throughout the cylinder crown interior, they were concentrated more around the intake valve seat. There were no indications of deformation or impact on the interior surfaces of the cylinder assembly.

**Figure 5.** View of the interior of the cylinder, showing combustion deposits accumulating, particularly on the intake side (left).

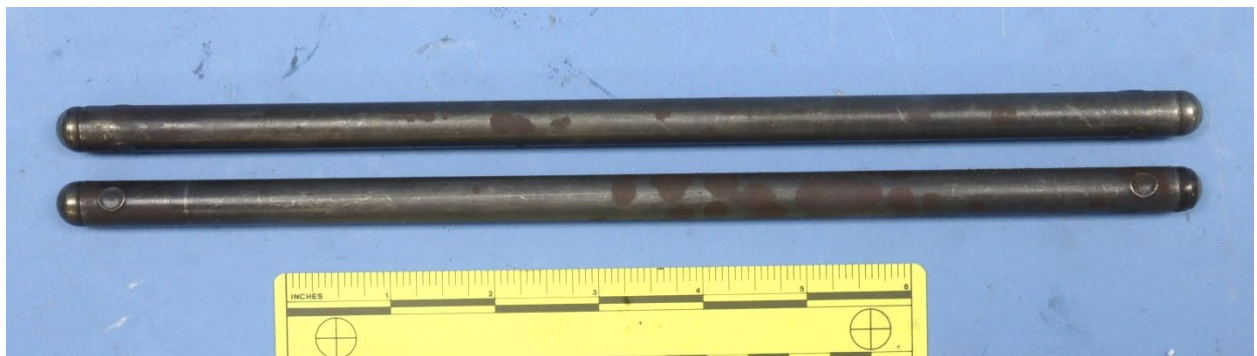
Figure 6 shows the two push rods as received. Neither rod exhibited any visible gross deformation or impact damage.

**Figure 6.** The pushrods from the #4 cylinder, as received.

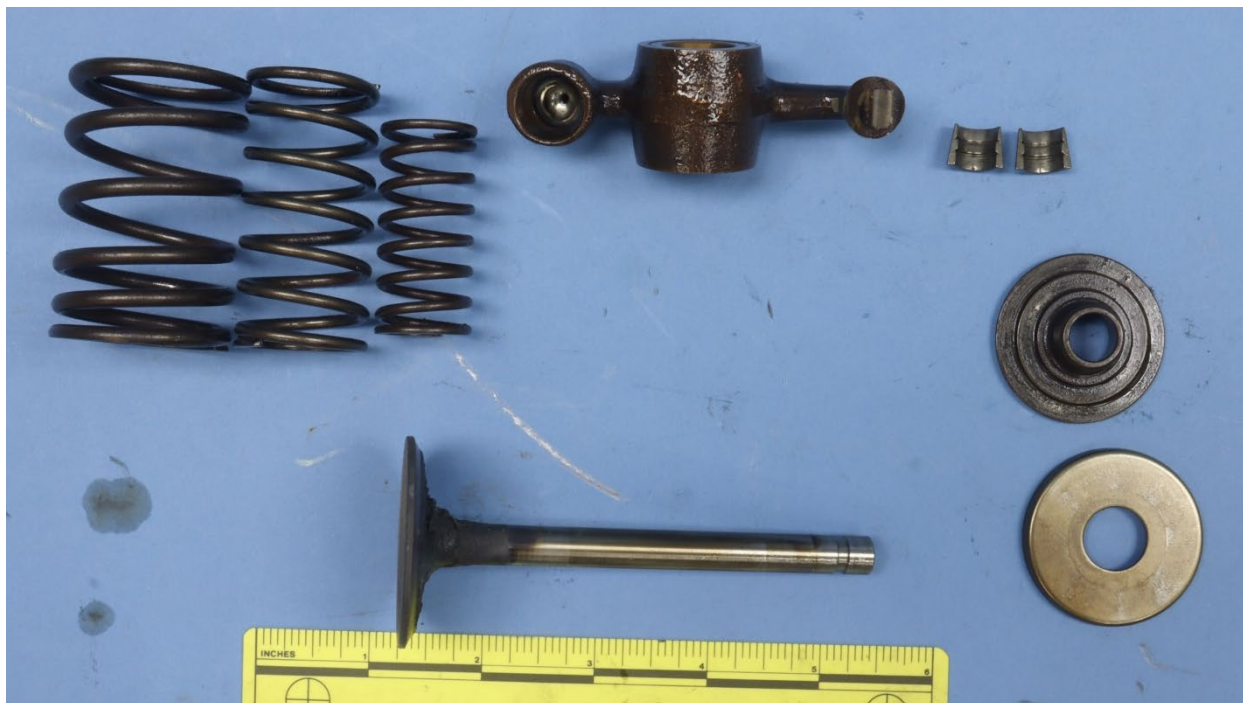
Figure 7 shows the components that had been removed from the intake side of the cylinder prior to receipt by the Materials Laboratory. These components included the three springs, rocker arm, two keeps, two retainers, and the intake valve. None of the components had fractured or deformed. Figure 8 shows the contact surfaces between the rocker arm and the intake valve stem. The wear pattern exhibited a centrally located streak, with two comparably sized semicircles on either side. This pattern was consistent with the rocker arm contacting the valve tip along the center line. There were no noted wear marks on the valve stem consistent with off-center positioning.

**Figure 7.** Components from the intake side of the #4 cylinder.

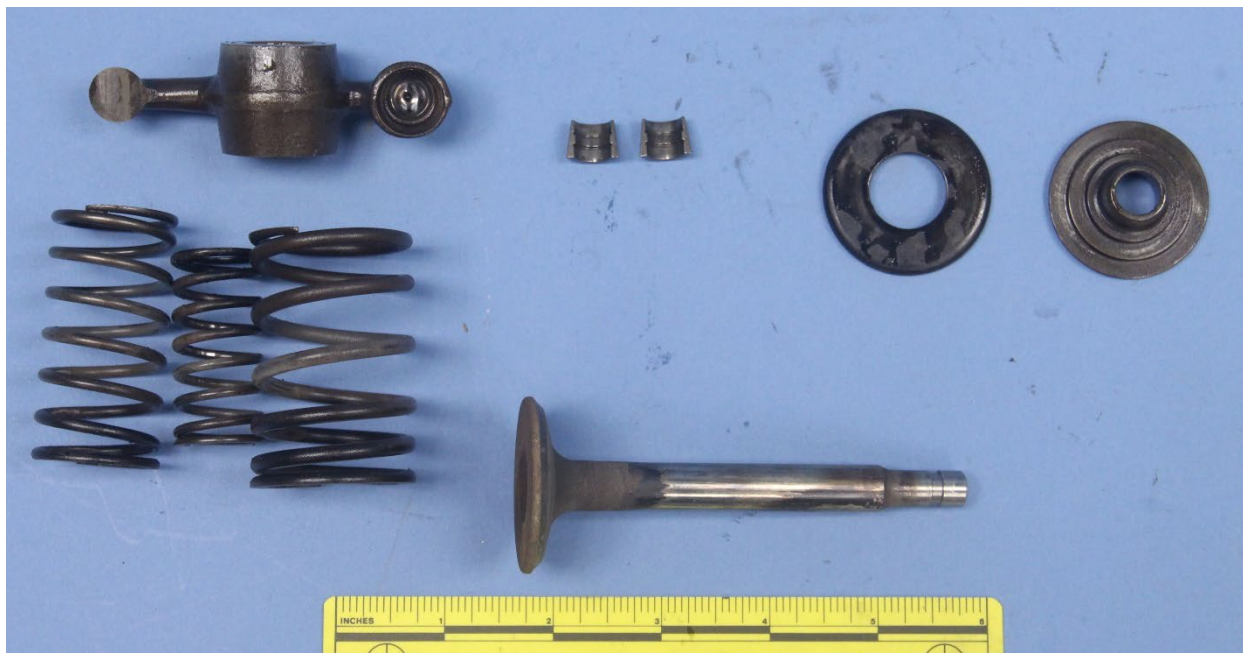
Figure 9 shows the components from the exhaust side of the cylinder, which had been previously disassembled. The components included three springs, rocker arm, two keeps, two retainers, and the exhaust valve. None of the components had fractured or deformed. Figure 10 shows the contact surfaces between the rocking arm and the intake valve stem. The wear pattern exhibited a centrally located streak, thinner in width than the intake valve, with two larger semicircles on opposite sides. These features were also consistent with centerline contact by the adjacent rocker arm.

**Figure 9.** Components from the exhaust side of the #4 cylinder.

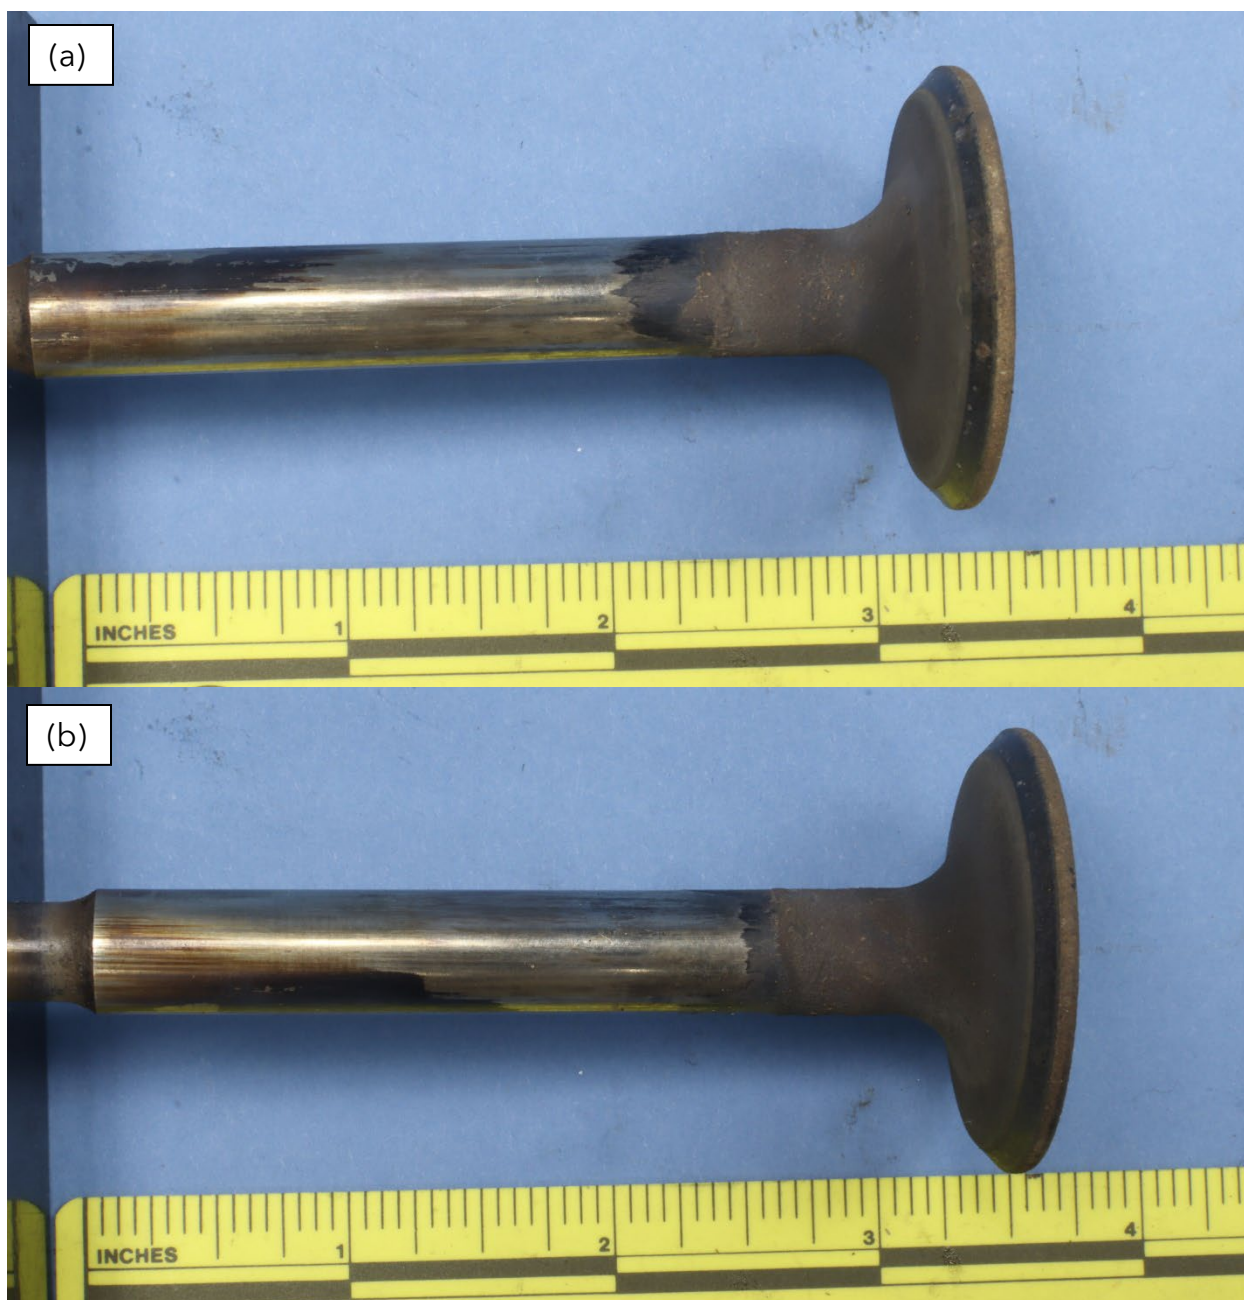
**Figure 11.** Side views of the stem near the head of the exhaust valve, rotated 90°.

Figure 11 shows the side views of the stem near the valve seat and the valve head, shown rotated 90° from each other. The 0.6 to 0.7 inches along the stem from the seat exhibited deposits, with the deposits in the nearest 0.5 inches from the seat exhibiting a dark brown color with a dull luster. The farther 0.1 to 0.2 inches of deposits exhibited a more reflective black color. These dark brown and orangish-yellow deposits were present over the exhaust valve head, as illustrated in Figure 12a.

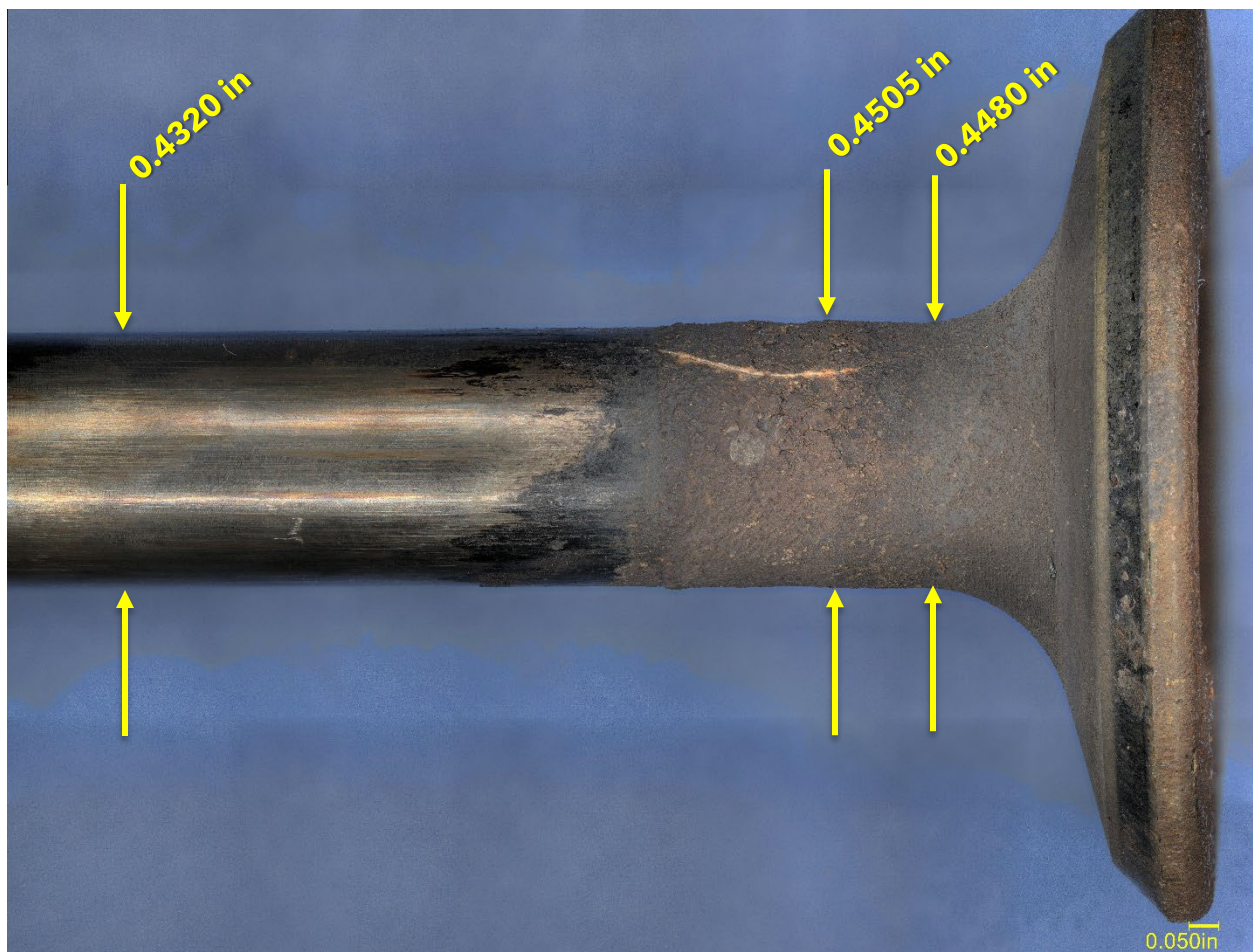
A closer view of these deposits along the exhaust valve stem is shown in Figure 13 and Figure 14. The deposits exhibited a flaky layered morphology, showing an increase in the overall diameter of the stem. The amount of additional thickness is annotated in Figure 13. The valve stem diameter was measured using vernier calipers

and was 0.4320 inches away from the deposits. The maximum diameter of the stem with the deposits was 0.4505 inches, indicating a deposit thickness of 0.0092 inches.

**Figure 13.** Closer view of buildup on the seat of the exhaust valve.

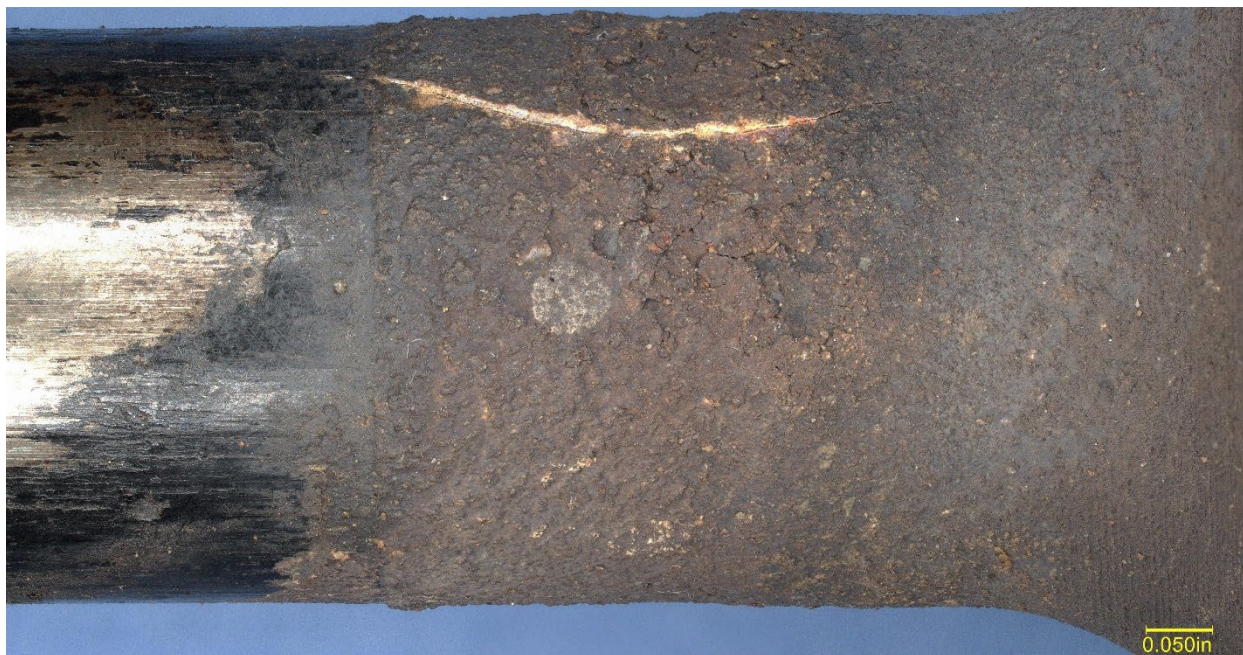
**Figure 14.** Closer view of the buildup on the stem in **Figure 13**.

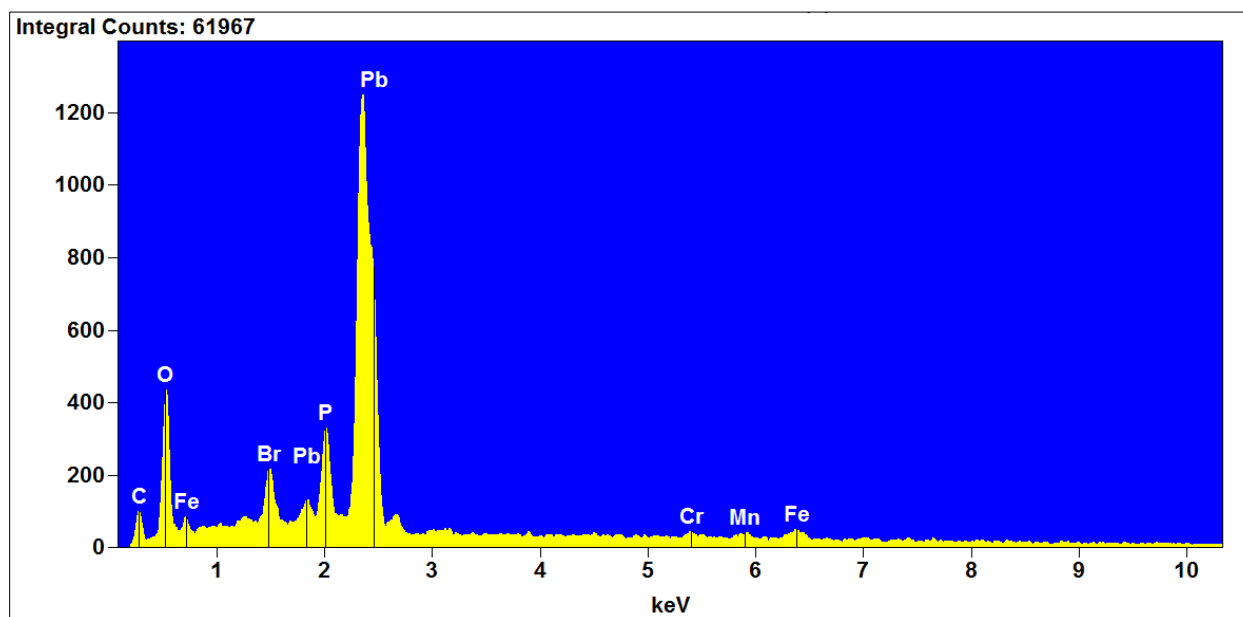
The deposits were examined using energy dispersive x-ray spectroscopy (EDS) in a field emission scanning electron microscope (SEM). Figure 14 illustrates a typical spectrum of the deposits on the exhaust valve. This spectrum exhibited prominent peaks of lead (Pb), with peaks of oxygen (O) and bromine (Br). These elements were consistent with lead-oxide combustion products from the brominated tetraethyl lead additive in avgas aviation fuel. The spectrum also shows iron, manganese, and chromium, consistent with the elements of the valve alloy steel.

The deposits were also examined with Fourier transform infrared spectroscopy (FTIR). The exhaust valve exhibited some indications of chlorine and siloxane. The other deposits were consistent with lead-oxide based deposits typical of avgas additives.

**Figure 15.** EDS spectrum from material extracted from the exhaust valve stem.

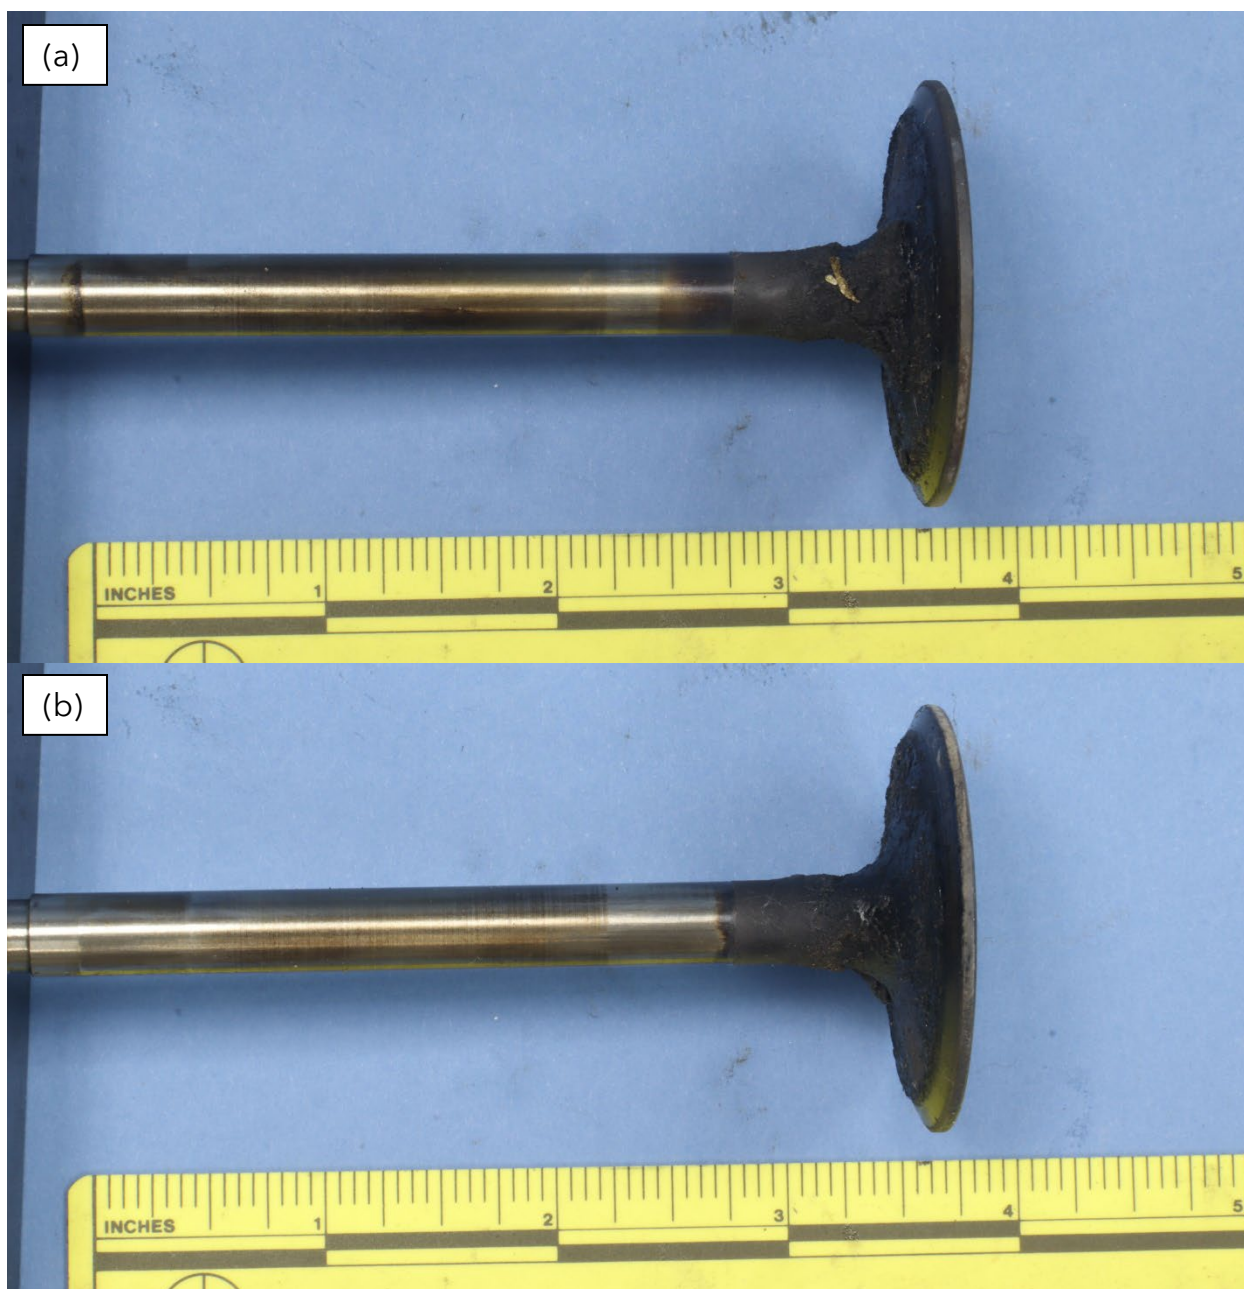
**Figure 16.** Side views of the stem near the head of the intake valve, rotated 90°.

The intake valve is illustrated in Figure 16. Like the exhaust valve, there were deposits along the stem up to 0.7 inches from the seat. There were also dull yellowish-brown deposits along the head of the intake valve facing the cylinder interior, as shown in Figure 17a. However, unlike the exhaust valve, the deposits along the stem near the intake valve seat exhibited a reflective black appearance. These deposits were also along the seat surface, shown in Figure 17b.

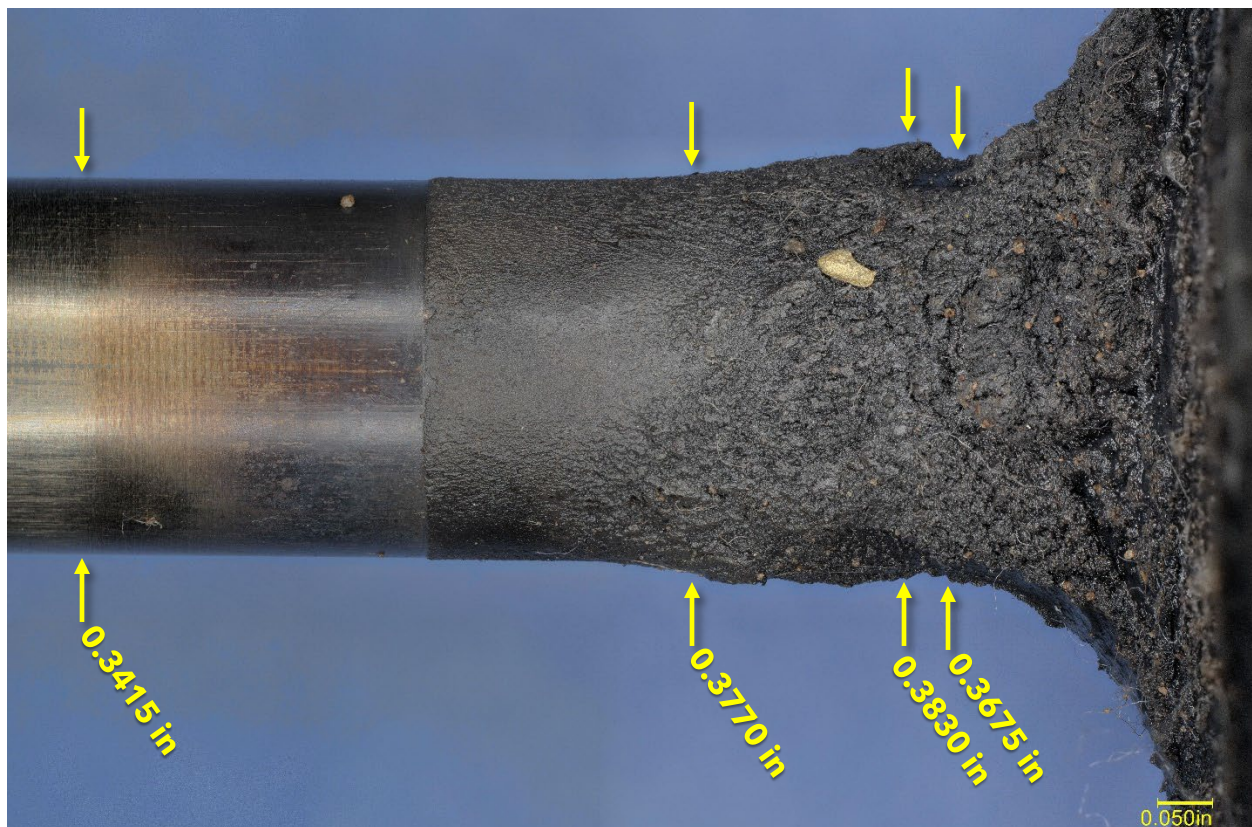
Figure 18 shows a closer view of these deposits, with a glare removal filter applied to illustrate the deposit texture. The deposits were layered but also protruding rather than flat and plate-like. The deposits were rounded but also exhibited definitive peaks and valleys (Figure 19). The buildup was not uniform, as shown by the opposite divots or depressions in the black deposits to the right in Figure 18. The deposit thicknesses were annotated in Figure 18. The intake valve stem diameter was measured as 0.3415 inches. The maximum diameter in the deposits was 0.3830, indicating a deposit thickness of 0.021 inches in that area.

**Figure 18.** Closer view of buildup on the seat of the intake valve.

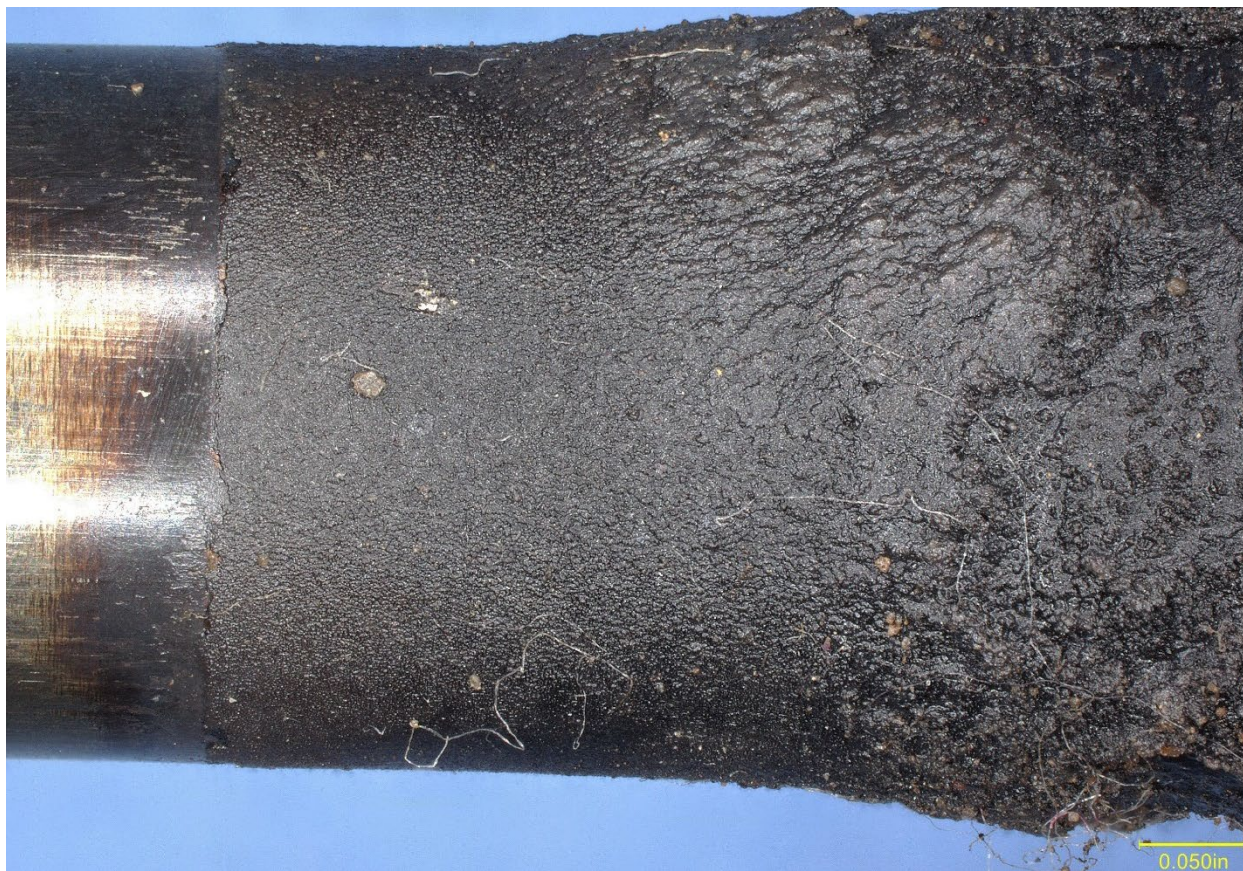
**Figure 19.** Closer view of the buildup on the stem in Figure 18.

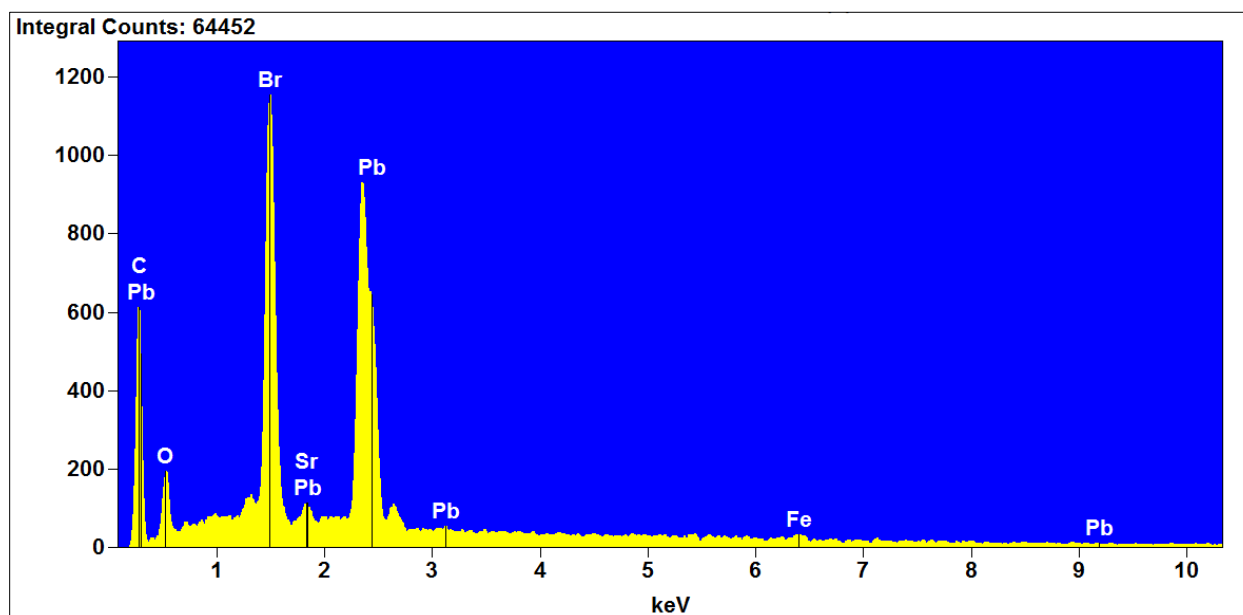
The deposits were examined using EDS, and Figure 20 shows a typical spectrum from the extracted material. This spectrum contained a high Pb peak and high Br and carbon (C) peaks, with a lower oxygen peak than the exhaust valve. The FTIR examination of the intake valve stem deposits showed indications of a single-chained polymerlike organic compound, consistent with deposits of unburnt fuel.

**Figure 20.** EDS spectrum from material extracted from the intake valve stem.
