## Air Safety Investigations

### Aircraft Incident/Accident Technical ReportAircraft Incident/Accident Technical Report

| Aircraft Incident/<br>Accident Information | Year: 1965 | Make: Cessna | Model: 172F |
| Air Safety Investigator Jennifer D. Barclay | | Report #: ASI-22-BC-T | Report date: 12-28-22 |

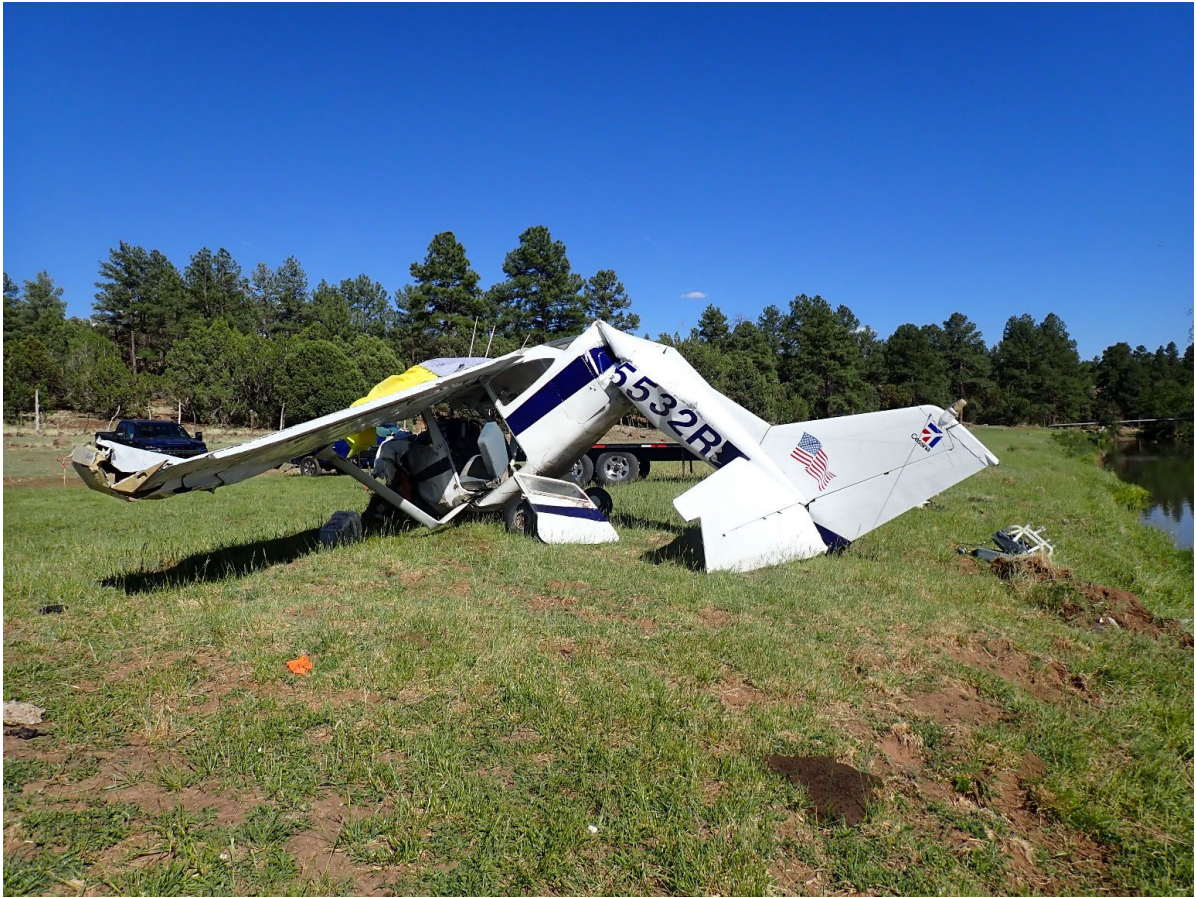
The aircraft impacted a creek bank in a cow pasture in a nose-low and wings level flight attitude. Compression damage was observed on both wings outboard of the strut attach point. Both wingtips separated from the aircraft, the right wingtip was not recovered from the creek. The nose area of the aircraft including the nose landing gear was forced aft. The fuselage buckled upwards at approximately Fuselage Station (FS) 124. There was no fire.

Wreckage overview, ASI-22-BC-005

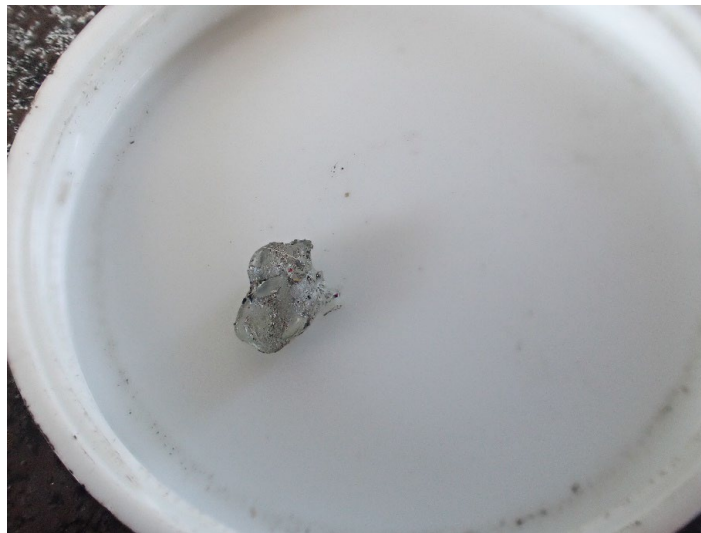
Fuel drained from the strainer was light blue in color and tested positive for water. However, the nose section of the aircraft had been submerged in water. The fuel strainer bowl contained a clear globule of material that appeared to be silicone. The bowl also exhibited light corrosion. No fuel was drained from the right wing tank. Approximately 16 gallons of fuel was drained from the left wing tank. Both wing tank finger screens were clean. Compressed air was used to blow through each line of the fuel system, including the vent line, and no obstructions were noted.

Globule of material removed from fuel strainer, ASI-22-BC-087

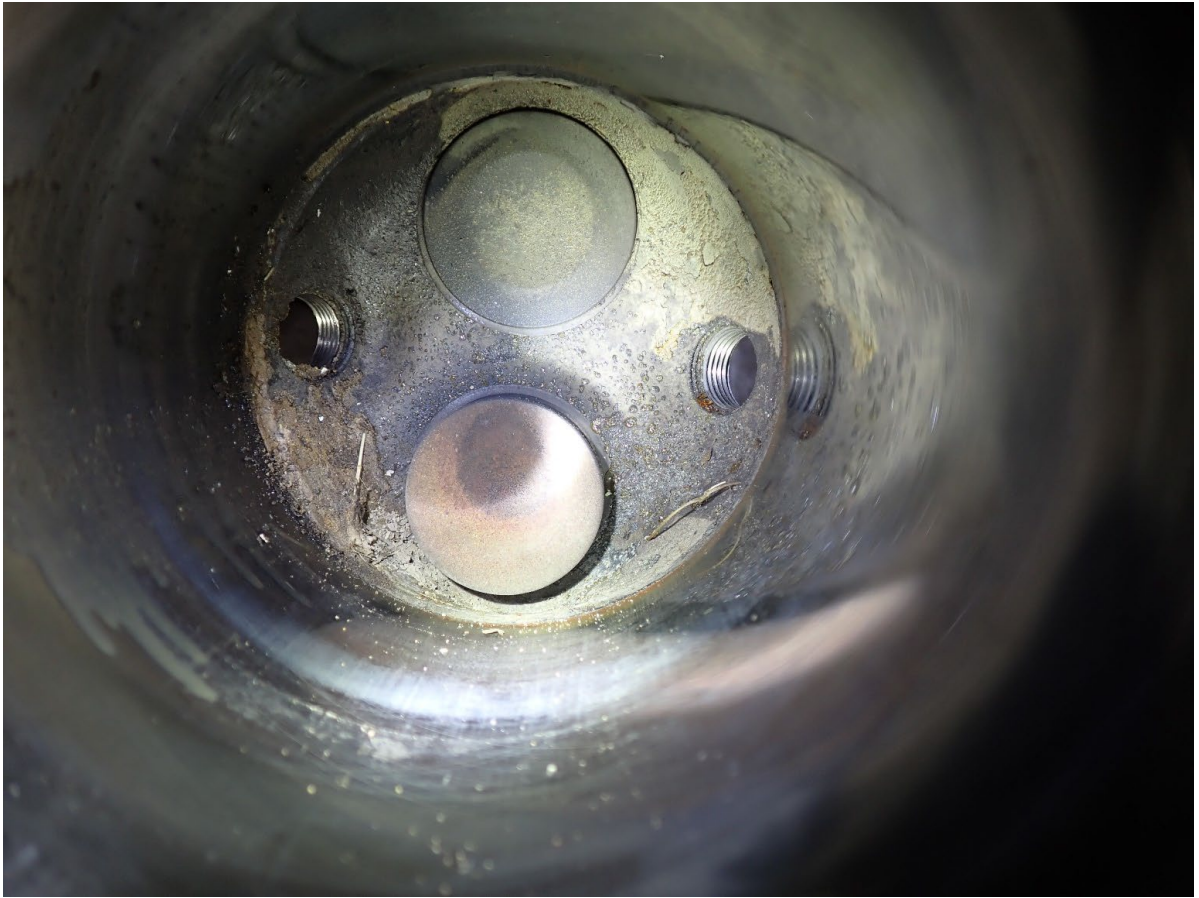
Cylinder 4, ASI-22-BC-104

The engine remained attached to the airframe. The carburetor was impact separated from the engine. Engine control continuity was not established. The mixture control at the carburetor was observed in the Lean position. Valve train continuity and thumb compression/suction were obtained on all cylinders except cylinder 4. The exhaust valve was staked; however, there was still no valve movement. Cylinder 4 was removed, and the exhaust valve was observed to be stuck in the open position. The magneto leads for the bottom spark plugs of cylinders 2, 4, & 6 exhibited impact damage. The leads of both magnetos were cut near the housing. The removed magnetos were rotated by hand and spark was observed on all leads. The bottom spark plug of cylinder 4 was lead fouled and contained additional unidentified debris. The vacuum pump would not rotate.

The engine was retained by the NTSB for further examination. The No. 4 cylinder was further examined on 08-12-22, by the NTSB-IIC. Per his notes: "During disassembly the exhaust valve stem was observed stuck in the sleeve in the cylinder head. Wear/polishing was noted on one side of the exhaust stem that protruded from the sleeve and the stem appeared to be off center from the sleeve. The exhaust valve was removed from the cylinder using a brass punch and a hammer.

Upon removal a black substance consistent with carbon buildup was noted along the length of the exhaust valve stem. The valve stem diameter measured .4134 at the base of the stem and .4325 at the top. The specified measurements for the valve stem indicated a minimum diameter of .4335 for P/N 629404 and .4325 for P/N 3921. The P/N of the removed exhaust valve was not determined. The cylinder and exhaust valve were retained for further examination."

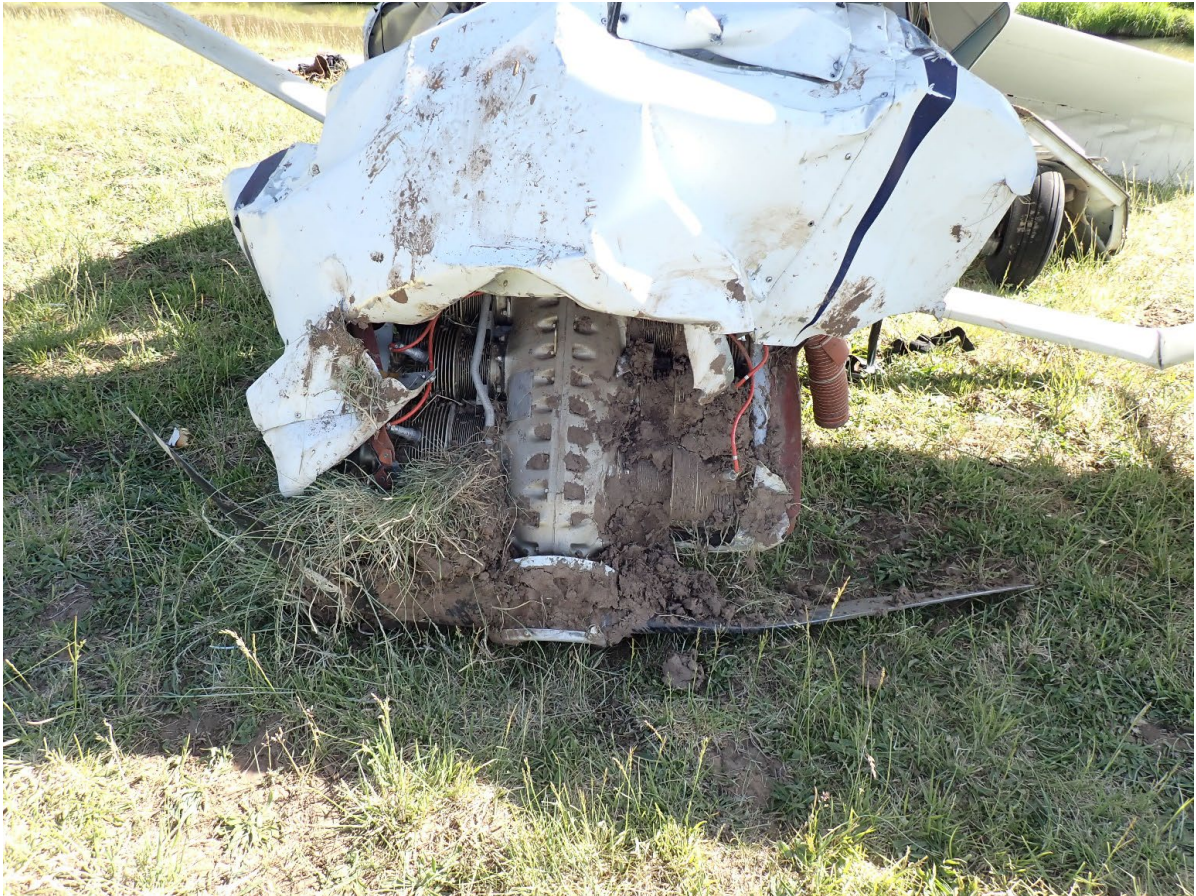
One blade was relatively straight; the other blade was bent aft at midspan. Both blades exhibited leading edge polishing.

Propeller & engine, ASI-22-BC-018
