# National Transportation Safety Board

WPR22FA195

## **SUMMARY OF FIELD AND FOLLOW-UP EXAMINATION NOTES**

Location: Lucerne Valley, California  
Date: June 2, 2022  
Time: 1130 Pacific daylight time (PDT)  
Airplane: N6366M

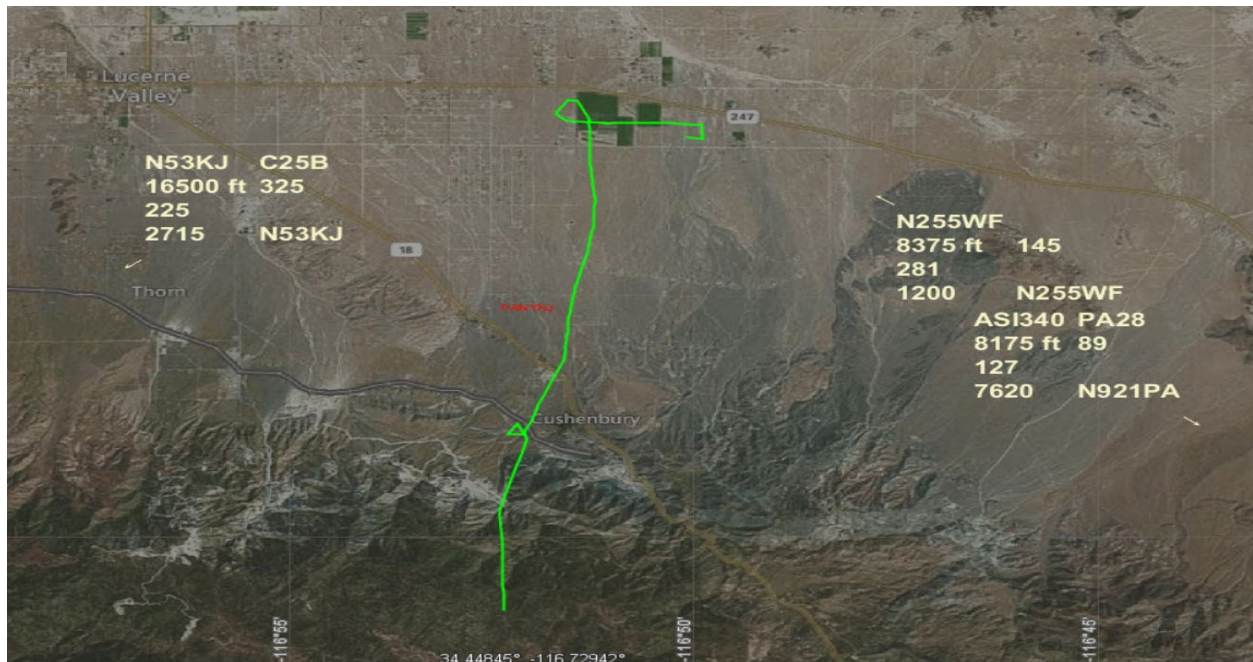
Figure 1. View of preliminary radar data of N6366M flight track

According to preliminary radar data (Figure 1), the pilot departed L35 and travelled northbound towards Lucerne Valley. Just short of Highway 247, the airplane maneuvered to the east and flew parallel the highway. The pilot maneuvered to the

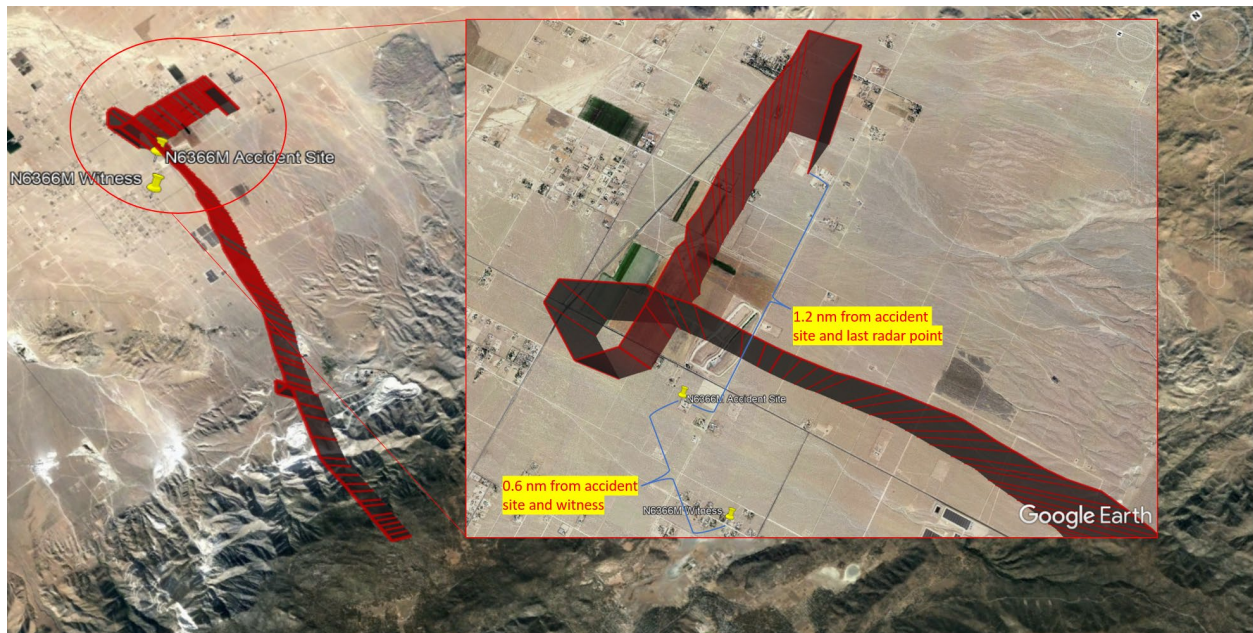
Figure 2. View of ADSB data plot over google earth

west and the last radar hit was located about 1 mile east of the accident site (Figure 2).

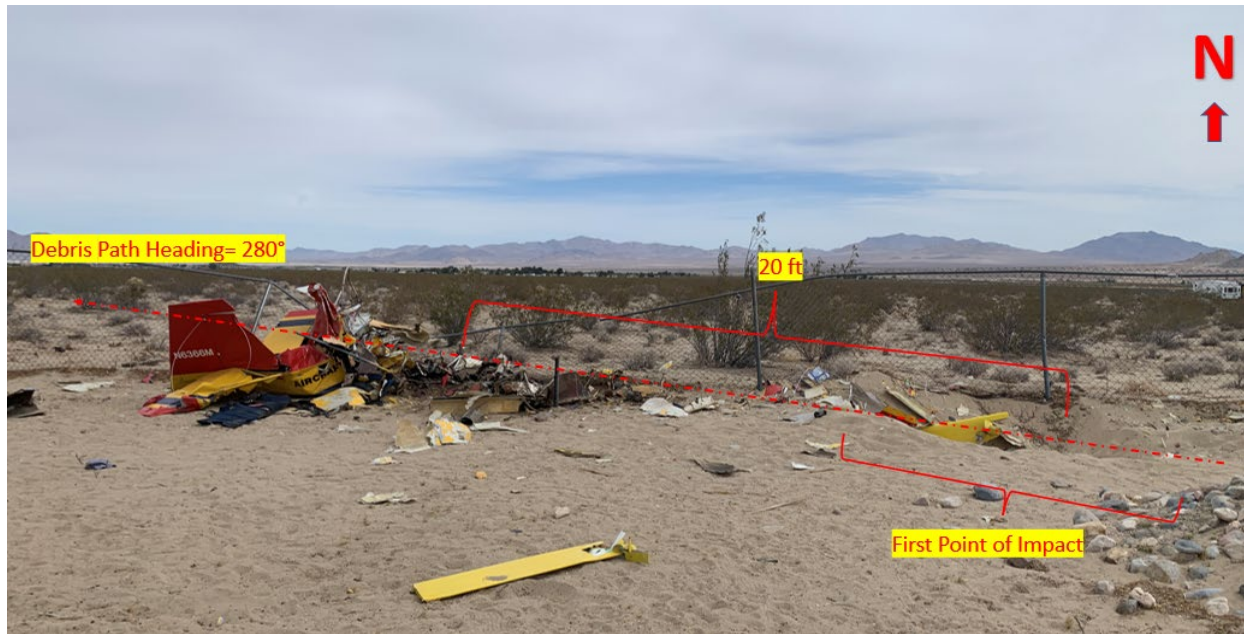
**Figure 3. View of main wreckage site**

The airplane impacted a dirt field within a residential property 10 nautical miles north of L35 at an elevation of 3,000 ft mean sea level. The wreckage debris path was about 200 ft long and oriented on a magnetic heading of 280°. Figure 3 shows the highly fragmented wreckage and debris path, consistent with a high energy impact.

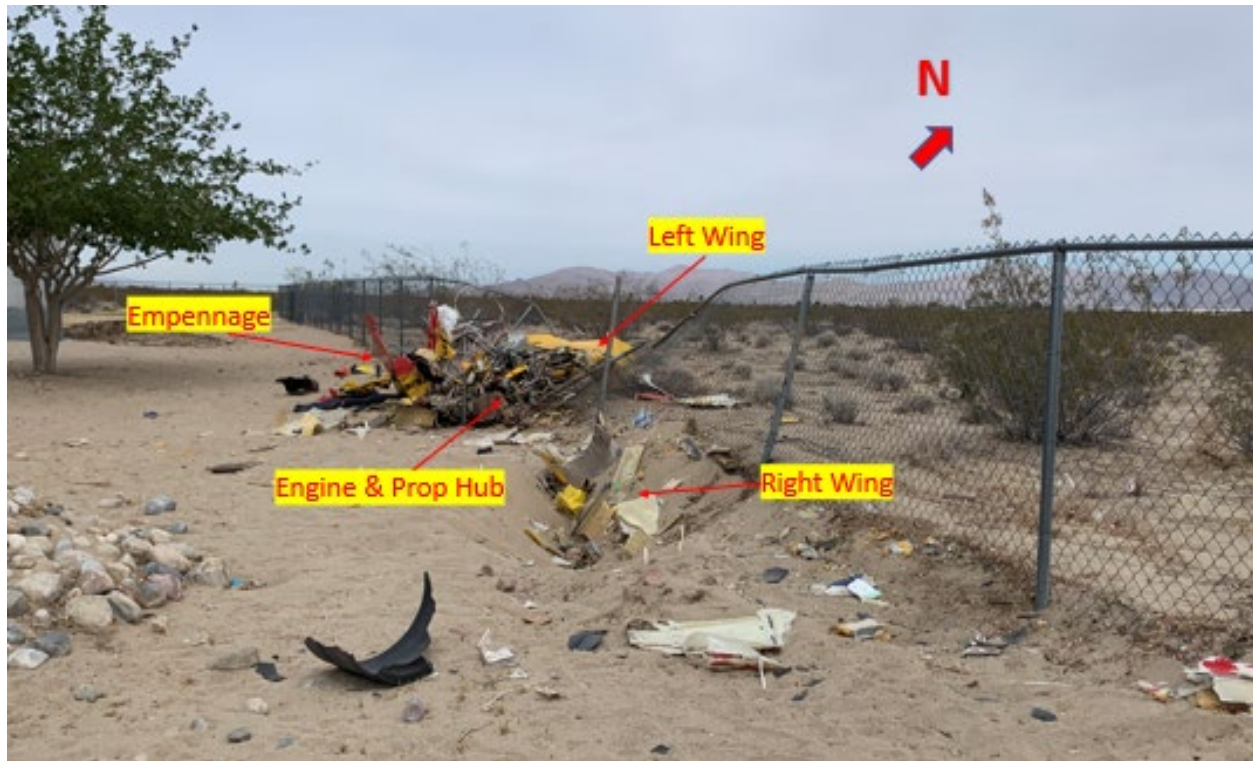
**Figure 4. View of airplane wreckage depicting the "4 corners" of the airplane**

The airplane came to rest on top of a chain linked fence on a magnetic heading of about 360°. The first point of impact (FPI) was identified by a 10 ft long, 6 ft wide, and 2 feet deep crater and a damaged statue. The FPI contained pieces of the right wing, right aileron, wooden propellers, and fuel lines. Ground scars at the accident site and damage to the airplane were consistent with the airplane impacting terrain in a steep, nose down and right-wing low attitude. A post-impact fire did not ensue, but fuel odor was present within the main wreckage, consistent with 100LL. All major structural components of the airplane were located within the debris field (figure 4).

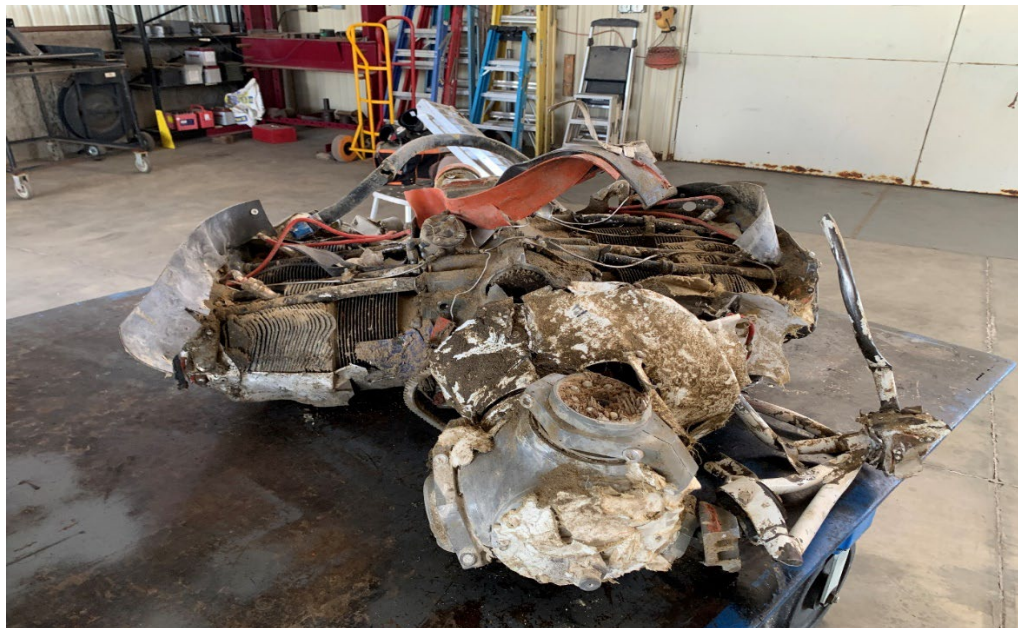
**Figure 5. View of engine prior to teardown examination**

The engine (figure 5) was a four-cylinder, air-cooled, direct drive, horizontally opposed, normally aspirated (fuel injected), internal combustion engine rated at 200 hp @2700 rpm. The engine and portions of the engine separated from the airframe. The forward section of the crankcase sustained significant impact damage. The magnetos, fuel injection servo, fuel pump, and started had separated from its respective mounting pad, consistent with impact damage.

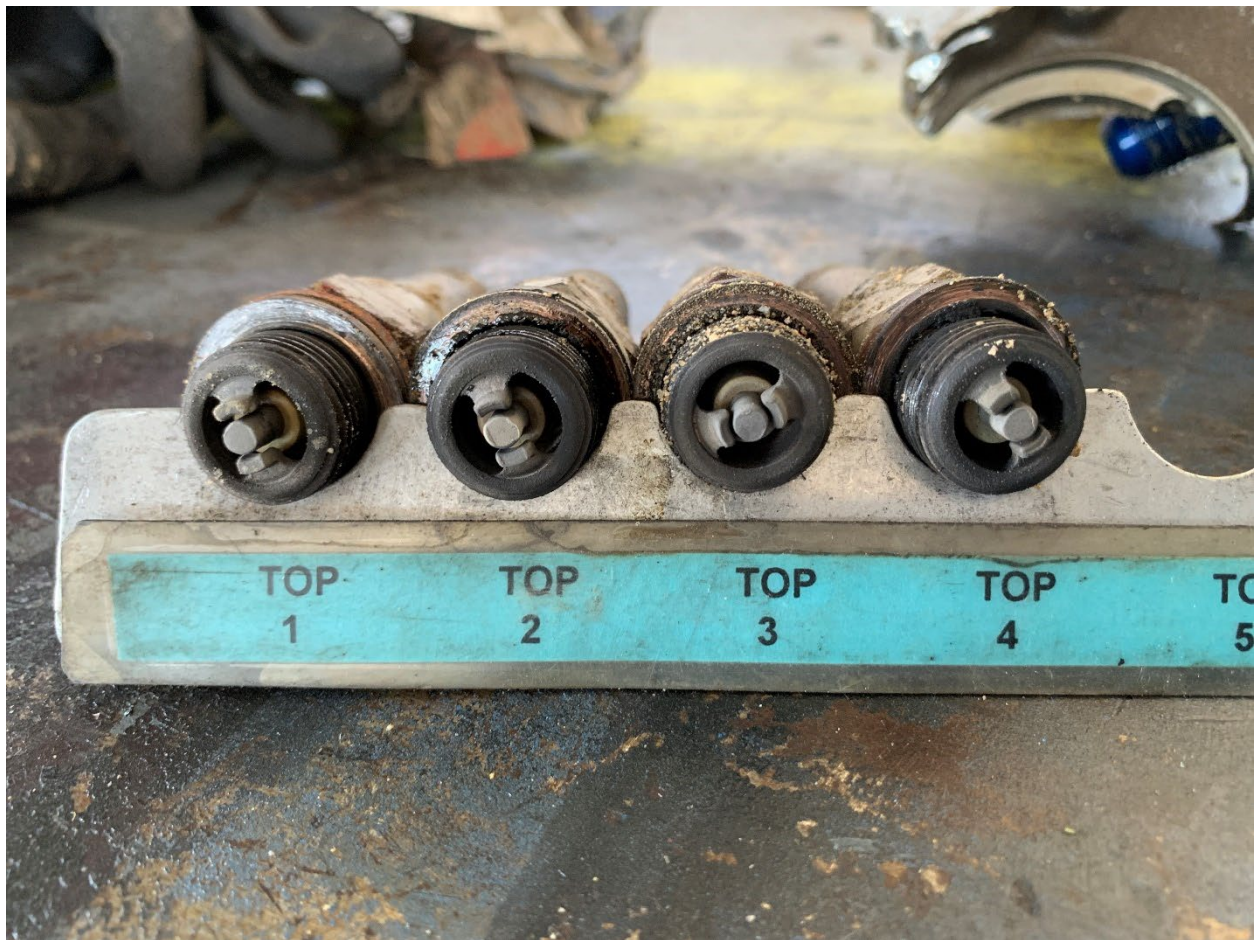
**Figure 6. View of top spark plug electrodes**

Removal of the top spark plugs (figure 6) revealed that the electrodes were mechanically undamaged, according to Champion Spark Plugs Check-A-Plug chart AV-27; each electrode displayed coloration consistent with normal operation.

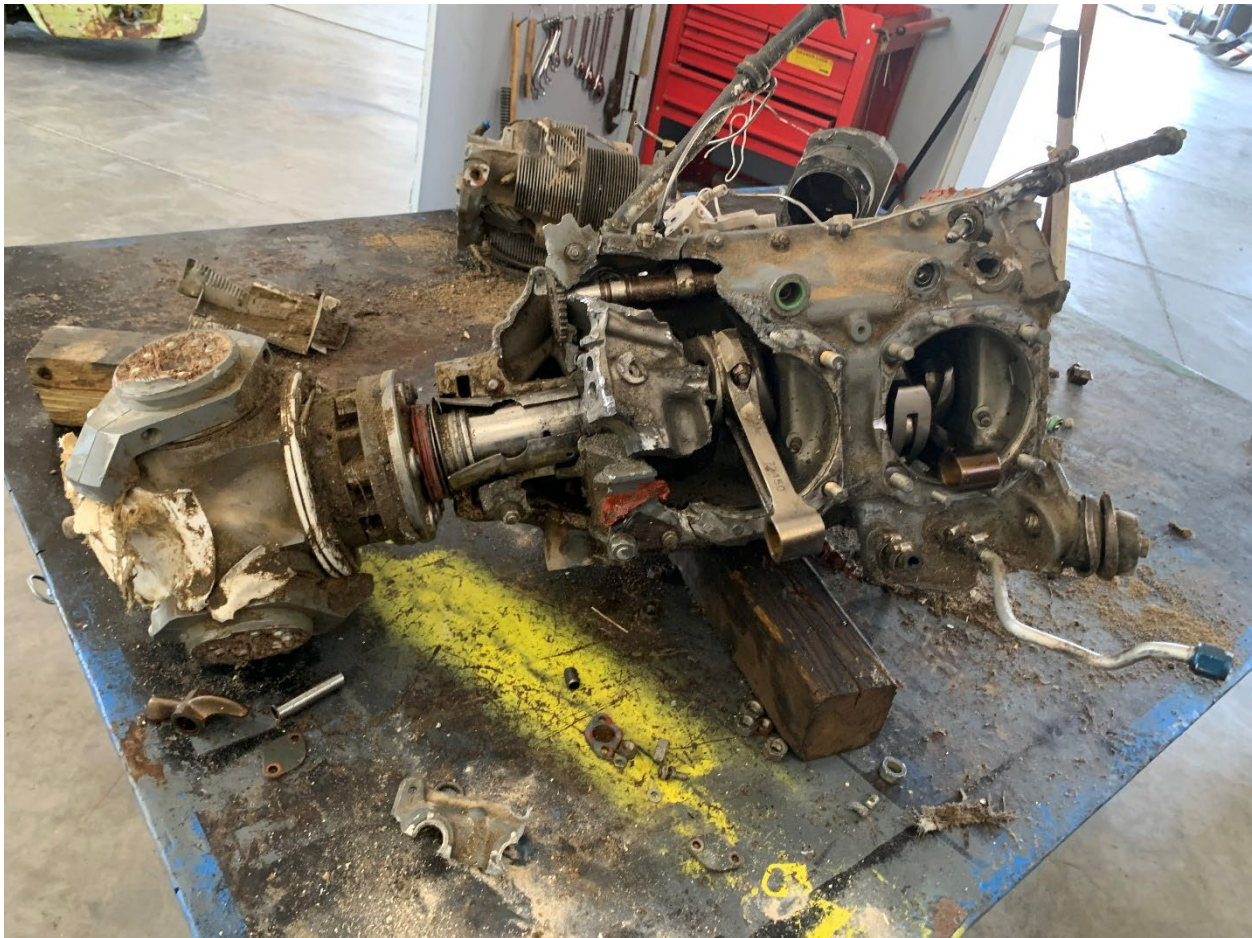
**Figure 7. View of engine after cylinder removal**

undamaged. There was no evidence of valve to piston face contact observed. The gas path and combustion signatures observed at the spark plugs, combustion chambers and exhaust system components displayed coloration consistent with normal operation. Removal of cylinders no. 2 and no.4 confirmed that the crankshaft and camshaft and its respective cam lobes had no evidence of lubrication depravation, contamination, or foreign object damage (figure 7). The crankshaft and attached connecting rods remained free of heat distress. There were no signatures or conditions observed consistent with any pre-mishap catastrophic mechanical malfunction. The camshaft was intact and each of the cam lobes exhibited their characteristic elliptical shape.
