National Transportation Safety Board

WPR22FA119

**INVESTIGATIVE SUPPLEMENTAL MATERIAL**

Location: Oceanside, California  
Date: 06/03/2022  
Time: 1347 Pacific daylight time  
Airplane: Cessna 208B Supervan 900

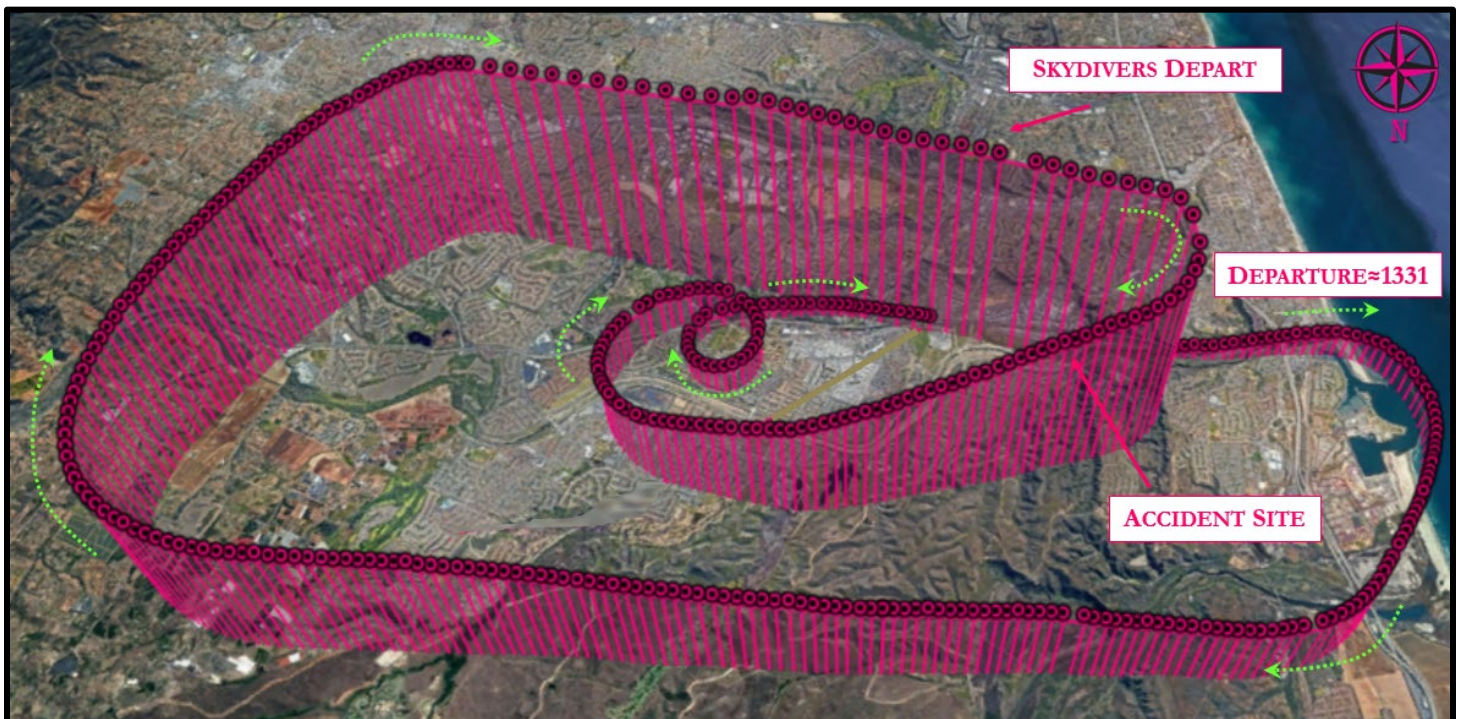
Figure 1: Flight Profile from ADS-B

Investigators reviewed video recordings, audio recordings, and flight track data covering the area of the accident during the time surrounding the accident using Federal Aviation Administration (FAA) provided Automatic Dependent Surveillance-Broadcast (ADS-B) data. After departing from runway 25, the airplane made a gradual climb to 11,575 ft msl as it circled to the right, back to the airport. The airspeed was reduced (presumably to unload the skydivers) and then made a steep, turning descent reaching 133 kts when transitioning to the downwind leg of the traffic pattern. The airplane was at an altitude of about 2,400 ft msl and 2.6 nautical miles (nm) from the approach end of runway 25 when it turned onto final approach. When the airplane was about 2 nm from the runway, it made a 360° right-turn which was about 0.5 nm in diameter.

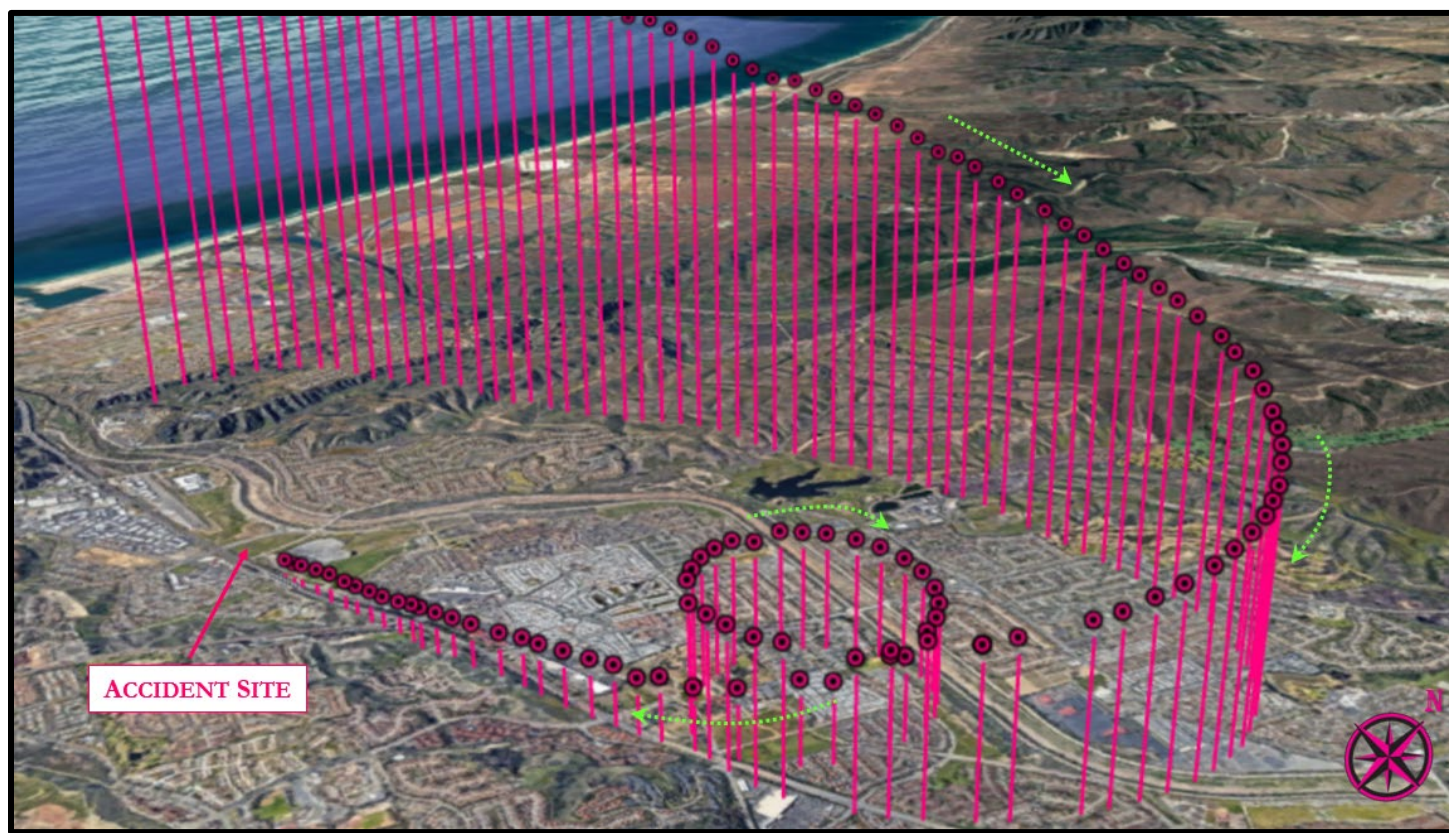
Figure 2: Final Approach Path (showing altitude)

At 1346:10, at about 1,025 ft msl, the airplane rolled out of the 360° turn and continued west toward the runway. For the remainder of the flight (one minute), the airplane was roughly following Highway 76 making a gradual descent toward the runway.

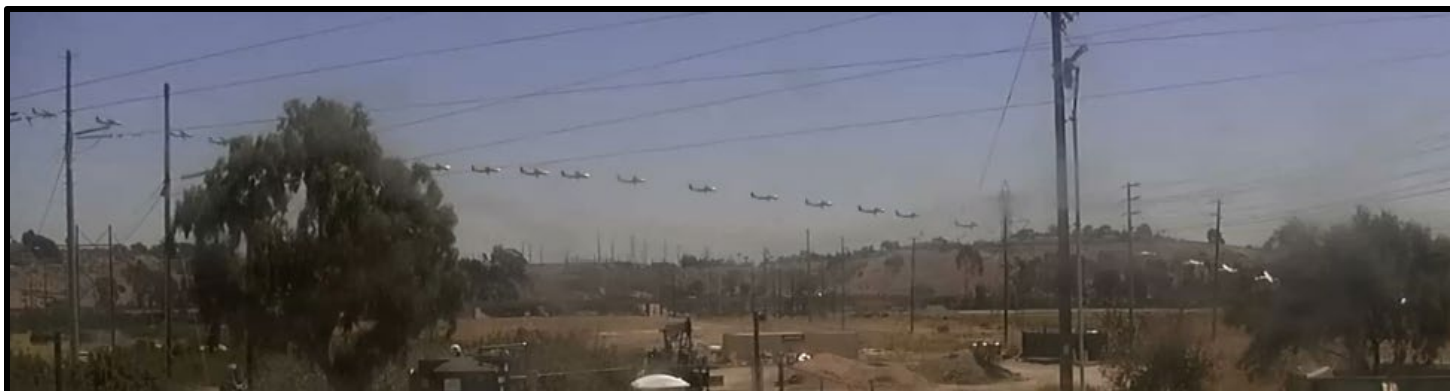
Figure 3: Security Camera Images Showing the Turn Just Prior to the Accident

The last recorded hit was located about 975 feet east of the accident site. At that time, the data indicated that the airplane was at 100 msl (equivalent to 60 feet above ground level) at a speed of 68 kts. Witnesses stated that they observed the airplane flying at a very low altitude (see Figure 3). The airplane then pitched down in a nose-low attitude and bank to the right. The airplane impacted terrain and collided with the side of a berm.

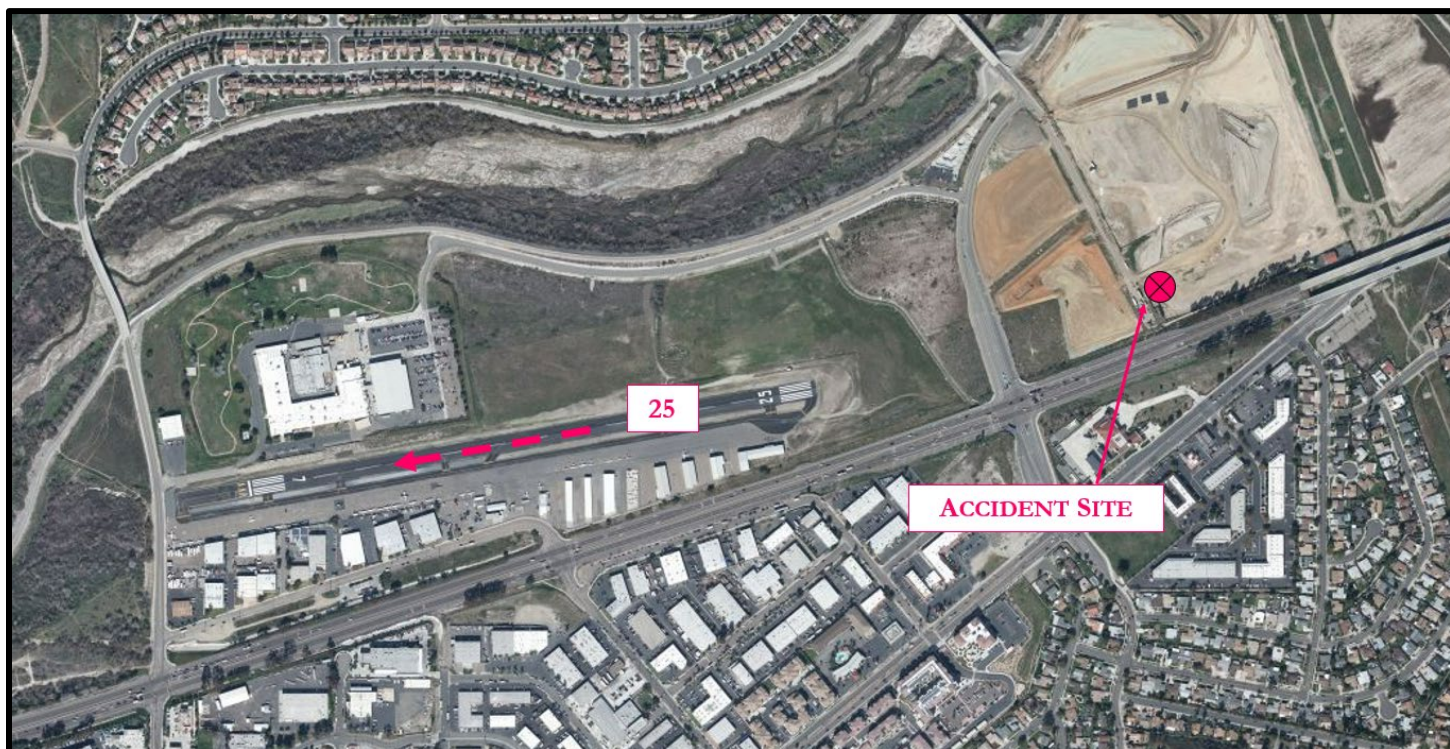
Figure 4: Accident Site in Reference to the Runway

The accident site was located about 1,615 feet east of the approach end of runway 25 on flat terrain composed of soft, dry dirt. The wreckage was found distributed over an approximate 125-foot distance with the nose pointed on a heading of about 335°. The right wing was partially separate from the fuselage root and had folded forward and over upon itself, coming to rest inverted. The first identified piece of debris was fragments of left lens, consistent with the tip of the right wing contacting the ground at the beginning of the accident sequence.

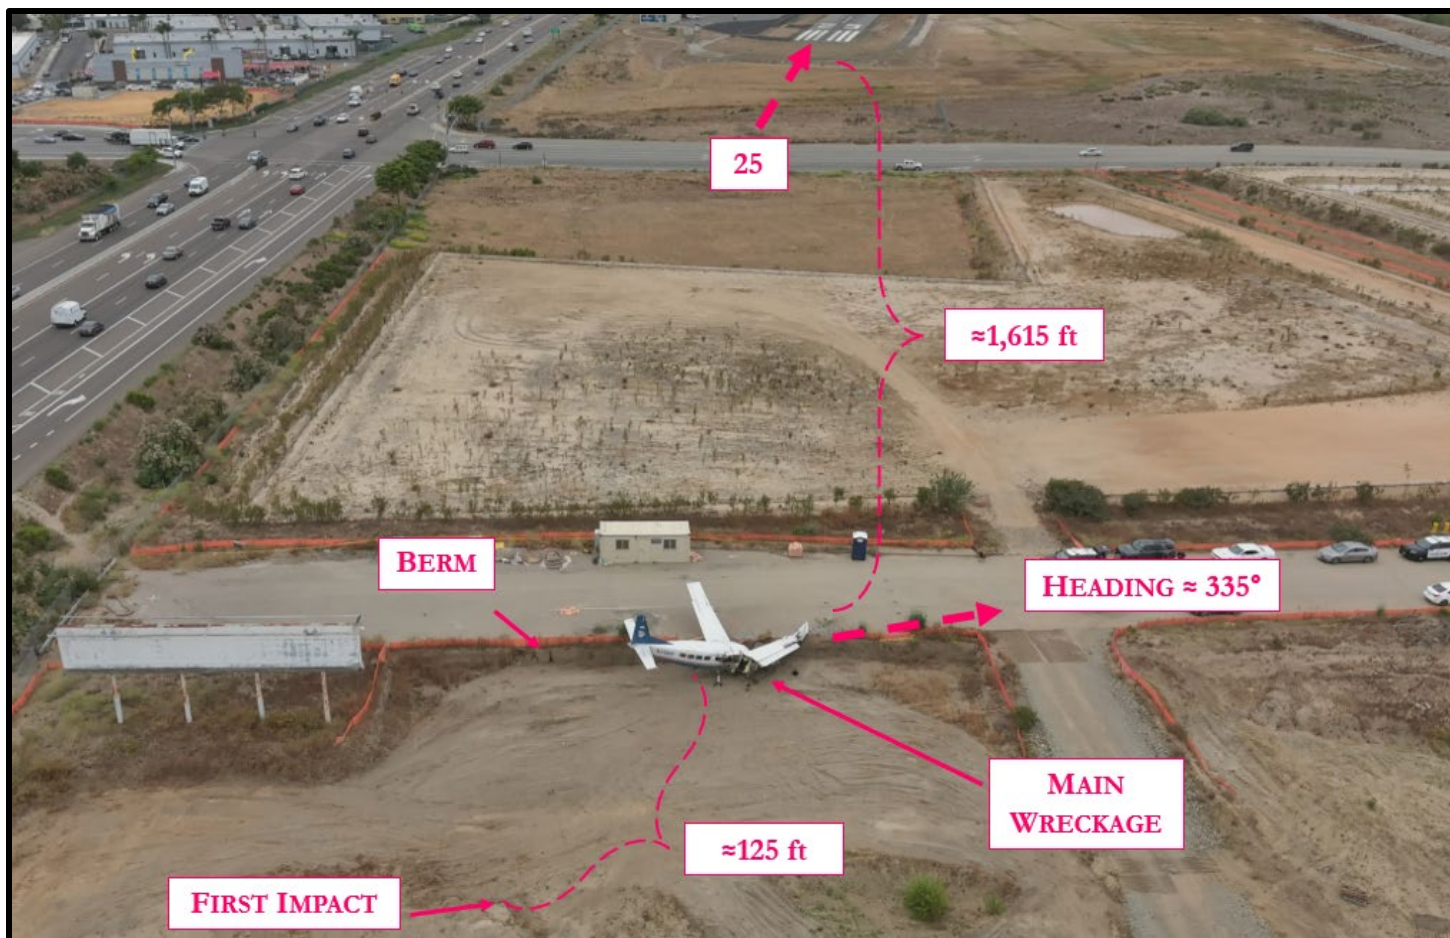
Figure 5: Accident Site Aerial View

The flaps were found in the retracted position. There was about 50 gallons of fluid, consistent in appearance and odor with JetA fuel, recovered from the right wing; no fluid was recovered from the left wing, but the fuel line had separated from the connection into the fuselage. The fuel system remained unbreeched from the header tank to the engine's fuel nozzles. There was fluid found in the header tank, in the airframe fuel filter, and in several fuel lines before and after the fuel control unit. The preliminary findings from the engine teardown (e.g., several compressor blade tips curled in the opposite direction of rotation and metal splatter on the turbine discs and stators) were consistent with the engine running at a low power setting at the time of impact.

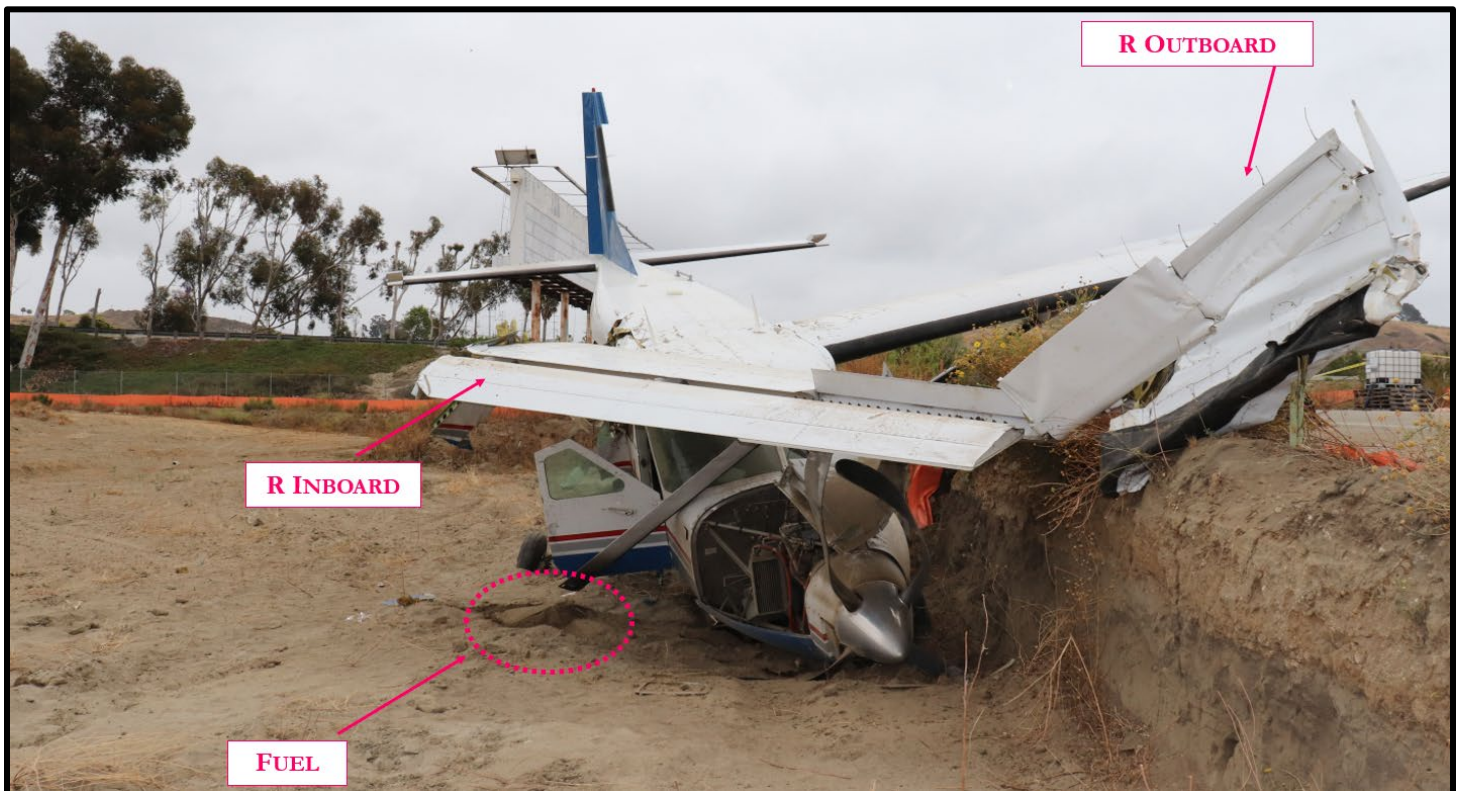
Figure 9: Main Wreckage

The left side of the fuselage was damaged between Fuselage Station (F.S.) 100 and F.S. 186. This deformation on the left side displaced the instrument panel and side console, extending into the left side of the cockpit. The left side windshield was broken, and there was deformation in the cockpit floorboard area, resulting in the binding of the elevator control column. Additionally, the left main landing gear strut was displaced inboard. The left wing beyond W.S. 228.50 showed impact damage with upward displacement of the wing tip. Although the left wing integral fuel tank was not breached, no fuel was found in the tank at the accident site. Both wing fuel shut-off valves were observed in the "ON" position. The left fuel tank selector was on and the right fuel selector was off.

The right wing was pivoted forward approximately 130° around the inboard wing leading edge, resting over the engine area. The outboard section of the right wing, beyond Wing Station (W.S.) 228.50, sustained significant impact damage, resulting in the upward displacement of the wing tip. The right wing integral fuel tank remained intact, and contained about 50 gallons of fuel. The rear spar fuselage structure of the right wing separated from the fuselage and remained attached to the wing. The main spar wing fitting lugs on the right wing were also observed to be separated, with the bolt remaining attached to the fuselage side of the fitting. The right wing remained connected to the fuselage by the aileron control cables.

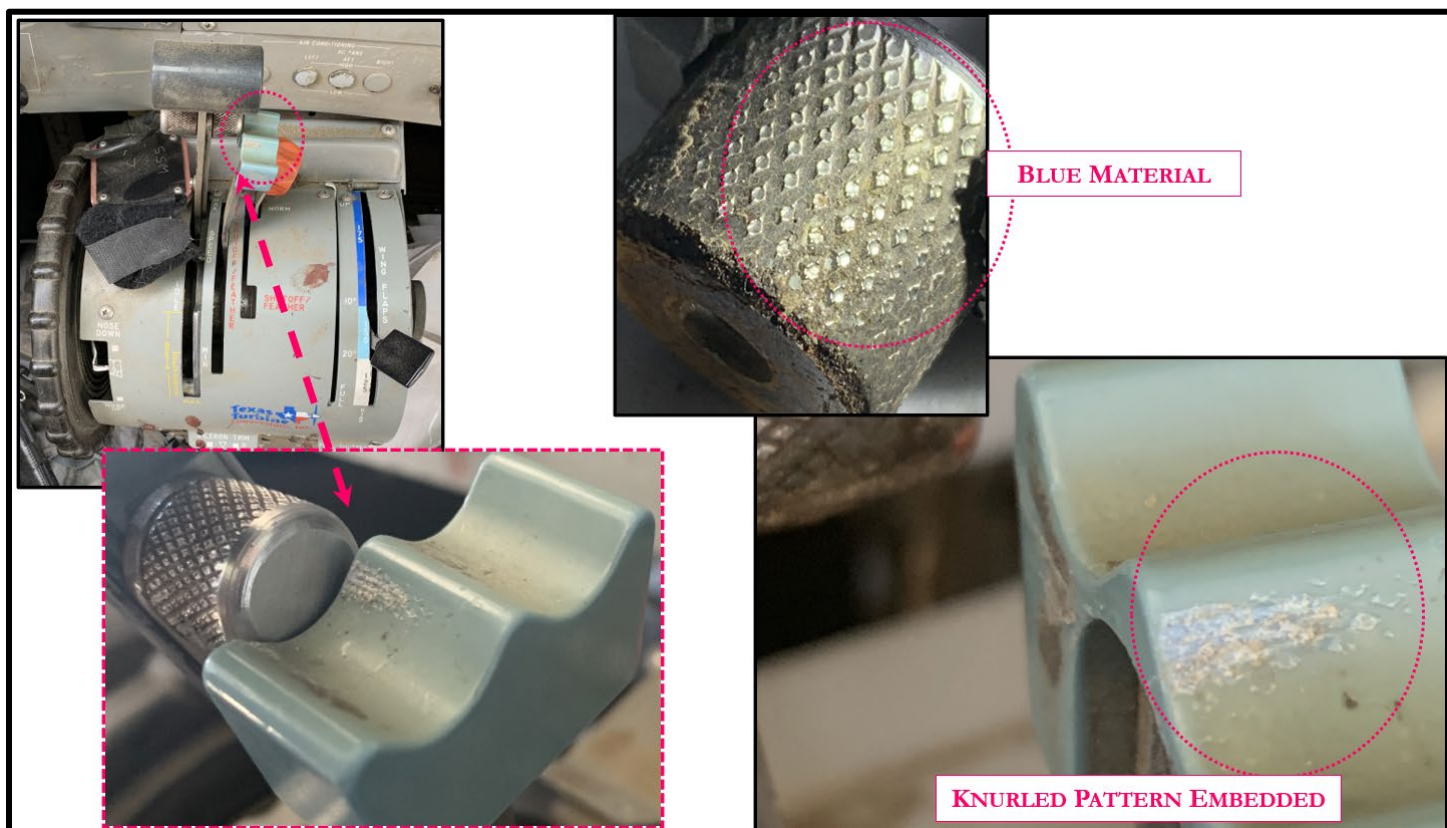
Figure 10: Accident Airplane Throttle Quadrant

Following the accident, the power and speed levers were observed in a full forward position. The top of the knob on the speed control lever was observed to have markings in the plastic, matching the pattern of knurling from the silver beta control knob. Additionally, there was blue material transfer from the speed control lever knob to the knurled beta control knob.

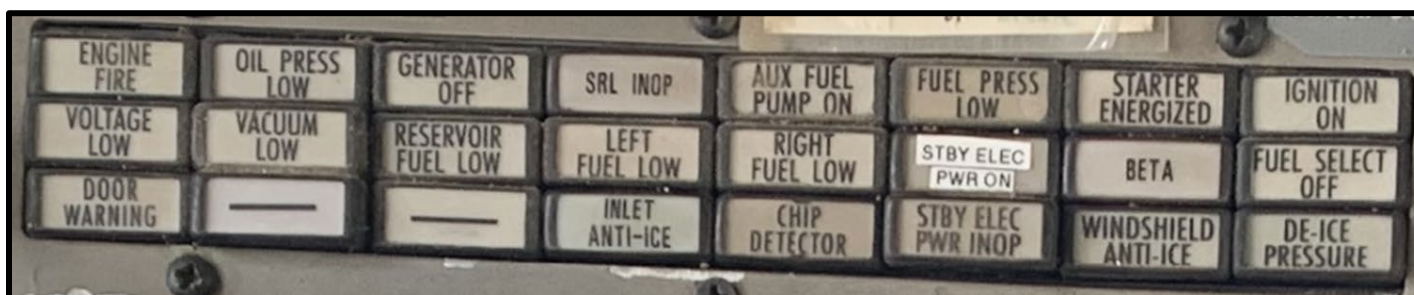
Figure 11: Annunciator Panel

An annunciator panel from the accident aircraft was submitted to the Materials Laboratory for examination. The panel contained twenty-four (24) individual annunciators. Each annunciator contained two (2) bulbs. The panel was intact and visually appeared to have had limited impact-related damage. The individual annunciator lights were removed from the panel and x-rayed to determine the status of the filaments inside each of the bulbs. The status of each light is listed in the chart below.
