# **WPR22FA197**

## **Hartzell Propeller Air Safety Investigator Exam Notes**

NTSB File No.: WPR22FA197

Aircraft: Cessna C-208B

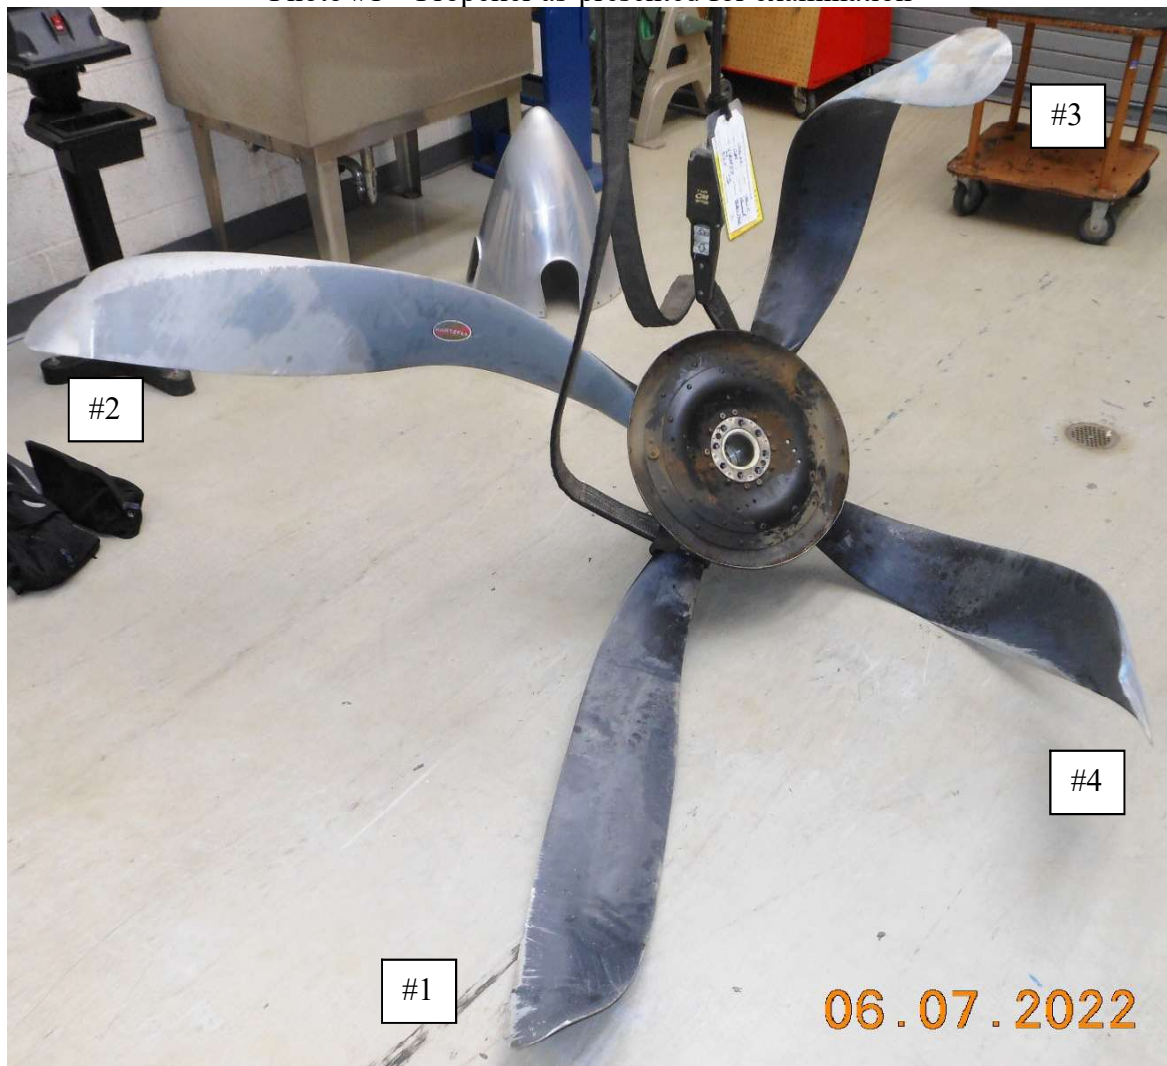
The propeller was presented for examination in the Honeywell Product Integrity Lab on June 7, 2022 as shown in Photo #1. On-scene photos show the forward fuselage/nacelle resting on Blade #2 and Blade #3 in contact with the ground (Photo #2). According to the Honeywell ASI the propeller remained attached to the engine propeller shaft flange with all eight bolts secure and lockwired. The propeller was removed from the engine by the Honeywell ASI on June 6 at Air Transport. All four blades remained attached to the propeller assembly with no blade fractures. Blades #1, #3 and #4 presented in a low pitch position, Blade #2 was rotated beyond low pitch such that it appeared facing partially backwards. The spinner dome was relatively undamaged and only exhibited some longitudinal scoring on the nose with no discernable counterweight impact marks. The spinner bulkhead appeared undamaged with no counterweight impact marks. Blade #1 link screw was bent opposite low pitch and the link arm was detached. The start lock plates on the #1, #3 and #4 clamps were fractured and not recovered. The #2 start lock plate was on the start lock pin. All the start locks brackets and plungers were intact and functional with finger force. The blade slip indicators (Photo #3) indicated Blade #1 had no slippage, #2 had slipped approximately 130° to low pitch, #3 slipped 5° to high pitch, and #4 slipped

Photo #1 – Propeller as-presented for examination

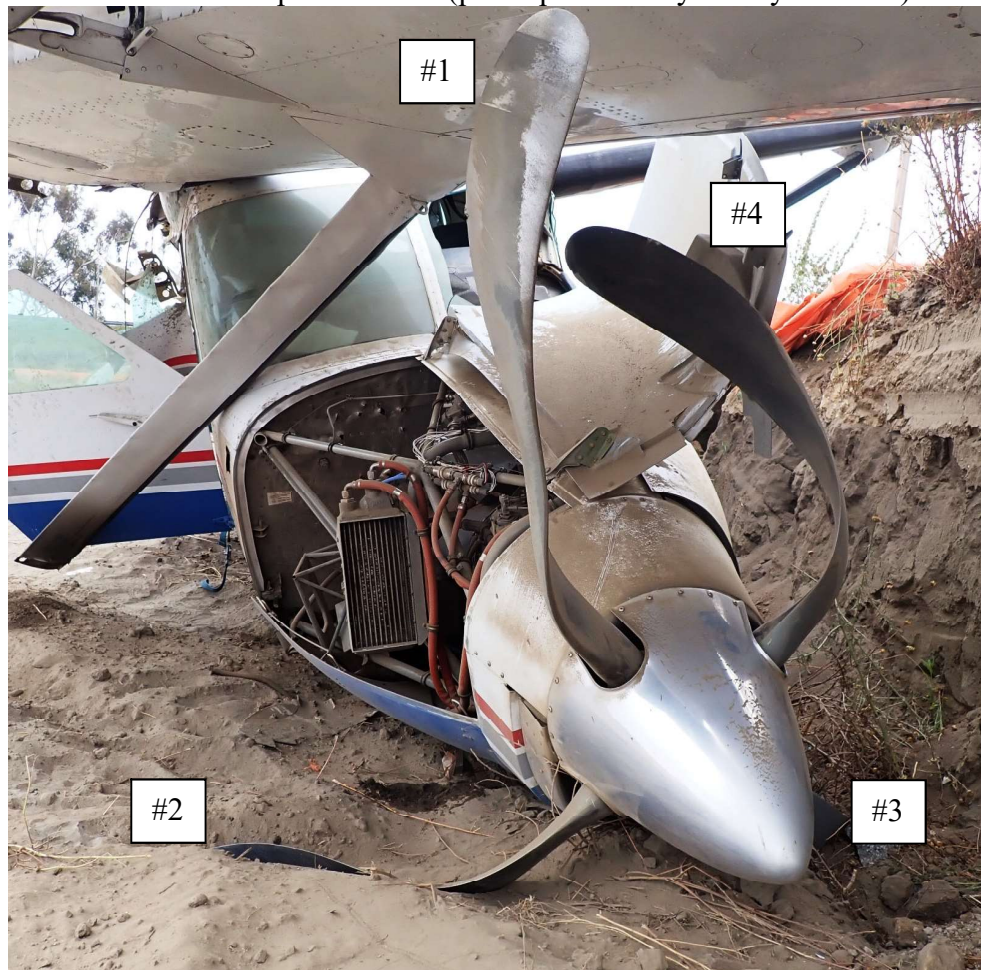
Photo #2 – Propeller in-situ (photo provided by Honeywell ASI)

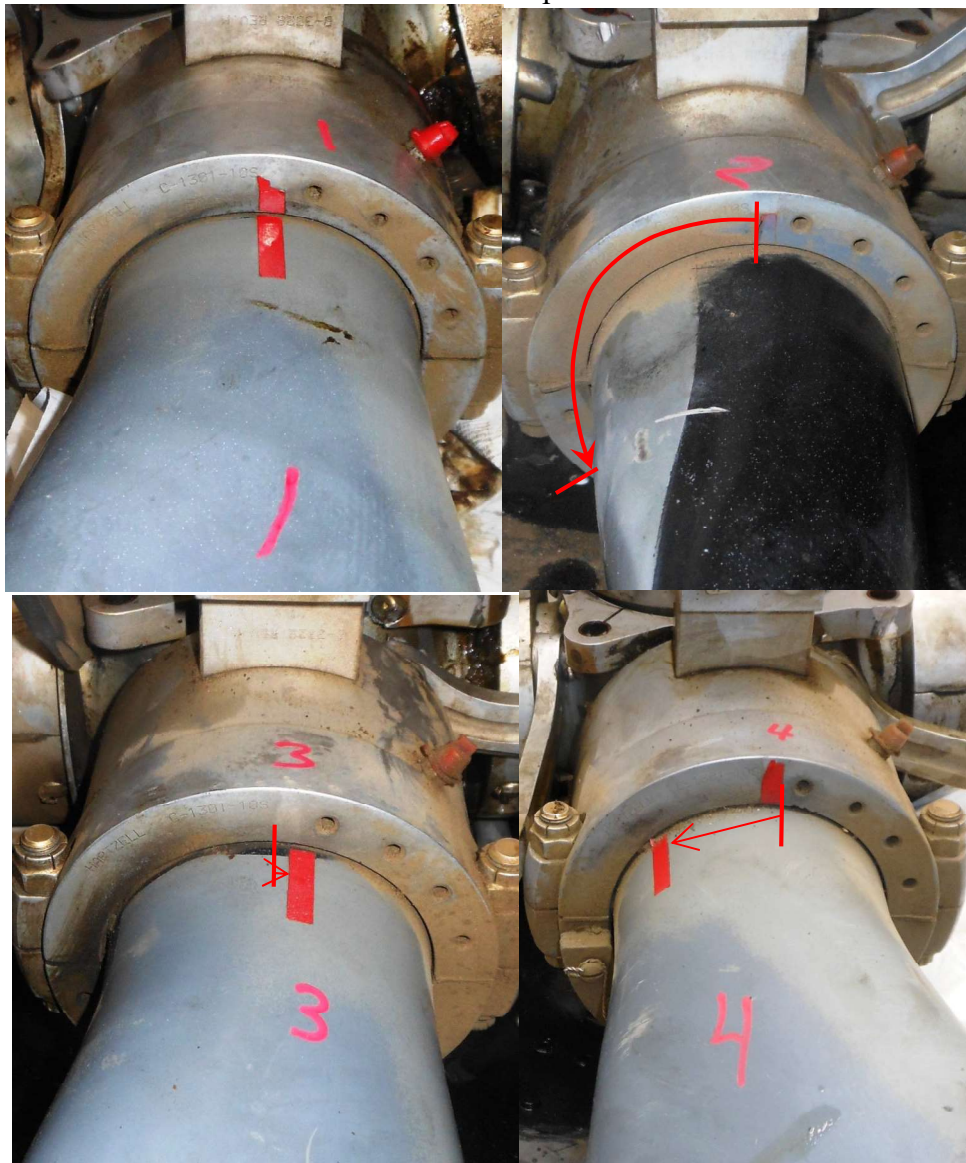
Photo #3 - Blade slip indicators

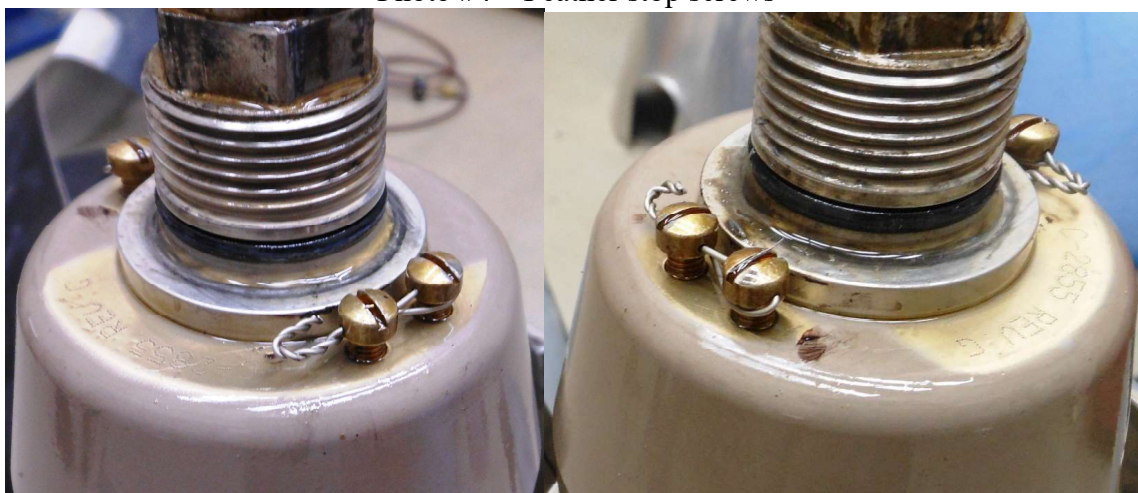
This piston nut was removed to release the feathering spring tension. The link arms were disconnected from the piston and the piston was removed; piston travel was smooth during removal. The internal ceiling of the piston and the feather stop screws (Photo #4) were not damaged indicating the propeller was not feathered at impact. With the link arms detached from the piston all four blade/clamp assemblies rotated smoothly by hand force. The link arms were bent in compression in varying degrees (Photo #5). The feathering spring assembly was intact and loaded with the forward and aft spring retainers in-place (Photo #6).

Photo #4 – Feather stop screws

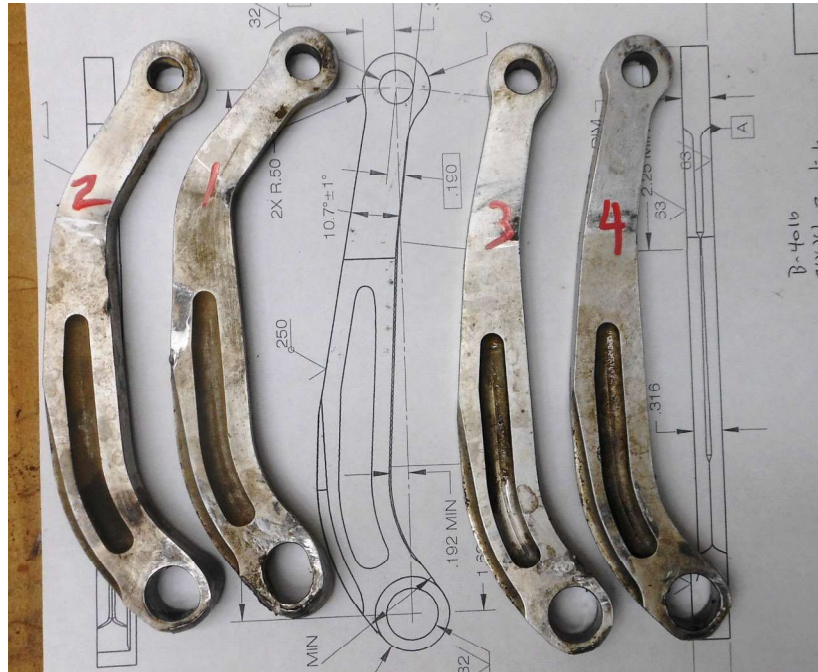
Photo #5 - Link arms

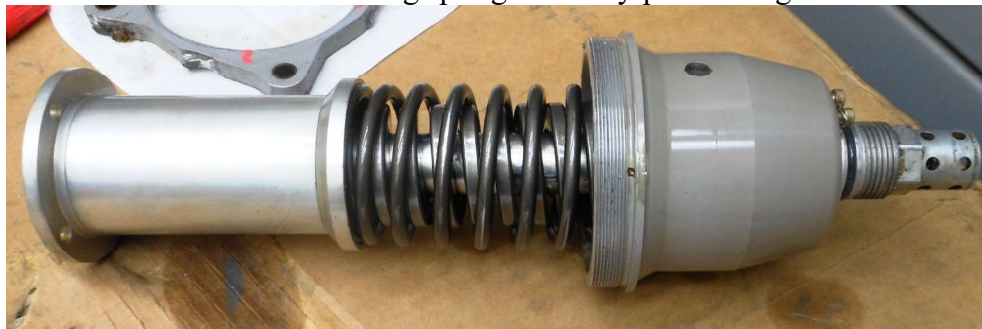
Photo #6 - Feathering spring assembly/pitch change rod

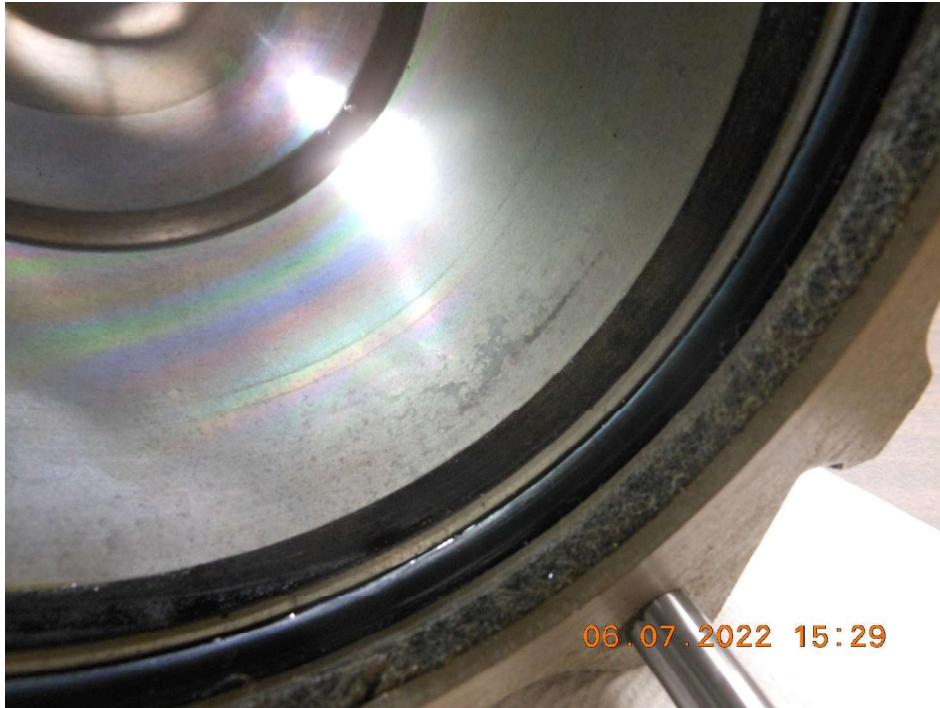
There were four marks on the internal surface of the piston (Photo #7) that may suggest a blade angle at impact. There were distinctive scuff marks on the cylinder at ~1.87" from the top corner (Photo #8). These marks translated to a blade angle with corresponding confidence levels are summarized below in Table #1.

| Internal Marks from Bottom Piston Edge | Approximate Equivalent Blade Angle | Pre-impact Confidence Level / Why? |
|---|---|---|
| 1.4" | -13.6° | Low – Mark is lower than reverse stop, impact sequence mark |
| 2.2" machine mark? | 14° | Low – This mark was very defined, narrow, and continuous around the circumference and resembled a machine mark |
| 2.35" machine mark? | 18.5° | Low – This mark was very defined, narrow, and continuous around the circumference and resembled a machine mark |
| 1.85" crease | 3° | Medium – Near flight idle blade angle |

Photo #7 - Piston internal surface marks

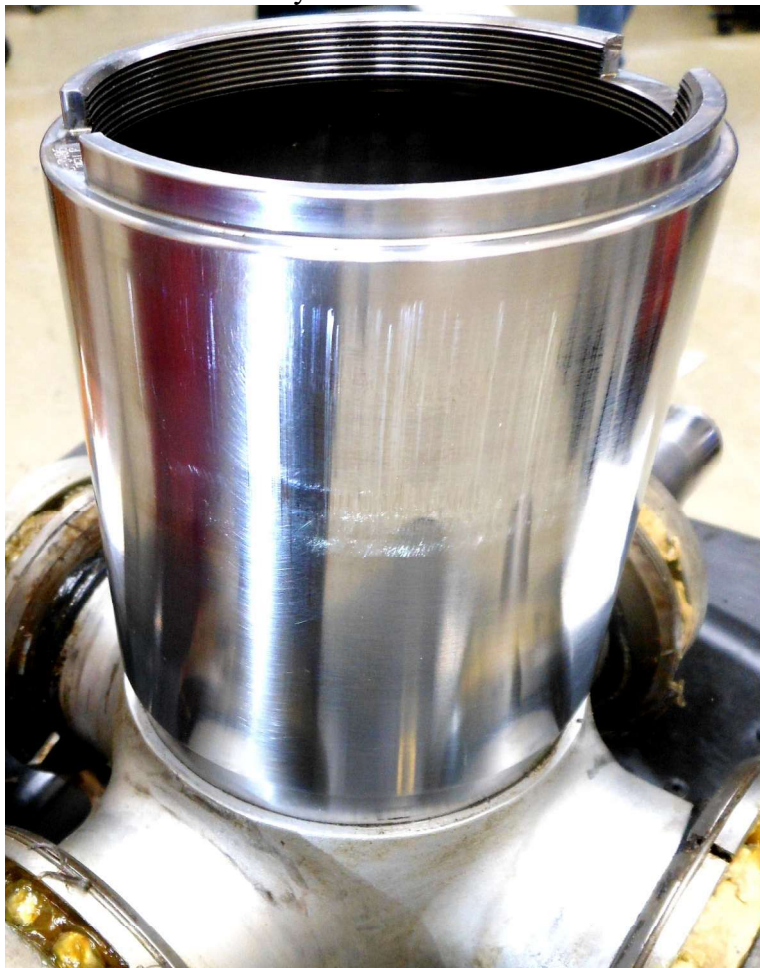
| Internal Marks from Bottom Piston Edge | Approximate Equivalent Blade Angle | Pre-impact Confidence Level / Why? |
|---|---|---|
| 1.87" scuff mark from top corner | 3.5° | Medium – Near flight idle blade angle |

Photo #8 - Cylinder surface scuff marks

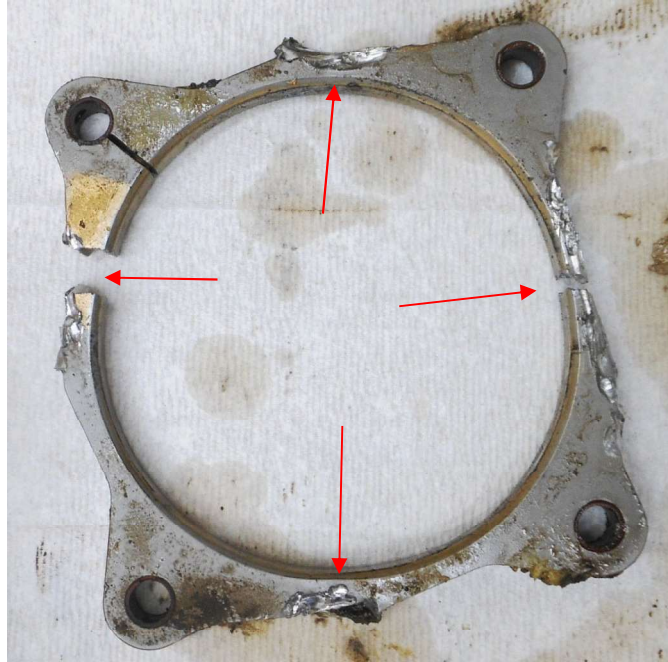
The guide rod collar was gouged in all four positions and fractured at two positions (Photo #9) by the link arm/screws forceful rotation to low pitch during the impact sequence. The hub was intact with no visible fractures. All four pilot tubes and bearing assemblies were intact. Blade #4 was the only blade that had a hub-to-butt impact crescent. It was in the approximately pure-aft direction suggesting the blade was at low/flat pitch position when it was made.

Photo #9 - Guide collar gouges and fractures

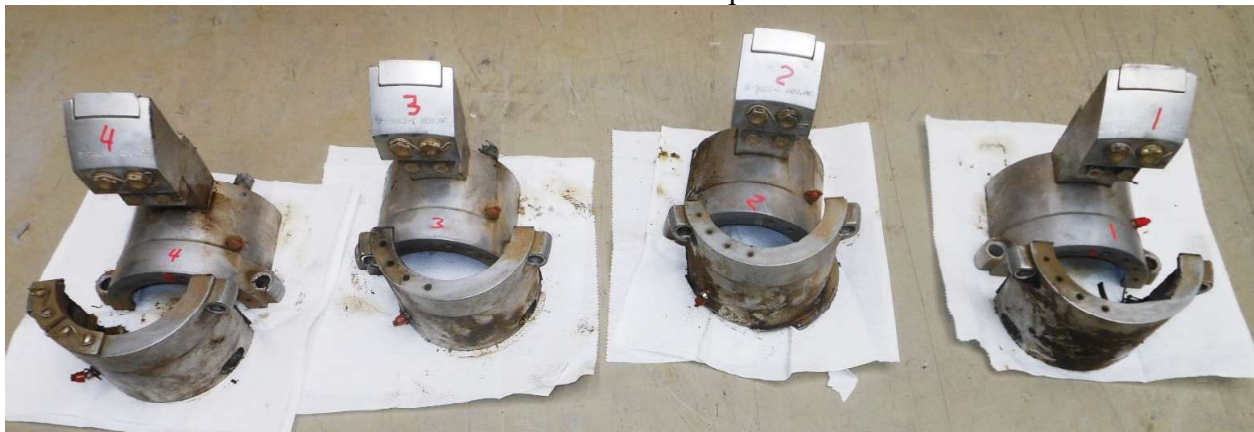
All four clamps and counterweights appeared intact (Photo #10). The counterweight slugs exhibited some scoring marks. The start lock plates on #1, #3 and #4 fractured from the clamps and were not recovered. All four clamp link screws were bent opposite low pitch and partially fractured at the cotter pin holes (Photo #11).

Photo #10 - Clamps

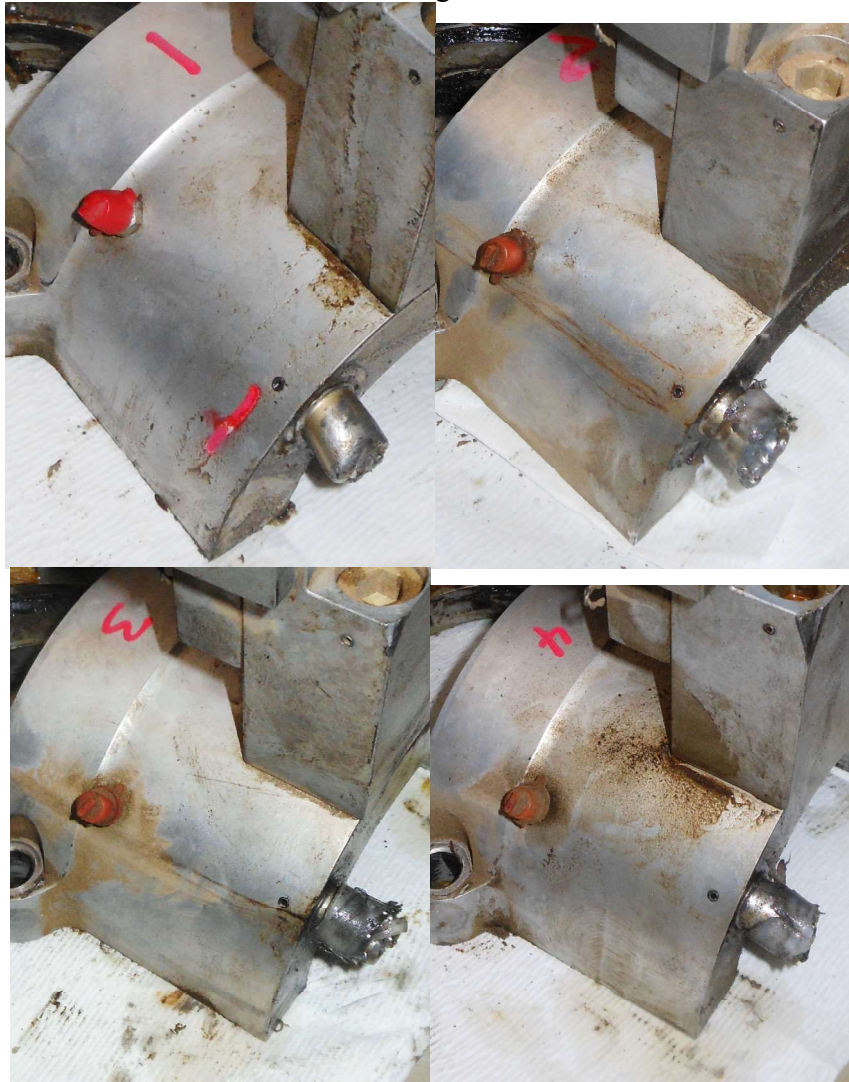
Photo #11 Montage - Link screws

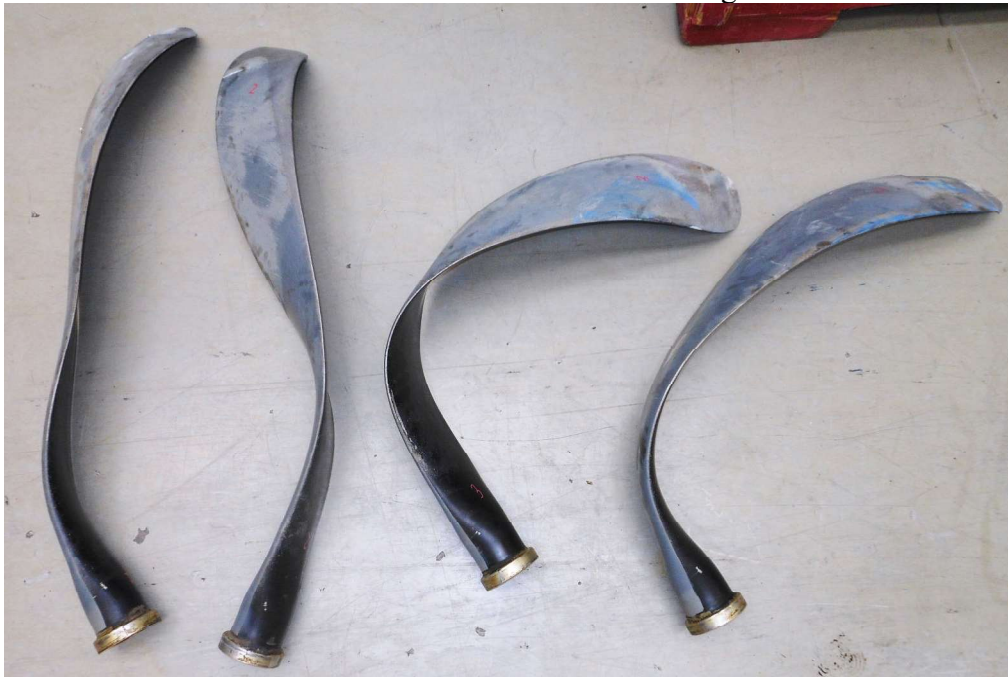
Blades were predominately bent aft (Photo #12). Blades #2, #3 and #4 had remarkable bending opposite rotation (Photo #13). All four blades were twisted toward low pitch. Blades #2 and #4 had some remarkable bends in the leading edge with material deformation toward low pitch (Photos #15 and #16). Blade #1 also had a remarkable leading edge wave bend in the mid-blade region with material deformation toward low pitch (Photo #17).

Photo #12 – Blades 1-2-3-4 left to right

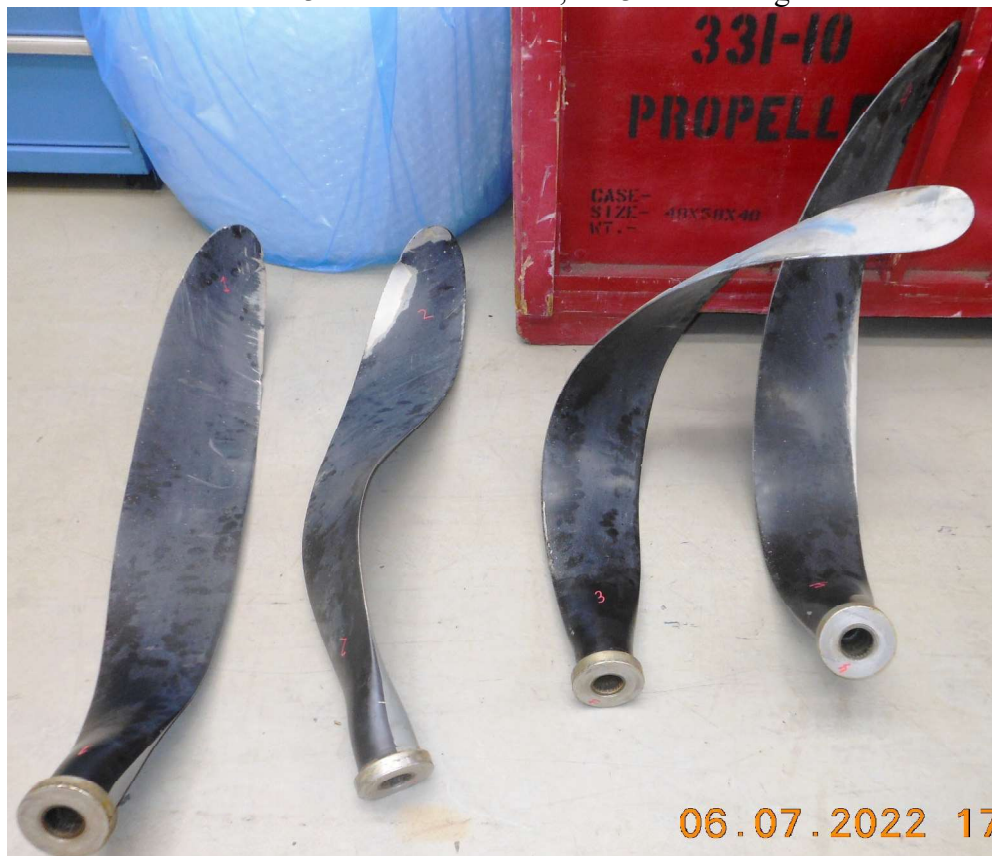
Photo #13 – Blades face side, 1-2-3-4 left to right

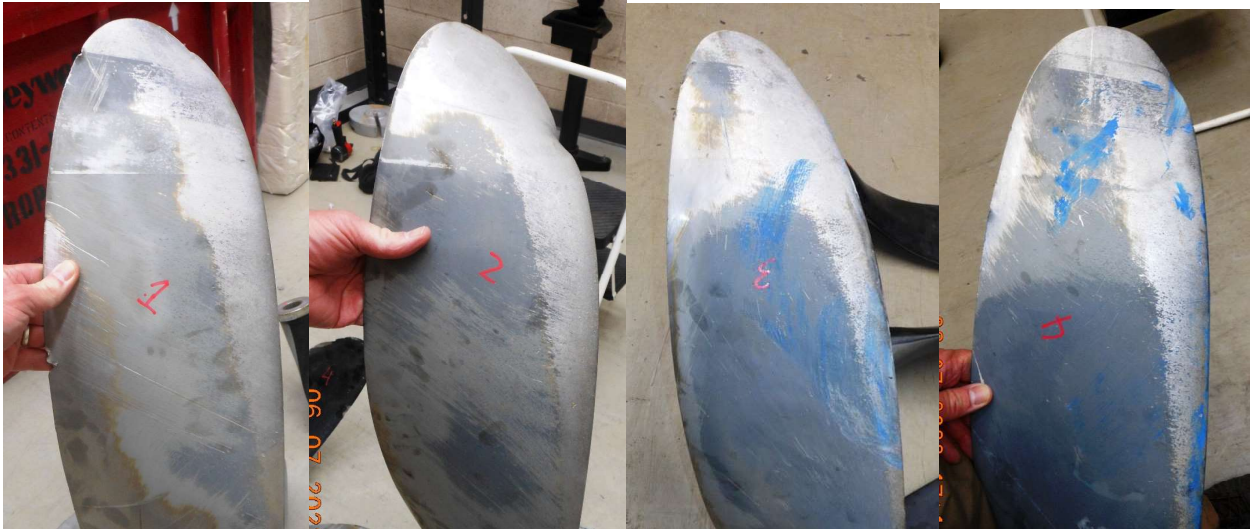
All four blades had chordwise/rotational scoring on the camber-side (Photo #14). Blade #2 had some face-side chordwise/rotational scoring, but as seen in the on-scene photos this could have been caused by dragging after rotation stopped (Photo #2). Blades #3 and #4 hit an airframe component at some point during the impact sequence by evidence of the blue paint transfer (Photo #14).

Photo #14 - Blade camber side tip area

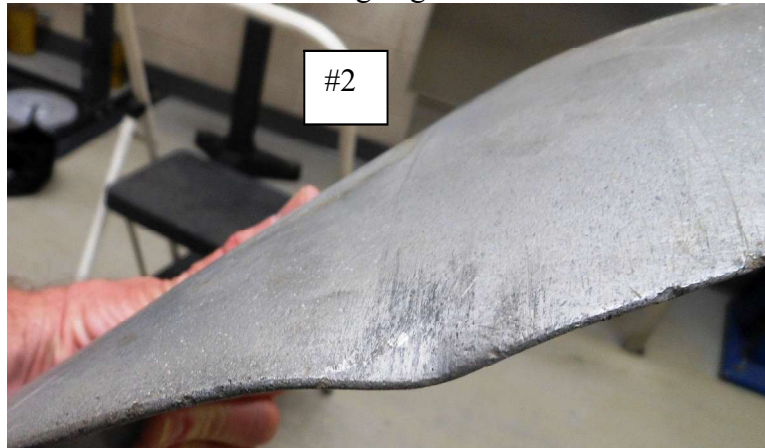
Photo #15 - Blade #2 leading edge bend & chordwise scoring

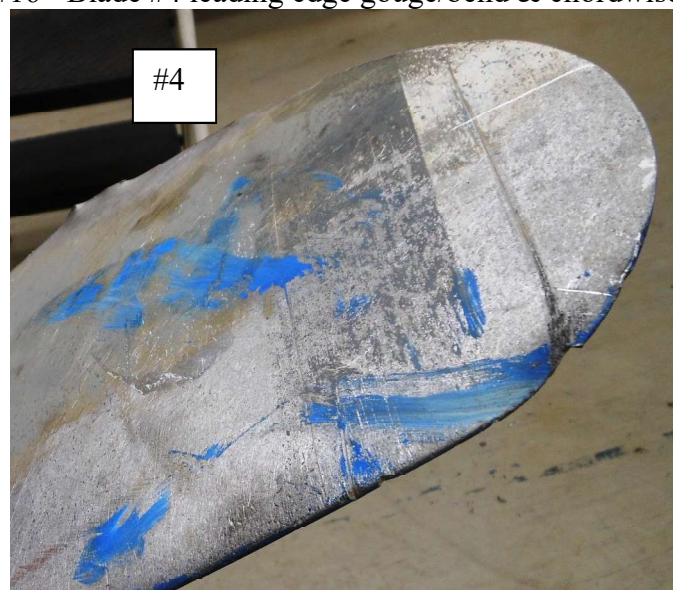
Photo #16 - Blade #4 leading edge gouge/bend & chordwise scoring

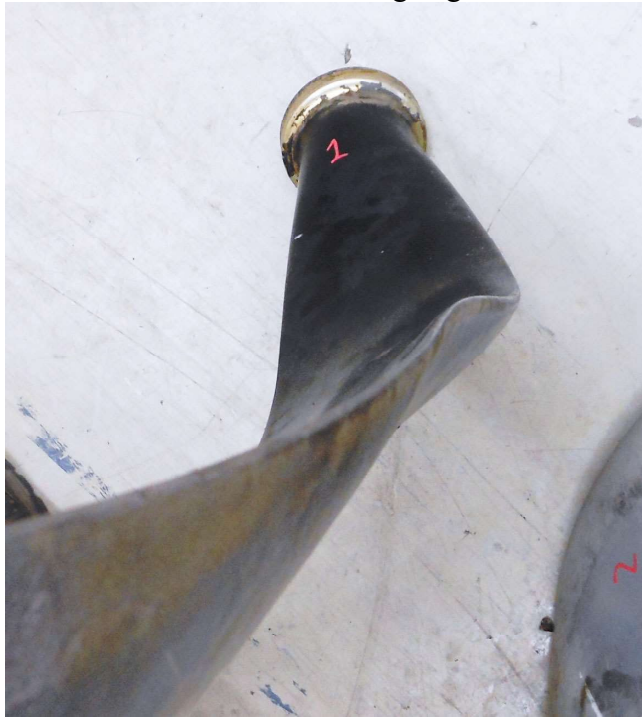
Photo #17 - Blade #1 leading edge wave bend
