# National Transportation Safety Board

WPR22FA214

## **ACCIDENT SITE, AIRFRAME, AND ENGINE EXAMINATION**

Location: Porterville, California  
Date: June 18, 2022  
Time: 1454 Pacific daylight time  
Airplane: N3835U, Cessna 336

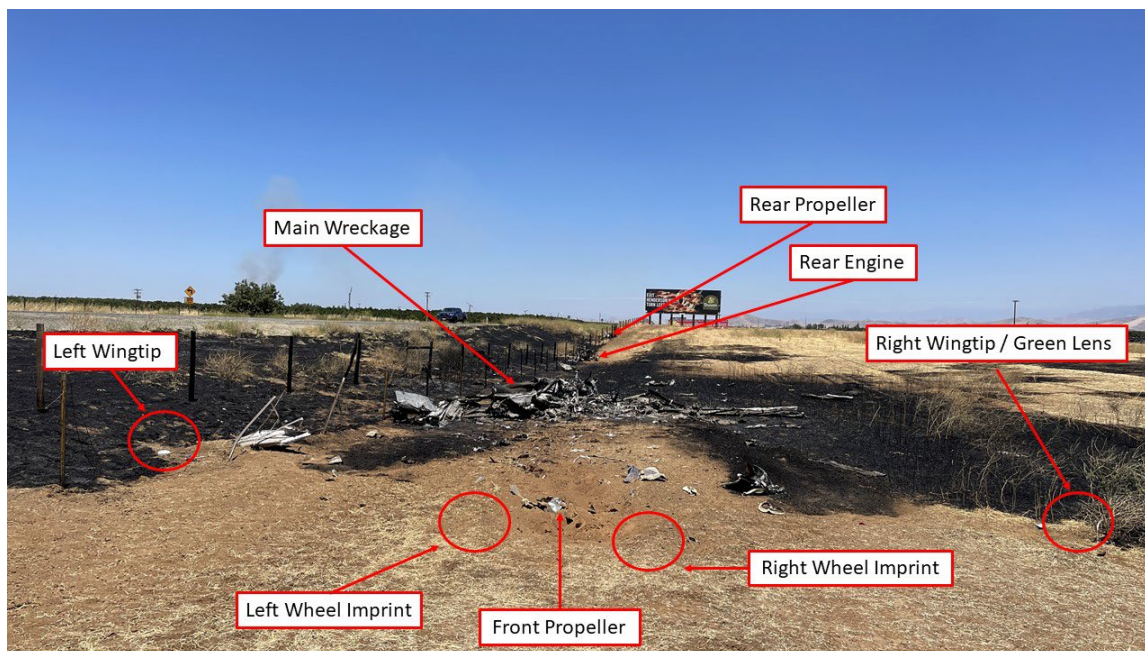
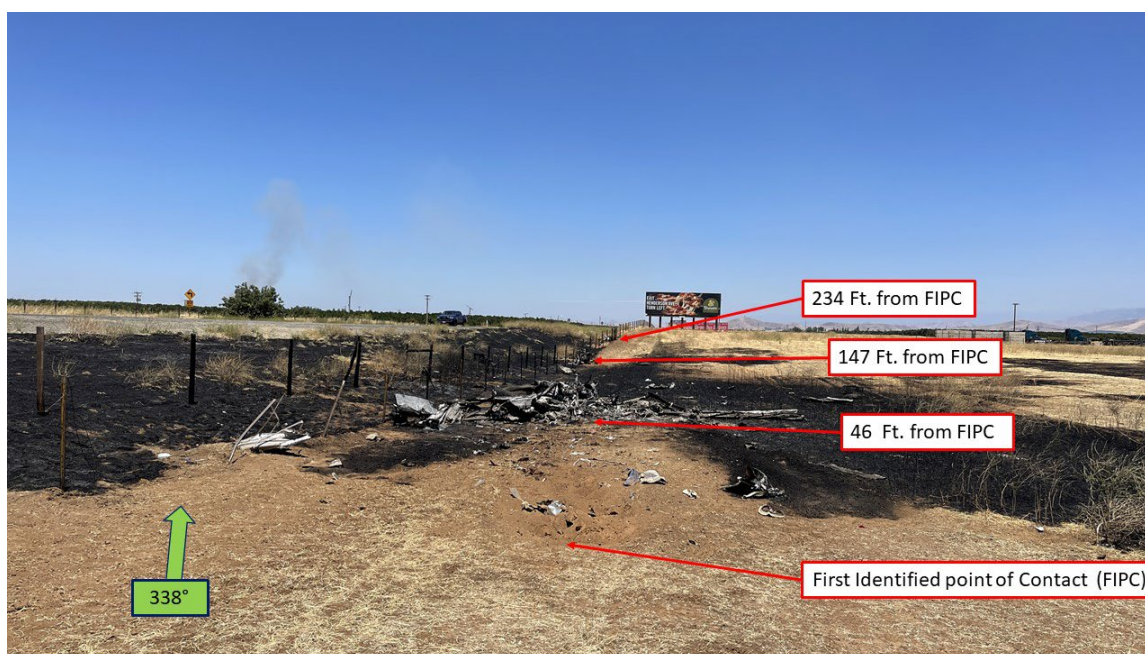
Examination of the accident site revealed that the airplane impacted an open field immediately adjacent to highway 65 on a heading of about 338° and was about 234 ft in length.

The first identified point of contact (FIPC) was a ground crater, about 5.5 ft in length and about 8 ft wide. Adjacent to the start of the crater, was 2 distinct impact marks on the left and right side, consistent with the left and right main landing gear. Embedded within the crater was the front propeller, portions of cowling, and the nose wheel shimmy damper. Extending from the end of the crater, was two distinct impact marks and slightly displaced dirt, consistent with the left and right wing. The marks extended out to wingtip debris and were consistent with the length of the wings. Within the debris of the right wingtip, green nav light lens fragments were observed. Adjacent to the debris of the left wing, was the aileron to aileron bellcrank, embedded within the ground, at an approximate 90° angle.

**Figure 1: Wreckage diagram.**

**Figure 2: Wreckage diagram.**

Extending from the FIPC was portions of various instruments, fragments of avionics, cowling, and fragments of aluminum. The main wreckage, which consisted of the front engine, both wings, left and right booms, remains of the fuselage, and empennage was about 25 ft from the FIPC.

The rear engine was separated from the airframe and located about 147 ft from the FIPC. The rear propeller was located about 234 ft from the FIPC.

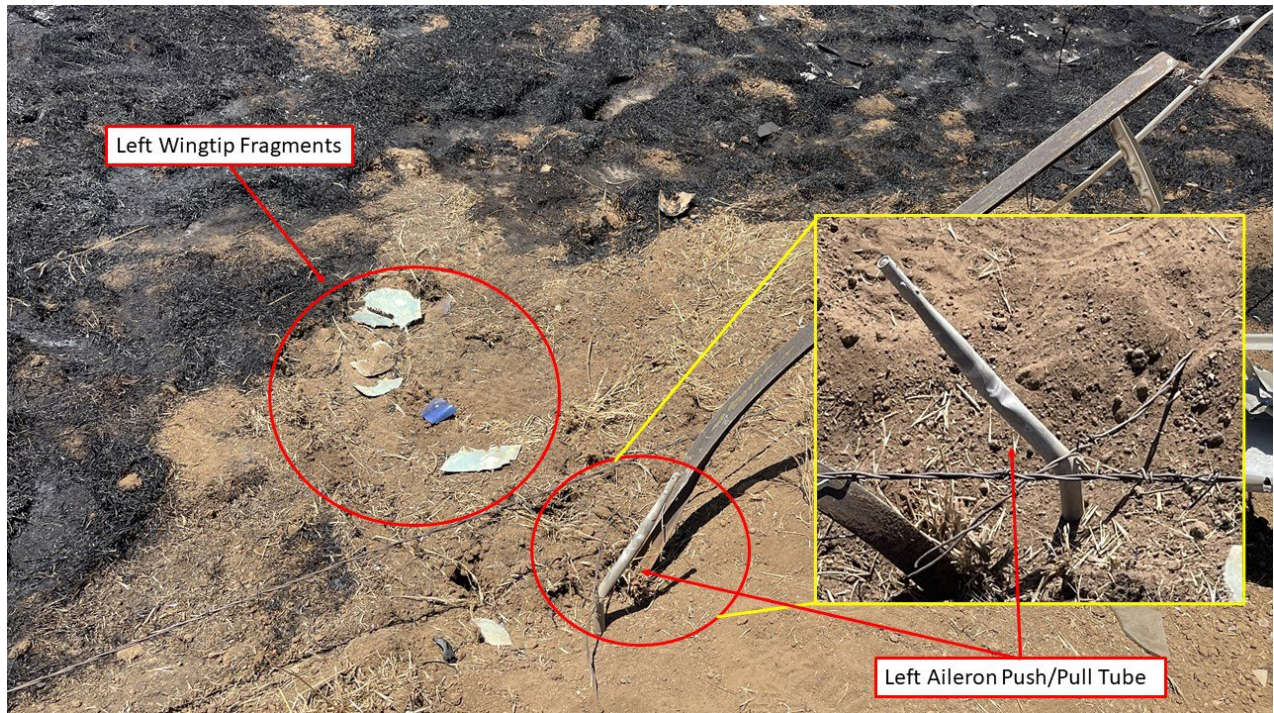
**Figure 3: Fragments of the left wingtip, and left wing aileron to bellcrank torque tube.**

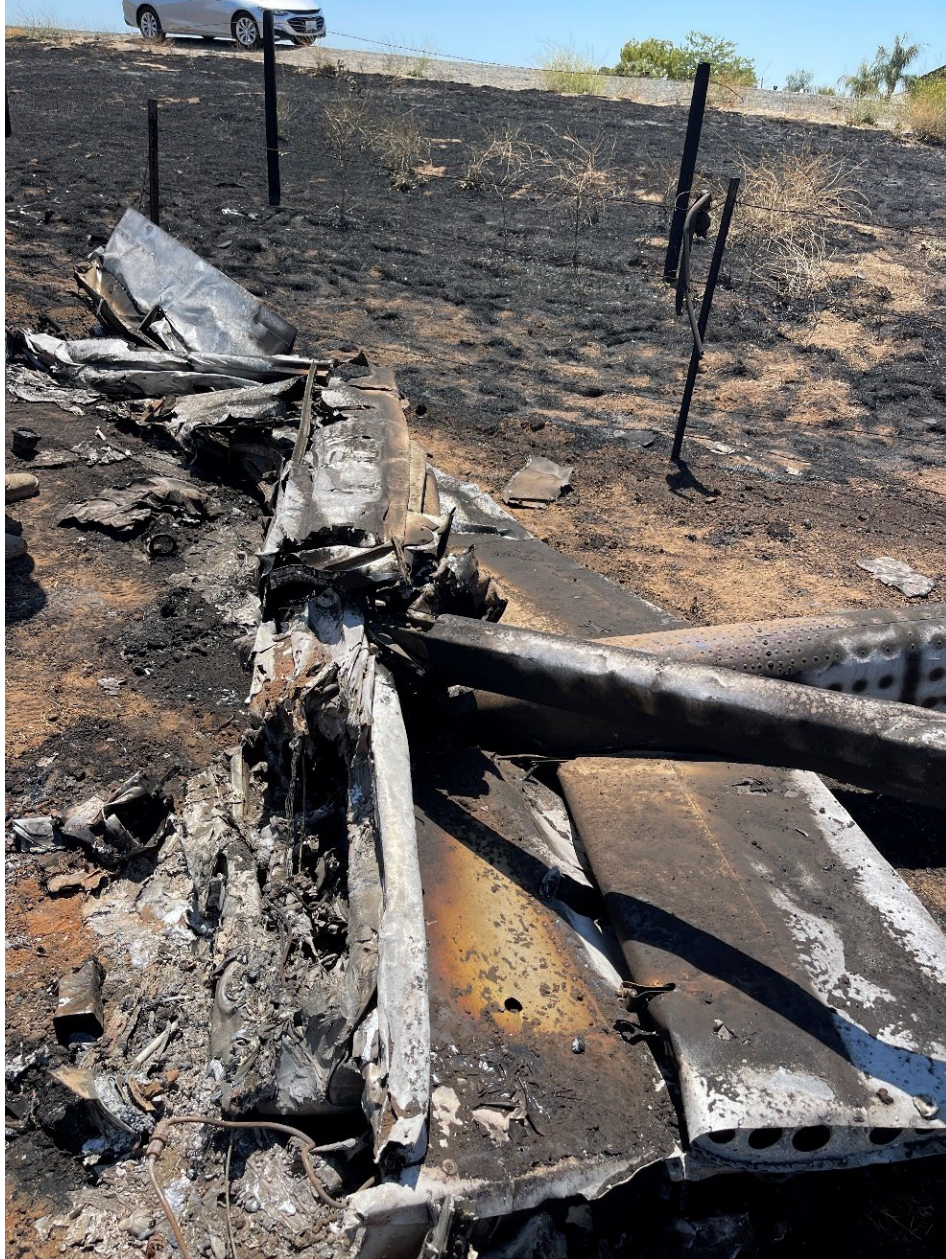
The left wing remained partially attached to the fuselage. The wing structure was compressed aft throughout the span of the wing. The forward spar was crushed aft to about 12 to 18 inches forward of the aft spar. The left outboard and inboard flaps were fire damaged and partially attached to the wing structure. The aileron remained partially attached to the wing structure.

**Figure 4: Left wing.**

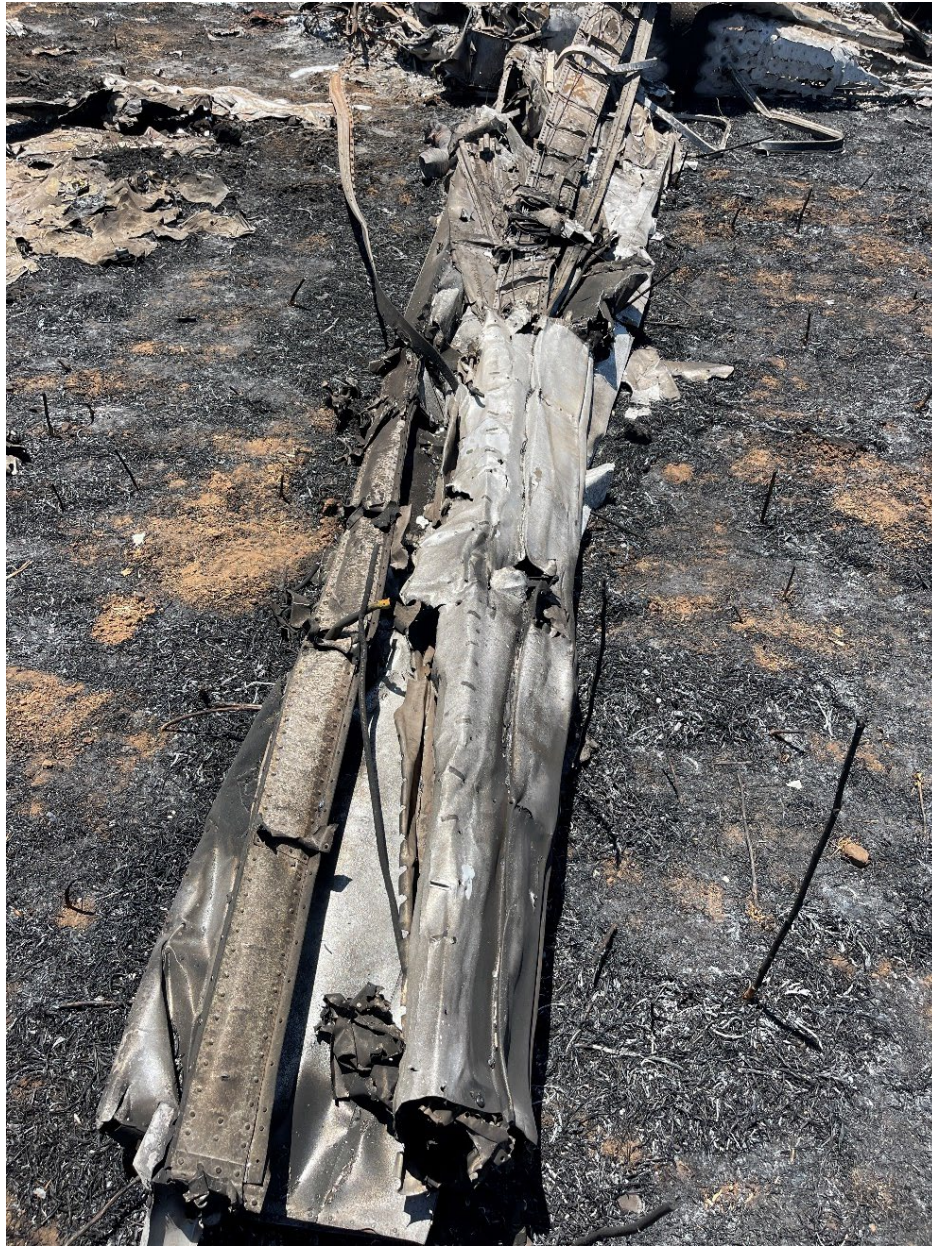
The right wing remained partially attached to the fuselage. The wing structure was compressed aft throughout the span of the wing. The forward spar was crushed aft to about 12 to 18 inches forward of the aft spar. Remains of the outboard and inboard flaps were present, however, the flaps were mostly consumed by fire and partially attached to the wing structure. The aileron was mostly consumed by fire and remained partially attached to the wing structure.

**Figure 5: Right wing.**

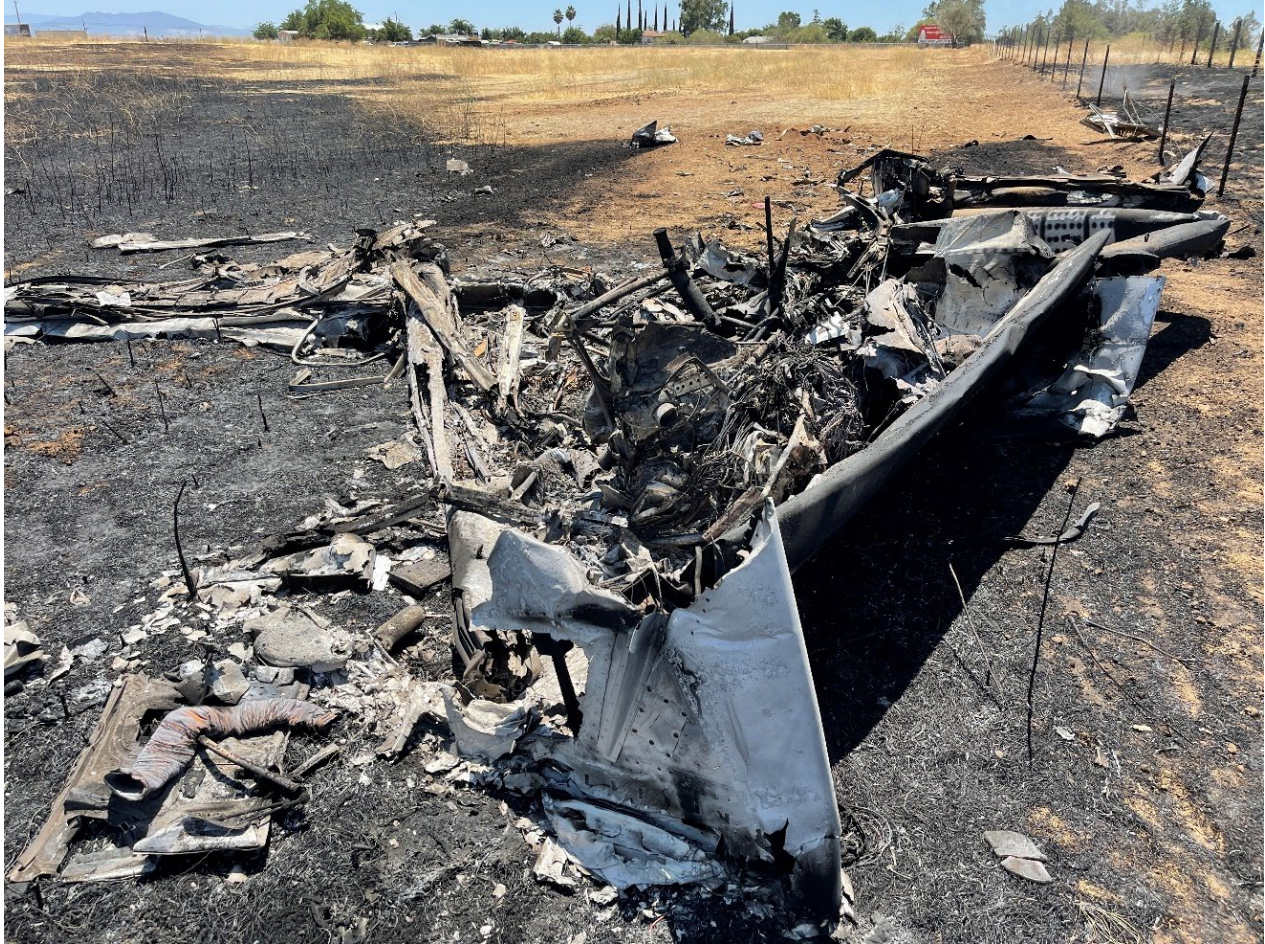
The left and right tail booms were impact damaged and partially consumed by fire. The left and right rudders remained attached to the empennage/tail booms and were both fire damaged. The elevator remained attached to the horizontal stabilizer. The horizontal stabilizer remained attached to the tail booms. The elevator and horizontal stabilizer were impact and fire damaged.

**Figure 6: Main wreckage, tail booms, and empennage.**

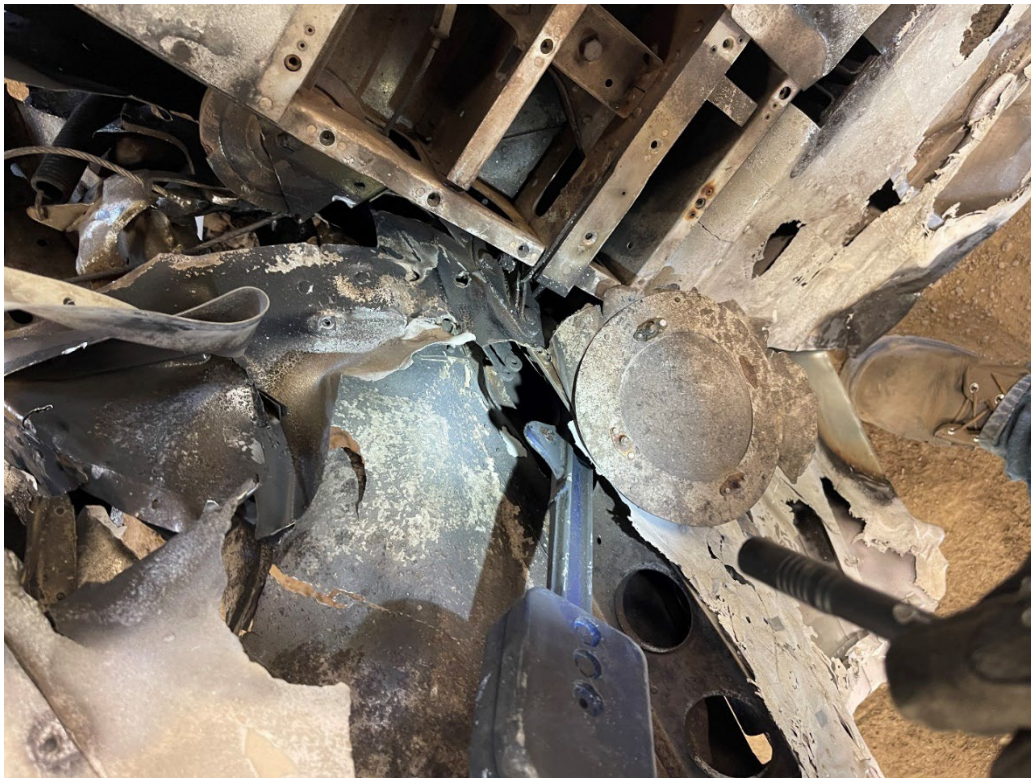
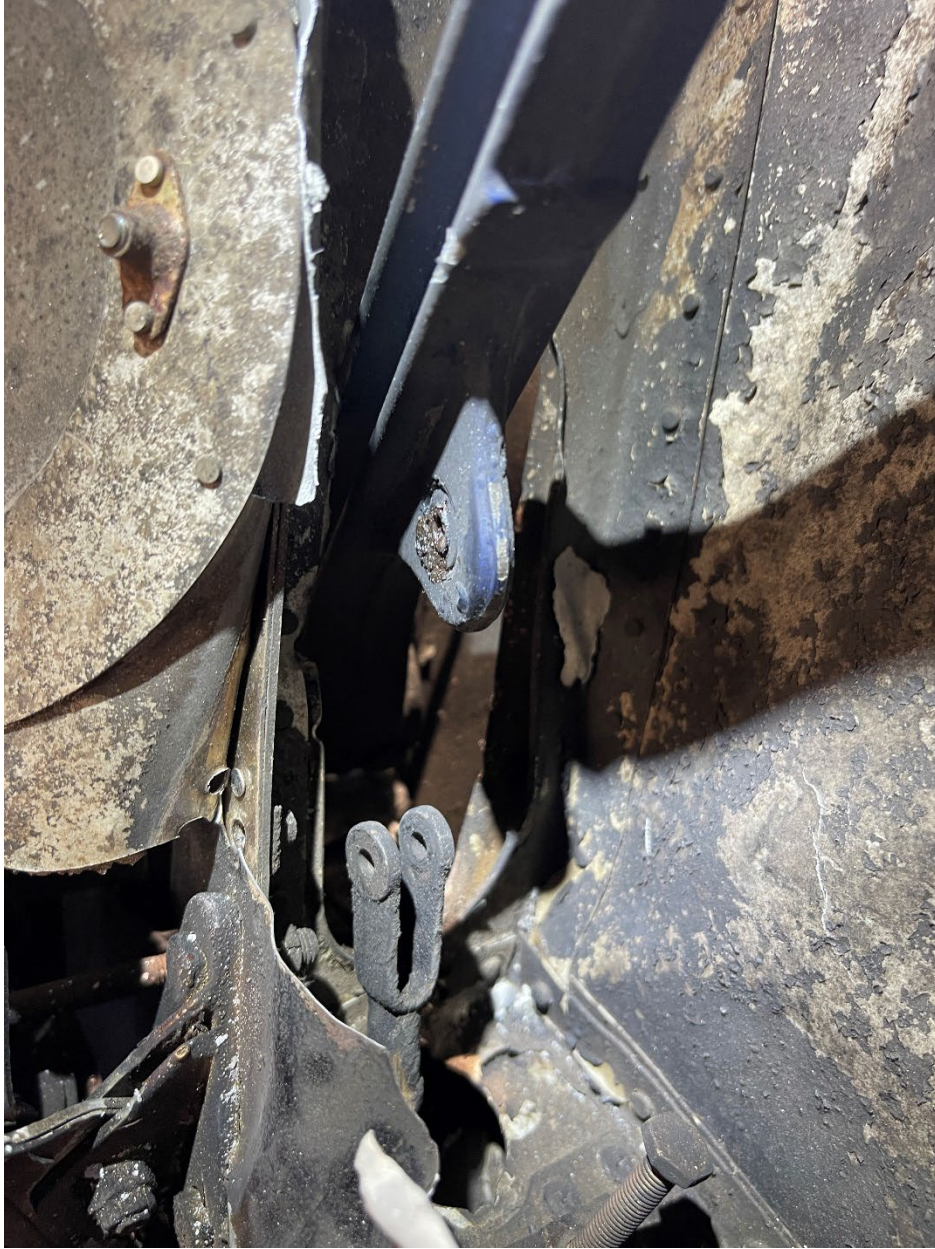
Examination of the recovered wreckage on August 2, 2022, at Plain Parts, Pleasant Grove, California, found the bolt, castellated nut, and cotter pin missing that connects the balance weight to the elevator control assembly. Soot was observed within the area of both connection points, including where the bolt and washer would have been installed. The missing bolt, nut, washer, and cotter key were not located.

**Figure 7: View of the separated control rod (balance weight to elevator).**

**Figure 8: View of the separated control rod (balance weight to elevator).**
