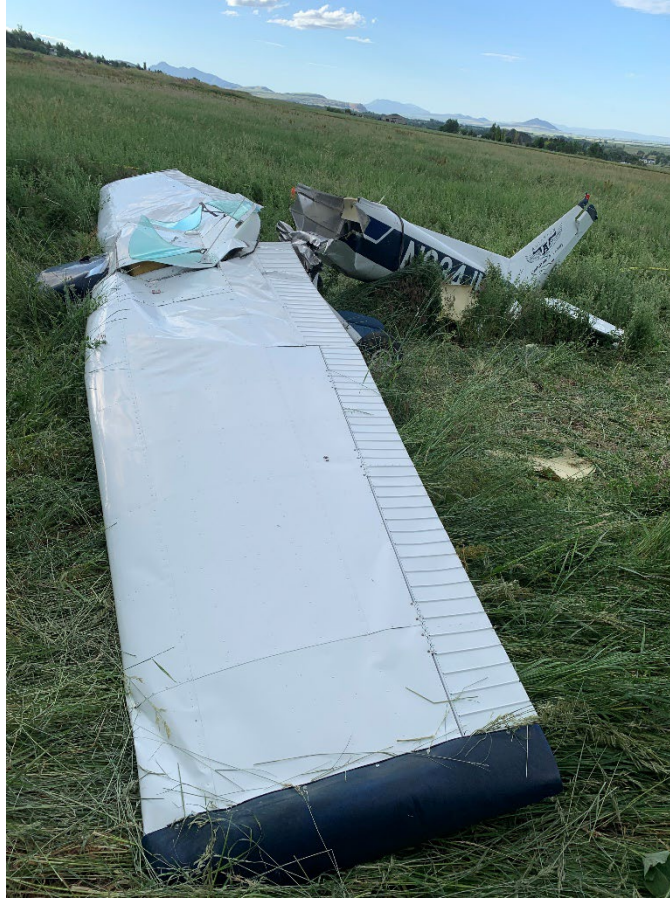
**Photo 1 – View of substantial damage to both wings and fuselage (Courtesy of IIC)**

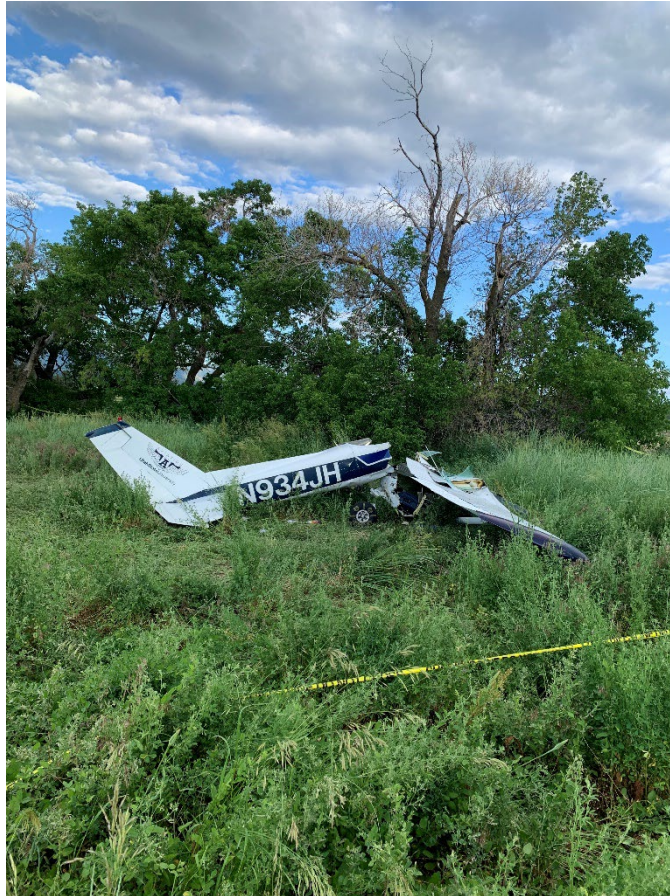
**Photo 2 – View of substantial damage to the fuselage (Courtesy of IIC)**

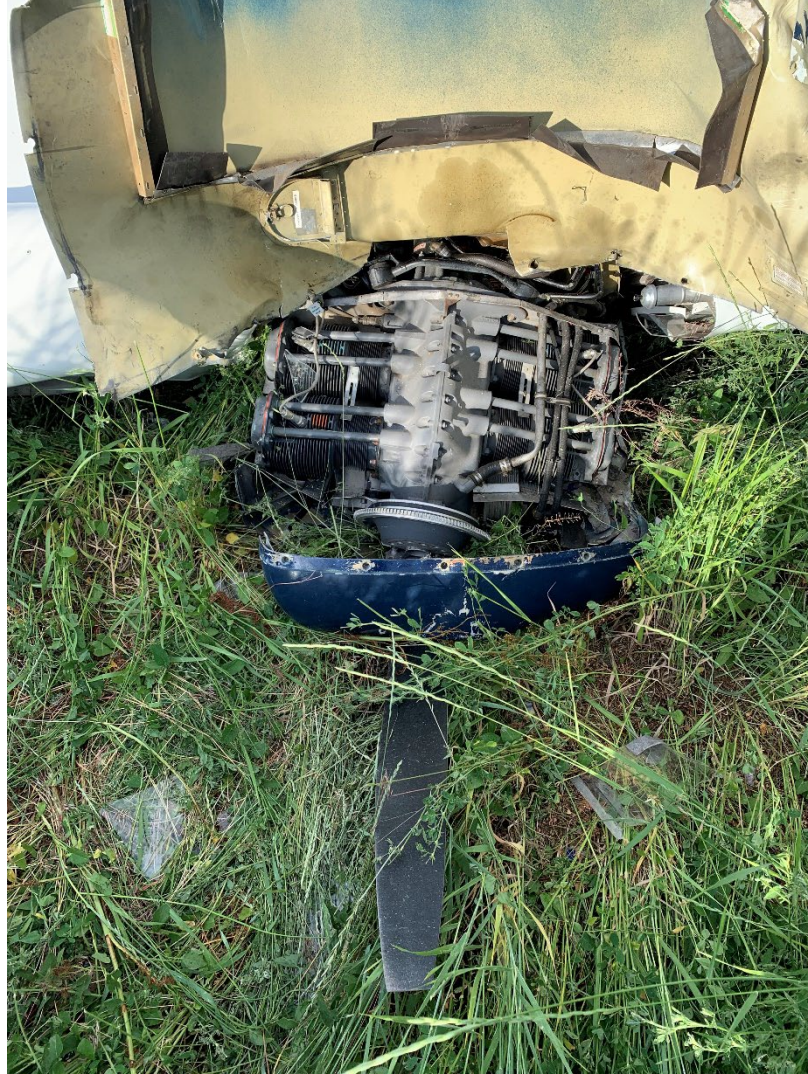
**Photo 3 – View of propeller and engine impact damage (Courtesy of IIC)**
