# National Transportation Safety Board

WPR22FA227

## EXAMINATION

Location: Mendon, Utah  
Date: June 24, 2022  
Time: 0903L  
0303 (UTC)  
Airplane: N934JH, 1979 Cessna Aircraft Company, Model 152

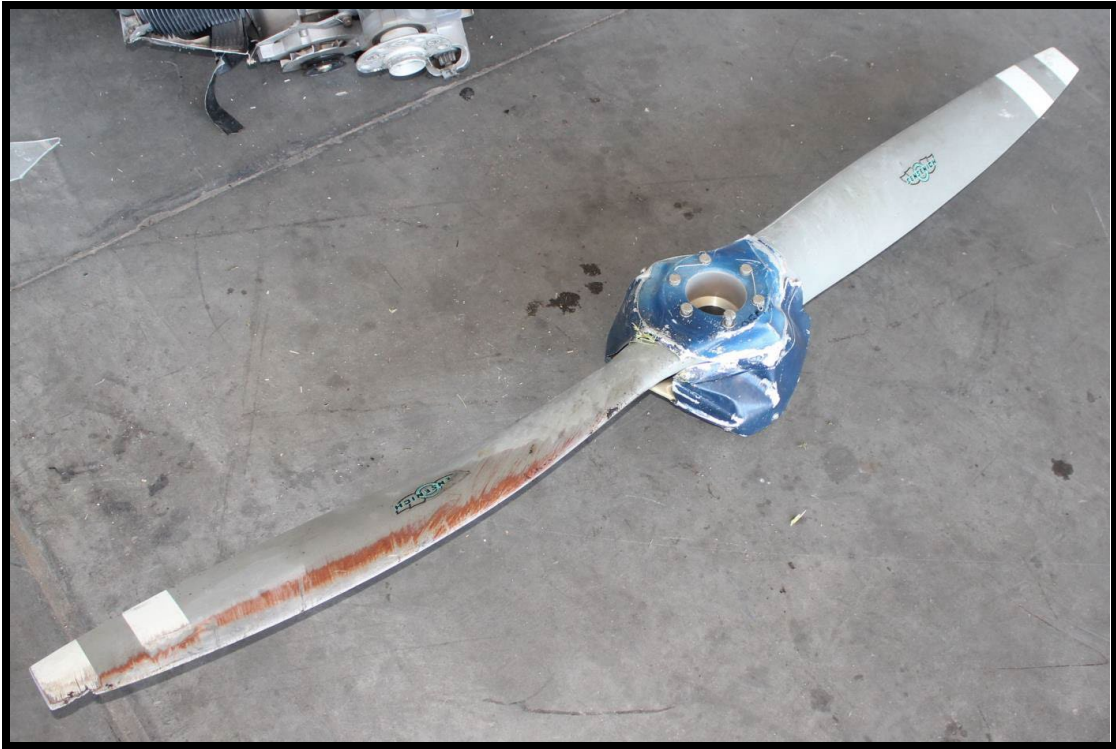
The metal two bladed, fixed-pitch propeller was displaced from the crankshaft flange at the mechanical attachment of the propeller. The fracture surfaces exhibited signatures consistent with overload due to the absorption of rotational energy. The propeller blades remained continuous from tip to tip. The spinner was crushed over the hub area of the propeller. One of the blades

exhibited leading edge damage and burnishing along most of the blade length. The opposing blade remained undamaged.

**Figure 3: N934JH Propeller removed for engine examination**
