## Air Safety Investigations Aircraft Incident/Accident Technical Report

| Aircraft Incident/<br>Accident Information | Year: 1979 | Make: Cessna | Model: 152 |
| Air Safety Investigator: Casey J. Love | | Report #: ASI-22-BK-T | Report date: 12-14-22 |

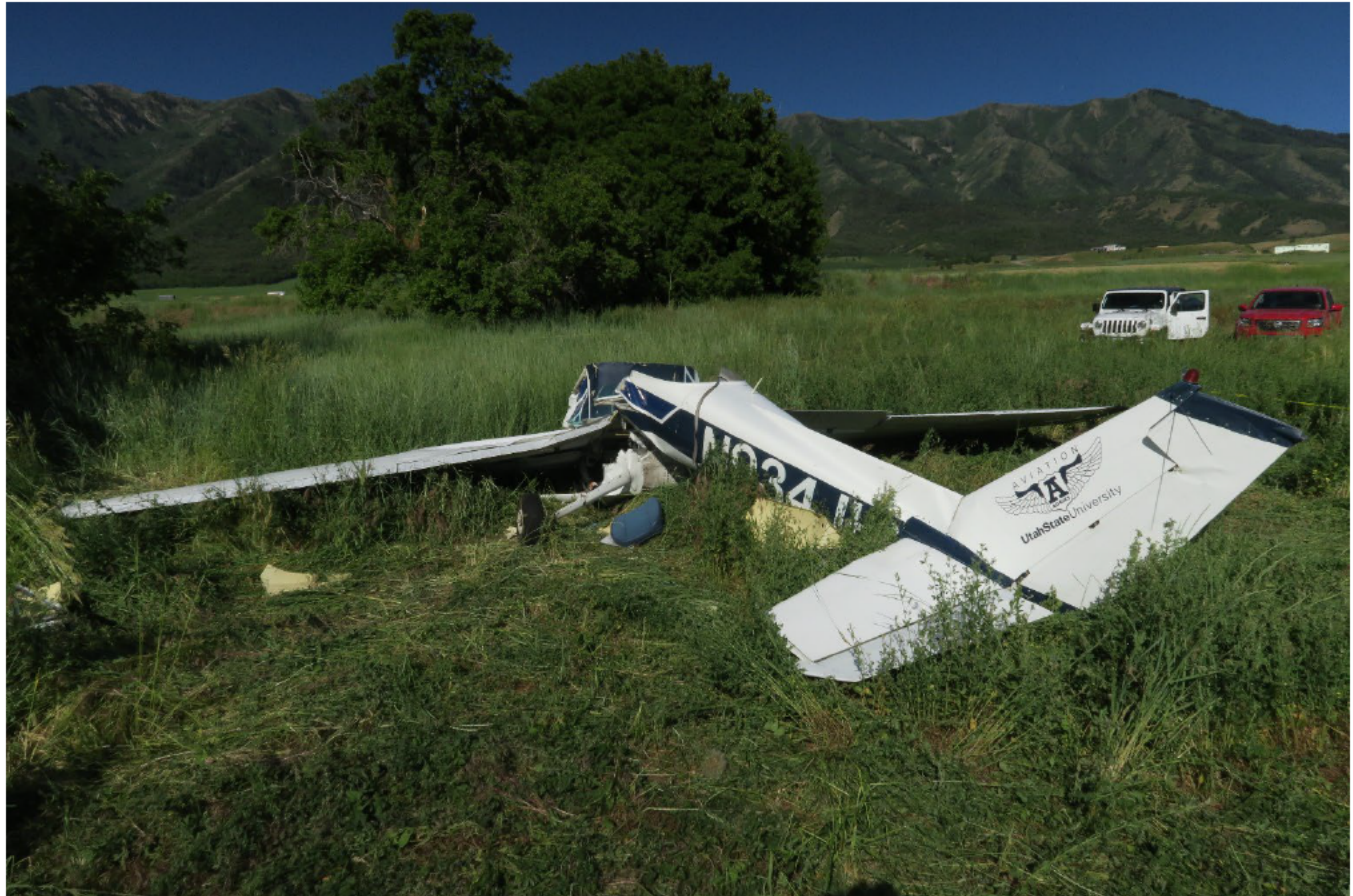
ASI-22-BK-006 (Wreckage Overview)

The aircraft impacted terrain with the wings level and nose in a near 45 degree down attitude. The cockpit was compressed upward and aft, decreasing cockpit volume. The wings remained connected to the wing attach fittings. Both lift struts remained attached to the fuselage and the wings. Both wing root skins exhibited compression damage. Neither wing leading edge exhibited signs of impact compression damage. The aluminum fuel tanks remained intact. The right wing was bent upward approximately 10 degrees outboard of the lift strut. The upper wing skins exhibited wrinkles consistent with compression. The lower wing skins in the same area exhibited wrinkles consistent with tension. The empennage remained intact. The left horizontal stabilizer was bent downward approximately 10 degrees about midspan.

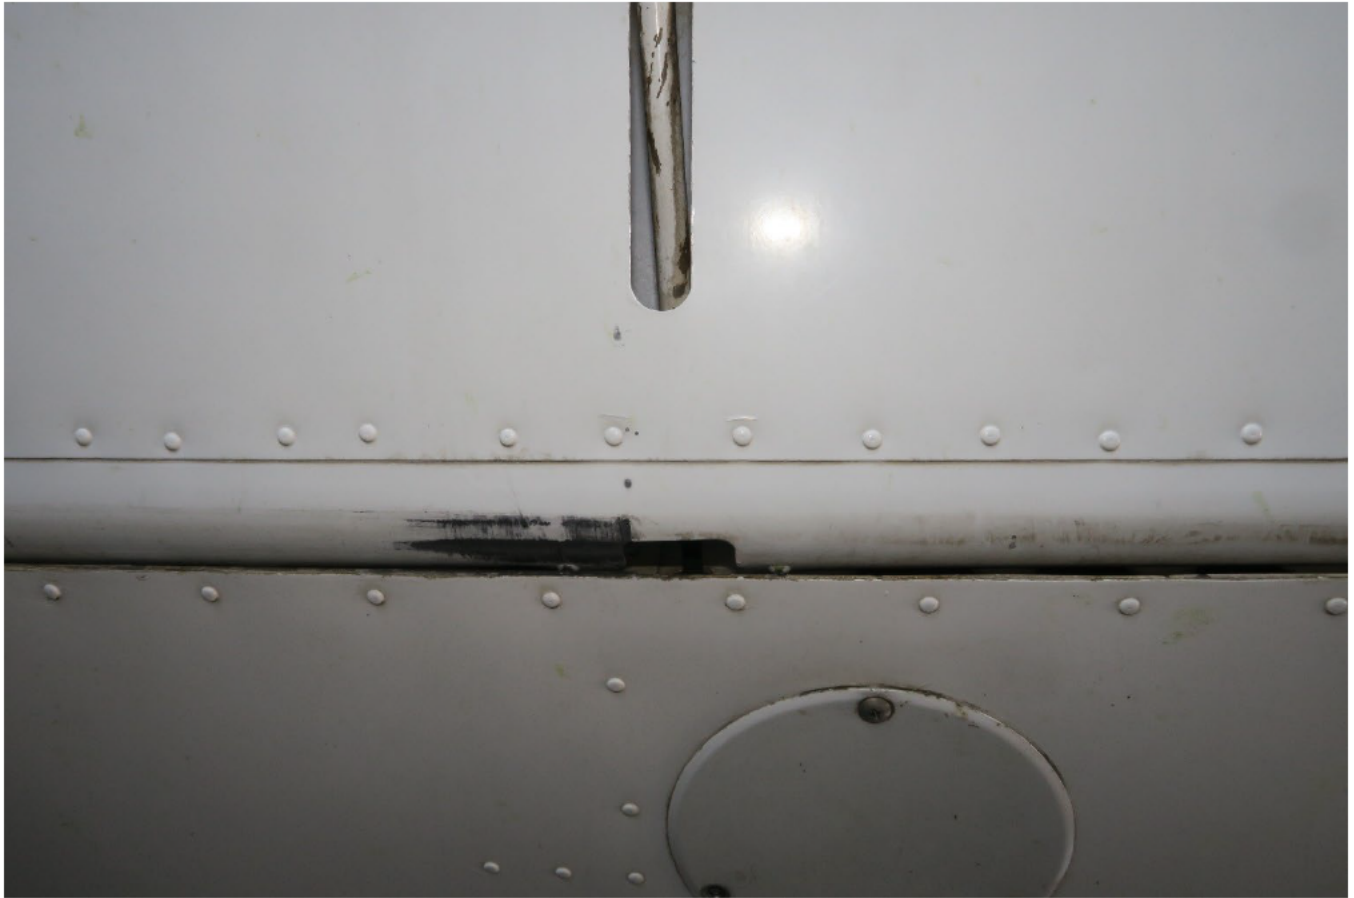
An area of chaffing approximately 4" in length between the right elevator and the right horizontal stabilizer lower skin existed in the area of the elevator trim actuator support structure. During examination there was light contact between the stabilizer skin and the elevator skin. The contact did not impede elevator movement during examination. The elevator was pushed downward, by hand, toward the stabilizer skin which only slightly increased contact and still did not impede movement. No other preimpact contact between the empennage control surfaces was noted.

Wreckage Exam ASI-22-BK-029 (chaffing area of right horizontal stabilizer and elevator)

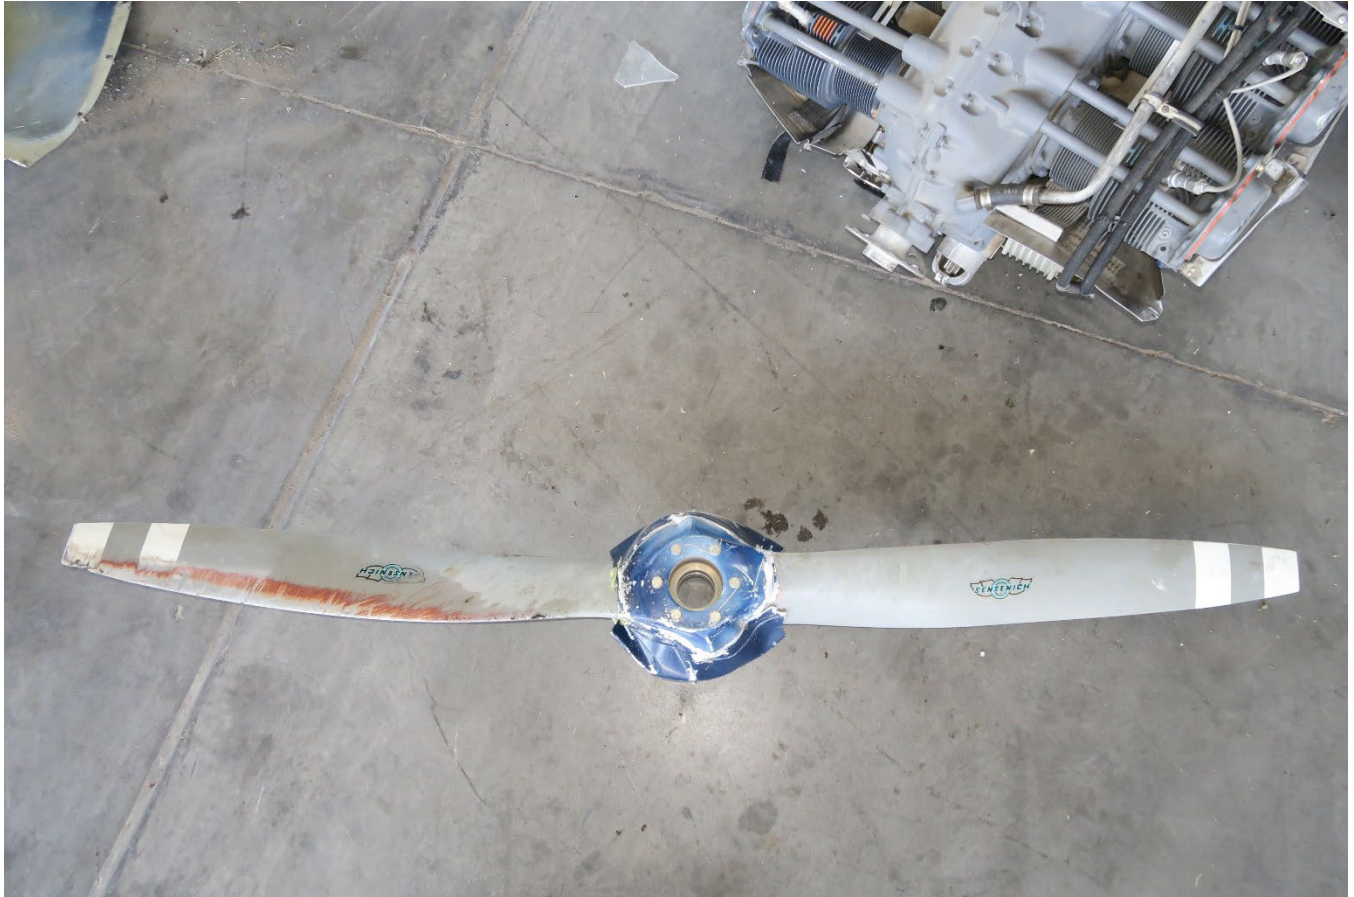
The propeller was observed in a vertical position with one blade underneath the cowling and the other upward. The 3 propeller attach bolts on the upper portion of the crankshaft flange were pulled from the crankshaft flange upon impact. The 3 lower bolts remained in place but were bent.

Blade A was unremarkable. Blade B was observed bent beneath the cowling on scene. The back of the blade exhibited polishing from near the root to the tip, toward the leading edge. Neither blade exhibited scoring or leading-edge gouging.

Wreckage Exam ASI-22-BK-016 (propeller)
