# National Transportation Safety Board

WPR22FA239

## **ON-SITE AND EXAMINATION SUMMARY**

Location: Lind, Washington  
Date: July 2, 2024  
Time: 1730 Pacific daylight time (PDT)  
0030 coordinated universal time (UTC)  
Airplane: Air Tractor 602-AT N602GH

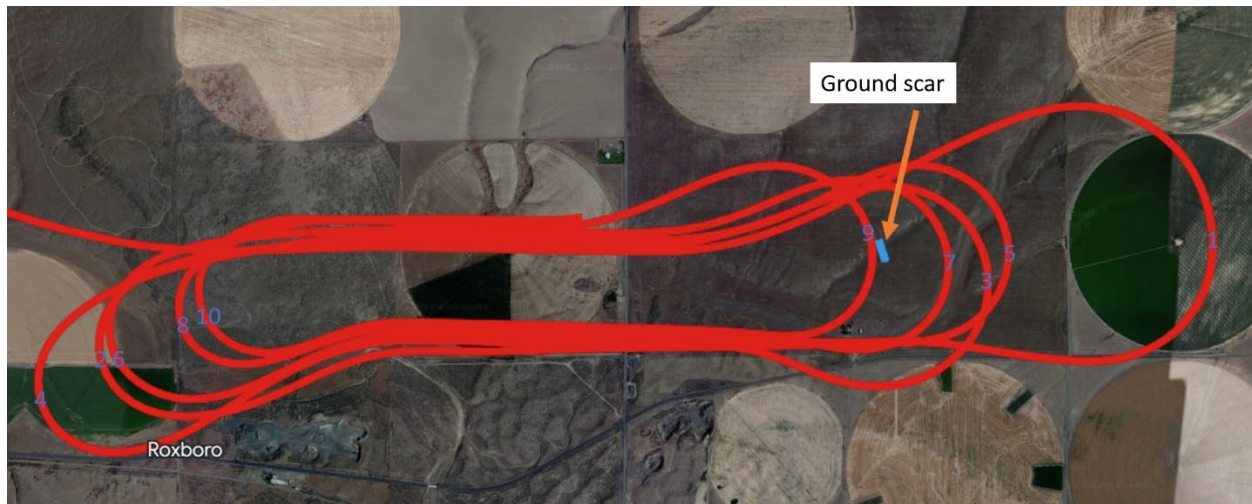
According to a witness, about 1717, the pilot departed his hangar after refueling and re-loading the hopper for an aerial application flight. Global positioning satellite data revealed that the pilot was applying pesticide in a west to east racetrack pattern (figure 1). The pilot was on a west to east track and while maneuvering at a low altitude over an open field, about 1733, the airplane impacted terrain. Surveillance video footage from a building about 1 nm southwest of the accident site showed that the airplane moved forward about wings level and transitioned into a steep, almost vertical, right turn. About seven seconds later, the airplane

starts a nose down, right wind low decent and then disappears behind a knoll. Shortly after, a plumb of dust is seen.

**Figure 1. GPS data plot of aerial application accident flight.**

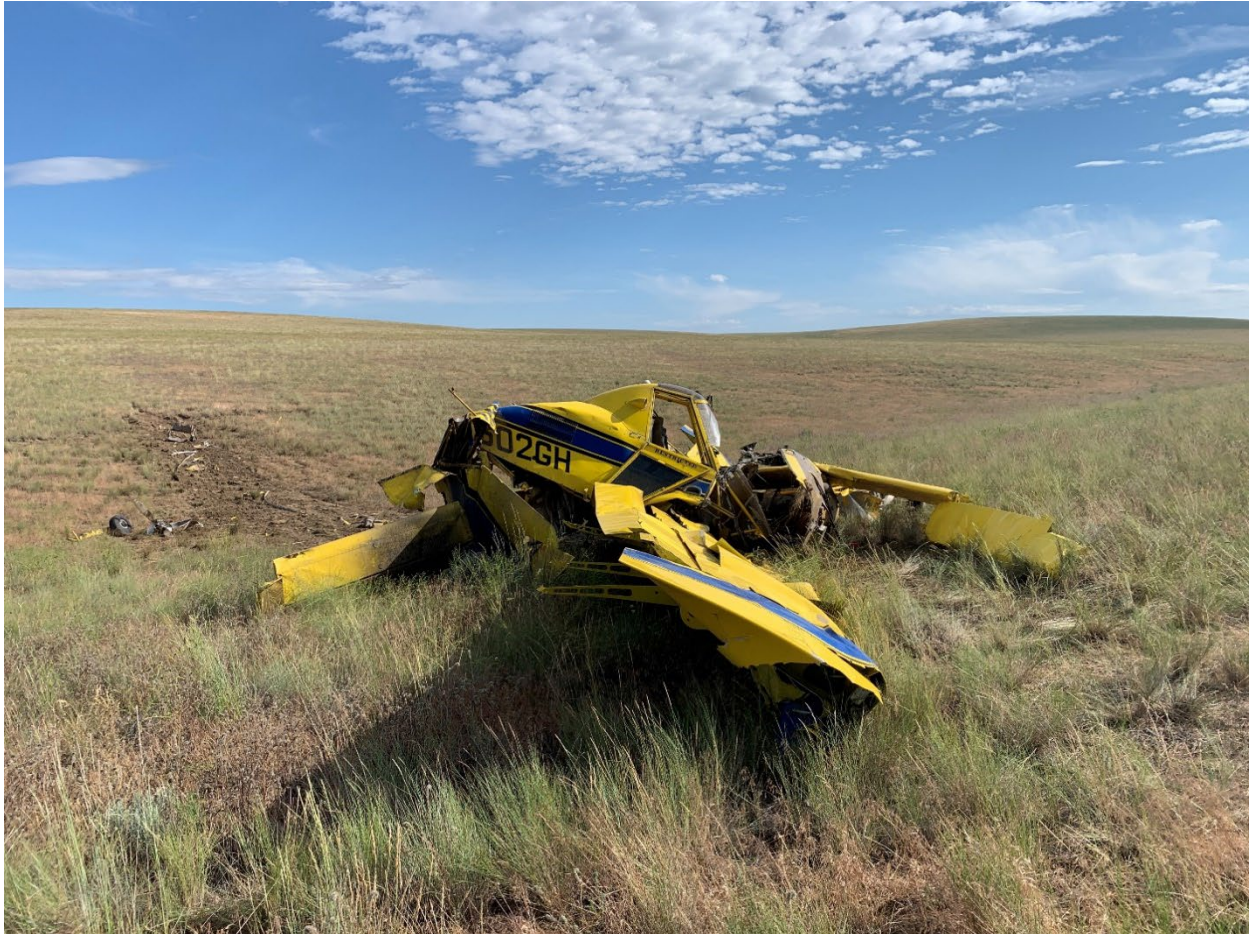
The airplane impacted a dirt field about 4.5 nautical miles east from the hangar at an elevation of about 18,83 ft mean sea level. The wreckage debris path was about 190 ft long and oriented on a magnetic heading of about 155 °. The airplane came to rest on upright after it slid upslope (figure 2).

**Figure 2. View of accident airplane in an open field.**

The first point of impact (FPI) identified was an impression in the ground consistent with the left tire, followed by the left wing and belly of the airplane. The FPI contained the left landing gear and fragmented pieces of fiberglass and fuselage. Ground scars and damage to the airplane were consistent with the airplane impacting terrain in a flat, shallow, left-wing low attitude. A post impact fire did not ensue, but fuel odor was present throughout the debris path, consistent with Jet A fuel. All major components of the airplane were located within the debris field.

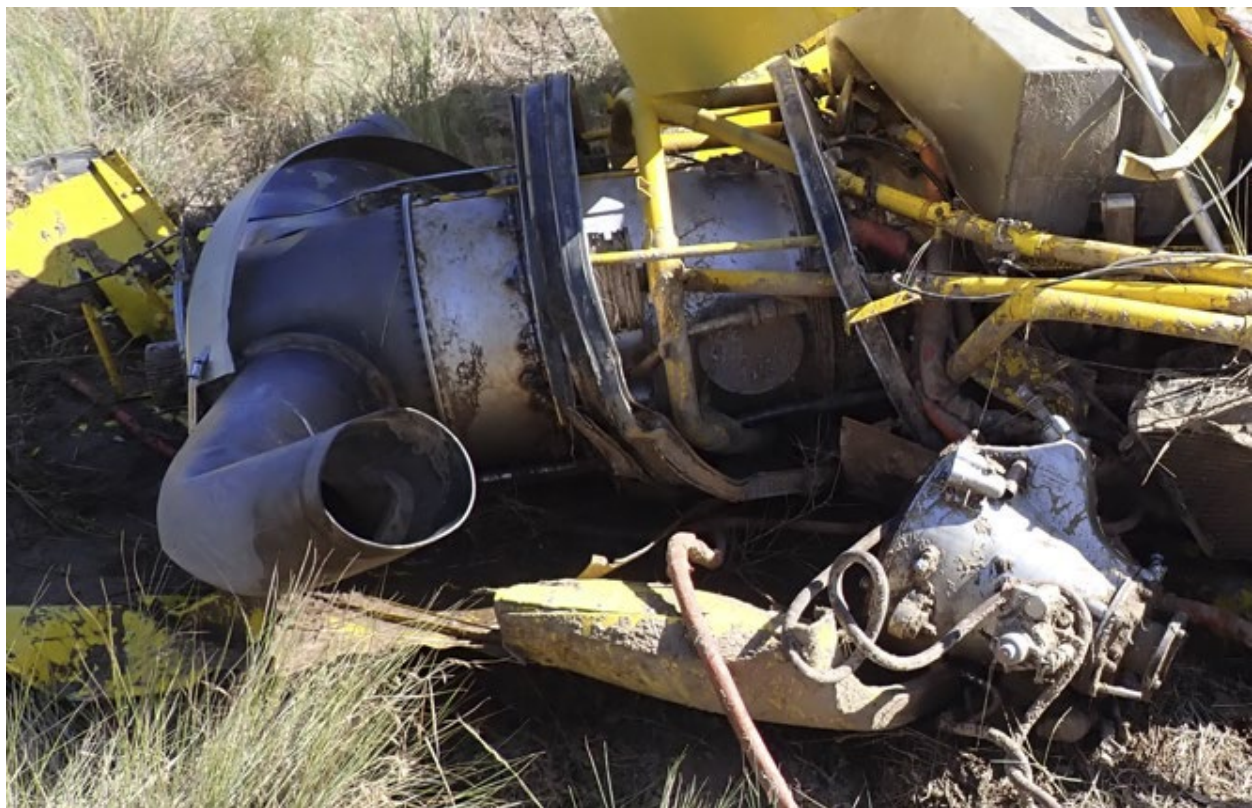
The powerplant, a Pratt & Whitney PT6A-65AG, serial number PCE-PN0004, remained attached to the engine mounts (figure 3). The reduction gearbox was separated from the engine at the "A" flange.

**Figure 3. View of accident airplane attached to engine mounts at the wreckage site.**

An engine examination revealed that the engine displayed contact signatures to its internal components consistent with the engine developing power at the time of the impact. Furthermore, the fractures seen throughout the second stage carrier slots were consistent with the engine operating under high power at the time of the accident. There were no indications of any pre-impact mechanical anomalies or failures to the engine or accessories that would have precluded normal operations.

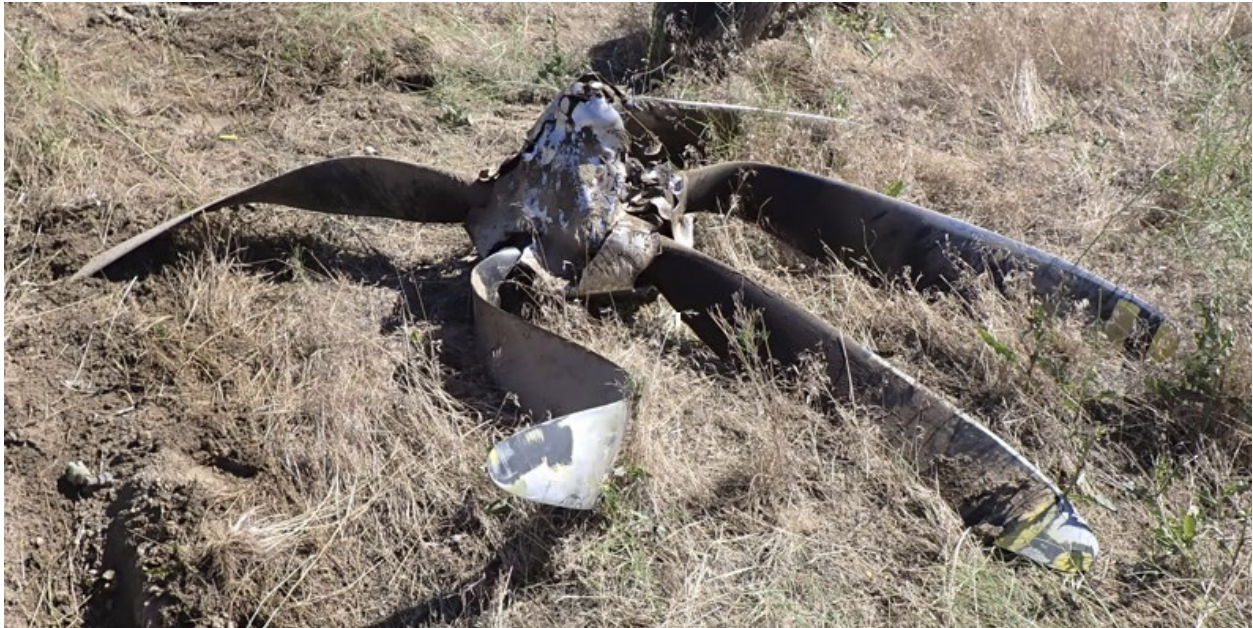
The airplane was equipped with a five-bladed Hartzell reversible propellers. The propeller hub and blade assembly separated from the reduction gearbox at the propellers flange. The second stage carrier No. 5 bearing journal was fractured consistent with tension overload. Each blades remained attached to the propeller hub. Damages to the blades were consistent to the engine operating within a high-power range at the time of the accident.

**Figure 4. View of propeller and blade assembly at the wreckage site.**
