WPR23FA239

## INVESTIGATION PHOTOGRAPHS

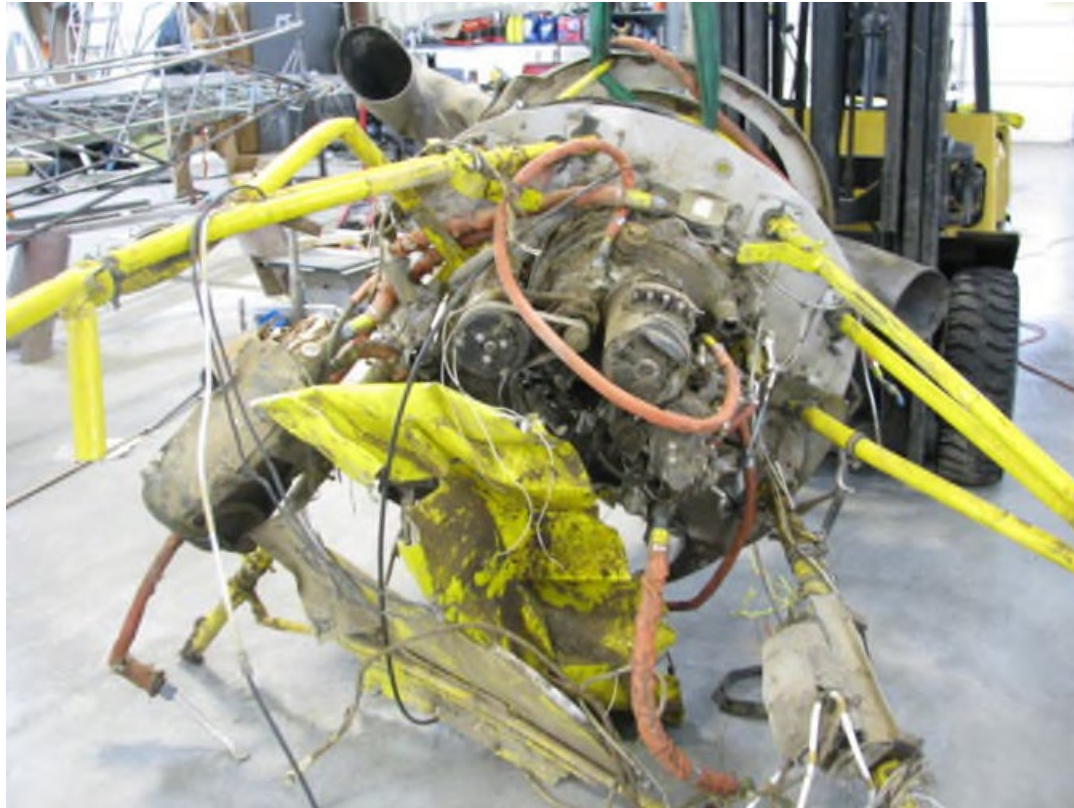
**Photograph 1 - View of accident engine during exam (courtesy of engine manufacturer)**

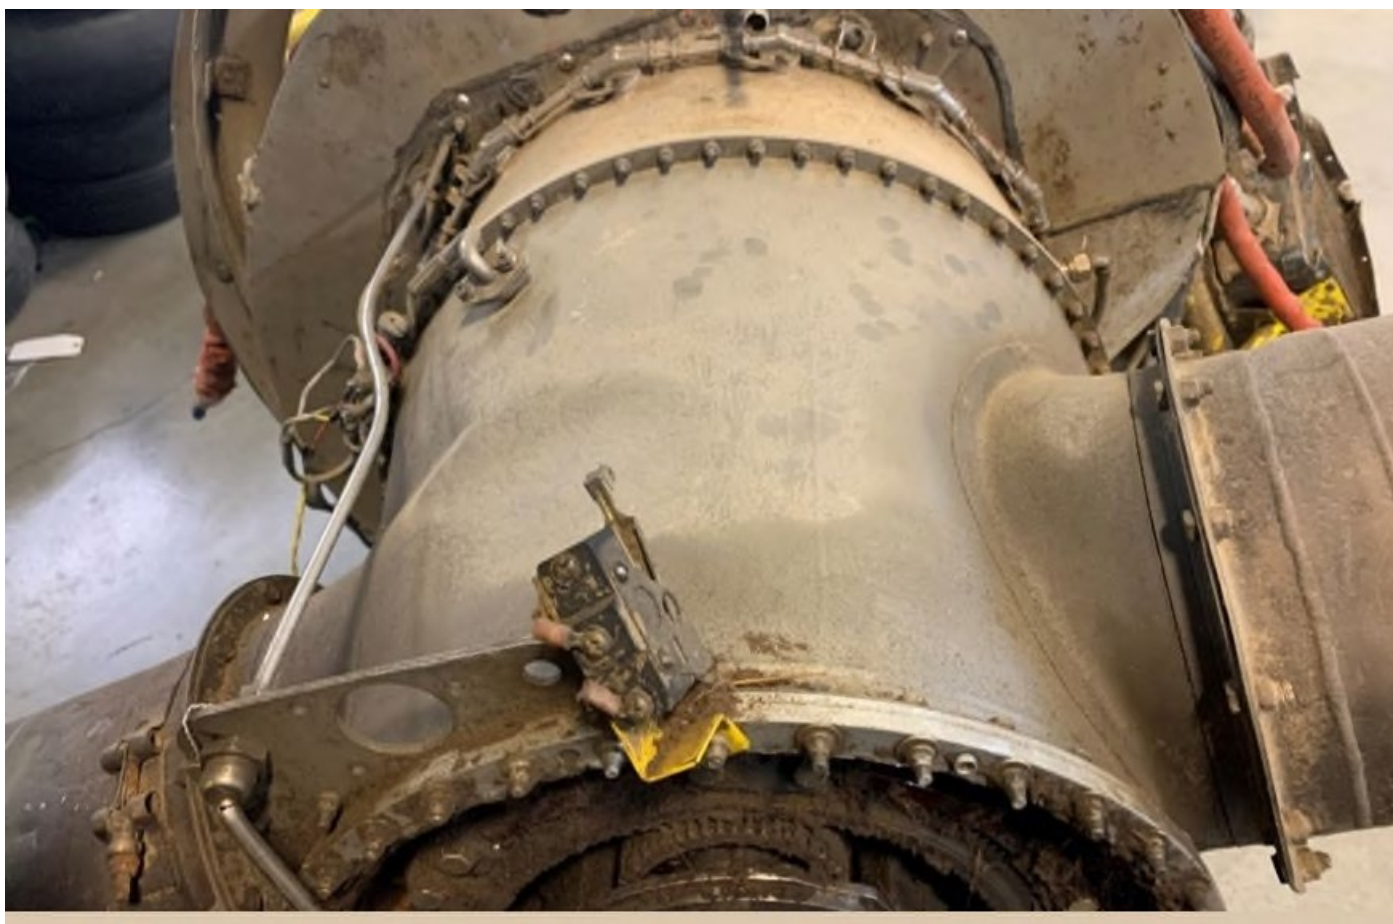
**Photograph 2 - View of exhaust duct with external deformation consistent with torsional energy**

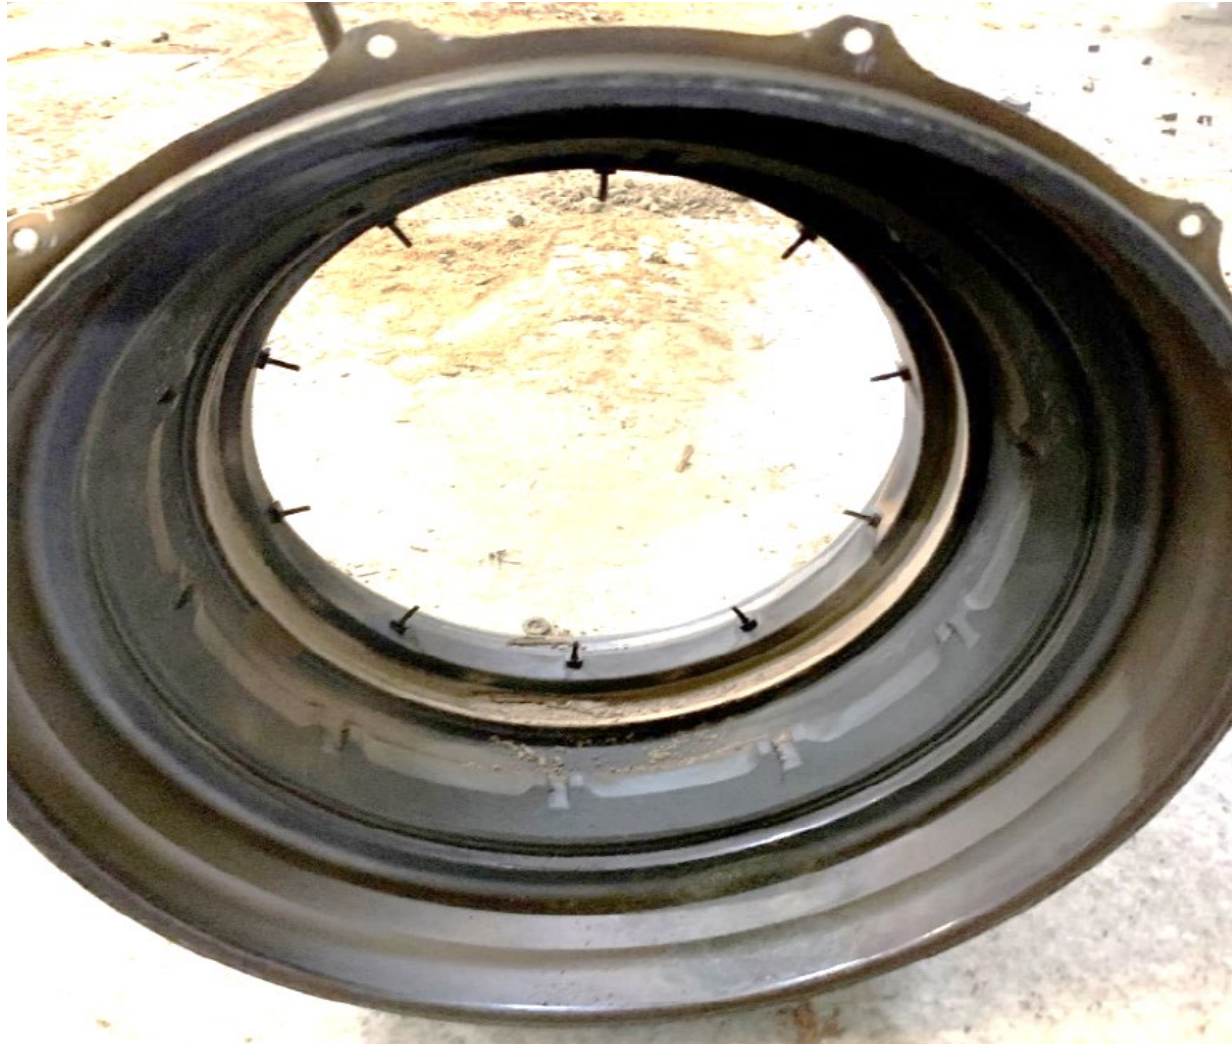
**Photograph 3 - View of Power Turbine stator housing with environmental debris**

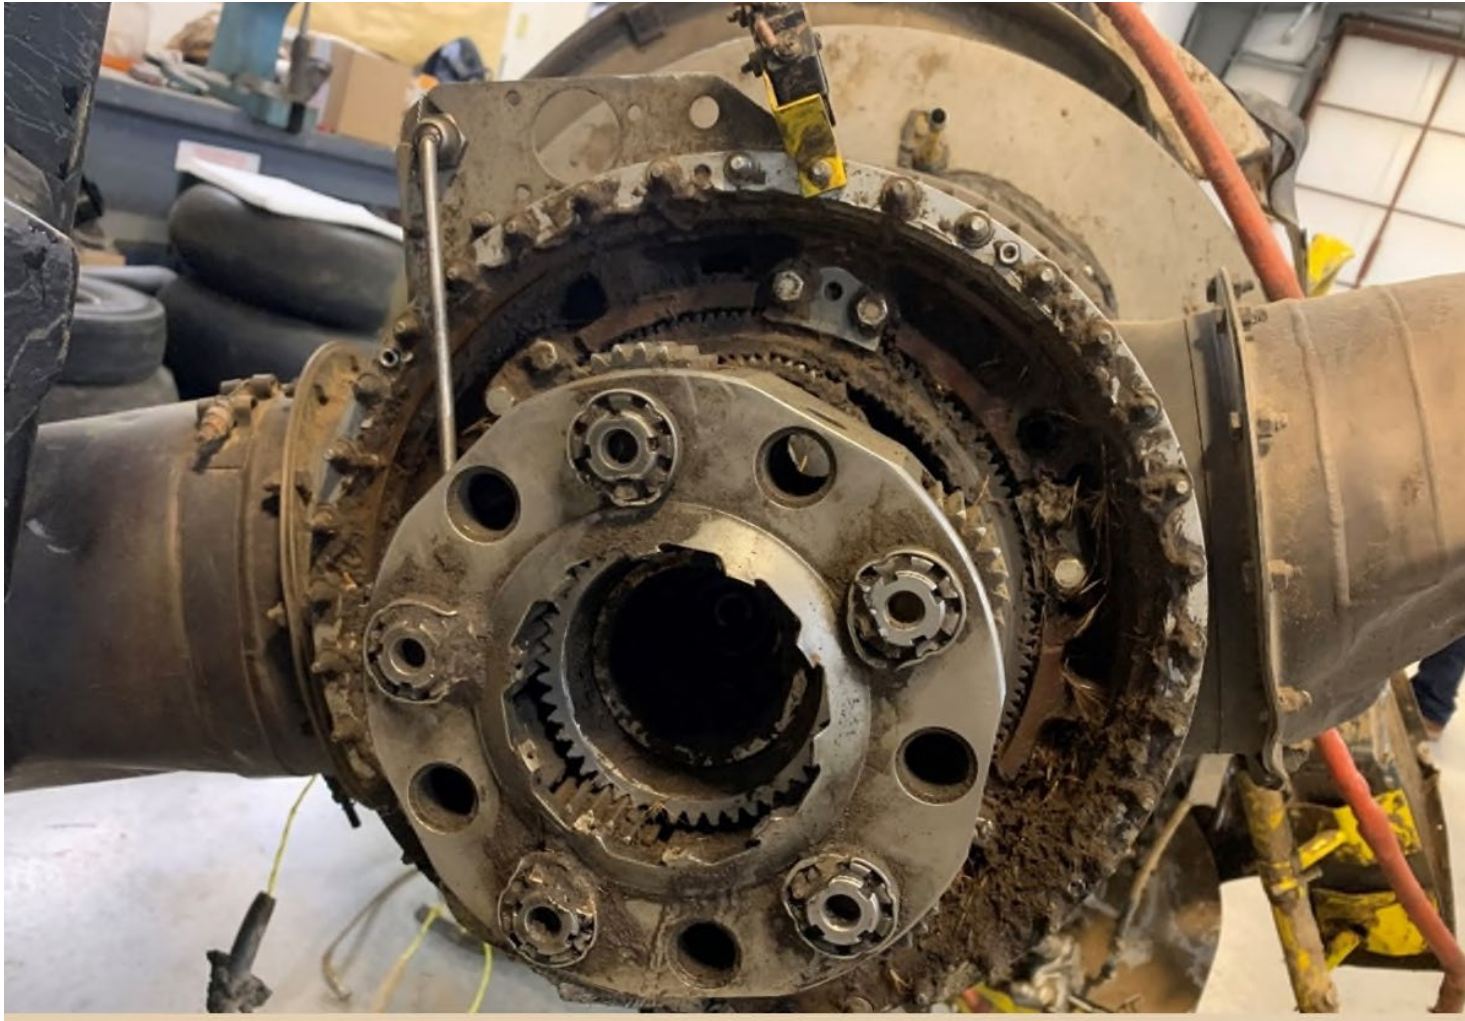
**Photograph 4 - View of reduction gearbox "A" flange fracture**

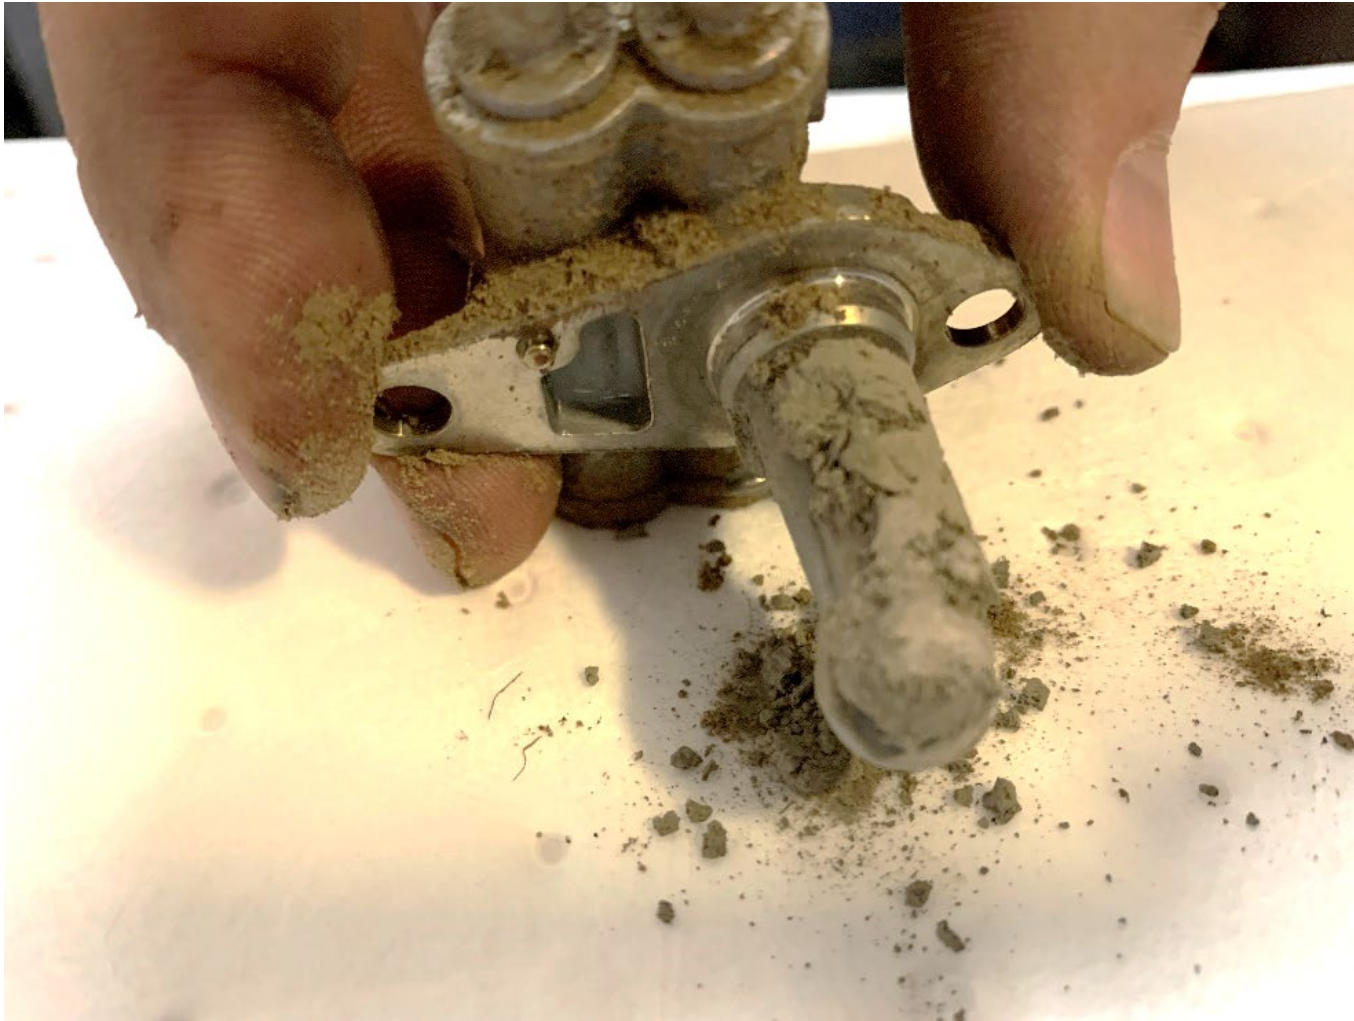
**Photograph 5 - View of a fuel nozzle removed packed with environmental debris**
